SUBJECT: Potential decreased service life of Slick 4-cylinder magneto distributor gear assemblies. **Based on process and component improvements following the initial release of this service bulletin, the serial number range is being extended in this revision. Magnetos previously returned for compliance to SB1-15 must be returned or inspected for compliance to this revision SB1-15A.**

ISSUED			REVISED		
MO	DAY	YR	MO	DAY	YR
07	02	15	11	12	18

PAGE NO.	REVISION
1 of 4	A

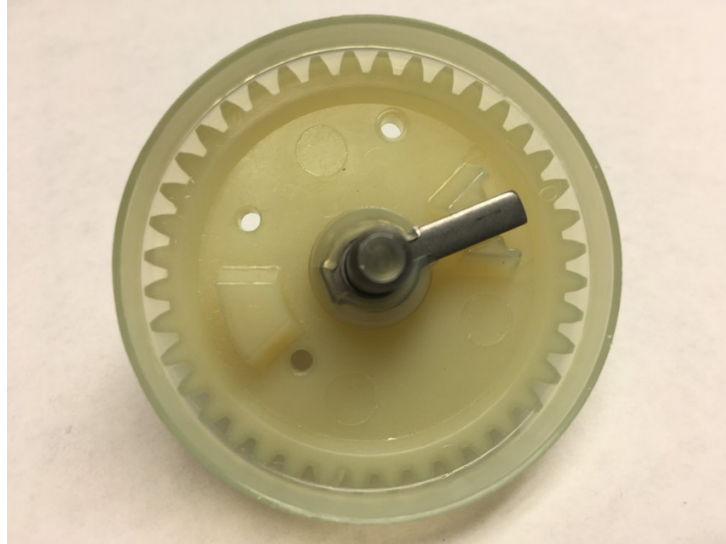
Figure 5. K3008 Distributor Gear With Monel Electrode

If it is not possible to confirm the version of the distributor gear that is installed in a given magneto from maintenance records, the magneto may be removed from the engine in order to have the housing and distributor block removed to allow visual inspection of the distributor gear. Distributor gears with Copper electrodes must be replaced with distributor gears with Monel electrodes.
