NO. LTC # **596-2017** **LETTER TO COMMISSION**

SUBJECT: Removal of Two Australian Pines on Pine Tree Drive

SUBJECT: Hurricane Irma Tree Assessment and Next Steps

Pine Tree Drive Tree Risk Assessment
Tree Risk Assessment Report

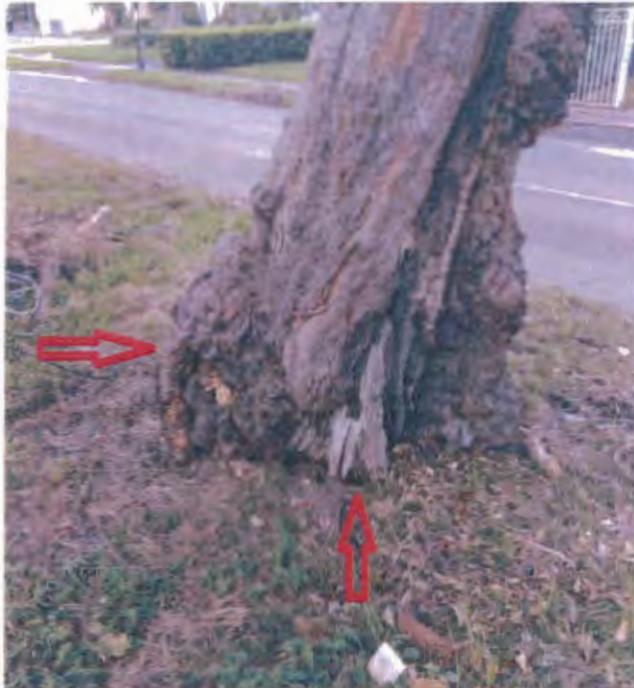
Photo 1 – Decay and Crack on Imminent Hazard

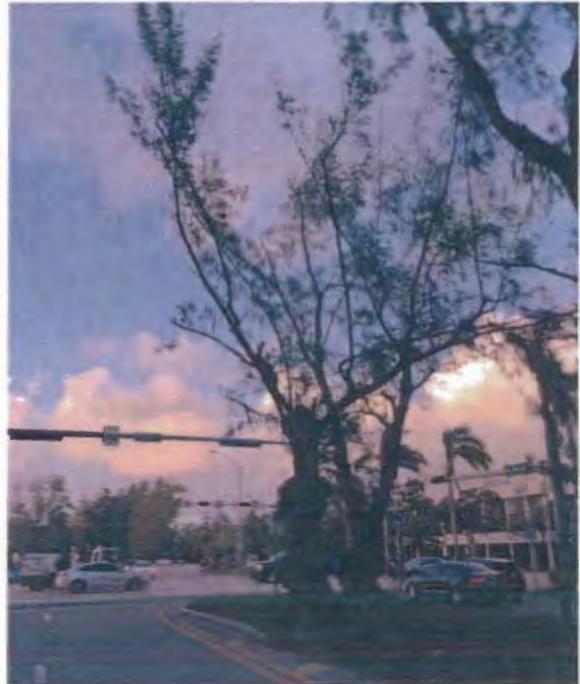
Photo 2 – Properly Pruned Australian Pine

The maintenance pruning will build off of the weight reduction pruning conducted earlier this year, which was deemed insufficient. The goal is to reduce the potential of the trees to fall during a storm before the start of next hurricane season. It is anticipated that the pruning can extend the useful life of these 254 trees for up to 10 years. Even after the pruning is completed, the city will need to continue evaluating the risk of the Australian pines on an on-going basis to determine how each tree responds to the weight reduction pruning, as well as how the decay in each tree progresses. Future assessments may determine that additional removals and/or pruning will be necessary depending on the risk factor of each tree's condition.

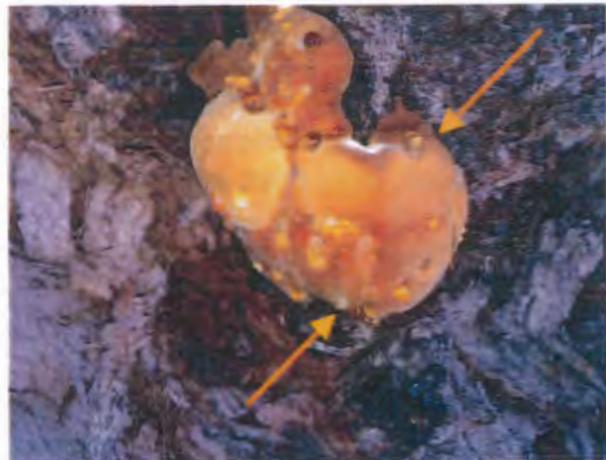
Figure 1 *Inonotus dryadeus* conks are regularly seen on the lower trunks and decaying galls on Pinetree Drive. It is a butt rot or basal rot fungi. Identification is easy because of the amber droplets that form on a fresh conk (arrows).

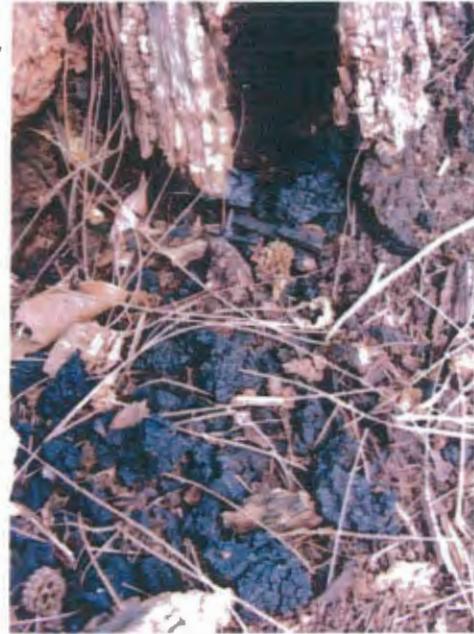
Figure 2 Pieces of black crusty pseudosclerotial plates of what I believe to be the pathogen *Kretzschmaria deusta* litter the ground below a basal cavity. These black crusty plates are found near the base of many of the Australian pines on Pinetree Drive.

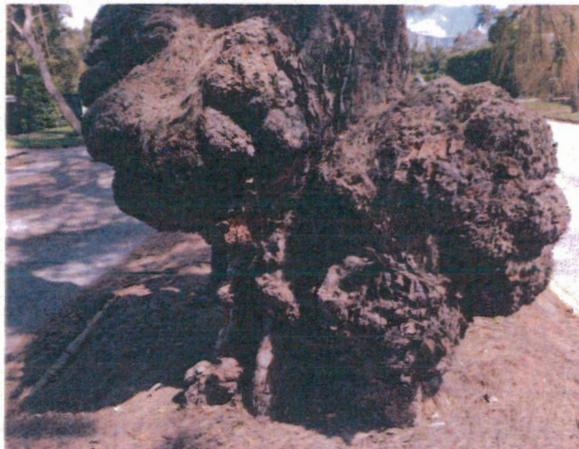
Figure 4 Large galls are prevalent on most of the Australian pine trees on Pine Tree Drive.

DBH Measurements - A tree measurement normally taken during tree evaluations, **DBH**, was not taken because the trees are heavily infested with large trunk galls or tumors, which we believe are caused by the bacterium *Agrobacterium tumefaciens*. The galls are technically called crown galls or crown gall tumors, but for simplicity we will refer to them as galls in this report. The large galls are often located on the trunk where the DBH measurement should be taken and the presence of the galls makes accurate DBH measurements difficult if not impossible. A majority of the trees (93 percent) had medium to very large galls on their trunks. Only seven percent of the trees were free of galls. Galls are not pathogenic and usually do not negatively affect the structure and strength of a tree as long as the galls are solid. However, if the gall begins to decay, as is the case with many of the galls on trees on Pine Tree Drive, we have observed the decaying galls can provide an entry point for a decay organism to enter the tree trunk and degrade the trunk tissue.

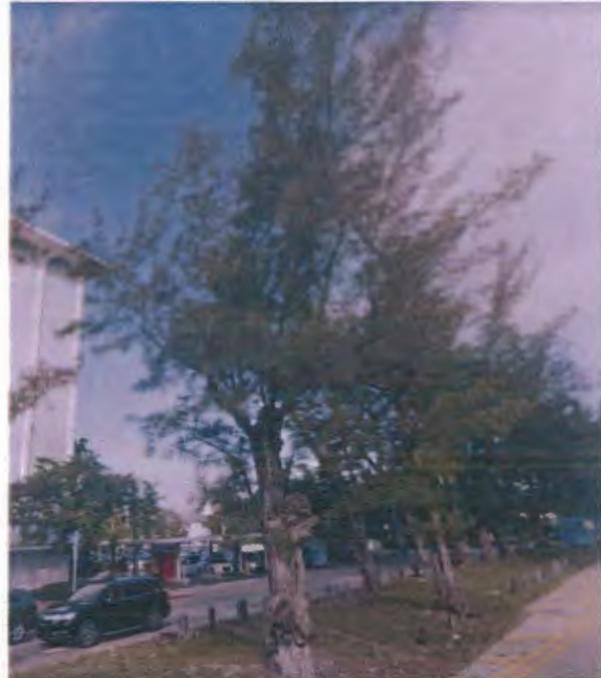
Figure 20 This Australian pine at 41st Street had its trunk broken years previously likely in a wind event. It is now about the size we recommend for Pine Tree Drive. Veteran trees tend to become smaller and more wind resistant through random limb failures. We can assist this natural process through crown reduction pruning.

Our preferred method of mitigation was in 2010/2011, 2014 and now is crown reduction which can reduce the forces placed on the trunk and base of the tree by wind events, excessive lean or long, sprawling lateral branches. Crown reduction can be even more useful where more of the trees exhibit higher probability of failure and root space is limited for the trees such as in the 9 foot wide median south of 41st Street.
