Sakonnet River Bridge

Emergency Inspection – August 29, 2016

**Prepared for:
Rhode Island Turnpike & Bridge Authority
Jamestown, RI**

**Prepared by:
Ammann & Whitney Consulting Engineers, PC
New York, NY**

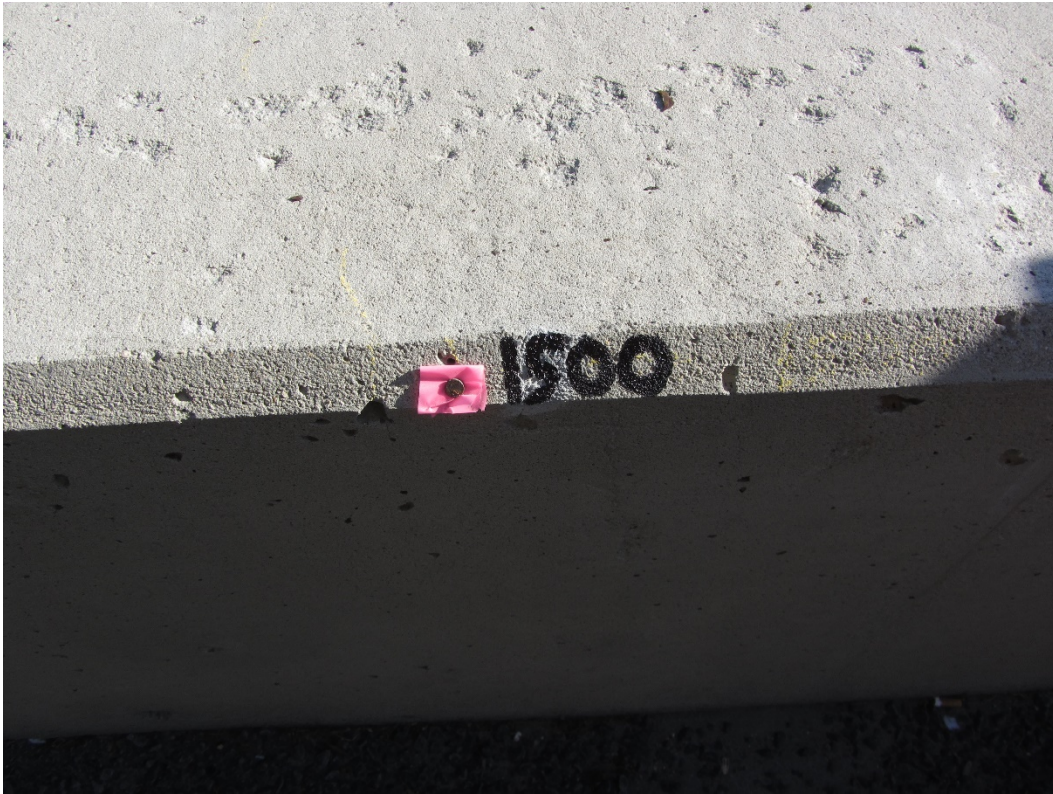
The inspection was performed from the northbound right shoulder (breakdown lane) at a location which was previously marked as 1500 (see photo 1). This is located in Span 6. Once the disabled A-75 was removed from the site, the concrete parapet and steel railing was inspected from the roadway side. The concrete parapet exhibited one area along its top edge where there was a scrape/abrasion mark (see photo 1). There was no cracking, spalling, or other visible damage attributed to the incident on the roadway side of the parapet.

Photo 1. Location of inspection.

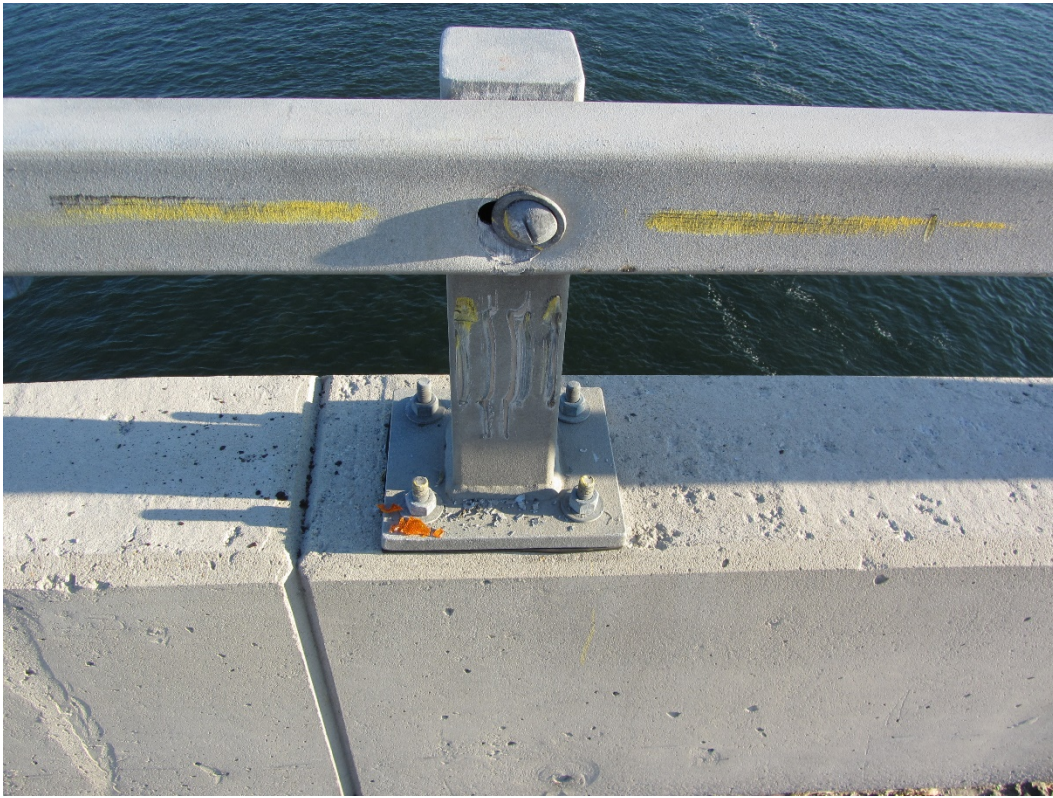
The galvanized steel railing exhibited several yellow paint rub marks (see photo 3). There were also a few areas of scrape marks on the railing (see photo 4). Several of the railing posts exhibited areas of scrapes (see photo 3 for railing and post conditions). The scrapes on the posts appear to be deep enough to go through the galvanizing. At a few locations, the bolt which connects the railing to the post was pushed slightly into the rail causing the wall of the tube steel rail to exhibit a slight depression. This caused the nut on the back side of the connection to loosen; it is currently only hand tight. Also, the bolts have been shifted within the slotted holes in the railing tube steel (see photo 3).

Photo 3. Paint rub marks on railing. Scrapes on post. Head of bolt has been depressed into wall of railing tube.

The Sakonnet River Bridge appears to have suffered no significant damage from the A-75 UBIU incident on August 29, 2016. There is no structural damage that effects the load carrying ability of the bridge. Although there are no structural concerns, the incident has created several maintenance issues that should be addressed. The scrapes in the galvanizing on the steel railing and posts have left bare steel exposed to the elements. It is recommended that these areas be repaired with a cold spray galvanizing compound. The loose/shifted bolts between the railing and the posts should be centered and retightened. An additional galvanized washer or galvanized washer plate may be required if the existing washer cannot cover the slotted hole. The two vertical struts supporting the navigation light tube should be replaced.

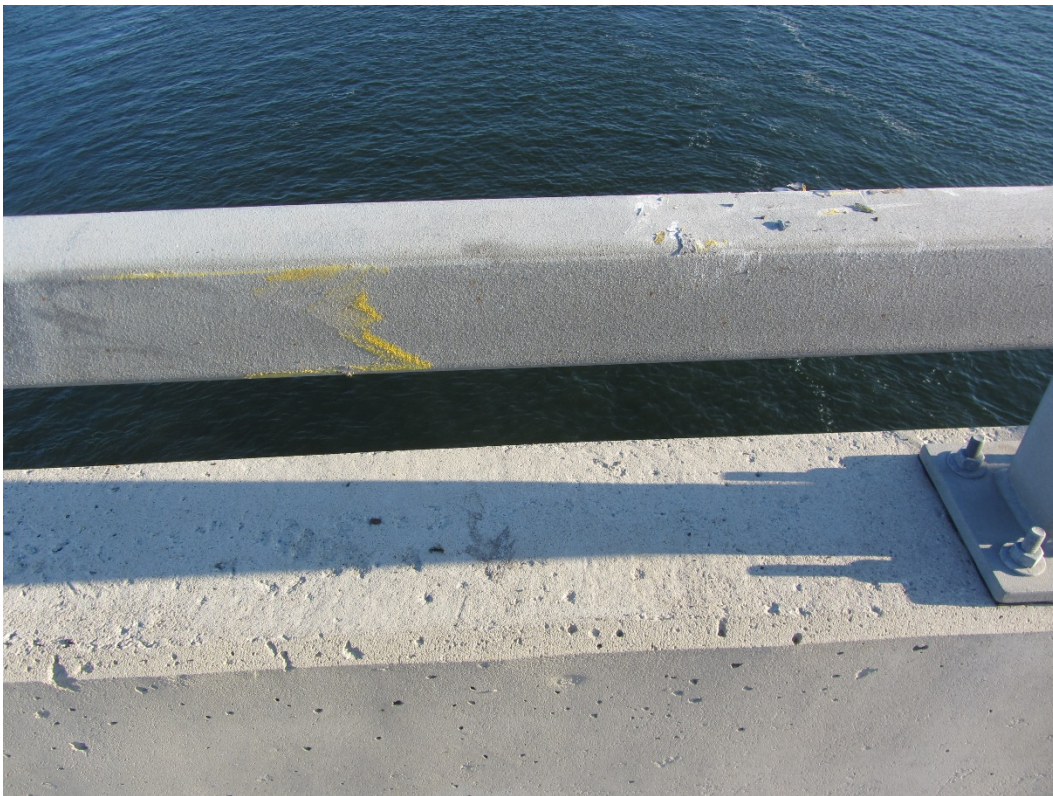
Photo 4. Paint rub marks and scrapes on railing.

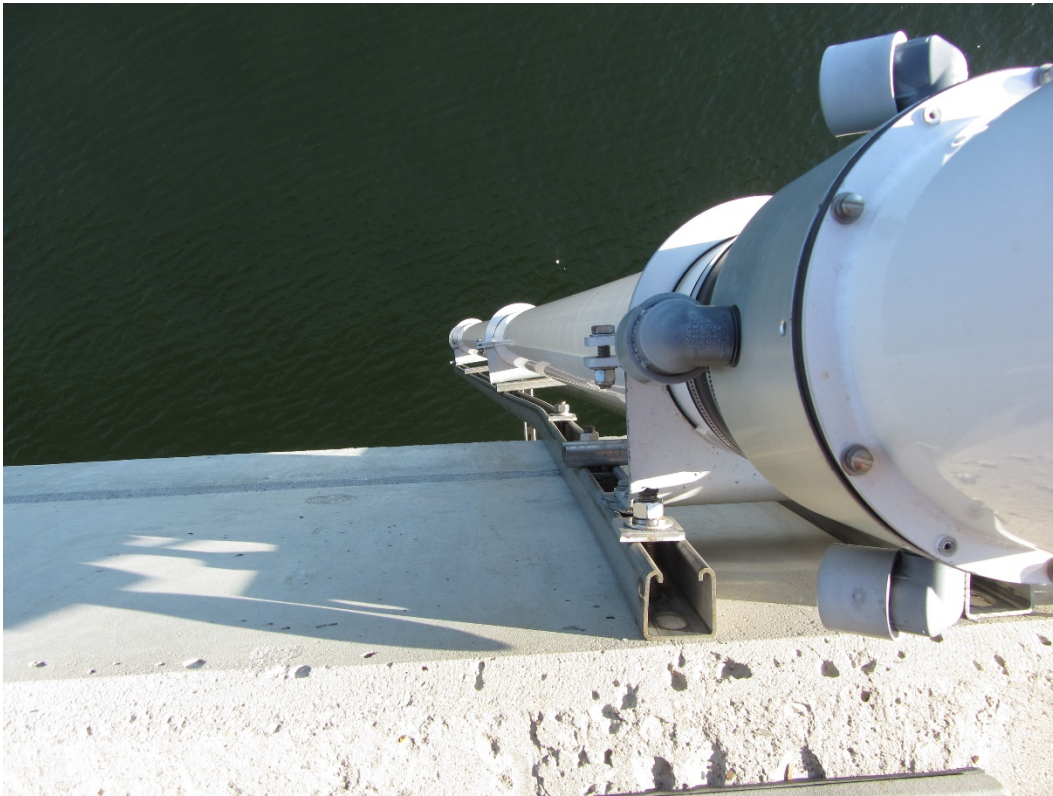
The navigation light (light tube) support struts have been bent. Just below the bottom edge of the concrete parapet/deck, the two struts have been bent to the north by a few degrees (see photo 5). At the bottom of the light tube, there is a yellow paint rub mark on the south side (see photo 6).

Photo 5. Just below bottom of concrete, the struts are bent to the north.

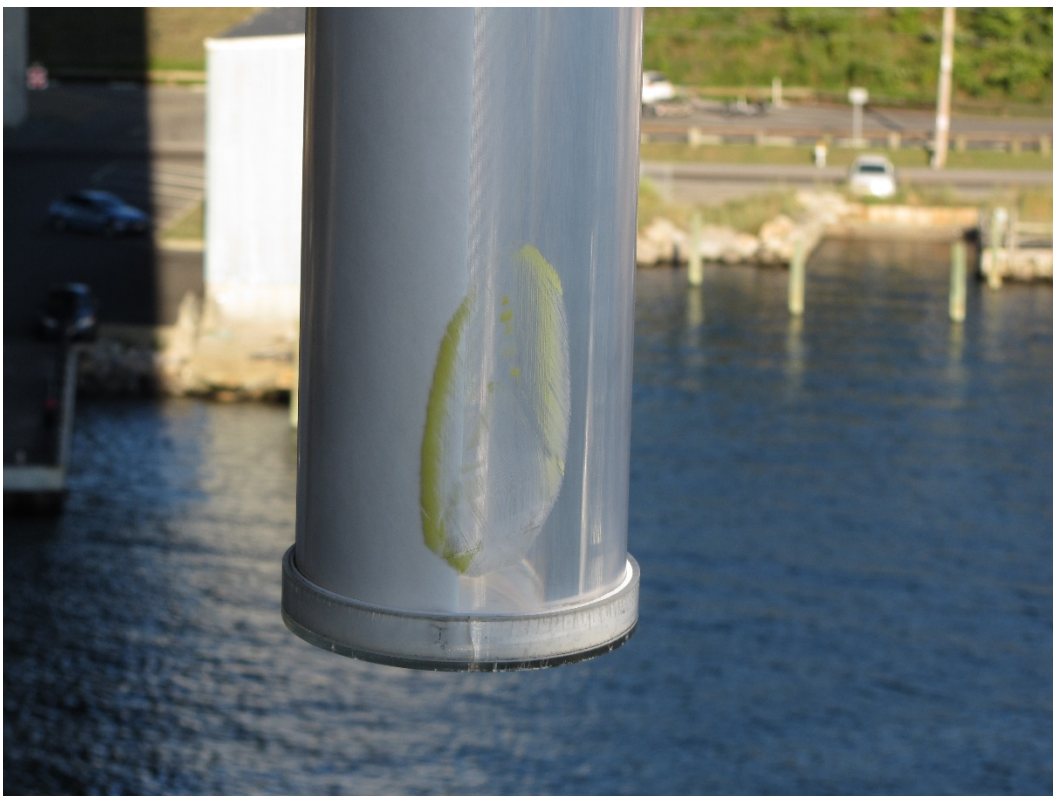
Photo 6. Yellow paint rub mark on the south side of the light tube at the bottom.

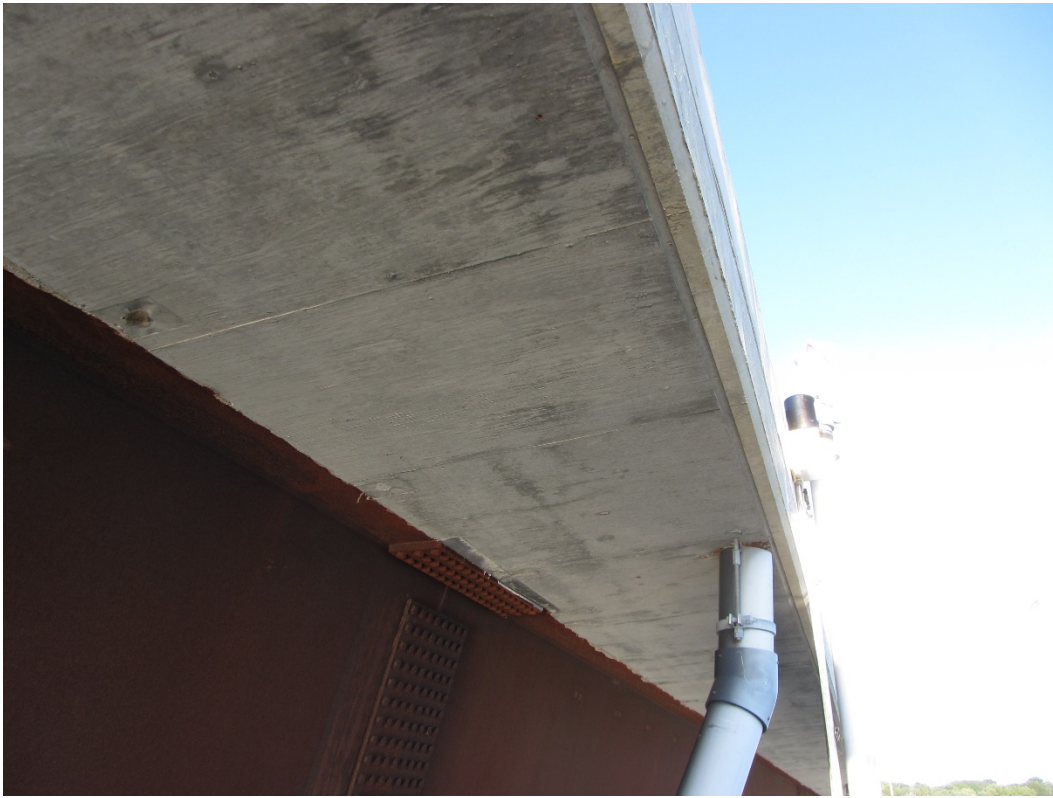
The outside face of the parapet, the underside of the concrete deck overhang, and the steel tub girders exhibited no signs of visible damage. There was no cracking or spalling in the parapet or deck overhang that appeared to be from the incident (see photo 7). There was no visible impact damage, scrapes, gouges, or cracks in the steel tub girders (see photo 8).

Photo 7. Outboard face of parapet and underside of concrete deck overhang exhibits no signs of distress from incident.

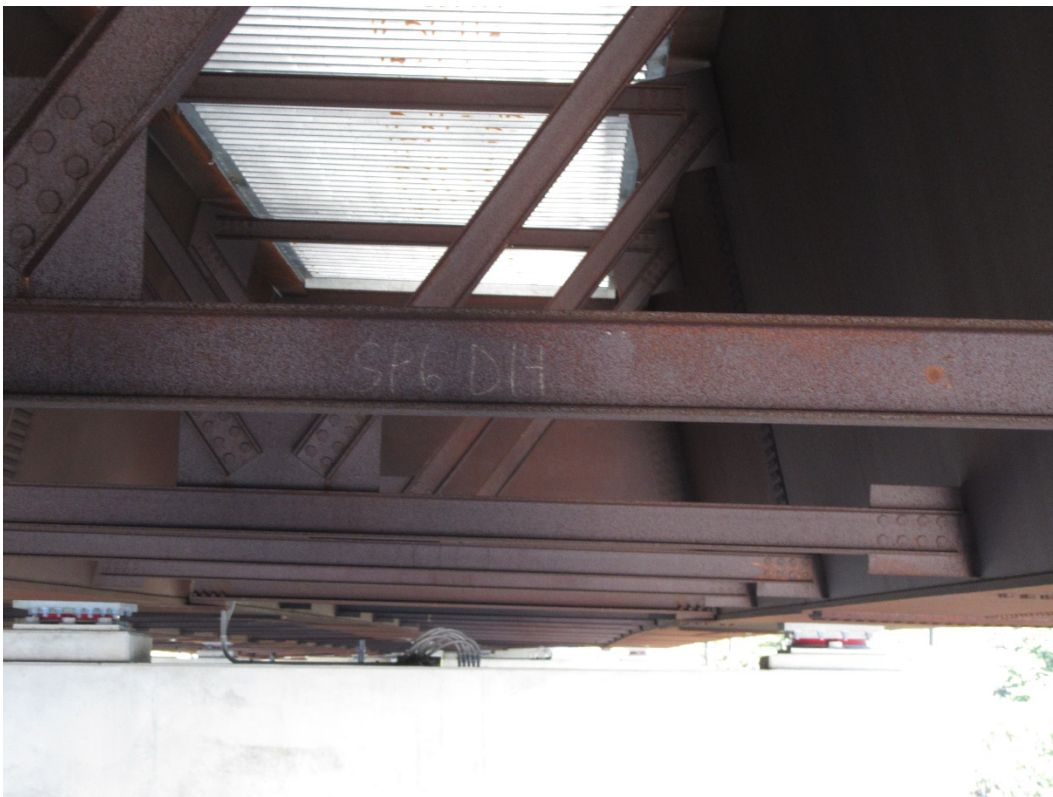
Photo 8. Steel tub girders and diaphragms exhibit no signs of impact damage.
