Kiawah Island Post Storm Beach Report

Hurricane Matthew

Prepared by Jim Jordan, Wildlife Biologist

October 11, 2016

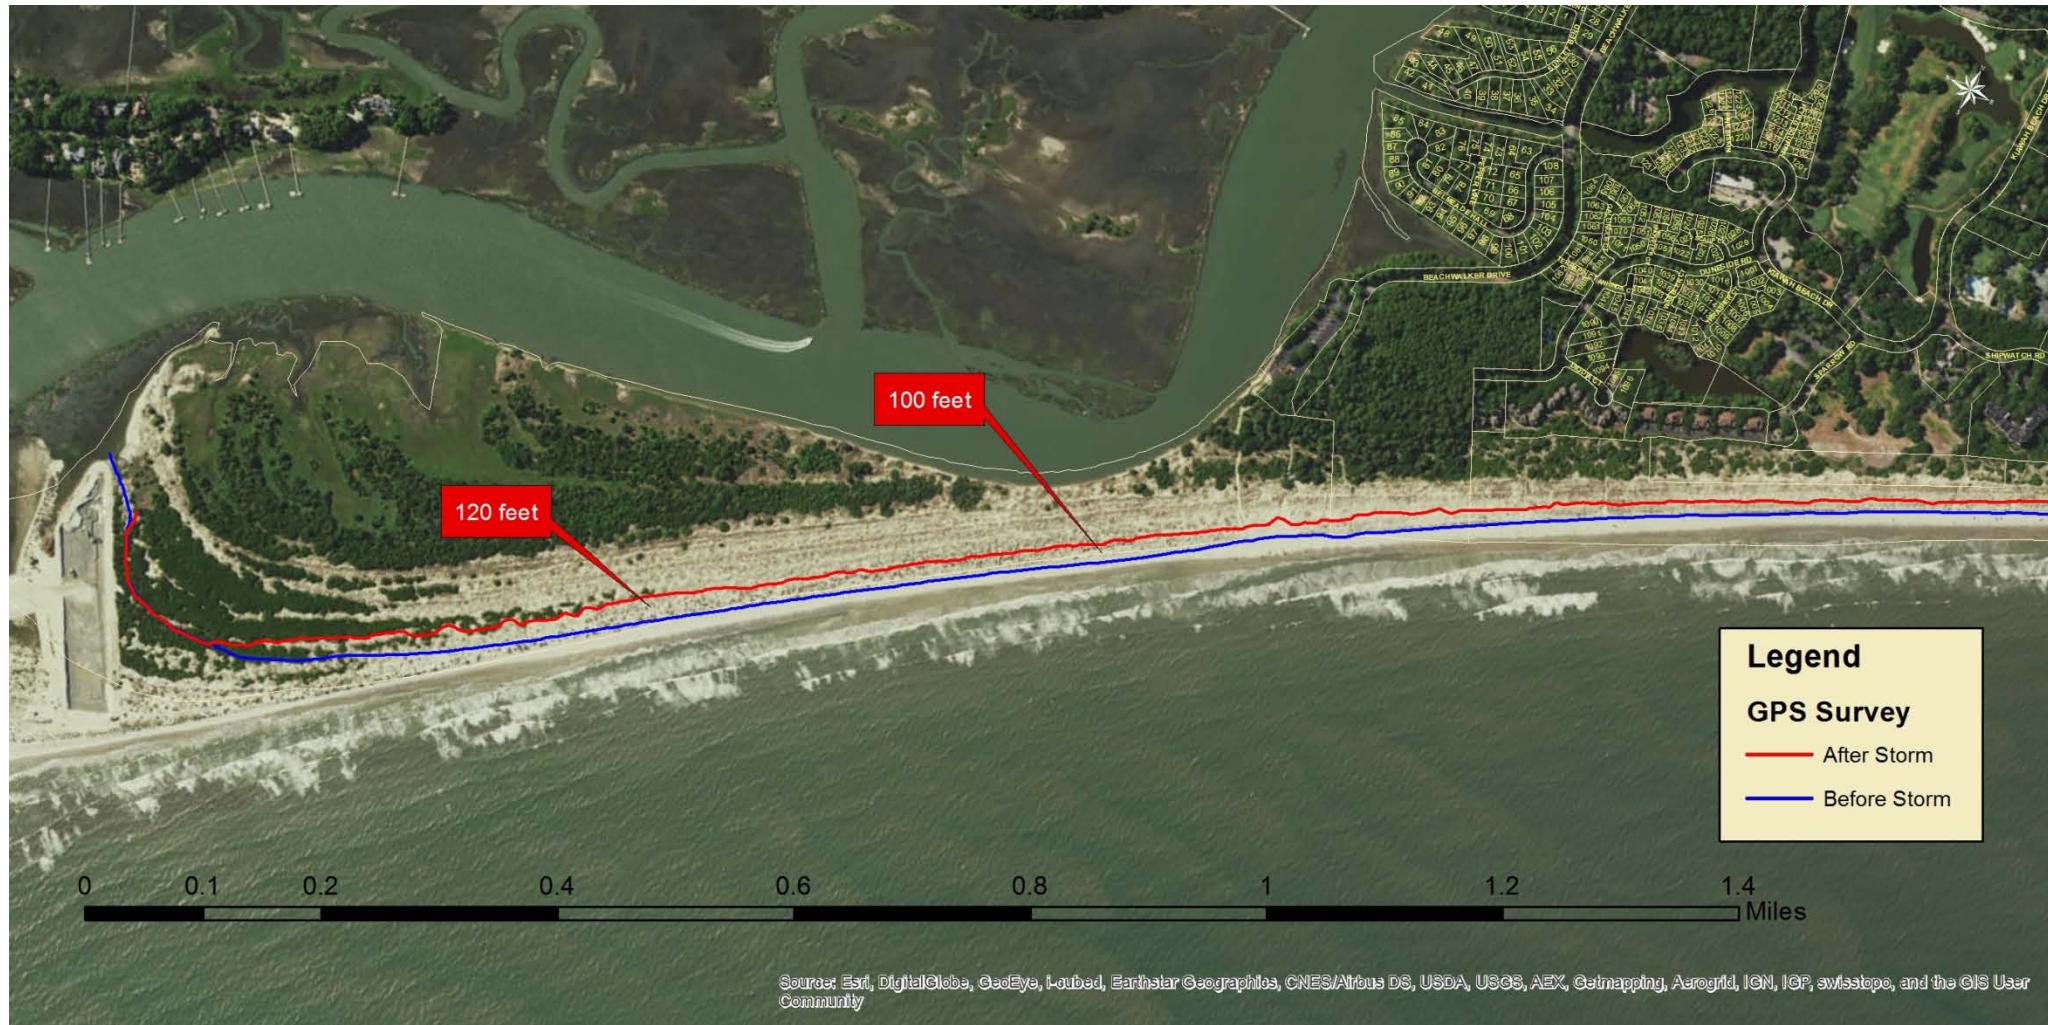
Captain Sam's Inlet to Beachwalker County Park

This area sustained 70-120 feet of erosion. The primary and secondary dunes were completely destroyed. There are no structures or boardwalks in this area.

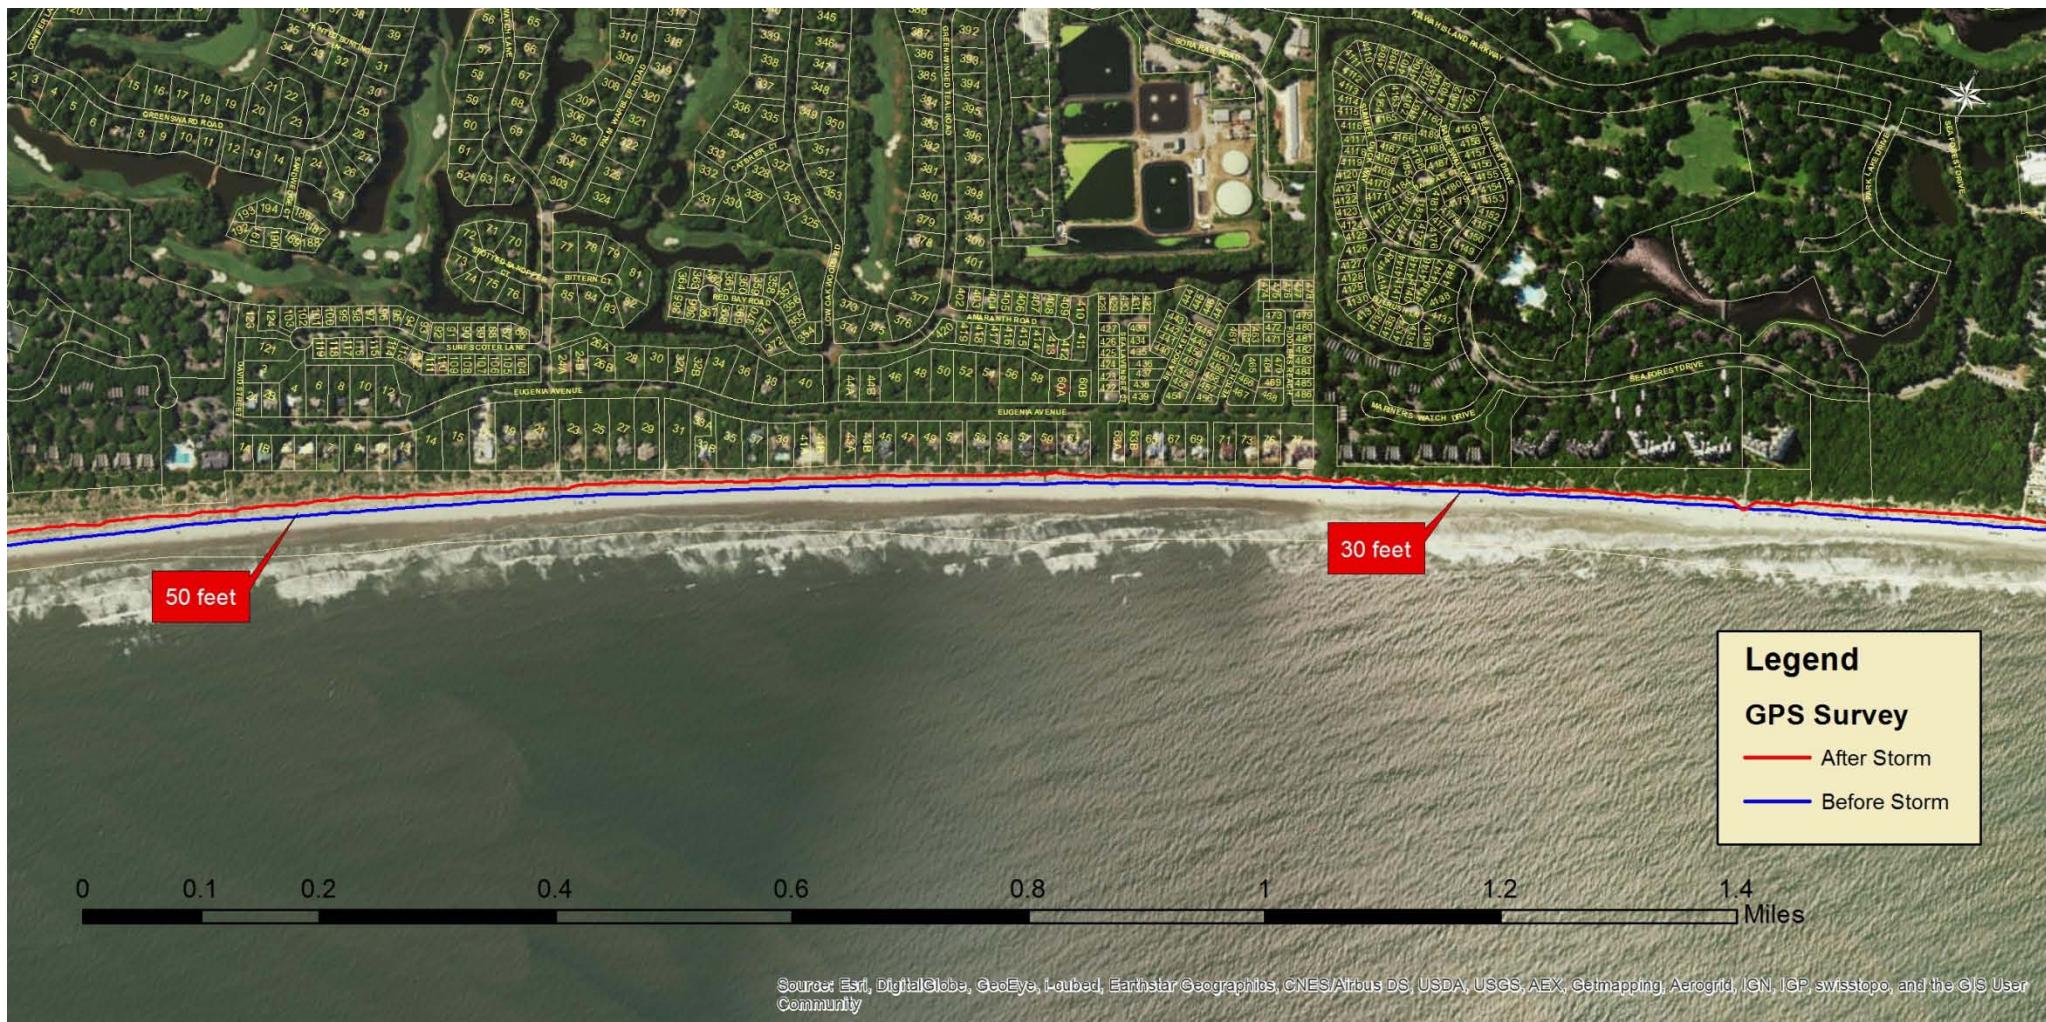
Beachwalker County Park to The Sanctuary

This area sustained 30-50 feet of erosion. Highest rates were seen near West Beach and the western portion of Eugenia Avenue.

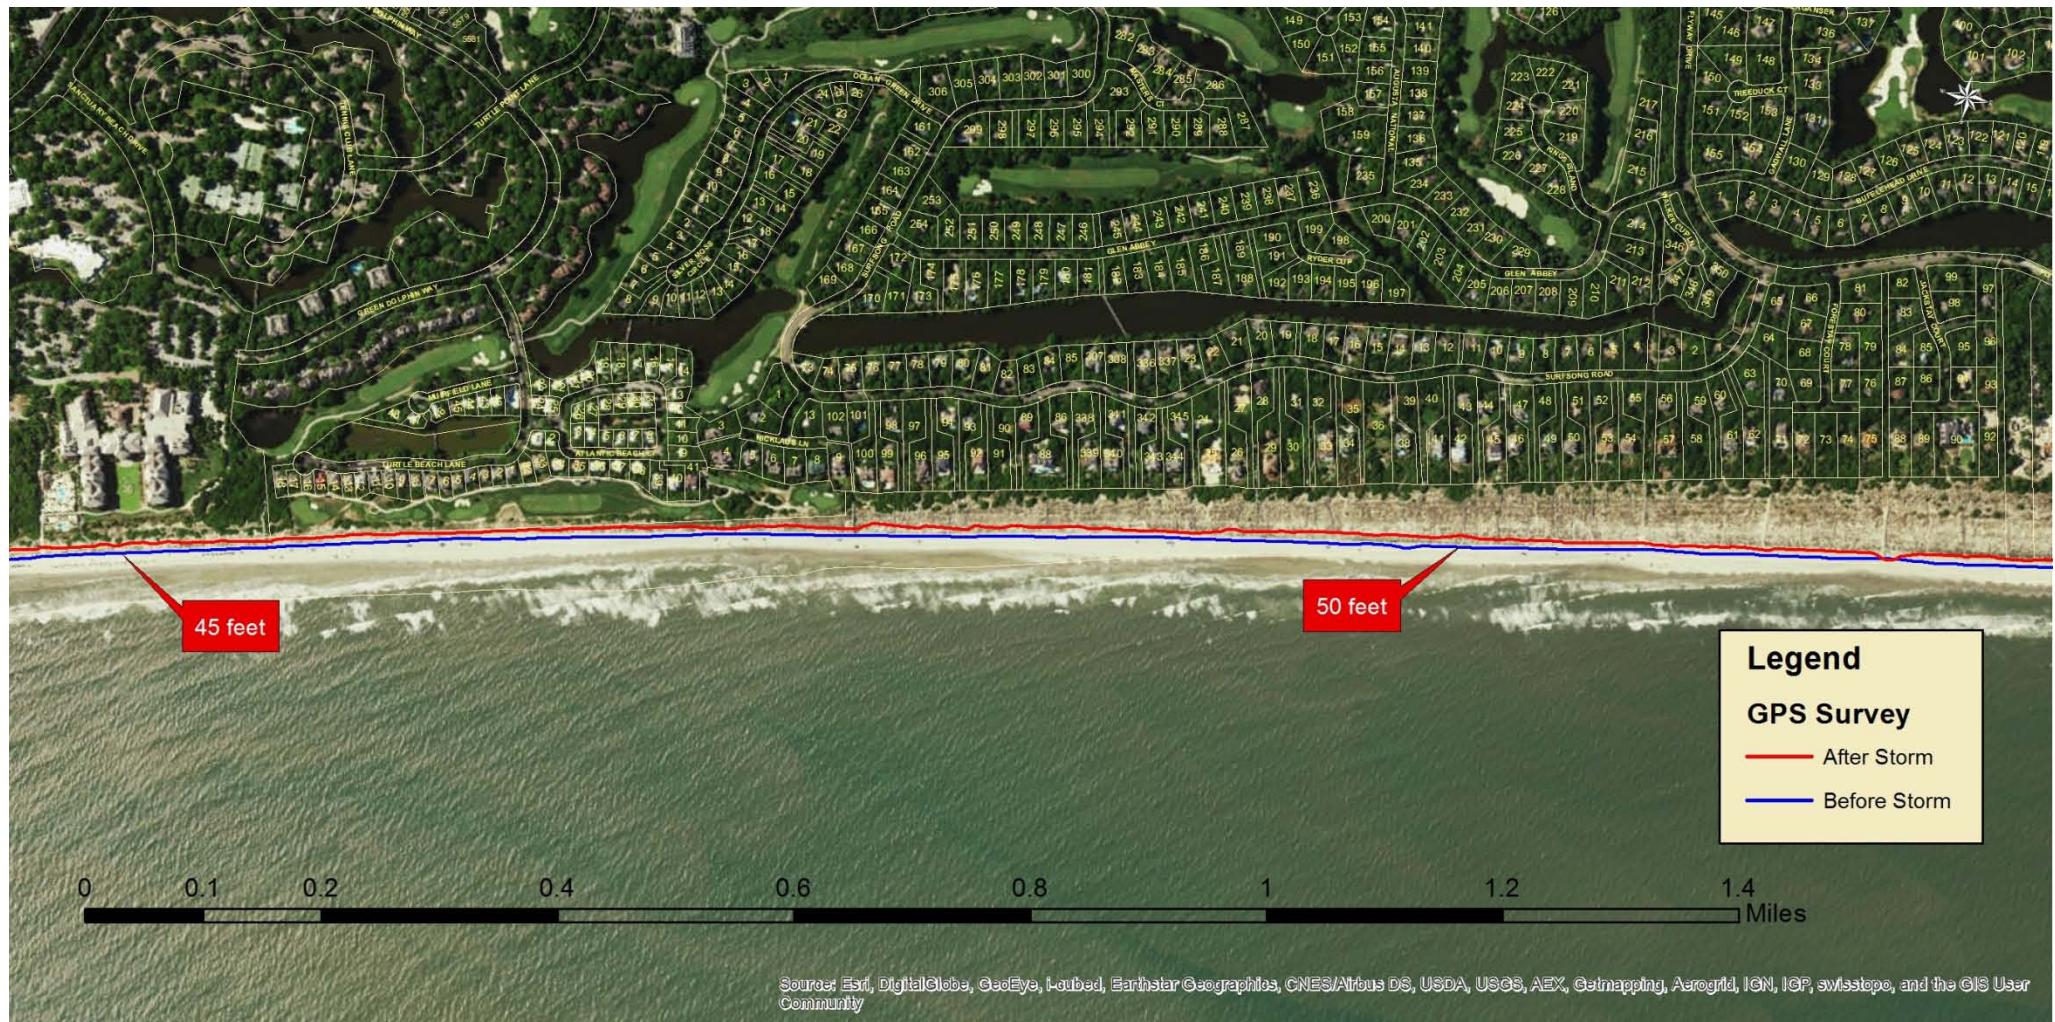
The Sanctuary to Jackstay Court

This area sustained 30-50 feet of erosion. Erosion rates were fairly uniform in this section, with the lowest rates adjacent to the eastern end of Surfsong Road.

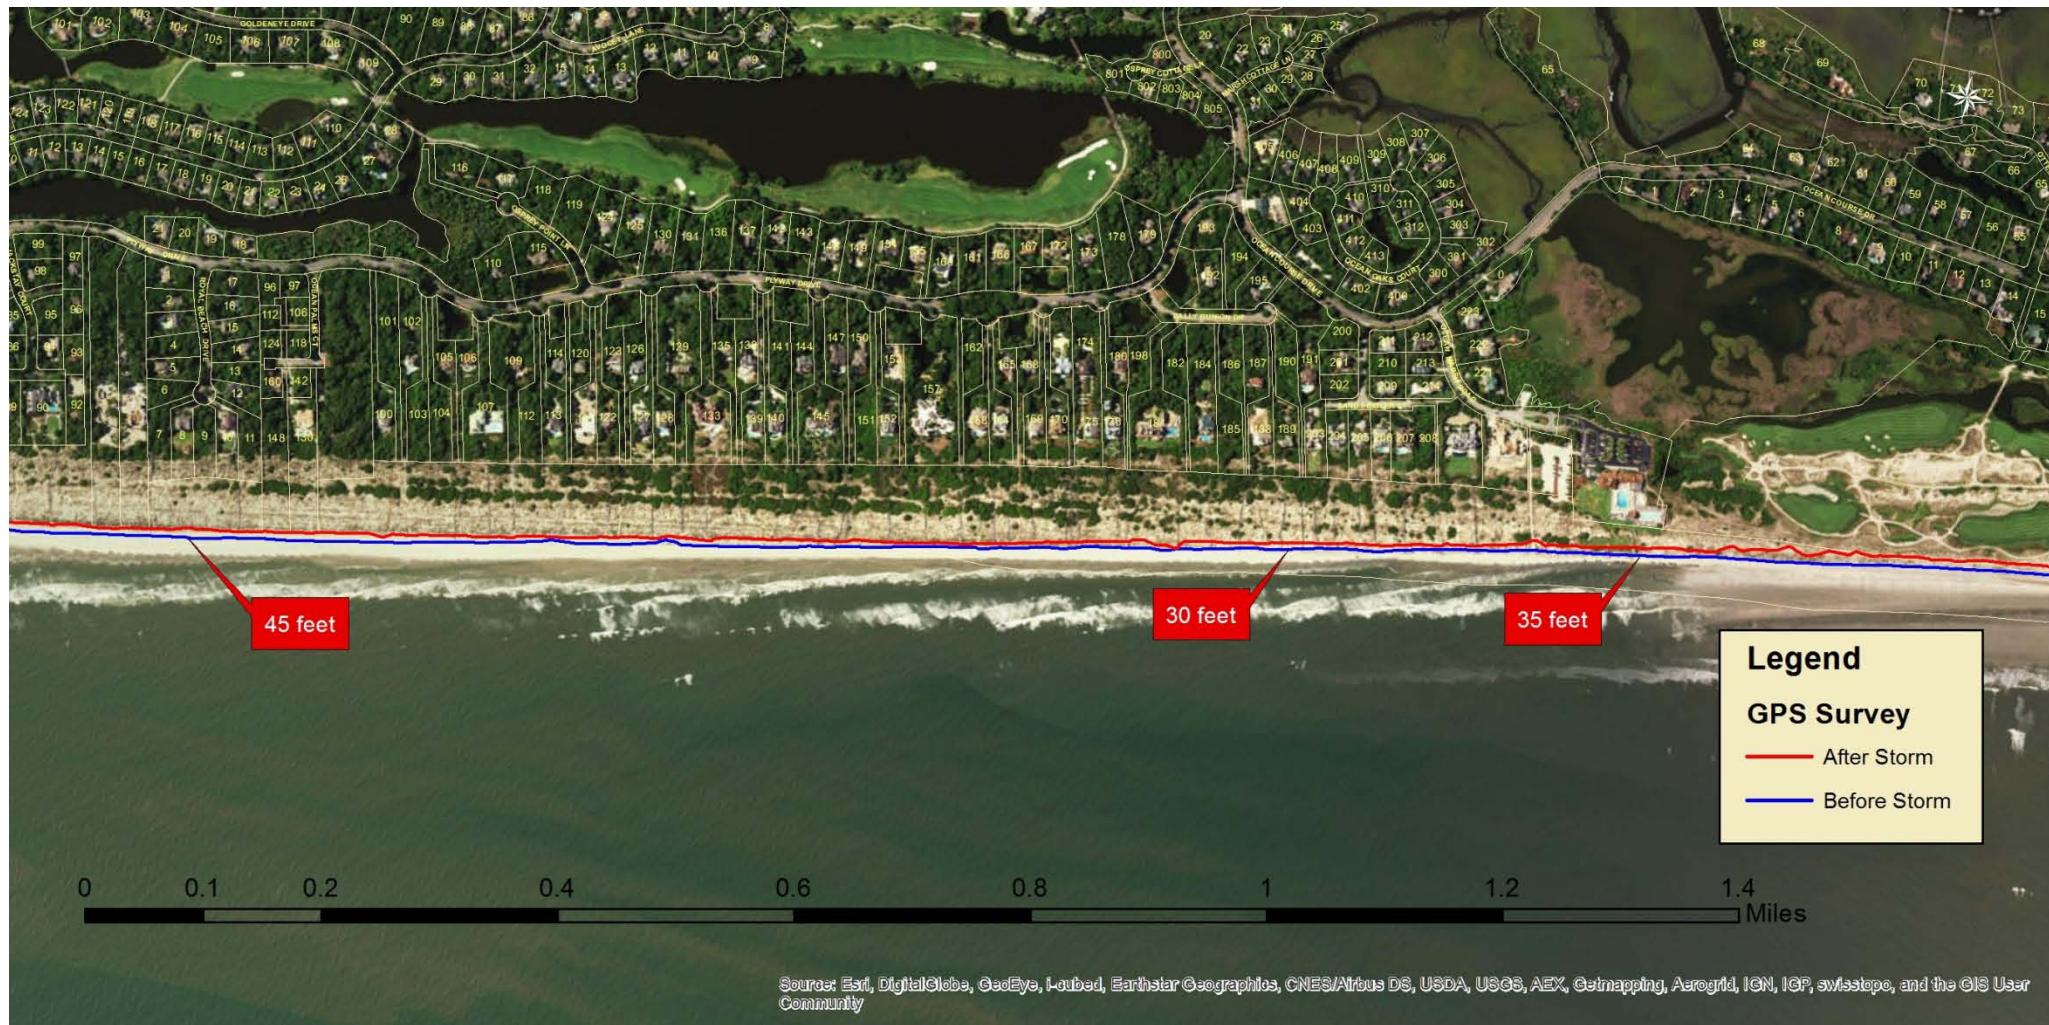
Jackstay Court to The Beach Club

This area sustained 25-45 feet of erosion. Highest rates were seen adjacent to Ocean Palms.

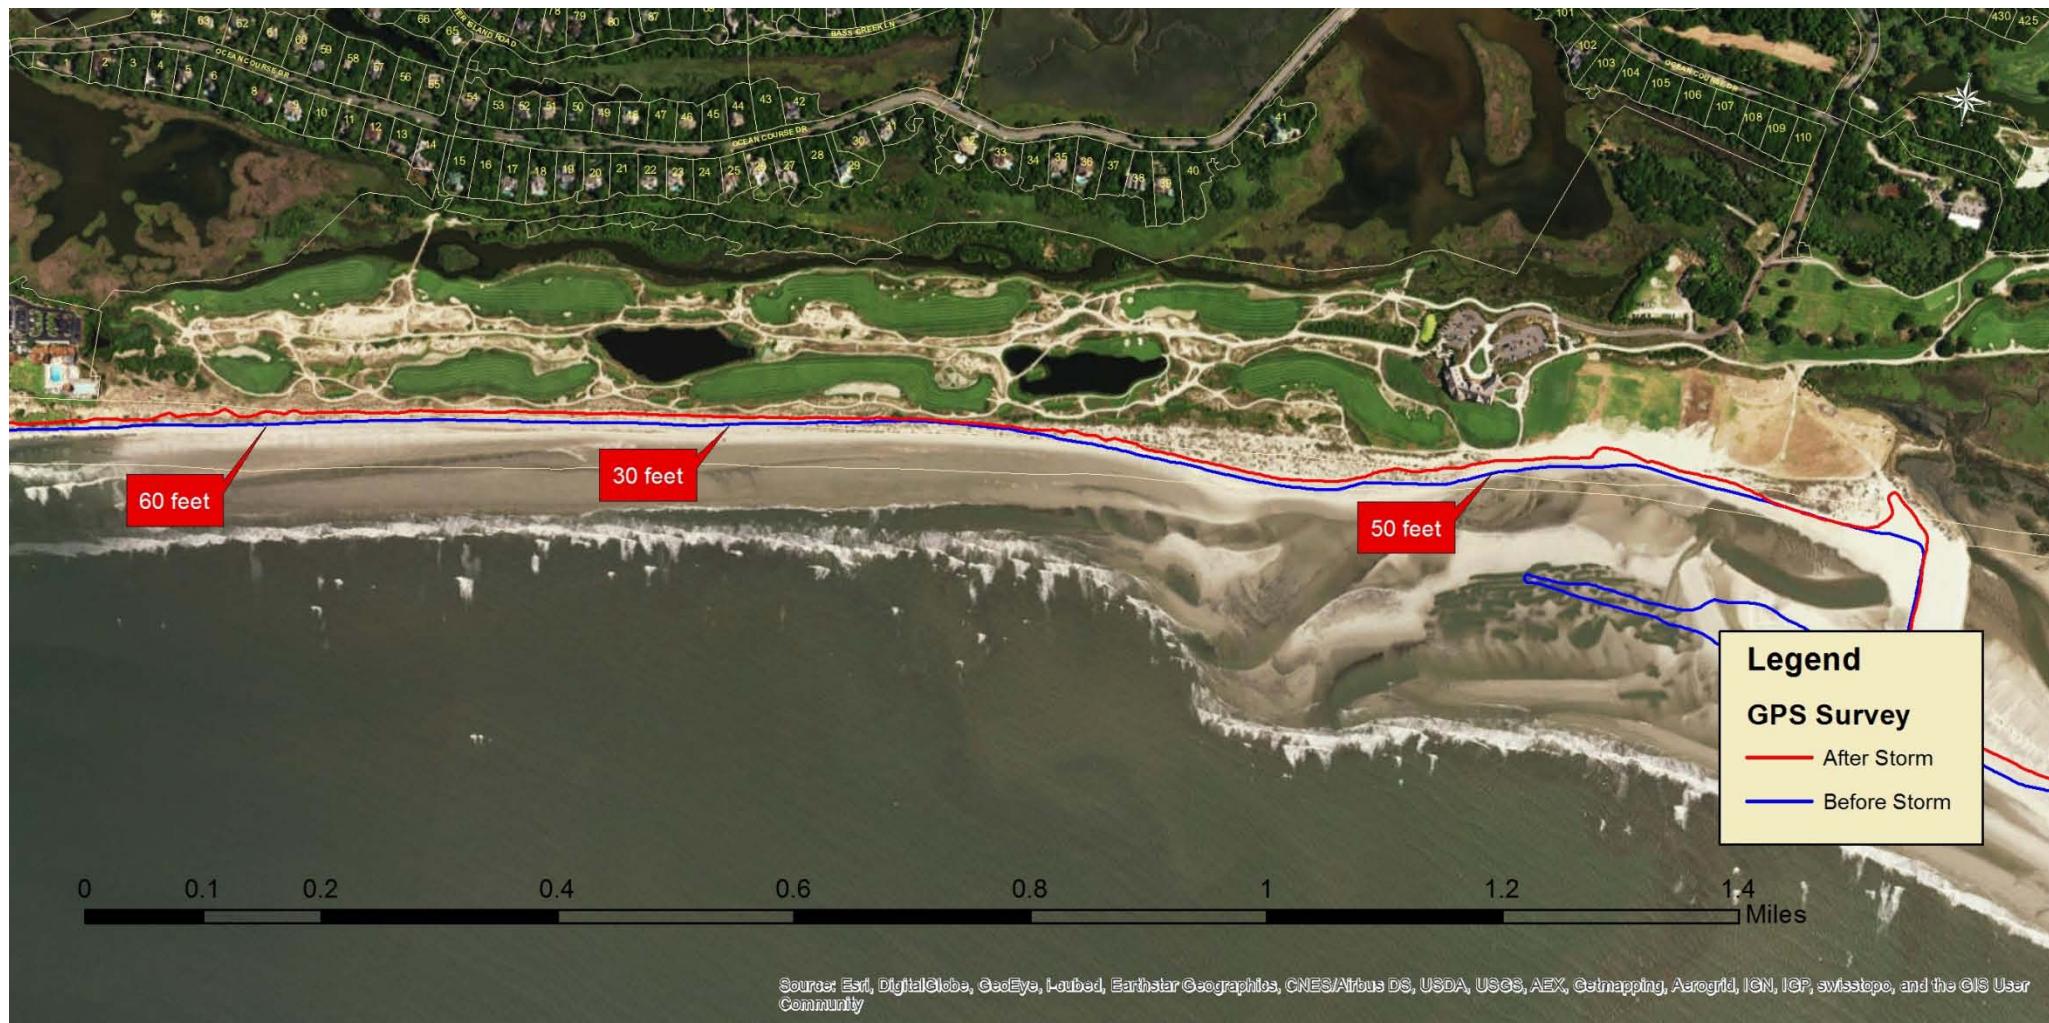
The Beach Club to Ocean Course Clubhouse

This area sustained 10-60 feet of erosion. Highest rates were seen just east of the Beach Club and adjacent to the Ocean Course Clubhouse.

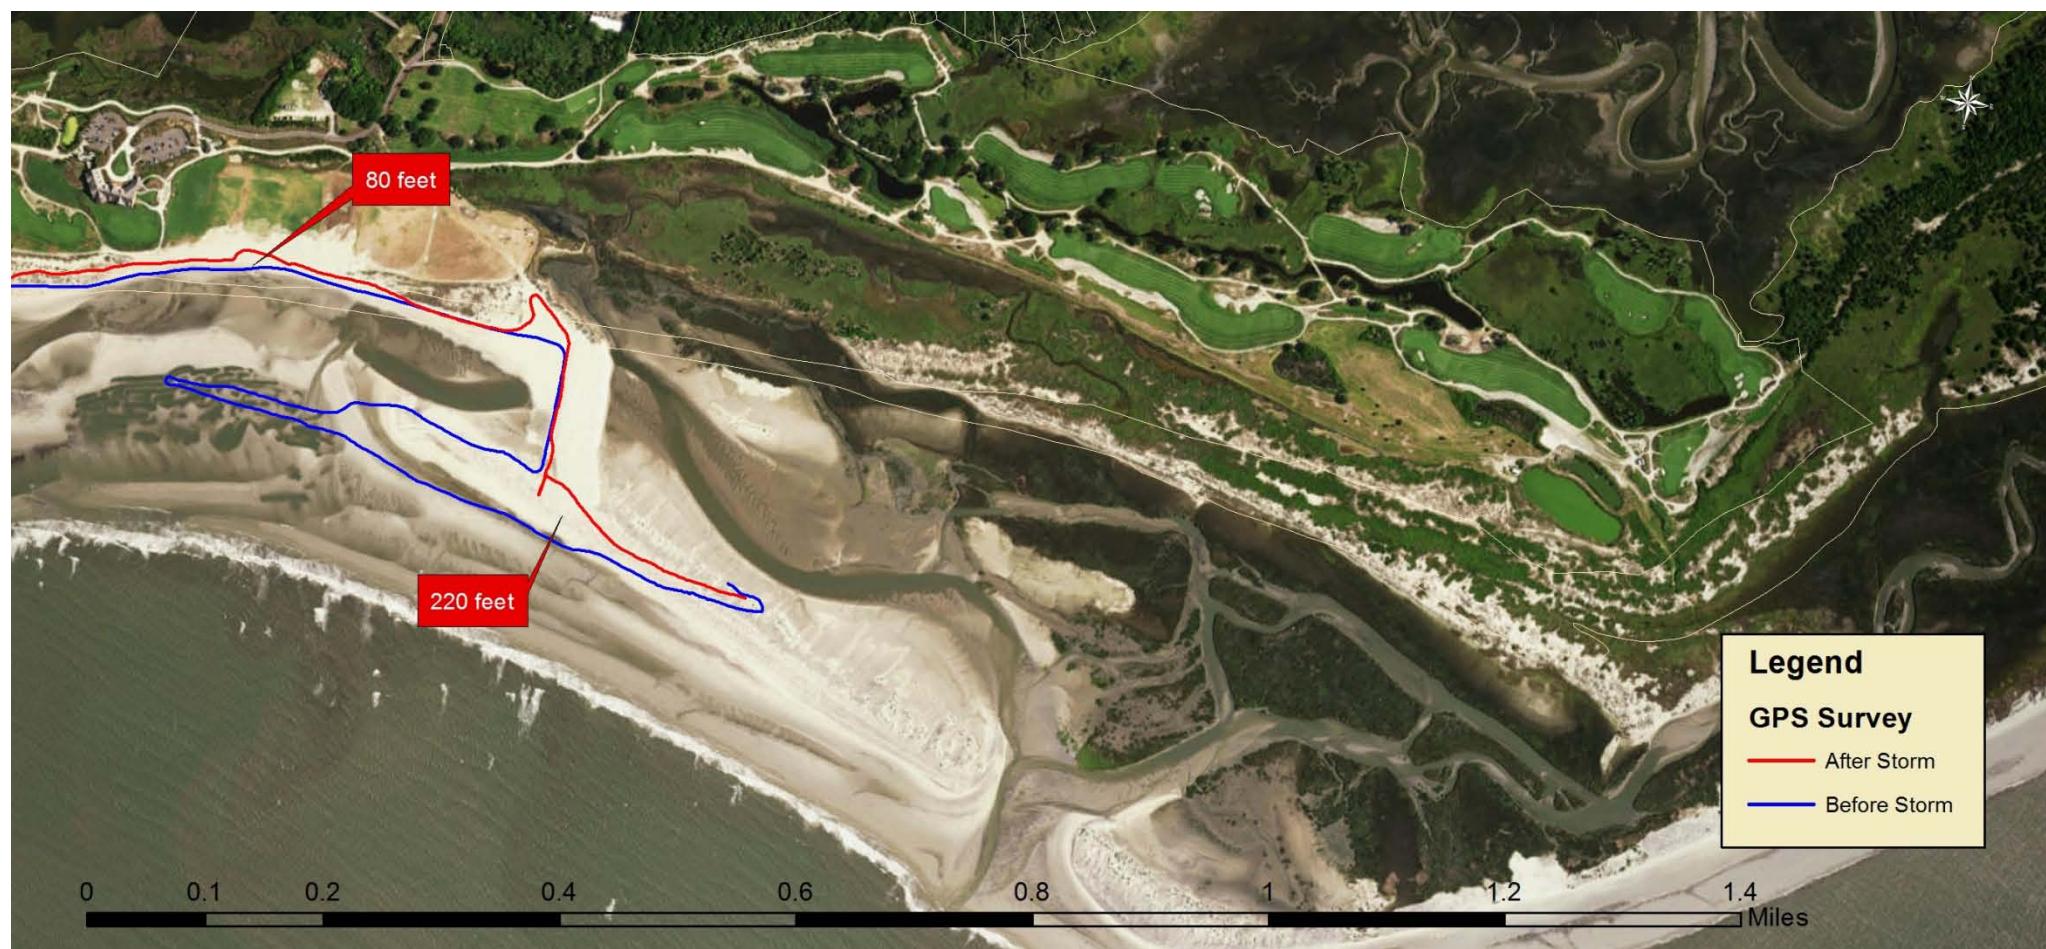
Ocean Course Clubhouse to New Inlet

This area sustained 10-220 feet of erosion. Sand fencing installed after the East End project was damaged but most remains in place. The new dike constructed during the East End Project was not breached and remains intact. The outer beach dune ridge directly in front of the Ocean Course Driving Range was completely destroyed. This will have a positive long-term benefit since it will allow waves to push additional sand directly onto the beach adjacent to the driving range and clubhouse.
