21-600 HANOVER PINEHILLS II

Weekly Site Photos Week Ending 5/19/2023

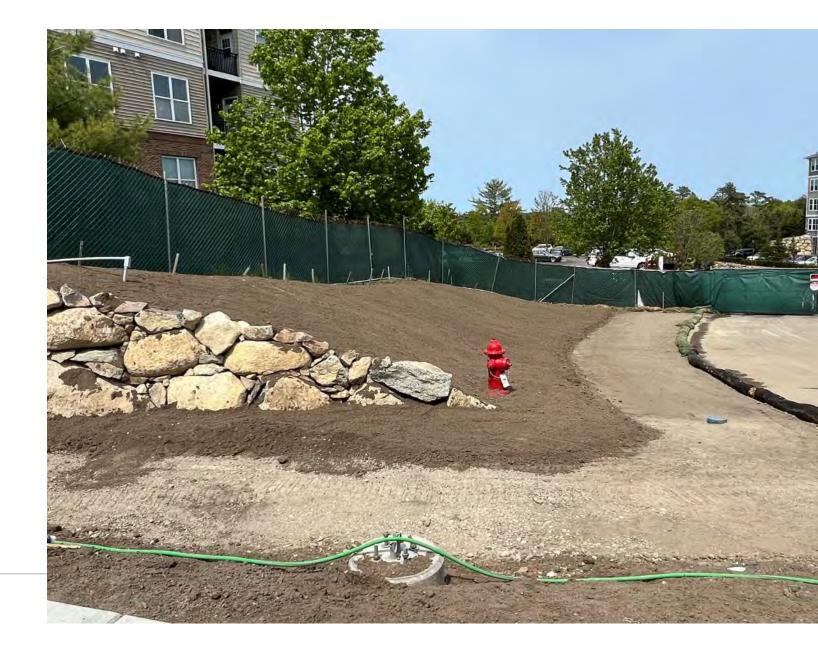
Sitework

Grading at Avalon gate

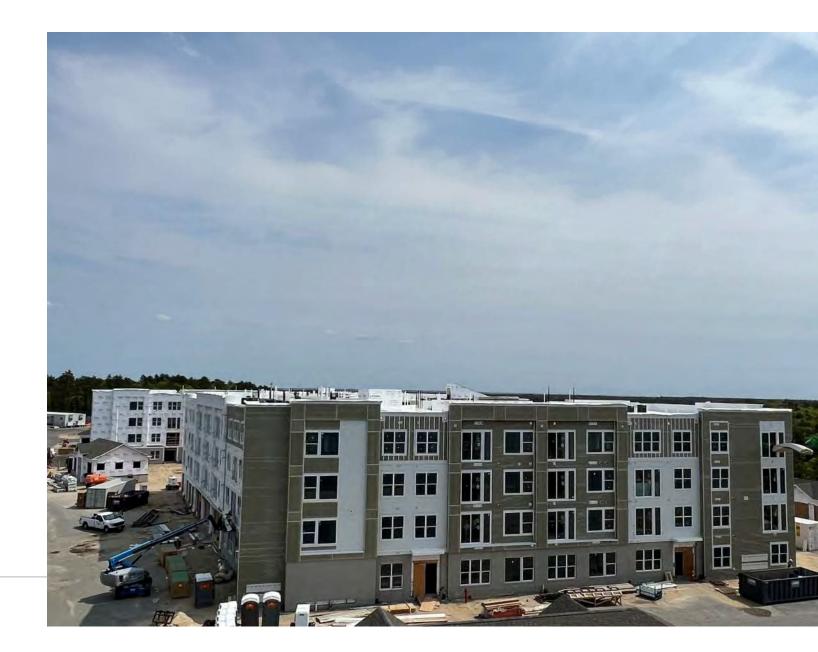
Building 1 Exterior

Exterior siding is ongoing

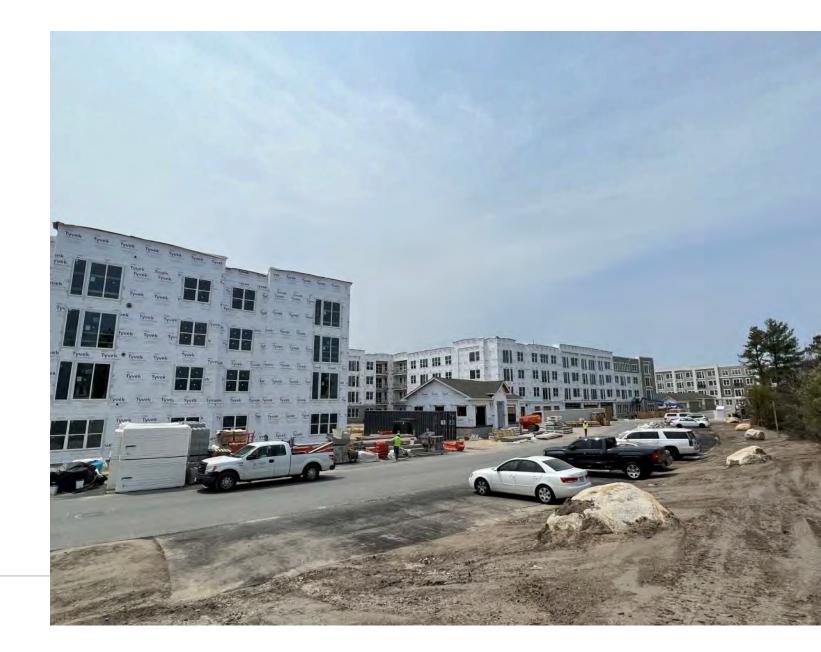
Building 1 Exterior

Exterior siding is ongoing

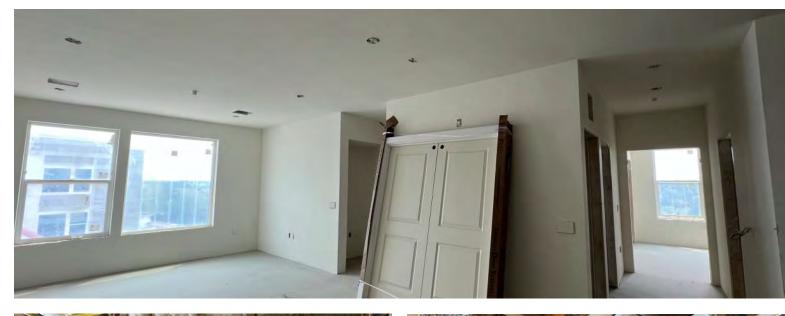
Top — level 4 with gypcrete

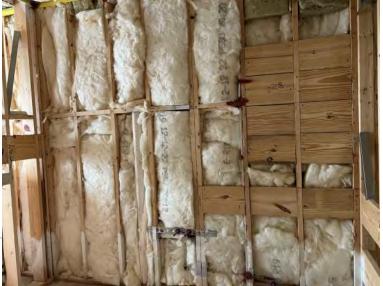
Bottom left — level 3 insulation started

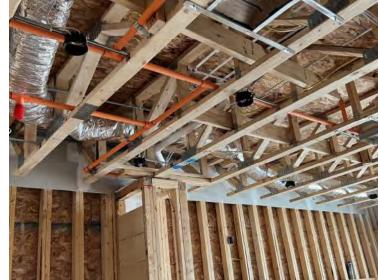
Bottom right — level 2 MEP ongoing

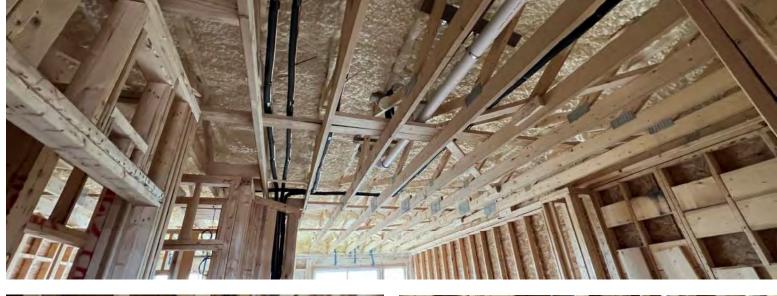
Top — level 4 MEP started

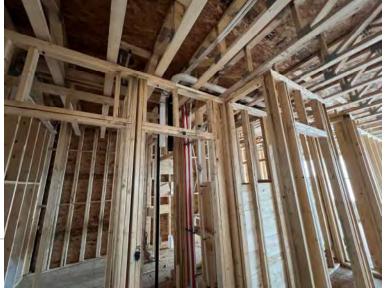
Bottom left — level 3 MEP started

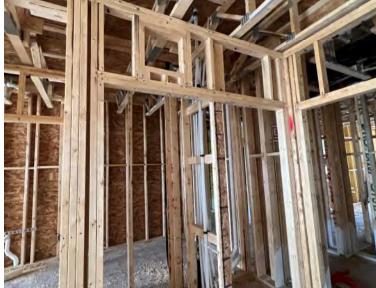
Bottom right — level 2 MEP started

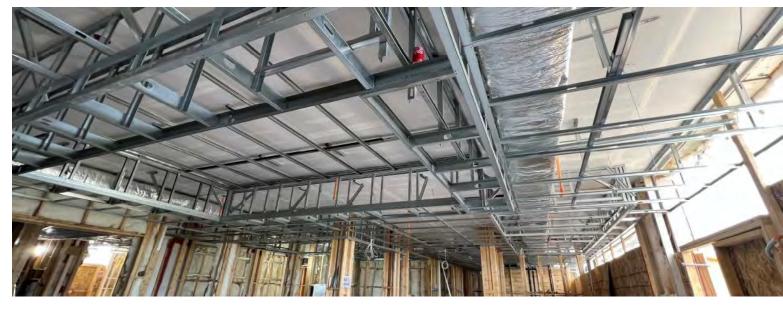
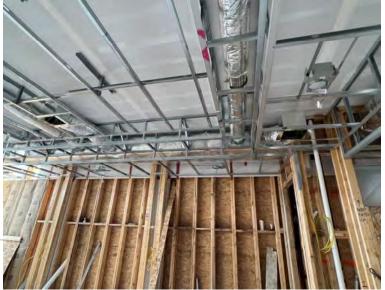
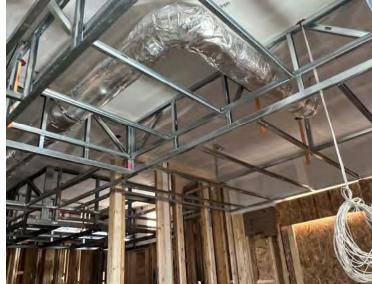
Clubhouse

Framing with MEP ongoing

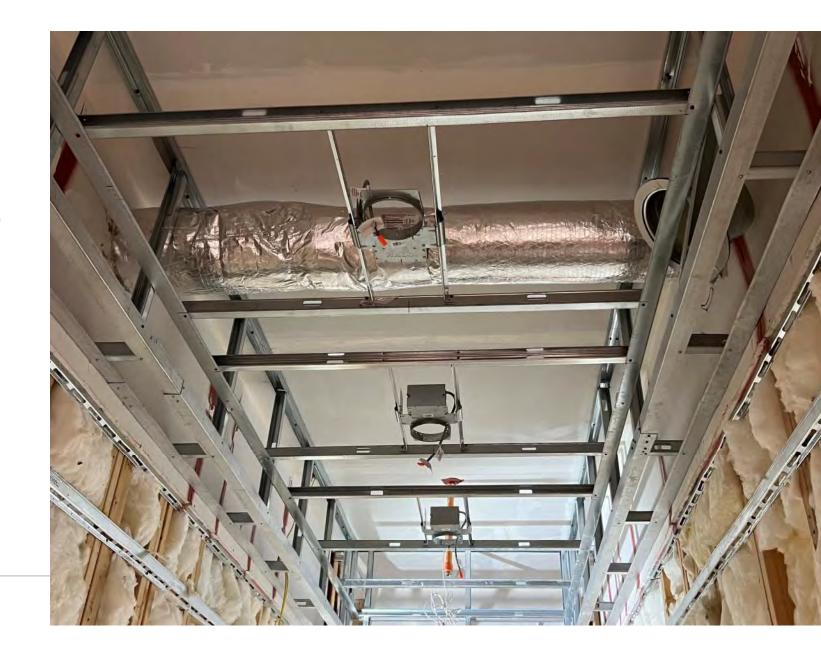
Clubhouse

Corridor framing and MEP rough started

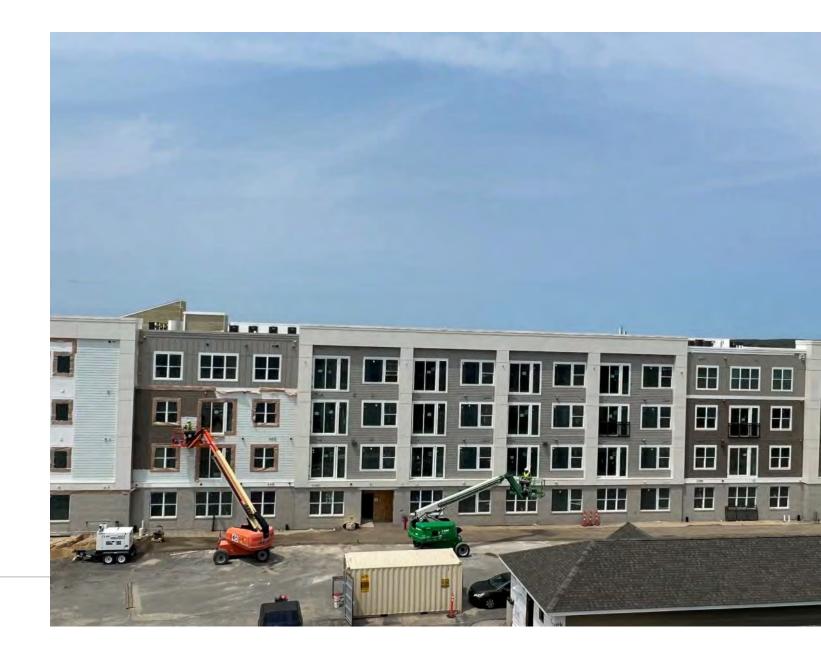
Building 2 Exterior

Exterior painting is ongoing

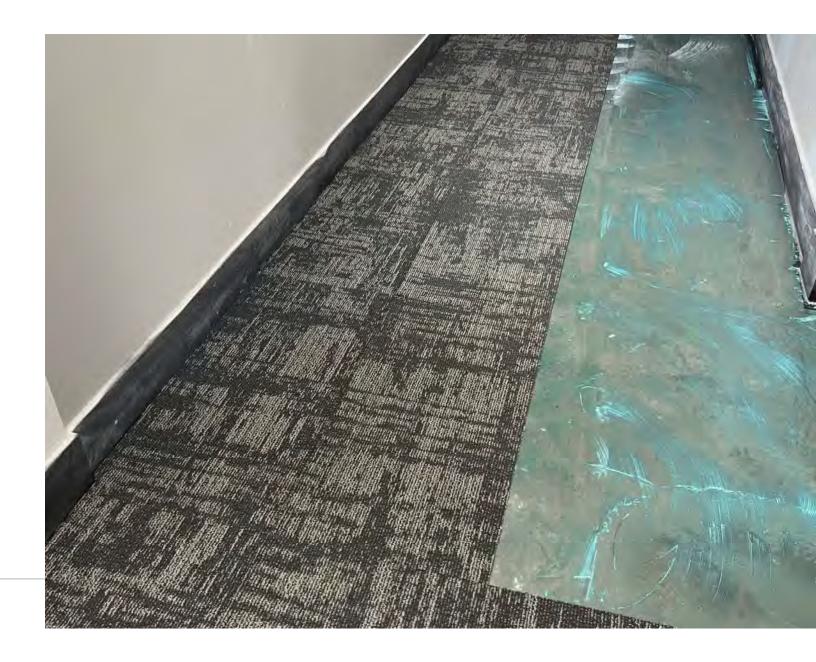
Building 2 Interior

Level 3 corridor carpet installation started
