Trestle Bridge Structural Assessment

Friends of Belchertown Greenway
Belchertown, MA

December, 2022

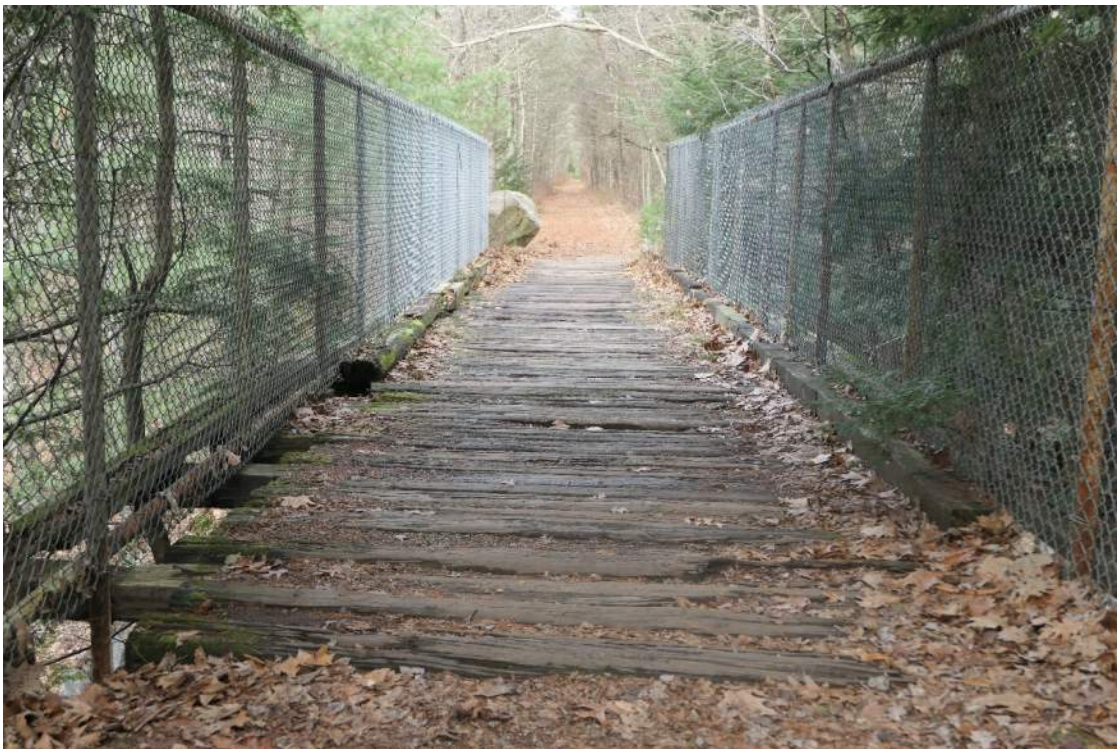
Overall View of Bridge, Top of Deck

The deck timber planks are overall in satisfactory condition considering the age of the structure, however there are areas of local deterioration, severe in some locations. At least one of the deck timbers has rotted away completely resulting in a large gap in the decking. The position of this timber being above a pile cap had allowed the hole to fill in with debris. In addition, a number of nail or spike heads were exposed, with a few inches of length left exposed at the time of the inspection. These present a tripping hazard or could potentially threaten harm to bicycle tires, pedestrian foot traffic or animal hooves.

5. Replace decking planks that are either deteriorated or are of insufficient length for the width of the bridge. Remove any exposed fasteners.
6. Upgrade the chain link fence to include bracketed connections and limit the post spacing to a maximum of 10 feet.

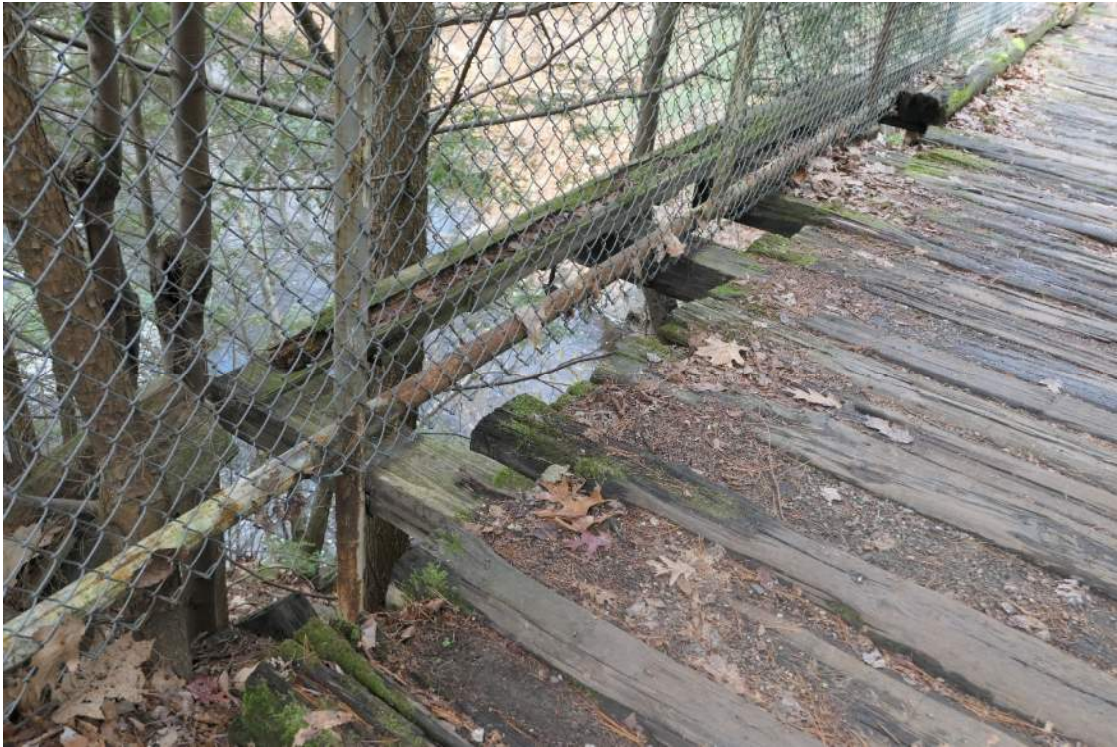
The curbs on the East side of the structure are full length and range from satisfactory to good condition. The curbing on the West side of the bridge is not full length, which combined with the deck planking not being full width, result in large gaps at the bridge edge. Where present, the curbing on this side is in satisfactory condition.

West Edge of Deck showing missing curb

7. Install missing curbing to eliminate any gaps between the decking and the chain link fencing.

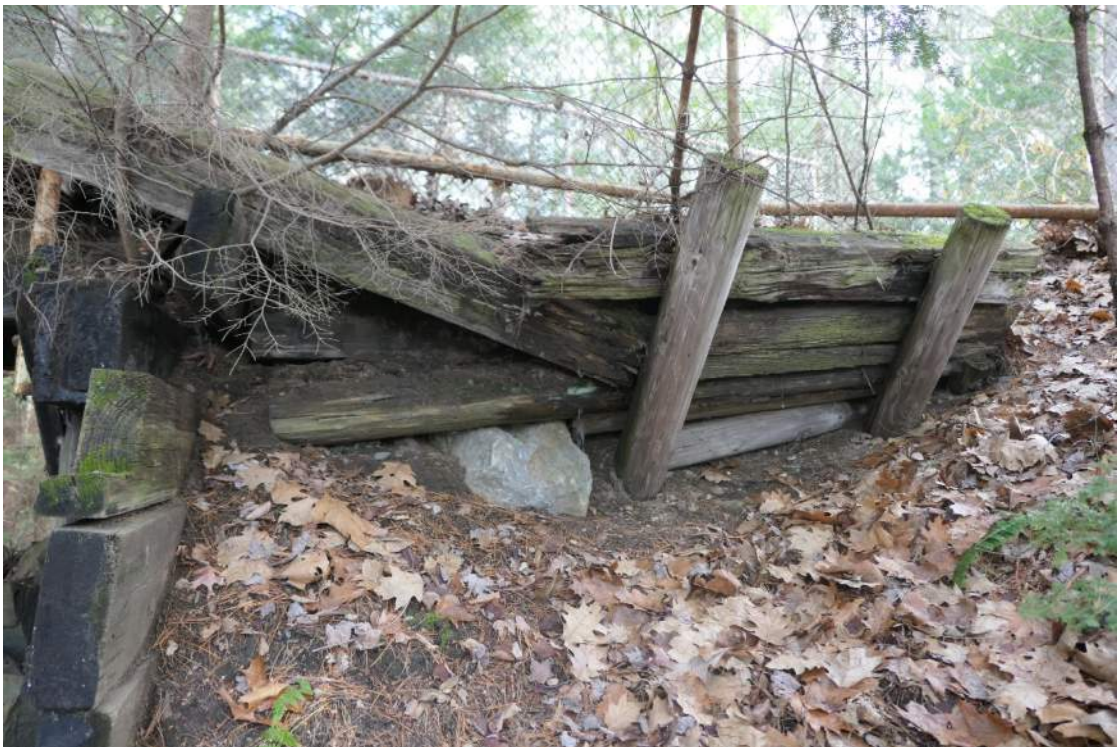
Southwest Wingwall

The bridge approaches, chain link fencing and decking are in generally poor condition. The wingwalls show excessive movement and deterioration, which has resulted in large gaps between the approach walkway and the chain link fencing. The fencing itself, while in good condition, should not be relied upon for protection, especially for light recreational vehicles. The post spacings are determined by the pile cap placement, and therefore are excessive at certain locations (exceeding 10 feet). In addition, the posts appear to be lag bolted through the timber members – these should be upgraded to bracket style connections for a sturdier attachment, as post deflection was noted.

1. Rehabilitation/construction of all wingwalls to ensure stable embankment slopes for both bridge approaches.
2. Replace or repair broken or deteriorated pile bent bracing members.

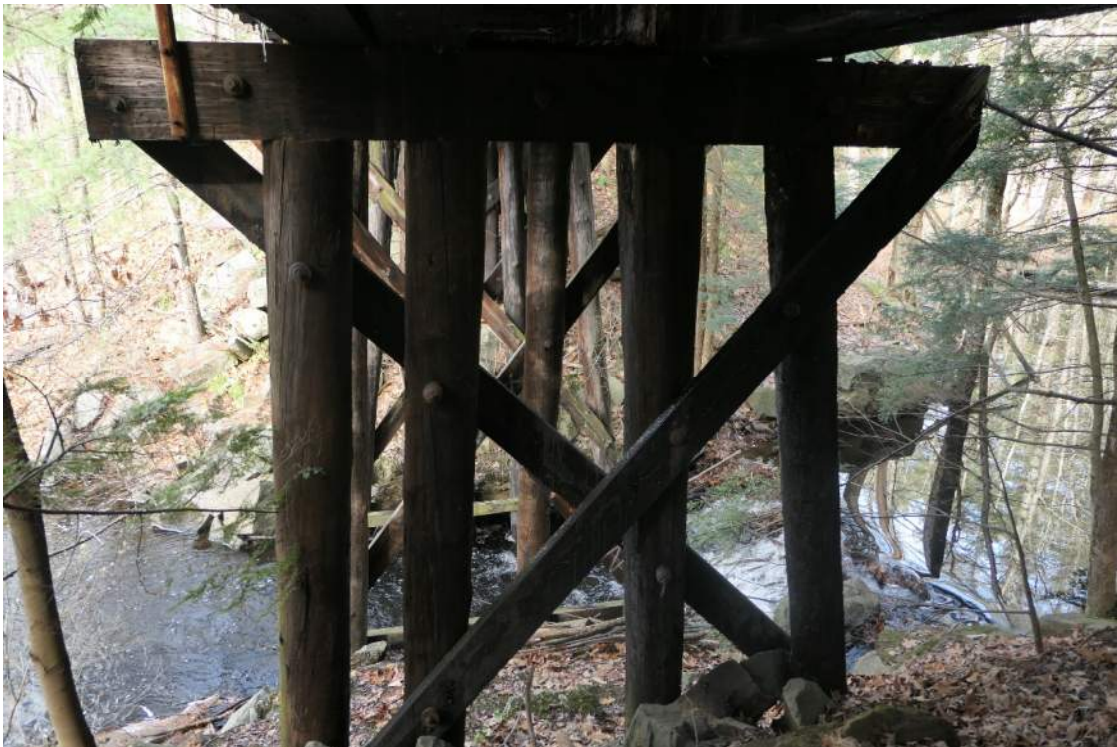
Typical Pier Pile Bent

There is some localized deterioration or damage to some of the bracing members, particularly at the end connections.

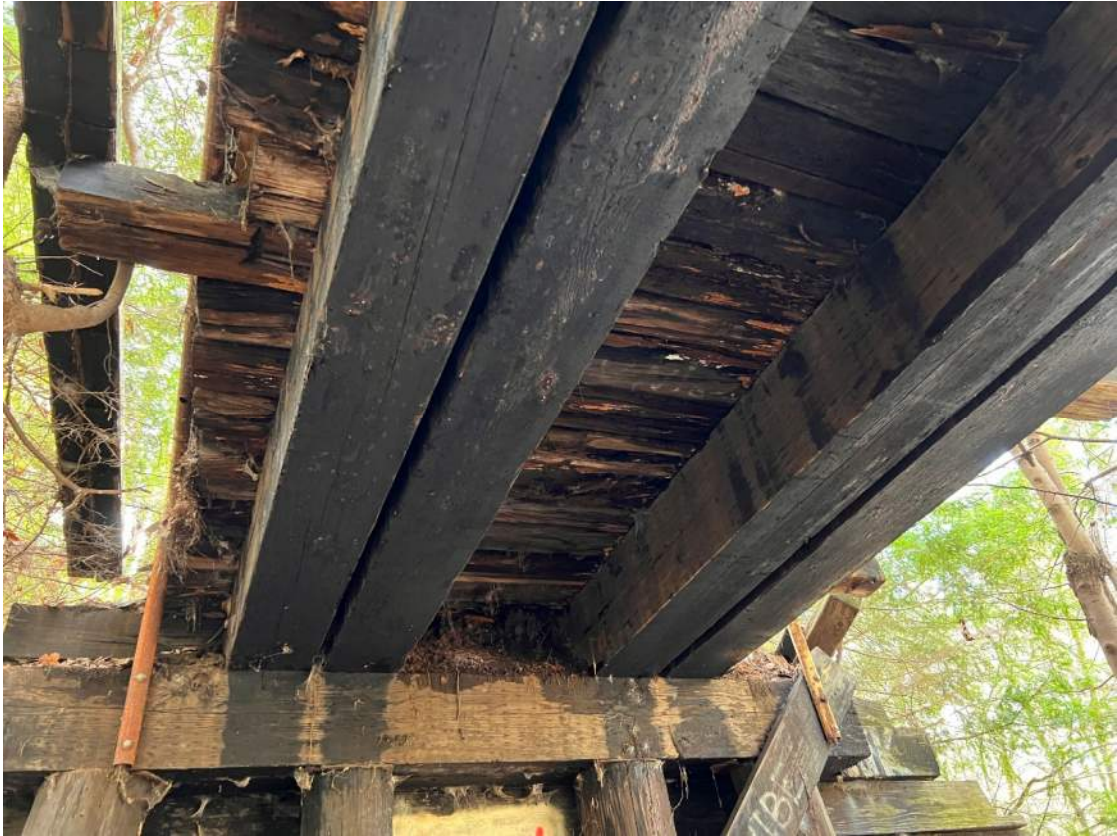
Typical Stringer Arrangement

The timber superstructure elements, which consist of the continuous timber stringers and pile caps, are overall in good condition. The timber stringers exhibited no visually apparent signs of rot, deterioration, or defects along the full length of the bridge. However, it is noted that the tops of the stringers were not able to be inspected, so there is the potential for some deterioration not otherwise apparent.

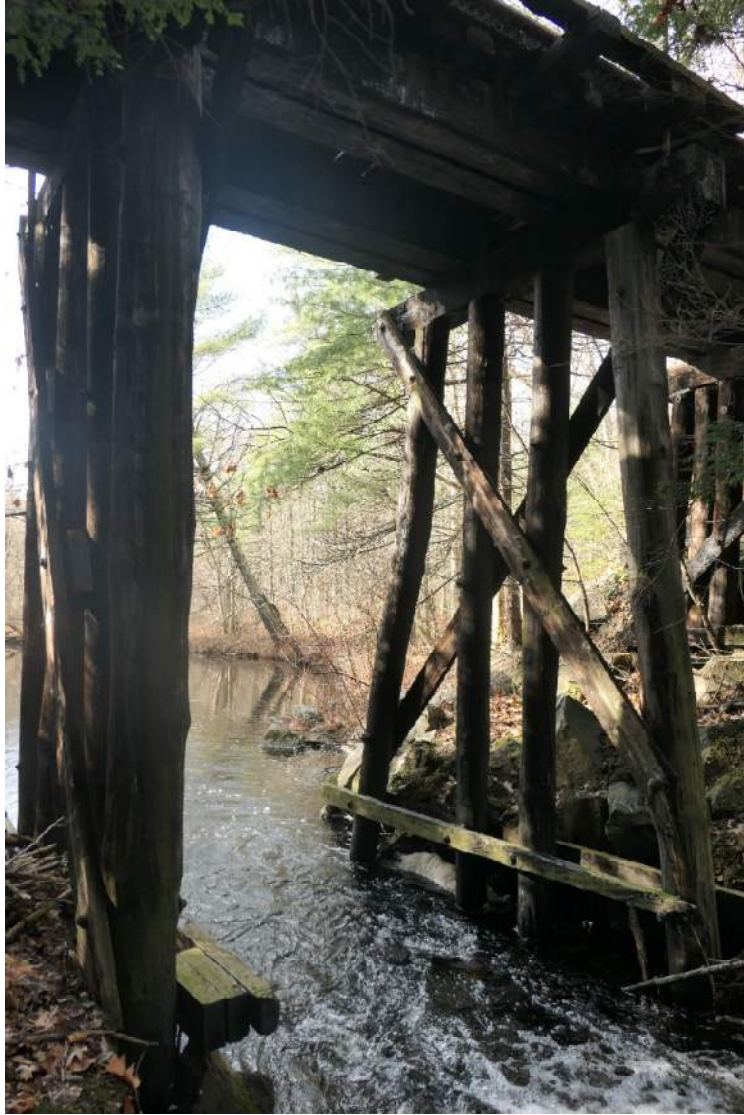
Pile Bents at Channel Crossing

The timber piles are in generally good condition, with the only deterioration noted at the top of the Easternmost pile of the Northern Abutment pile cap, which is generally limited. While not visible, there were no signs of damage or deterioration at the base of the piles in the channel.

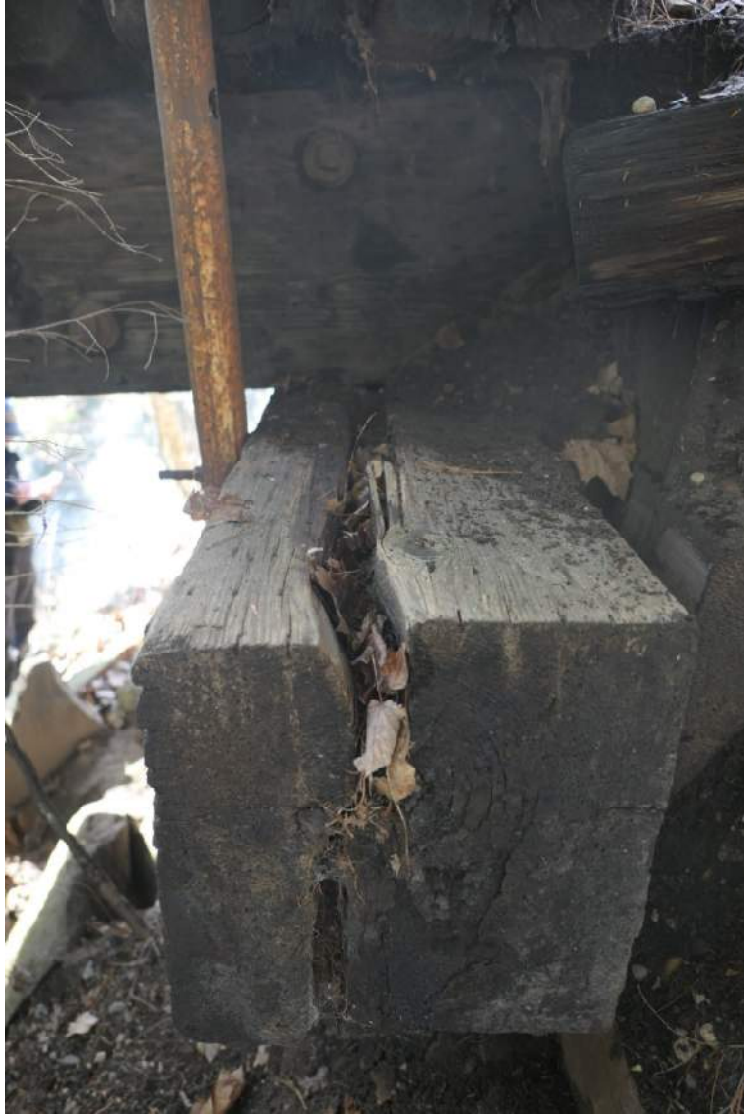
The pile caps, apart from the one at the Northern Abutment, are likewise in good condition with no significant deterioration noted. The pile cap at the Northern Abutment does exhibit splitting, significant rot and deterioration for roughly half of the length, starting from the East end. It was estimated that there's around 1/3 section loss of the pile cap over this length.

Northern Pile Cap – End Splitting

3. Replacement of the deteriorated pile cap at the Northern abutment. Based on the level of deterioration, repair is likely not practicable.
4. Repair the rotted section at the top of the timber pile at the Northern abutment pile cap. Depending on the extent of deterioration, this may be accomplished by cleaning out the rotted sections of wood and filling with epoxy.

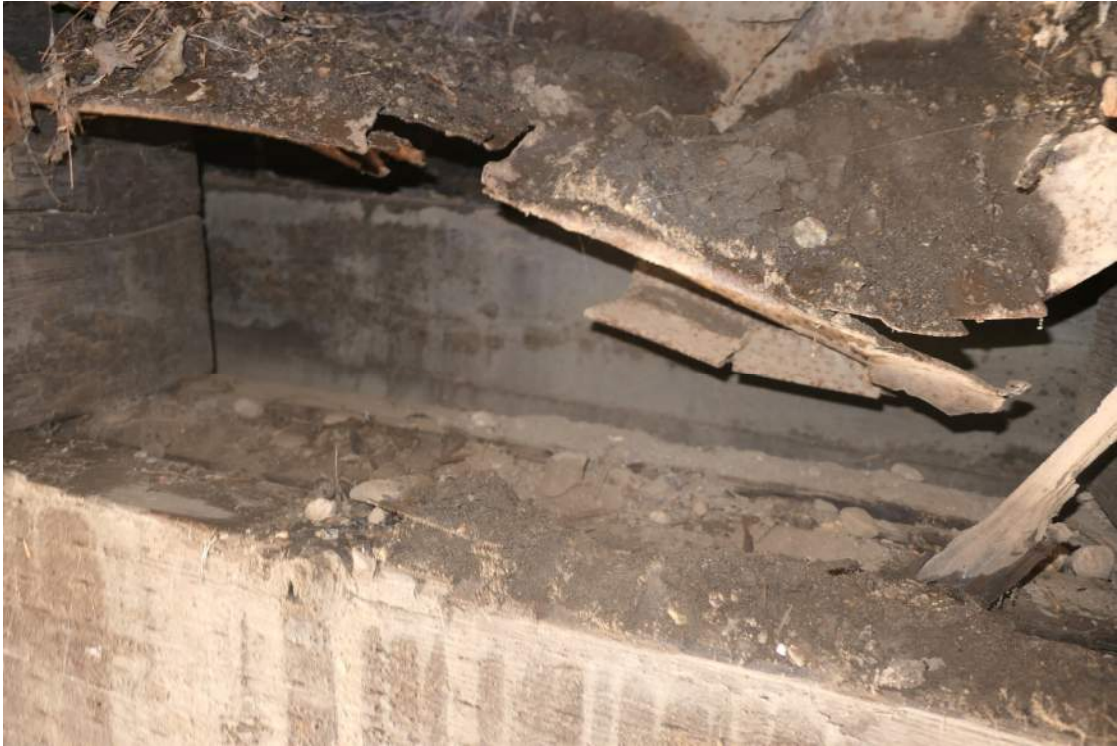
Northern Pile Cap – Rot at Top of Timber

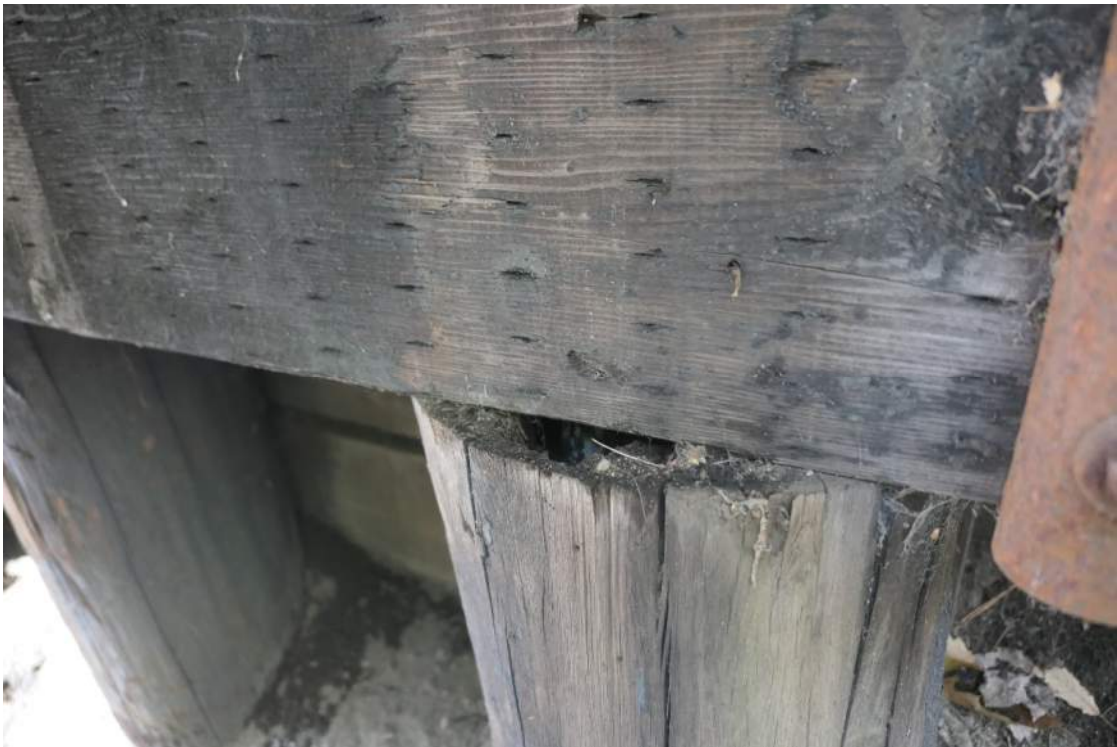
Rot at Top of Pile – Eastern Pile, North Abutment
