# Mass Central Rail Trail Evaluation of Existing Bridges

## Wayside Branch - Waltham to Berlin

### Summary of Evaluation

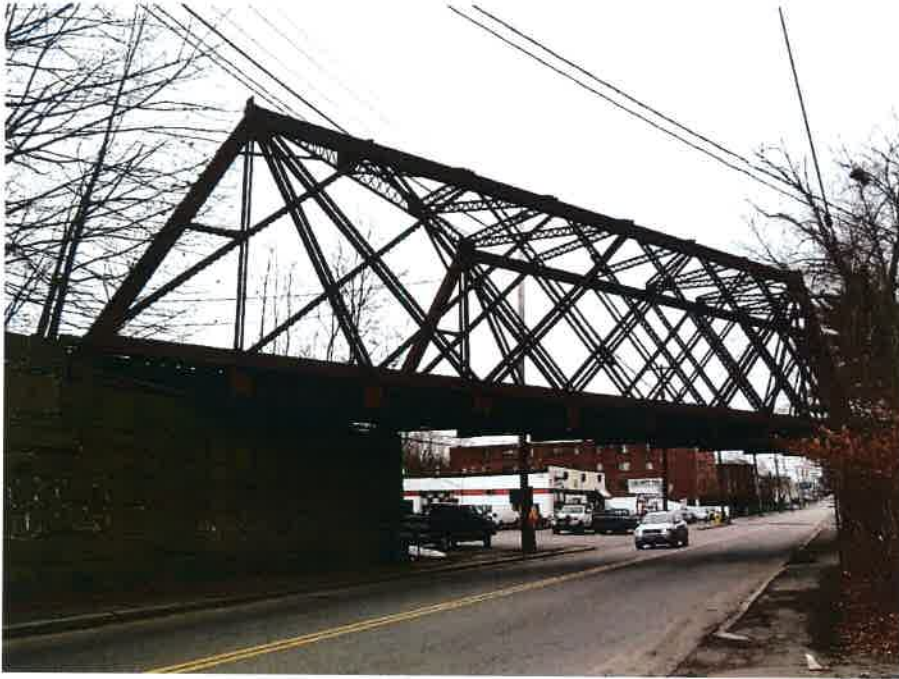
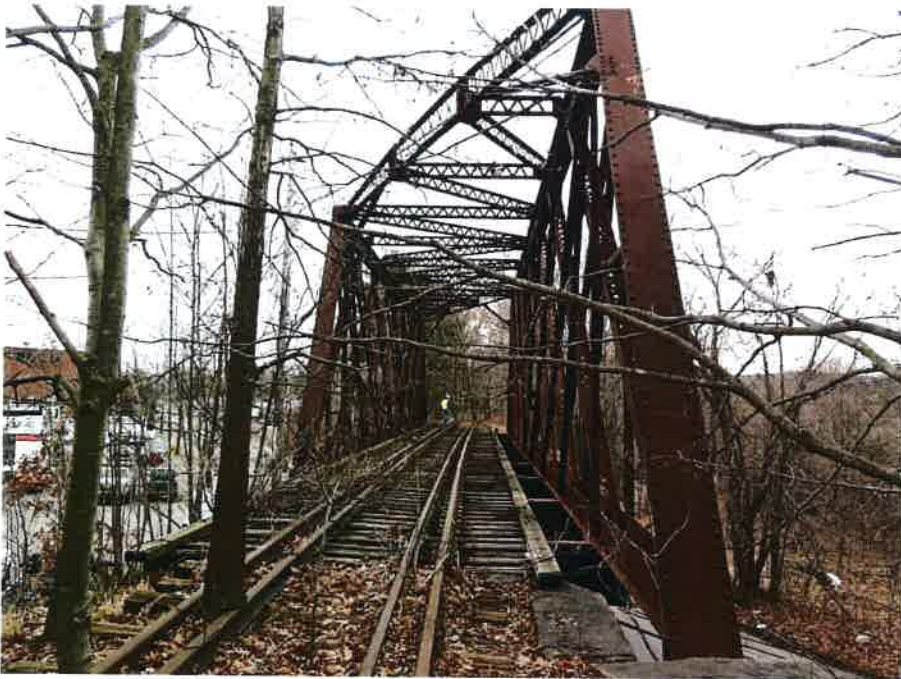
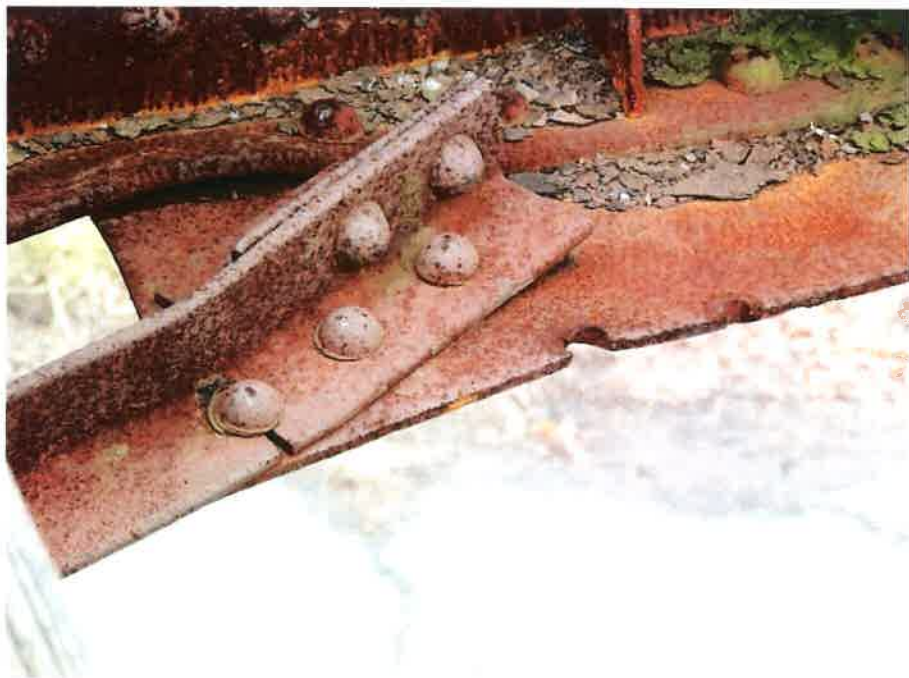
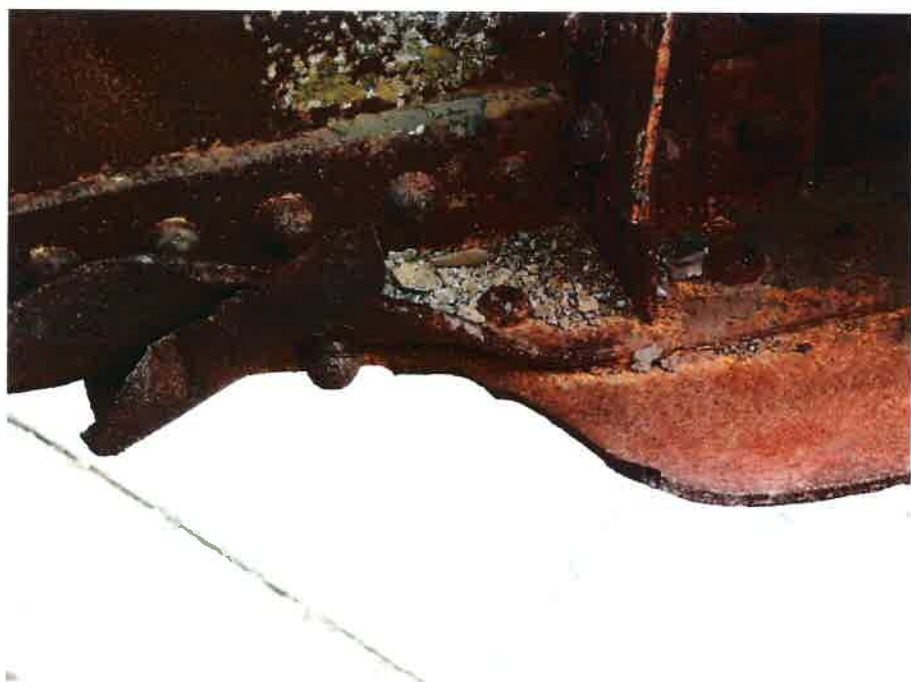
Linden Street, Waltham: 1894 Riveted Lattice Thru Truss on Stone Abutments

- Some minor impact damage to secondary bracing members under the deck
- No paint remaining on the steel
- Cracked, loose and missing mortar in the stone abutments

- Remove and dispose of existing timber ties and steel rails
- Repair bent, cracked/ broken gusset plates and bracing angles
- Clean and paint steel
- Replace mortar joints in the abutments
- Construct new concrete bridge deck, curbs and bridge railings (a concrete slab with curbs is recommended since this bridge is over roadway and pedestrian traffic to prevent ice hazards below)

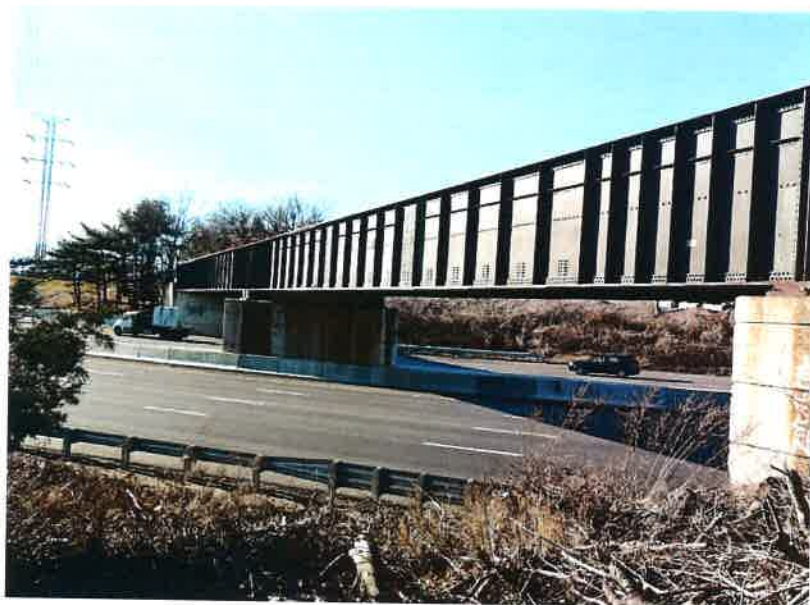
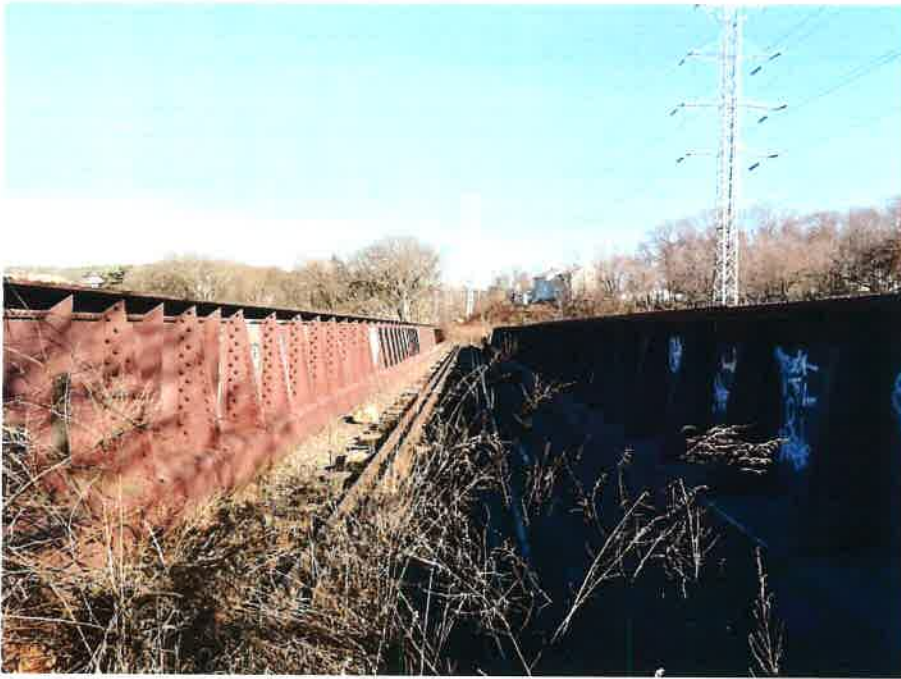
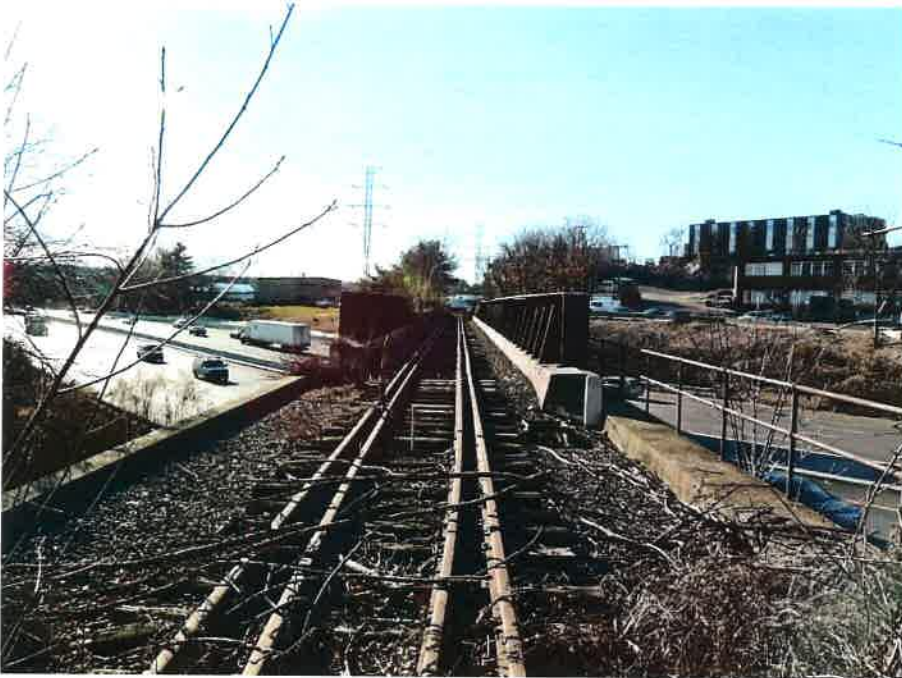
## Route 128, Waltham: 1960 Two Span Thru Plate Girder on Concrete Abutments and Pier

- Paint is in fair condition, except for graffiti on the inside face of the both girders and on the outside face of the north girder (accessible by a catwalk). The underside of floor beams, diaphragms and deck plate has peeling paint. Bridge was last painted in 1988.
- Verify adequacy of existing bridge drainage, make upgrades as required.

- Remove and dispose of existing timber ties and steel rails
- Clean and paint steel (cover graffiti surfaces only), entire structure will require future painting
- Upgrade bridge drainage system
- Pave pathway over the bridge
- Install a timber guardrails along the inside face of the girders
- Remove the catwalk along the north side of the bridge (potential safety hazard)

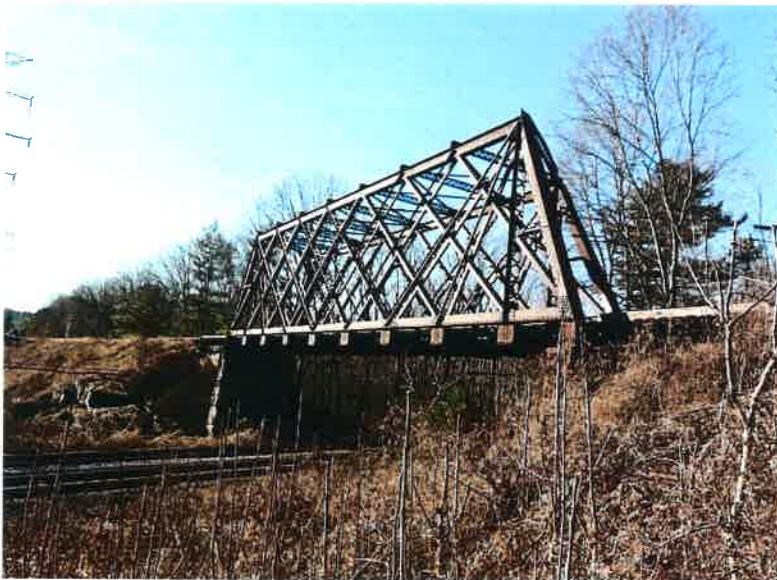
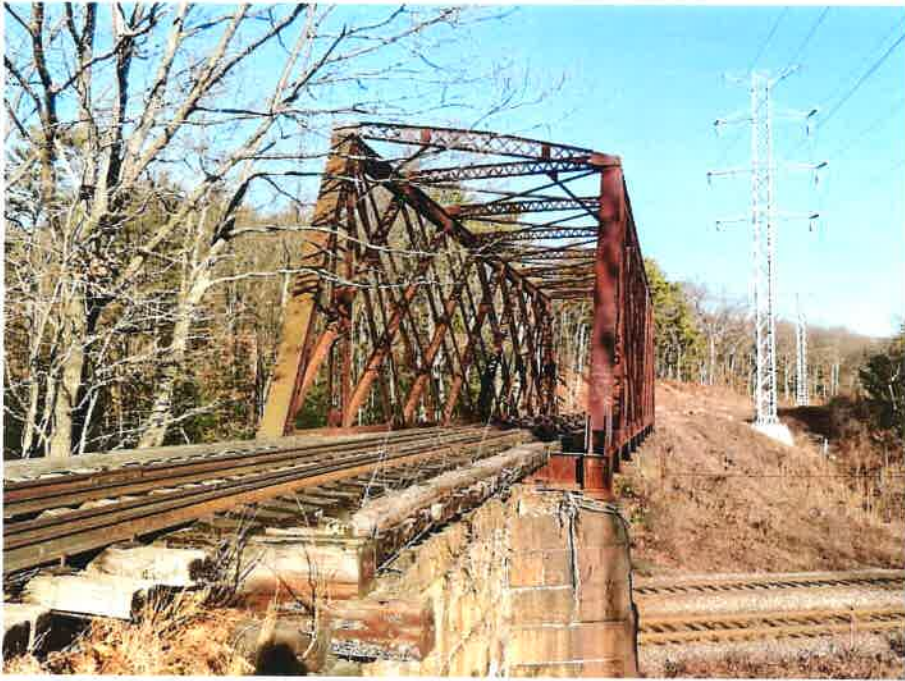
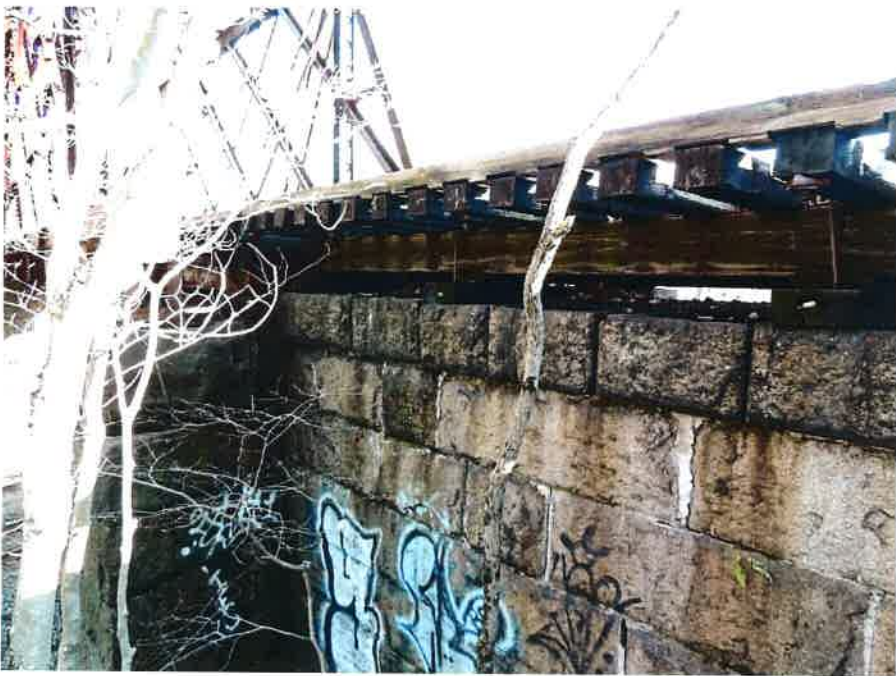
## Over MBTA Fitchburg Line, Weston: 1896 Riveted Lattice Thru Truss on Stone Abutments

- No paint remaining on the steel
- Cracked, loose and missing mortar in the stone abutments and wingwalls
- Timber ties are in fair condition, but will need to be replaced to widen the bridge deck

- Remove and dispose of existing timber ties and steel rails
- Clean and paint steel
- Replace mortar joints in the abutments
- Construct new timber bridge deck and railings
- Construct new backwalls/wingwalls to facilitate widening of the bridge deck to 14 feet

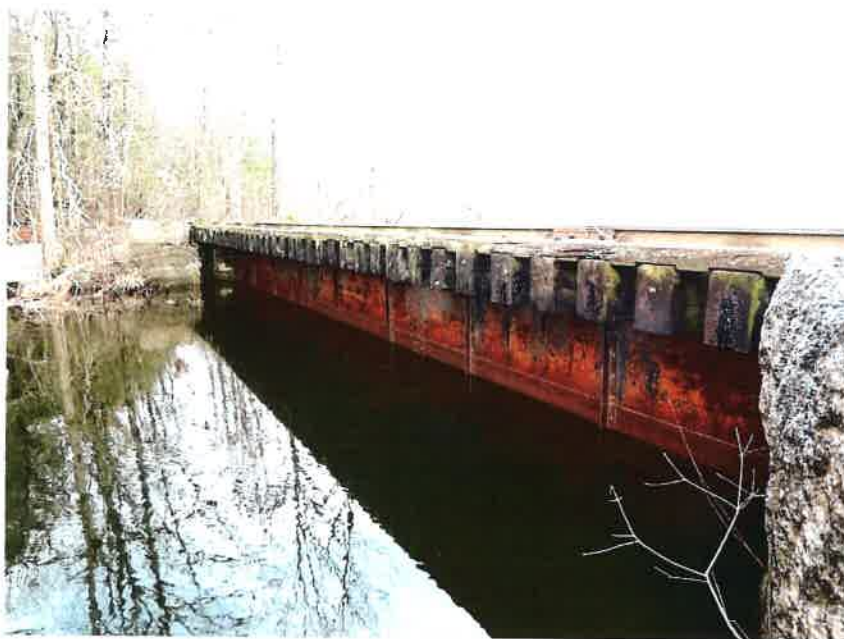
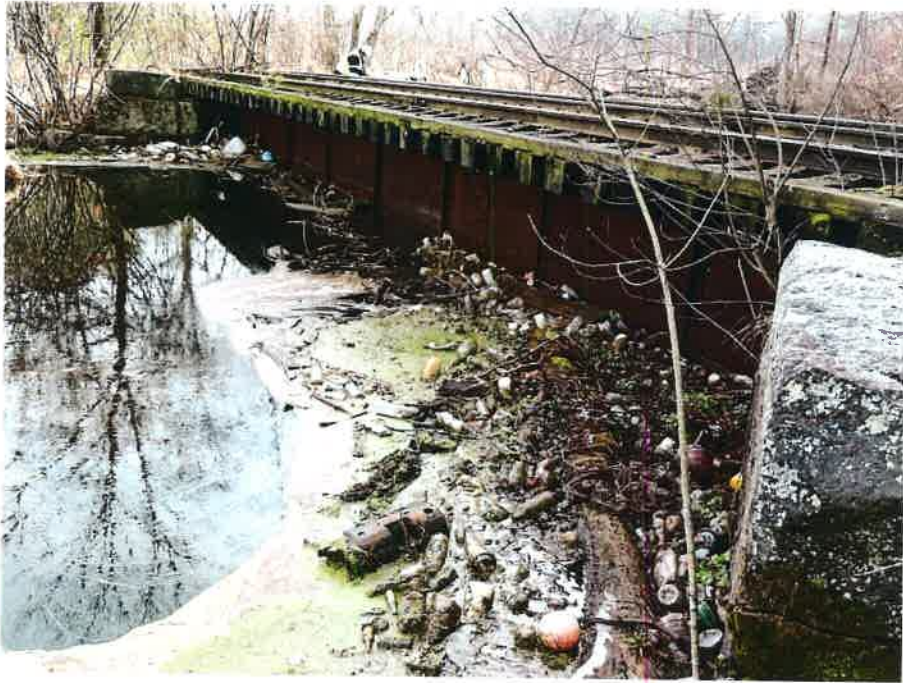
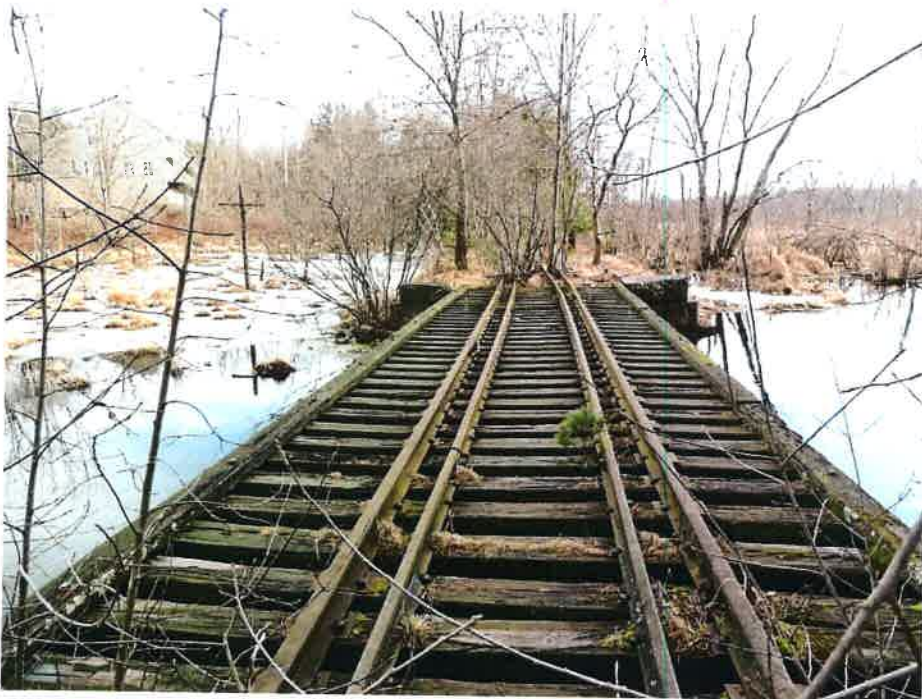
## #127 Hop Brook, Sudbury: 1881 Riveted Plate Deck Girder, Stone Abutments, Timber Piers

- Bottom of Girders are submerged (possibly due to flooding of wetland from beaver dams)
- No paint remaining on the steel
- Timber ties are in poor condition, and will need to be replaced to widen the bridge deck
- Condition of abutments and intermediate piers cannot be determined due to flooding

- Investigate the cause of flooding and rectify if possible
- If water level cannot be lowered, the bridge seats need to be raised and the girders reset (this will require considerable additional costs for raising the approach pathway profiles to meet the new bridge deck elevation)
- Remove and dispose of existing timber ties and steel rails
- Complete miscellaneous repairs to steel as required
- Clean and paint steel
- Install new timber transverse beams
- Construct new timber bridge deck and railings
- Replace mortar joints in the abutments
- Construct new backwalls/wingwalls to facilitate widening of the bridge deck and approaches to the proposed 14 feet trail width and raising of the bridge deck elevation and approaches
- Repairs/ replacement of intermediate piers

For this bridge an alternative option to rehabilitation of the existing superstructure is proposed; installation of a new superstructure that would allow for adequate freeboard under the span, with a comparable cost to rehabilitation of the existing superstructure.

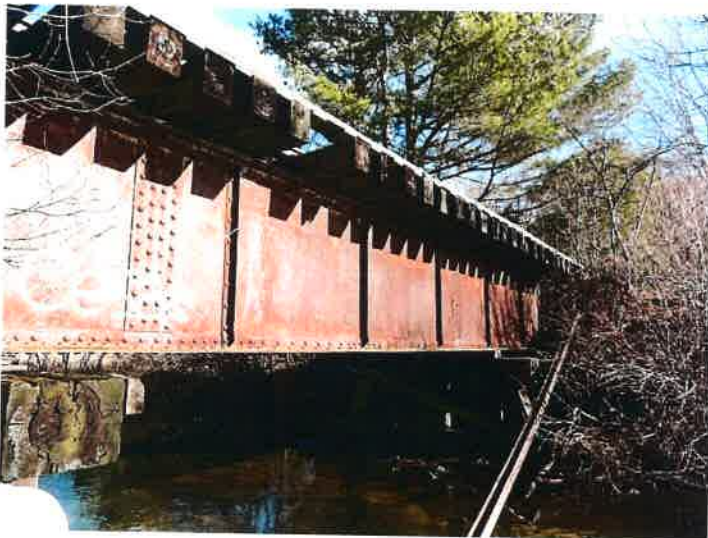
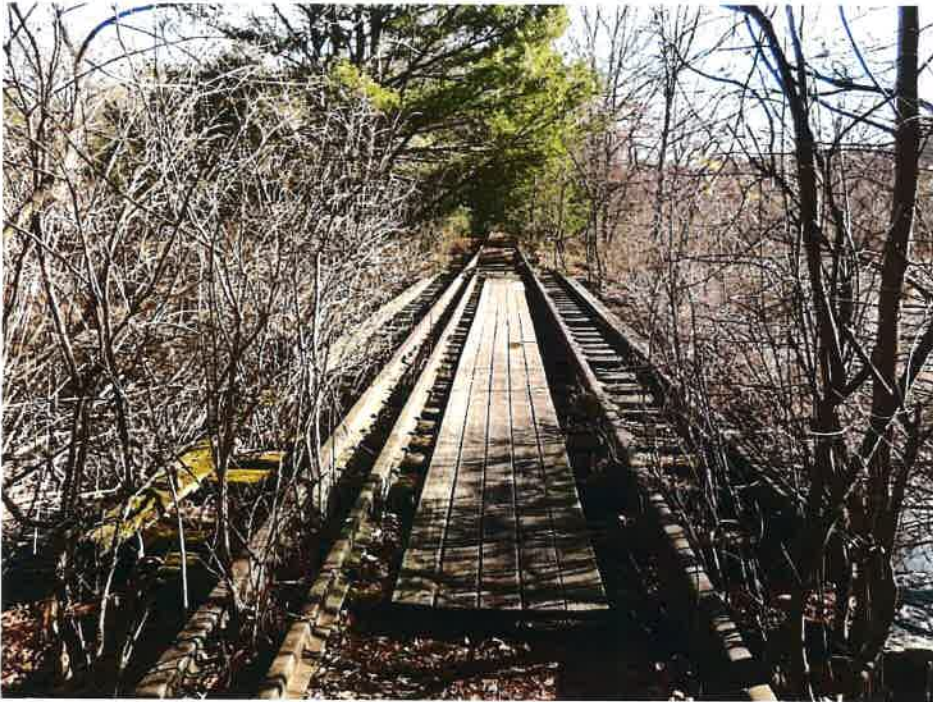
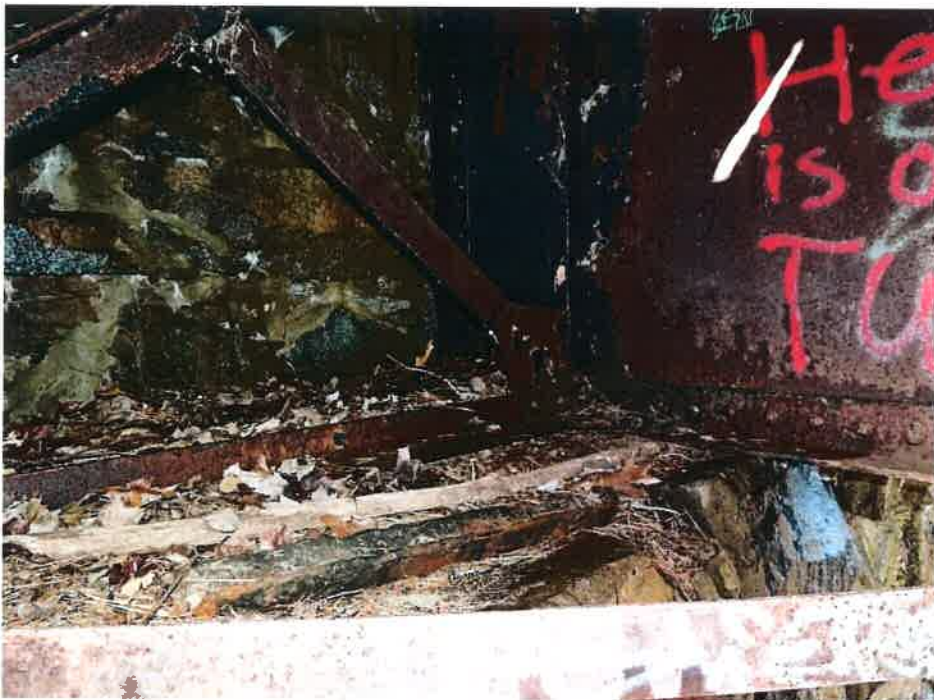
#128 Hop Brook, Sudbury: 1881 Riveted Plate Deck Girder, Stone Abutments, Timber Piers

- No paint remaining on the steel, graffiti on inside faces of girders
- Timber ties are in poor condition, and will need to be replaced to widen the bridge deck
- Damp debris on bridge seats
- Missing, loose mortar joints in the stone abutments
- Ends of timber pier caps display some decay

- Remove and dispose of existing timber ties and steel rails
- Complete miscellaneous steel repairs as required
- Clean and paint steel
- Replace mortar joints in the abutments
- Repair/replace pier caps
- Modify backwall to facilitate widening of bridge and approach to the proposed 14 feet trail width
- Construct new timber bridge deck and railings

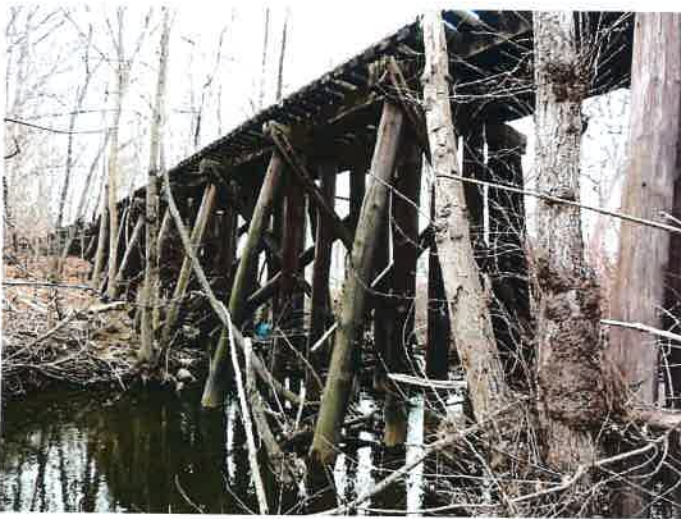
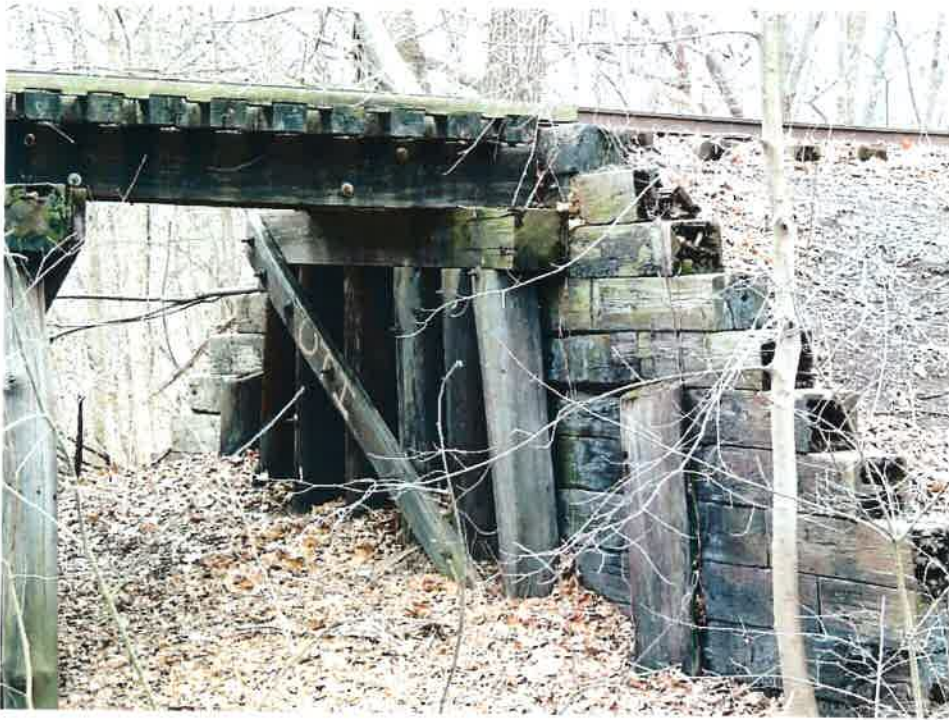
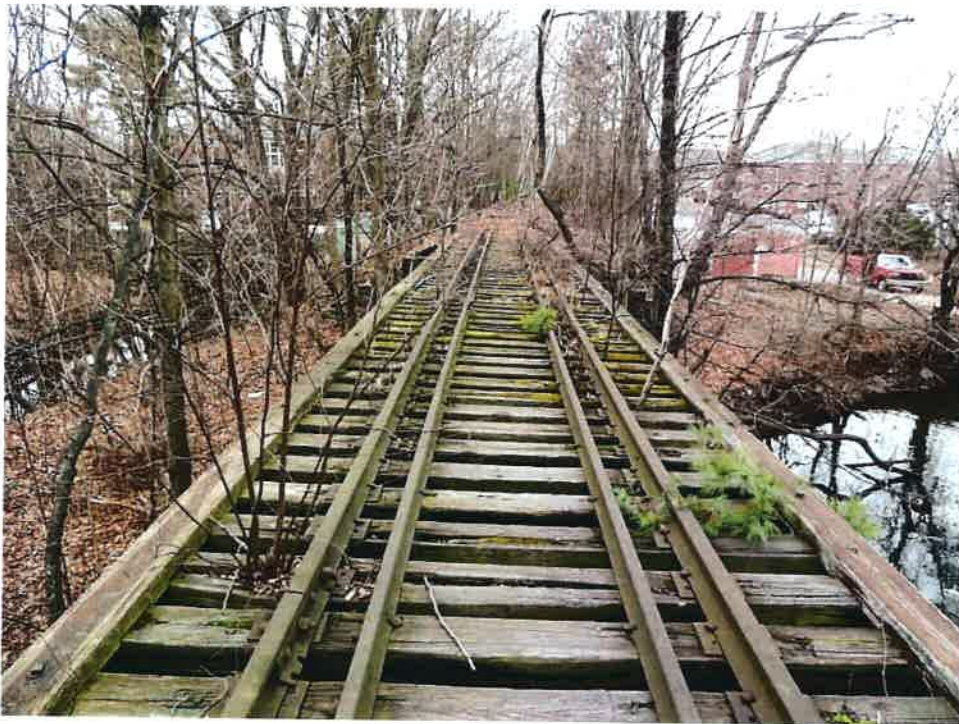
Clematis Brook, Waltham: Timber Pile Trestle (open timber tie deck)

- Timber ties are in poor condition, and need to be replaced to widen the bridge deck
- Timber backwalls have decay and need to be replaced
- Ends of timber pile caps display some decay
- Accumulating debris in stream is against the upstream side of the timber pile bents

- Remove and dispose of existing timber ties and steel rails
- Remove timber backwalls and reconstruct new backwalls and wingwalls to support backfill
- Repair/ replace timber pile caps as required
- Clear stream bed of accumulated debris against the pile bents
- Install new additional longitudinal timber beams and construct new timber deck and railings

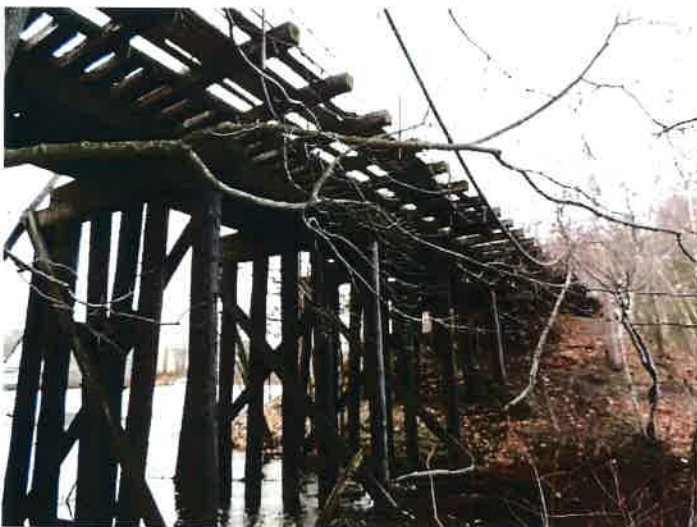
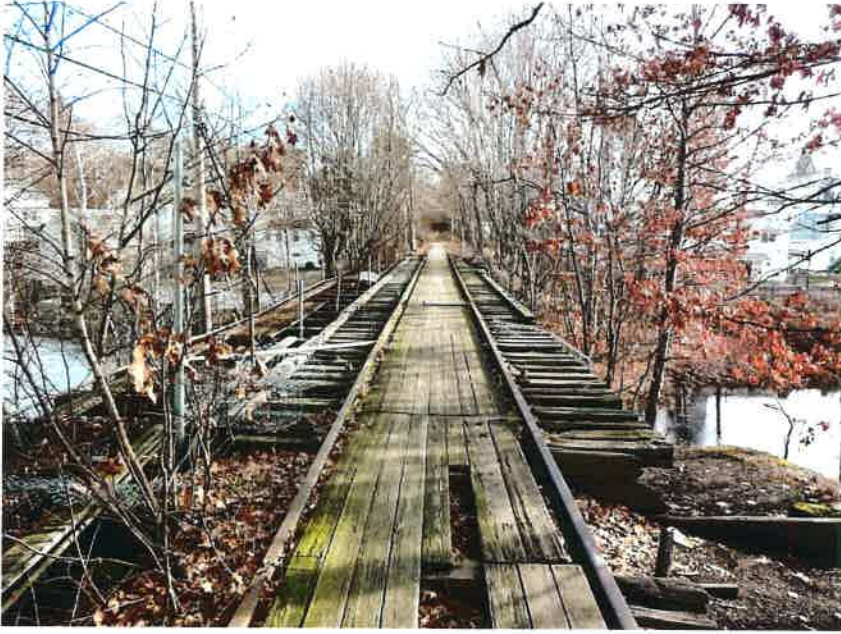
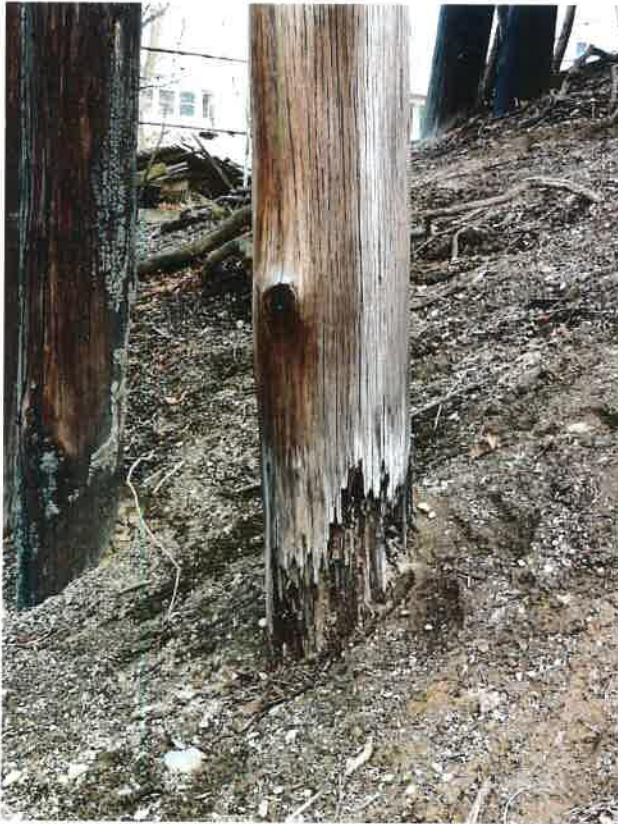
## Bruce's Pond, Hudson: Timber Pile Trestle (open timber tie deck)

- Timber ties are in poor condition, and need to be replaced to widen the bridge deck
- Timber backwalls have decay and need to be replaced
- One timber pile displays some decay
- Minor fire damage to timber ties and beams (damage to beams not significant)

- Remove and dispose of existing timber ties, steel rails, remains of timber catwalk and fencing
- Remove timber backwalls and reconstruct new backwalls and wingwalls to support backfill
- Repair deteriorated timber pile (cut out decay/ splice/plate and bolt repair section)
- Install additional longitudinal beams and construct new timber deck and railings

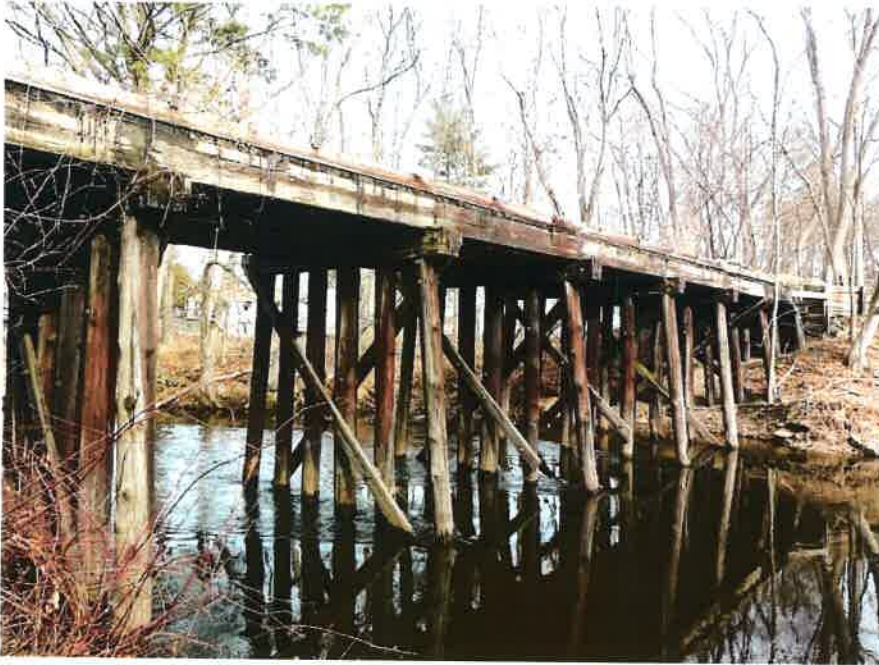
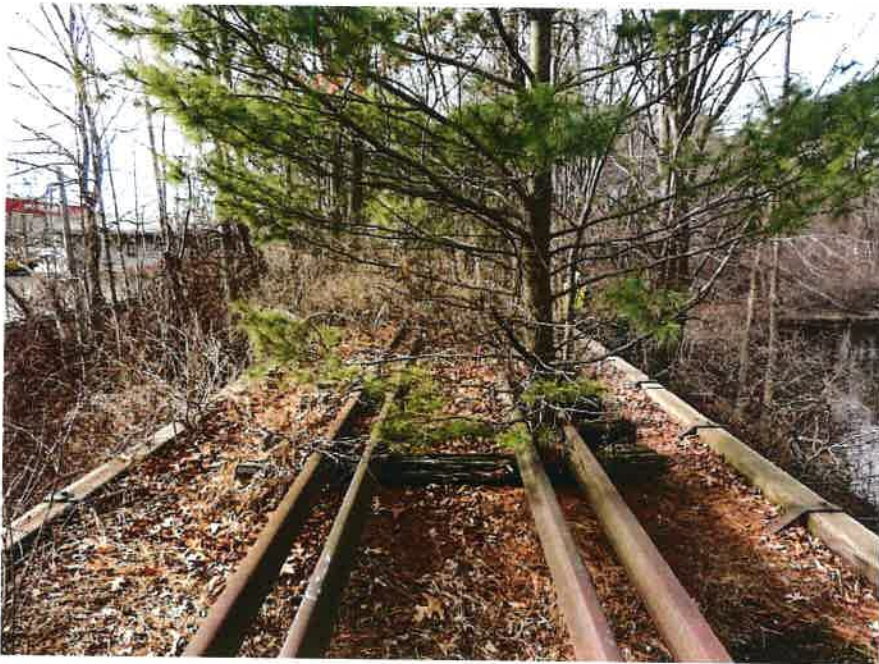
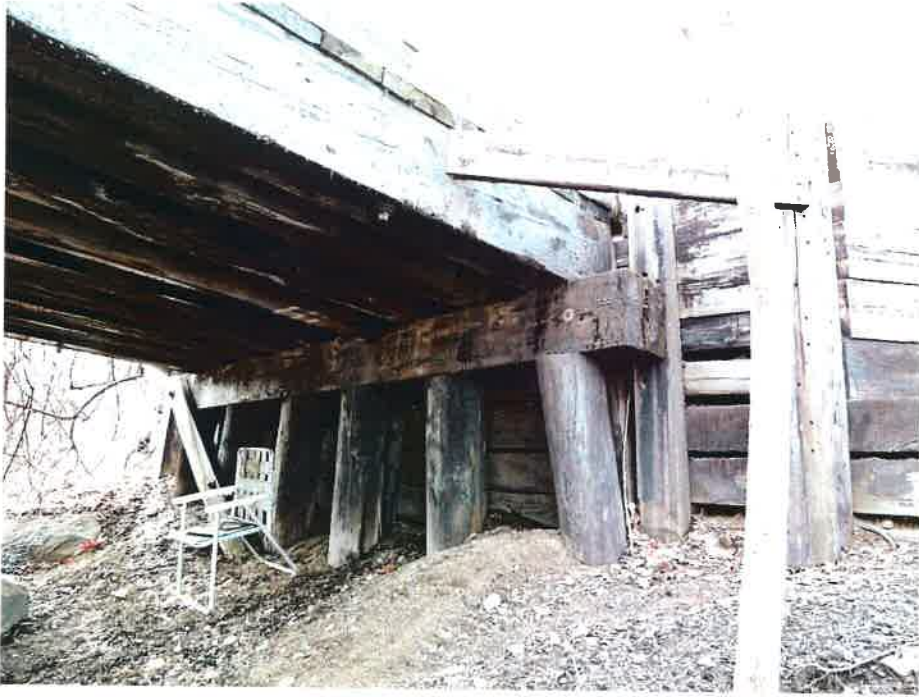
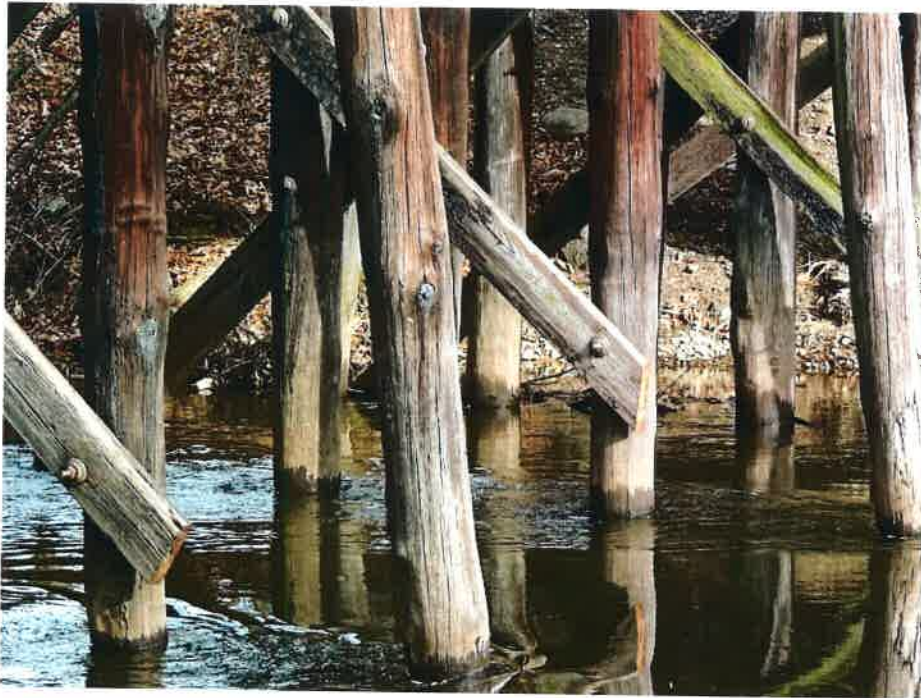
### Assabet River, Hudson: Timber Pile Trestle (timber deck with ballast)

- Ballasted timber deck supports significant vegetation growth (trees up to 8 inch in diameter); the condition of the wood deck is suspect to decay, will likely need replacement
- Timber beams appear to be sound, some decay at top of beams can be expected
- Timber backwalls and wingwalls have decay and need to be replaced
- Some cross bracing on the timber pile bents is split, cracked and weathered, and at two locations has been cut off near the waterline on the upstream side of the bridge (possibly damaged from floating debris)
- Condition of piles below the waterline could not be determined

Further in depth evaluation of this bridge should include an underwater inspection of timber piles and a hydraulic analysis of the bridge before consideration is given to investing capital to rehabilitate this bridge for the proposed rail trail. If it is determined that this structure warrants rehabilitation, the following is required:

- Remove and dispose of trees, timber ties, steel rails, and ballast
- Remove and dispose of timber curbs and timber decking
- Replace any deteriorated timber beams
- Remove timber backwalls and wingwalls; reconstruct new backwalls and wingwalls to support backfill
- Repair deteriorated timber pile cross bracing
- Construct new timber deck and railings

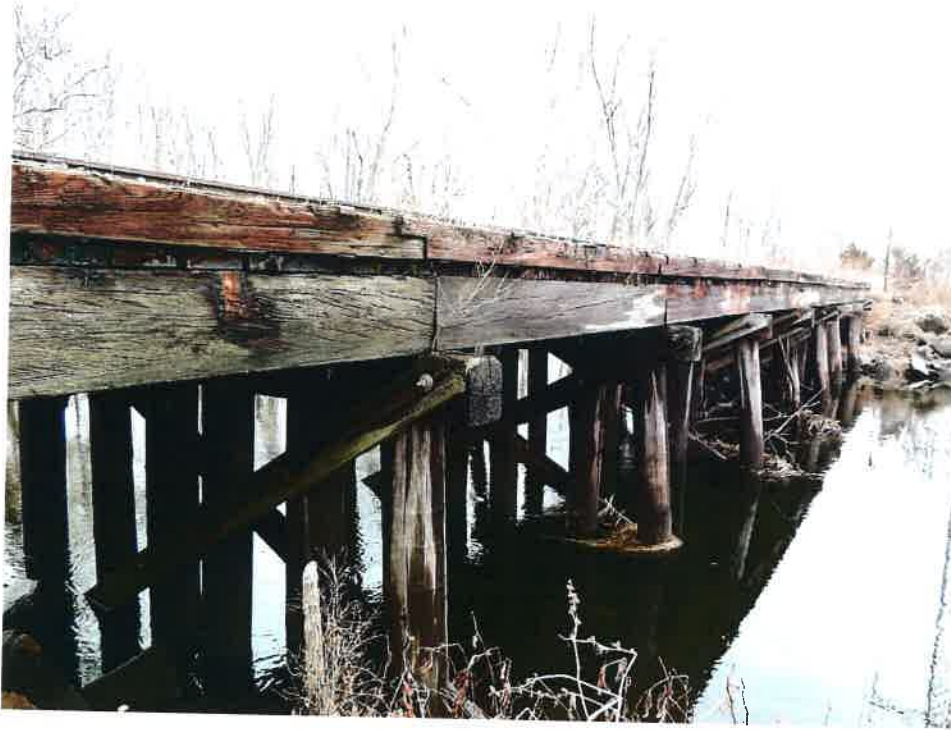
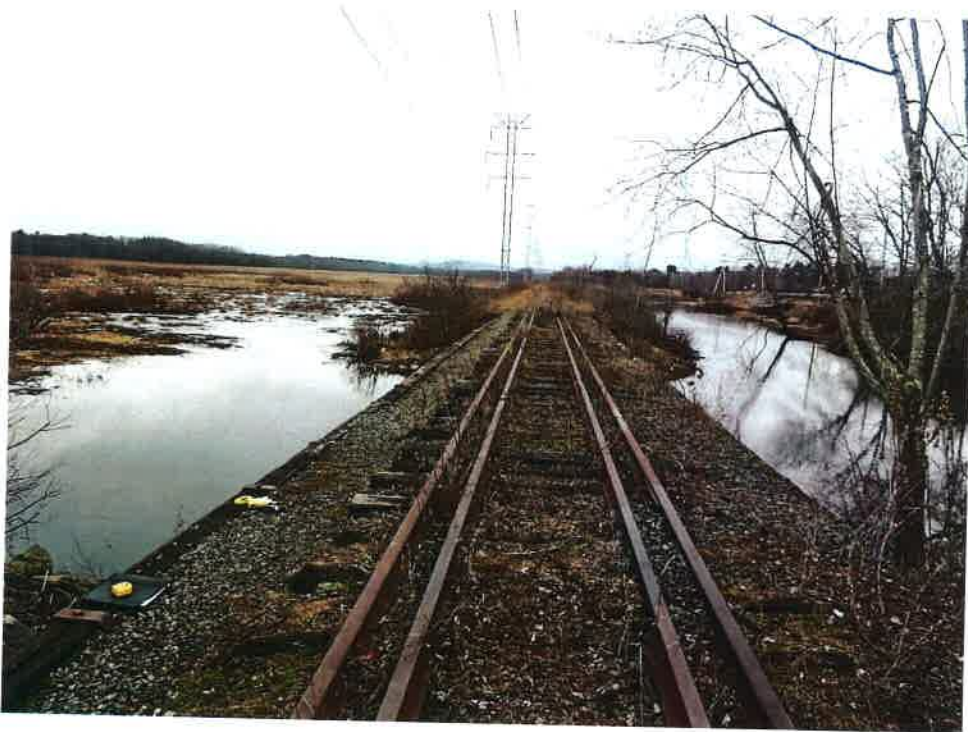
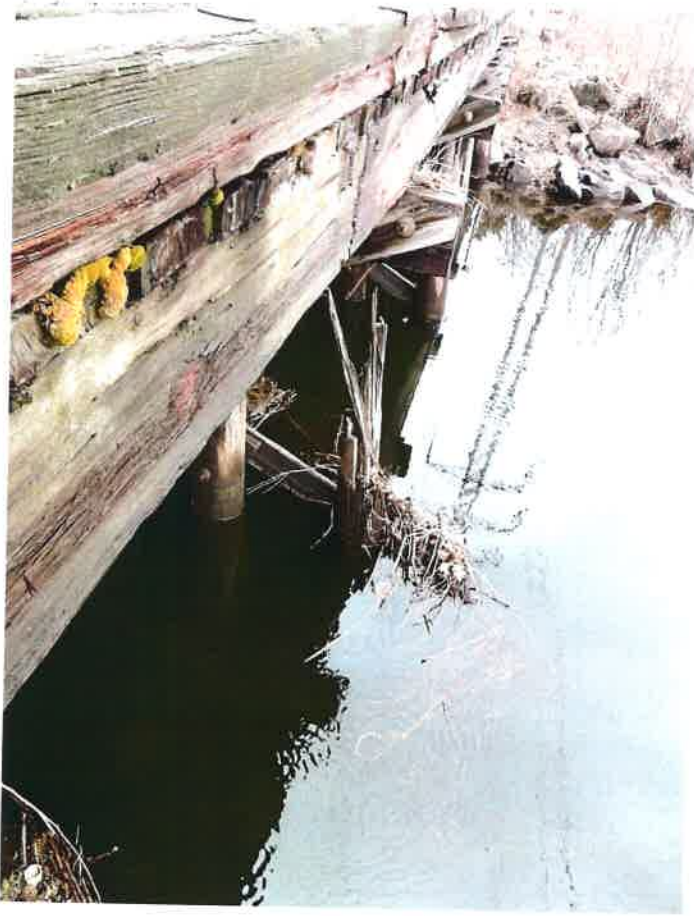
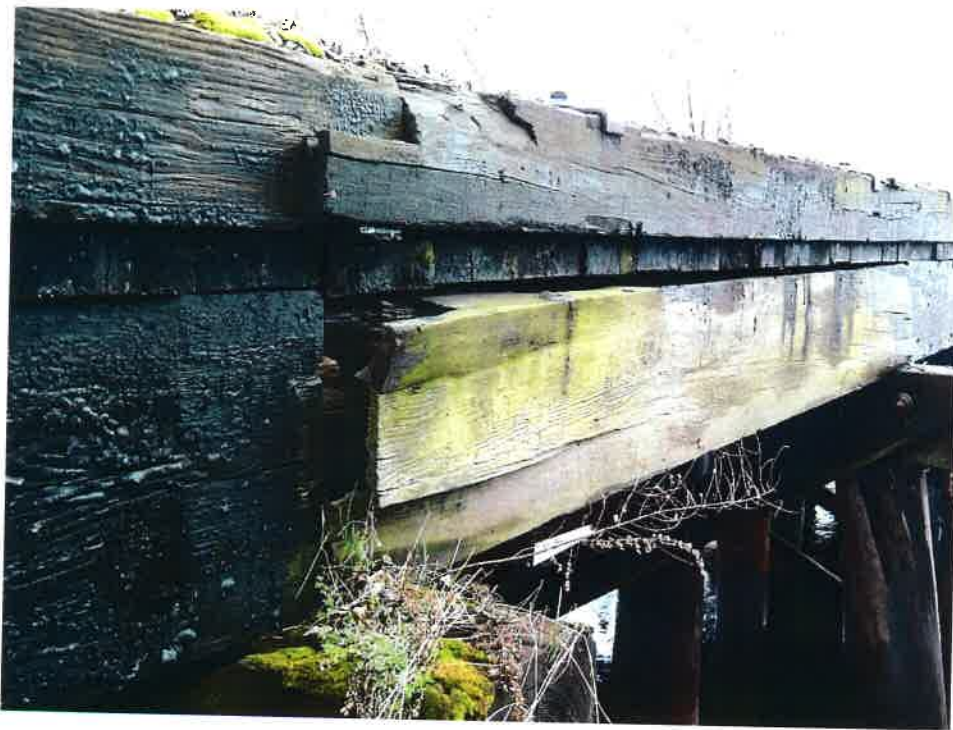
## Great Meadows Wildlife Refuge Sudbury River, Sudbury: Timber Pile Trestle (timber deck with ballast)

- Ballasted timber deck, the condition of the wood deck is suspect to decay, will likely need replacement
- Timber beams have some decay, expect some will require replacement
- Timber pile caps display some decay , with splits, cracks and weathering, suspect some may require repair or replacement
- One timber pile at mid span on the upstream side of the bridge is severed possibly damaged by floating debris, and will need to be spliced/reinforced
- Condition of piles below the waterline could not be determined
- Cross bracing on the timber pile bents is split, cracked and weathered

Further in depth evaluation of this bridge should include an underwater inspection of timber piles and a hydraulic analysis of the bridge before consideration is given to investing capital to rehabilitate this bridge for the proposed rail trail. If it is determined that this structure warrants rehabilitation, the following is required:

- Remove and dispose timber ties, steel rails, and ballast
- Remove timber curbs and timber decking
- Repair severed timber pile
- Repair deteriorated timber pile cross bracing
- Repair/ replace deteriorated timber pile caps as required
- Replace deteriorated timber beams as required
- Construct new timber deck and railings
