# Mass Central Rail Trail Evaluation of Existing Bridges

## Wayside Branch - Waltham to Berlin

### Summary of Evaluation

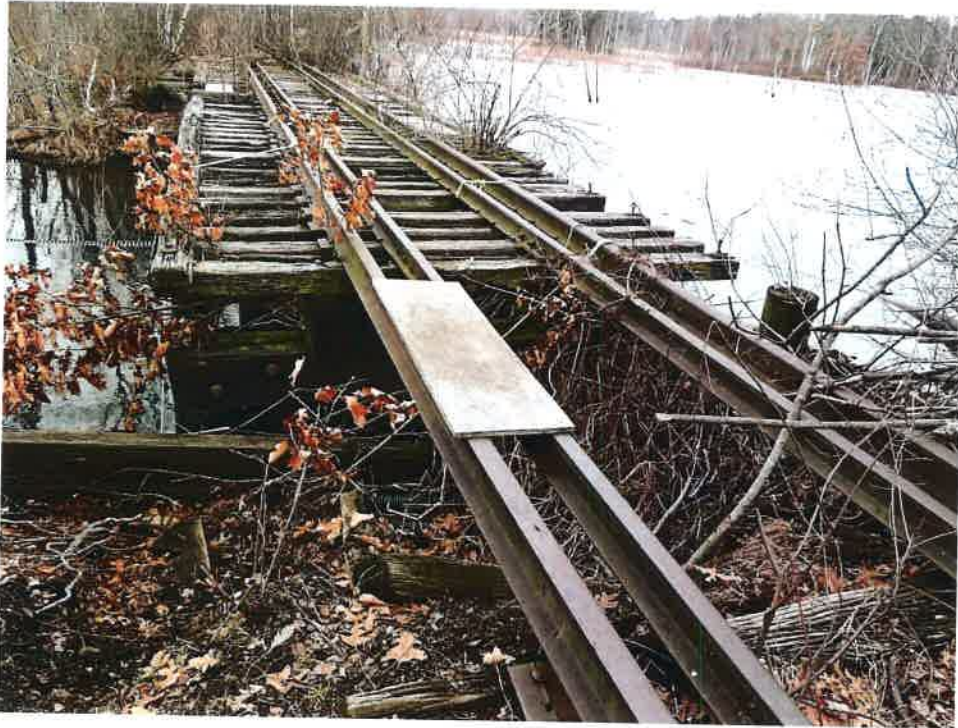
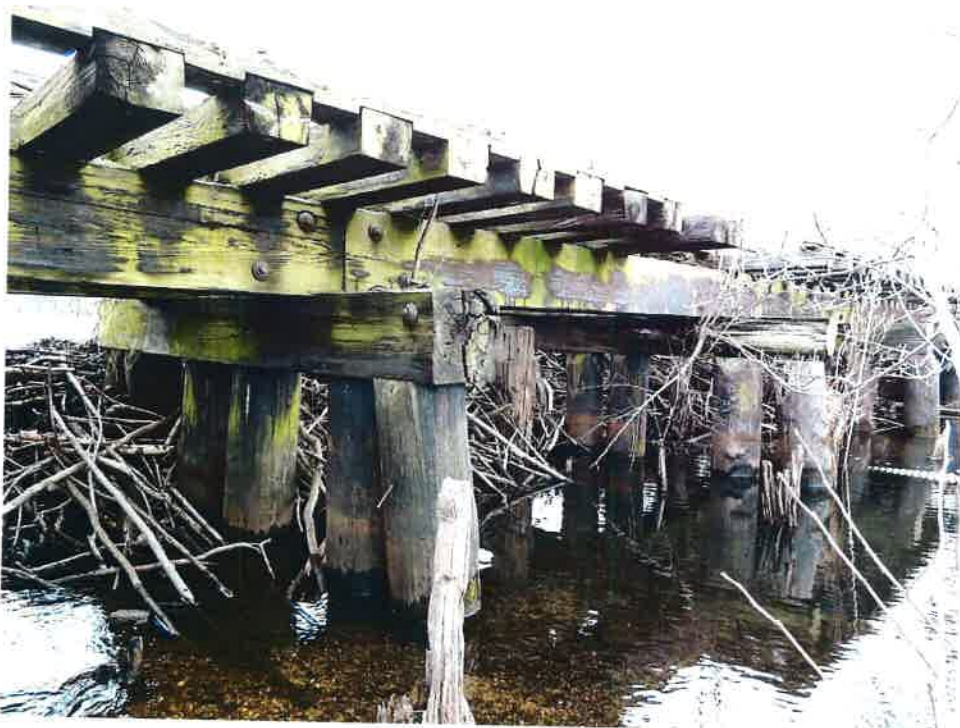
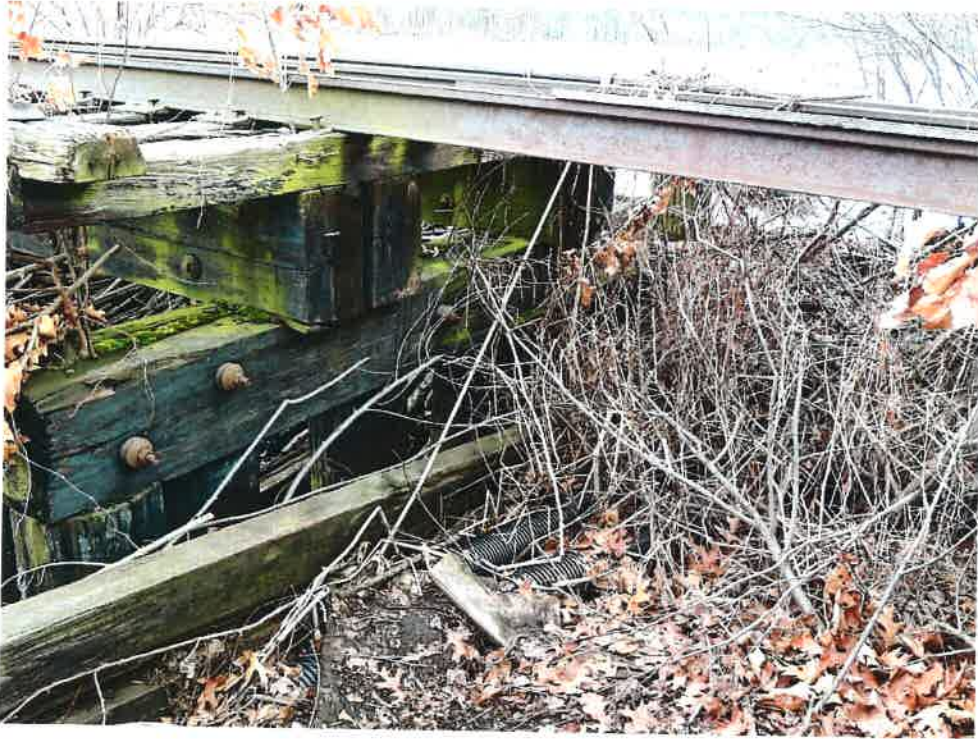
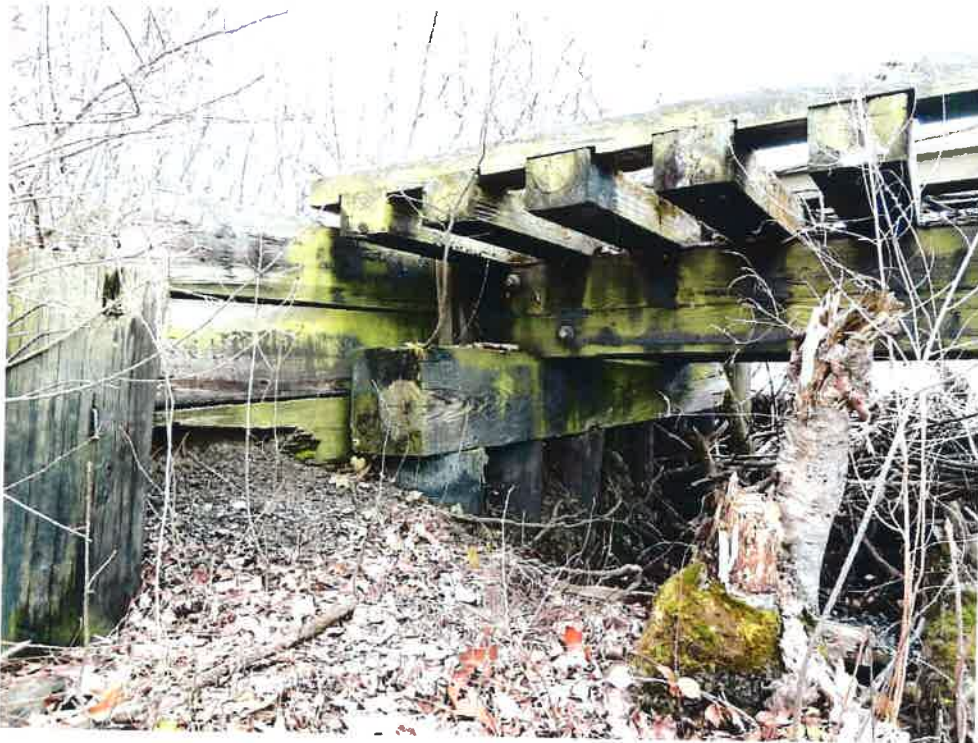
### Fort Meadow Brook, Hudson: Timber Pile Trestle (open timber tie deck)

- Entire structure is in poor condition; timber ties, beams, pile caps and backwalls (timber piles may be able to be re-used)
- Heavy debris built up against the pile bents on the upstream side of the bridge (possibly a beaver dam) is obstructing the flow and the west approach has washed out behind the end pile bent and backwall.
- An attempt has been made to divert the flow around the obstruction using flexible drainage conduits

Proposed Rehabilitation: As noted above, the timber piles are the only elements that could possibly be re-used for rebuilding of this bridge. The current multiple pile bent configuration has facilitated the collection of debris, and the removal of these pile bents and a complete replacement of this bridge with a new single span structure would be the ideal option for this bridge location. If budget considerations dictate reusing of the existing timber piles and rebuilding of the bridge, the following items with estimated costs will be necessary:

- Remove and dispose of existing timber ties and steel rails, timber beams and timber pile caps
- Remove timber backwalls and reconstruct new backwalls and wingwalls to support backfill
- Restore west approach embankment
- Replace timber pile caps
- Install new timber beams, new timber deck and railings
- Obtain approval to design and install water level control devices (WLCD) to regulate the water level behind the beaver dam obstruction to avoid future washouts of the adjacent embankments
