Service Bulletin

SUBJECT: Mandatory inspection of impulse coupled Slick by Champion magnetos.

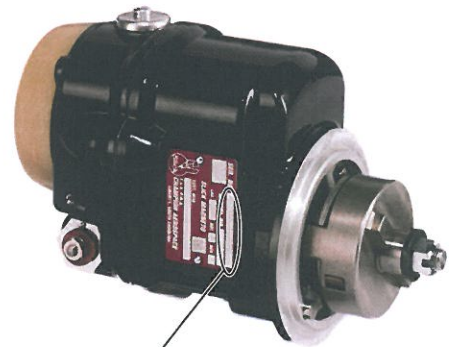
LETTER "B" INDICATES
REPAIRED MAGNETO

SERIAL NUMBER LOCATED
ON MAGNETO DATAPLATE

MANUFACTURED DATE
LOCATED ON IMPULSE
COUPLING REPLACEMENT KIT

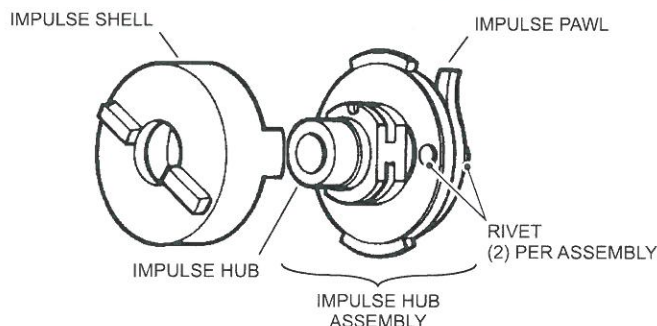
2. Remove, disassemble, and clean the impulse coupling per current revision of applicable magneto manual and per current revision of F-1100 Master Service Manual or L-1500 LASAR Master Service Manual.
3. Inspect the impulse coupling per the maintenance manual. If any movement is found in the rivets, the impulse coupling must be rejected. Reference WARRANTY INFORMATION for resolution options.

4. Repeat this recurring inspection per the requirements listed in the COMPLIANCE section.
5. In no instance shall a repair of the impulse coupling be attempted for loose rivets.
6. Liberally oil ALL new or removed impulse couplings with clean engine oil prior to installation. Make sure all castellated drive nuts are torqued to 120-320 in-lbs. Reference Champion Service Letter SL1-17 for additional information.
