DISTRIBUTOR NOTIFICATION

IMPORTANT PRODUCT NOTIFICATION

RE: Lodestar NH Load Limiter Inspection Procedure

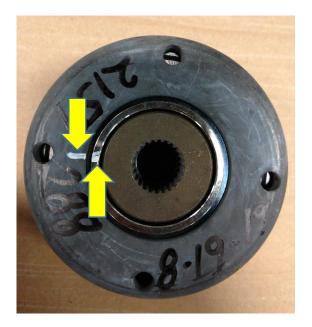
1. Verify the factory paint tick marks are aligned. Figure below shows a load limiter set at the factory setting and acceptable for reuse as long as replacement is not required due to normal wear.

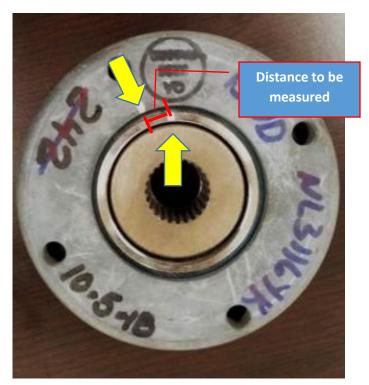
2. If the tick marks have separated, measure the distance between the marks as shown below. If the marks are less than 0.25" apart, the load limiter is acceptable for reuse as long as replacement is not required due to normal wear. If the marks are more than 0.25" apart in either the clockwise or counter clockwise position, the load limiter shall be replaced.
