# BARTLESVILLE FIRE DEPARTMENT

## FIRE INVESTIGATION REPORT

### WITH ORIGIN AND CAUSE REPORT

| <b>Incident Number:</b> | 2026-1451 (NERIS/CAD: 2026-000001451) |

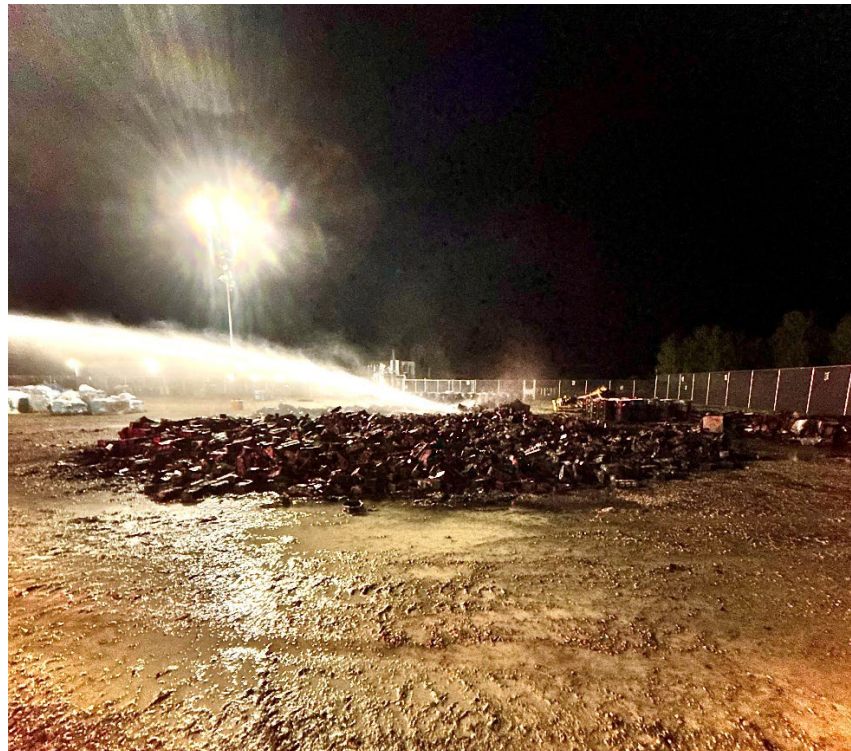
**Note:** Photo shown below is the fire debris which was spread out by the Blue Whale Materials using skid steers and forklifts. Photo dated: April 15<sup>th</sup> 2026.
