Race Rock Lighthouse  
Long Island Sound, New York  
**Report of Investigation**  
30 August 2019

**REPORT OF INVESTIGATION  
Race Rock Lighthouse**

Race Rock Reef, Long Island Sound, SW of Fishers Island, Suffolk County, New York  
WSA Ref No 1909.01

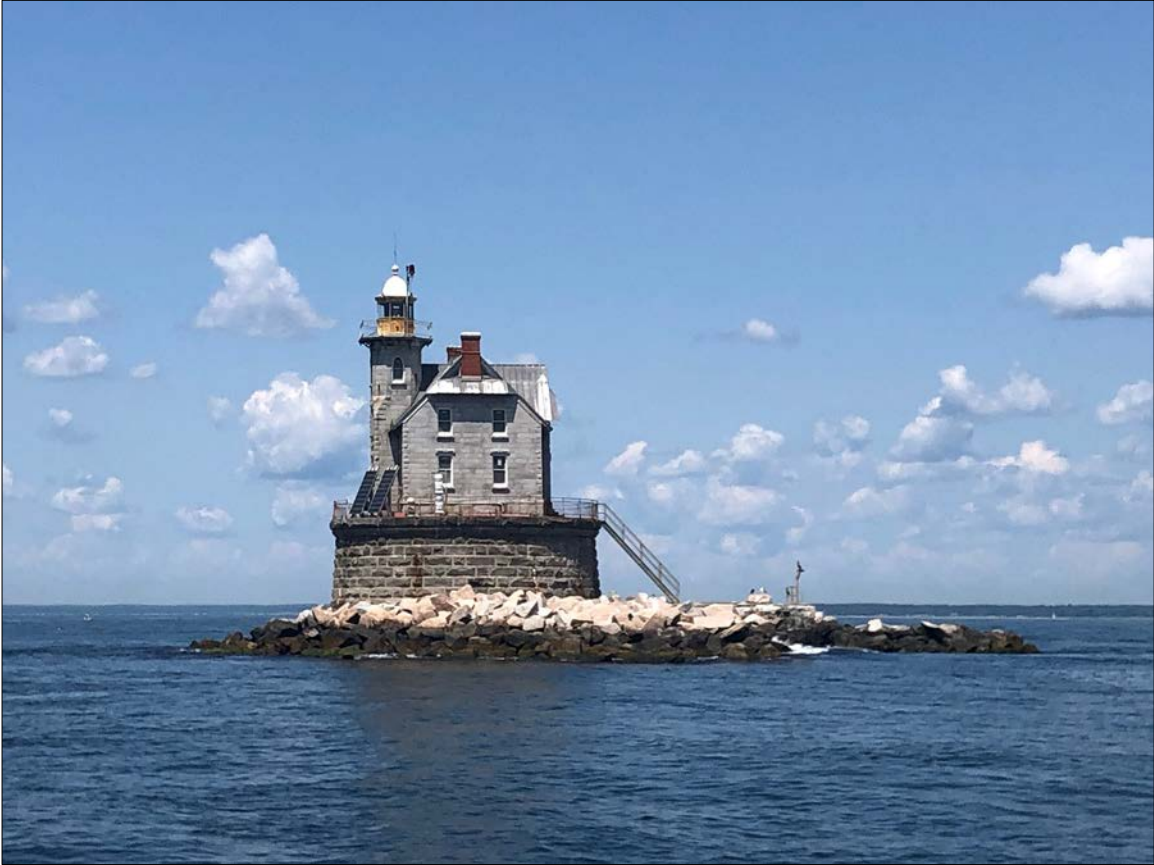
**Photo 4.** View of Lighthouse looking west.

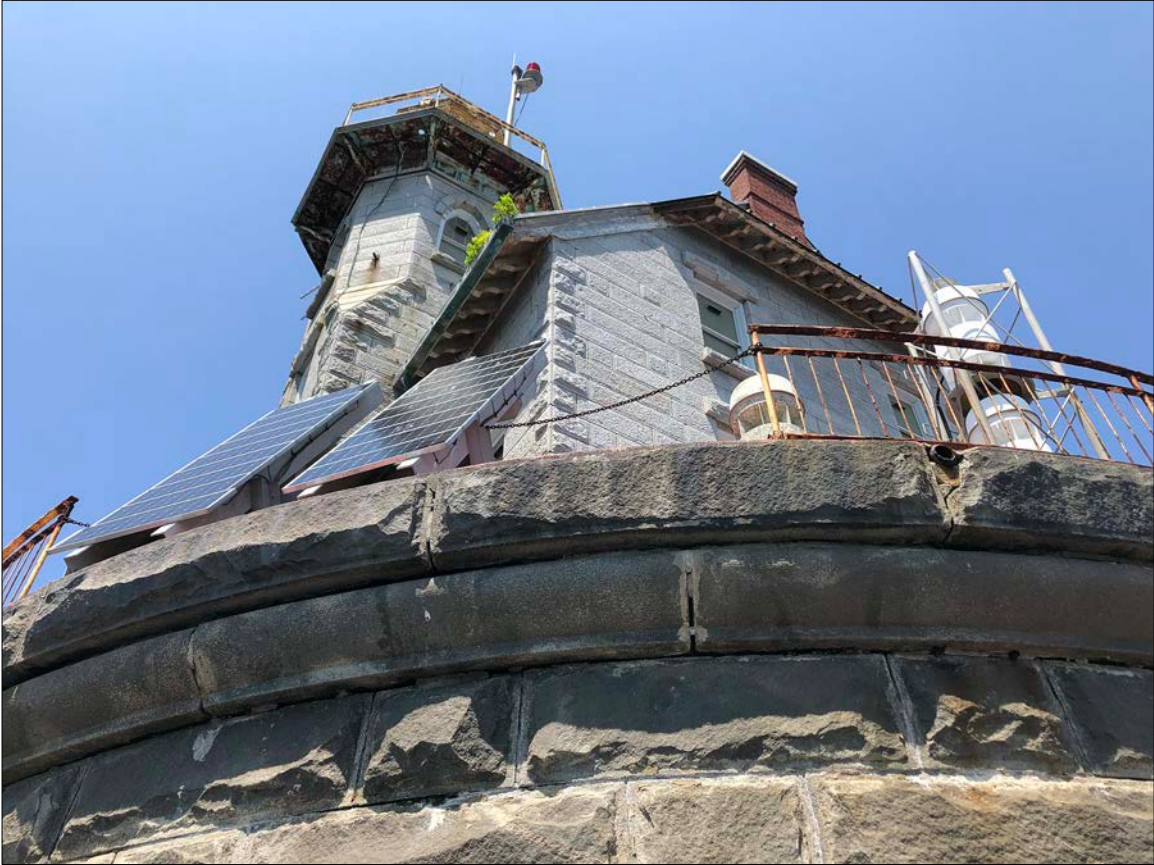
**Photo 6.** Missing rails, open masonry joints, gutters filled with organic matter, and similar myriad but addressable issues combine to undermine stability, even of structures built to last hundreds of years or more.

- 1.1. Concentrated rainwater is creating an ongoing damaging condition as it makes its way through open masonry joints, earlier internal drainage lines (previously abandoned), openings at the intersection of the building's exterior wall and drum deck, as well as through the breached drum deck itself.
- 1.2. Remove and reform perimeter gutters and flashing systems associated with the roof, walls, tower and chimneys. At the base of the building, gather and direct water over the top of the drum deck to at least 4' beyond the drum walls.

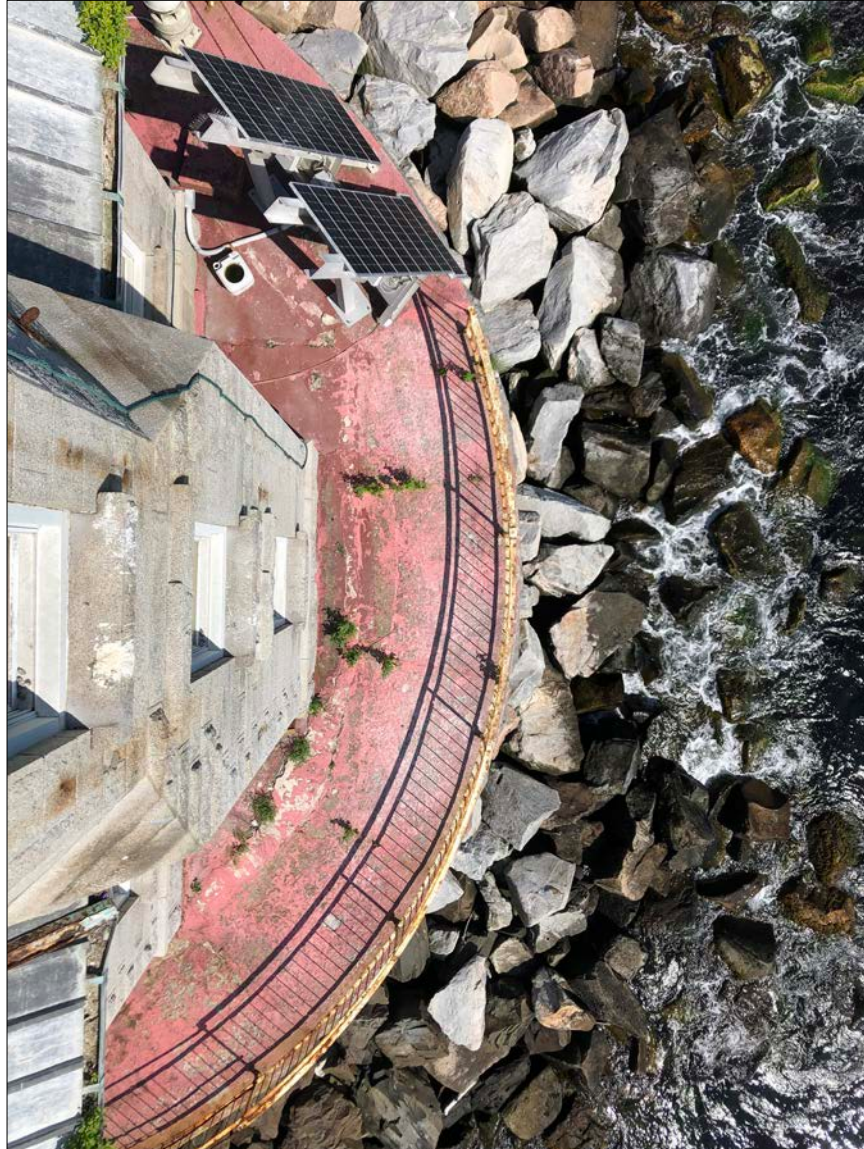
**Photo 7.** View from the Lantern Gallery to the drum, deck & riprap below.

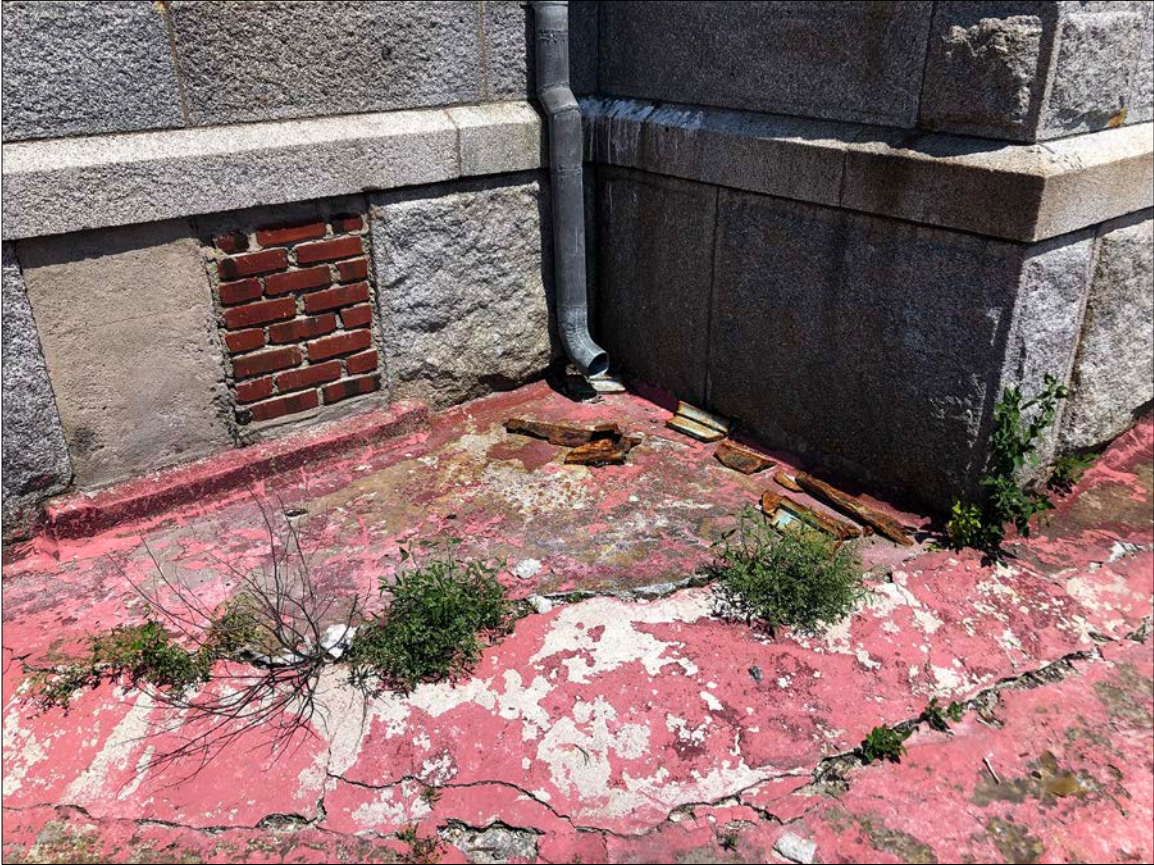
**Photo 8.** The Drum's deck surface is a crucial first line of defense, protecting the foundation and stores below. Cracks and breaching allow infiltration of vegetation and other organic matter, exacerbating the condition. Rainwater, left to spill adjacent to foundation walls, compounds deterioration. Note shards of cast iron that have fallen from the Lantern above.

- 3.1. Tarp. Provide continuous tarp over entirety of drum deck. Secure from 4' above base of building exterior walls to 6' below deck level over stone perimeter walls (10' vertical).

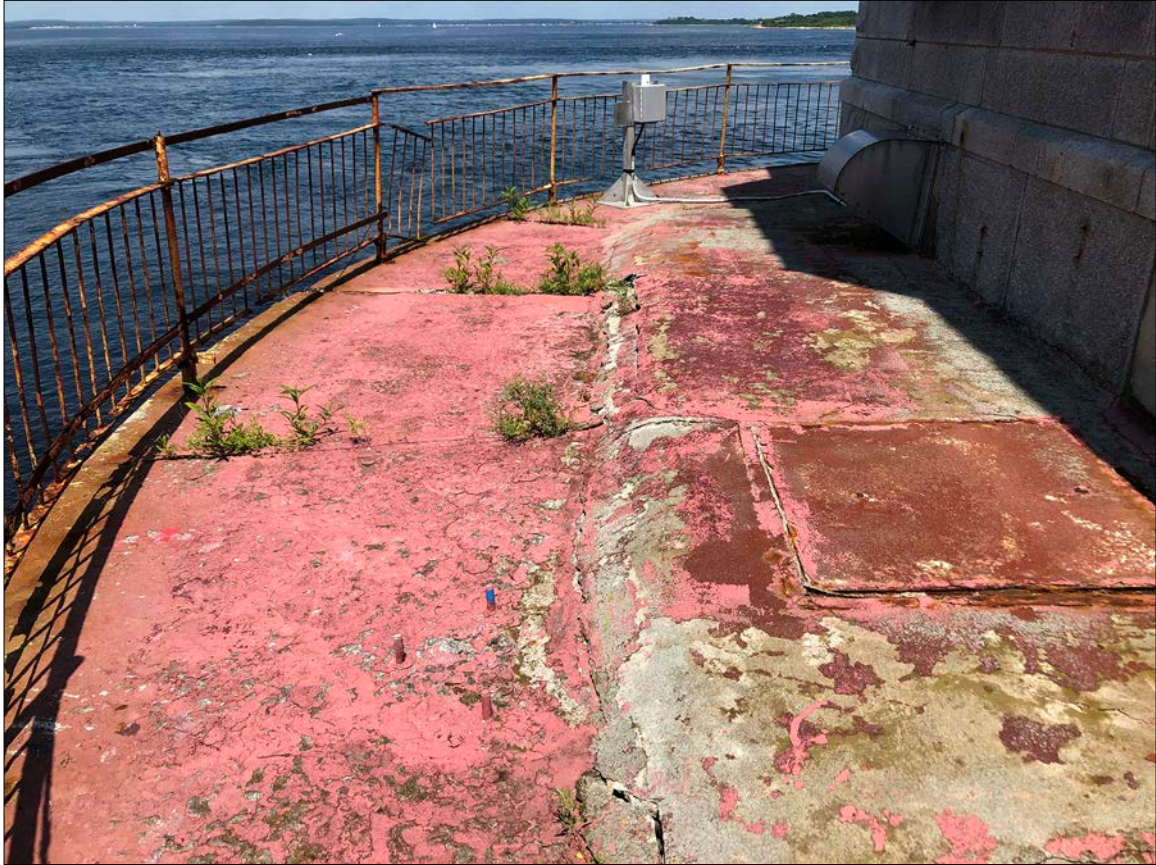
**Photo 9.** General view of the Drum deck and perimeter railing, both of which are currently in an unsafe condition. Bulkheads to the right provide access to the cellar and stores; in their deteriorated state, and without being safely cordoned, they harbor potential for a serious fall to nearly one story below.

- 2.1. Both hatches leading from the drum deck to the Cellar are disguised, albeit also roped off to deter stepping on them. While these important access links need to remain, they also require re-structuring to keep a person from inadvertently falling through them.

- 2.2. A temporary perimeter rail system needs to be employed that does not limit the ability of the original to be eventually restored. In its present condition, the original railing is not a proper fall arrest device.

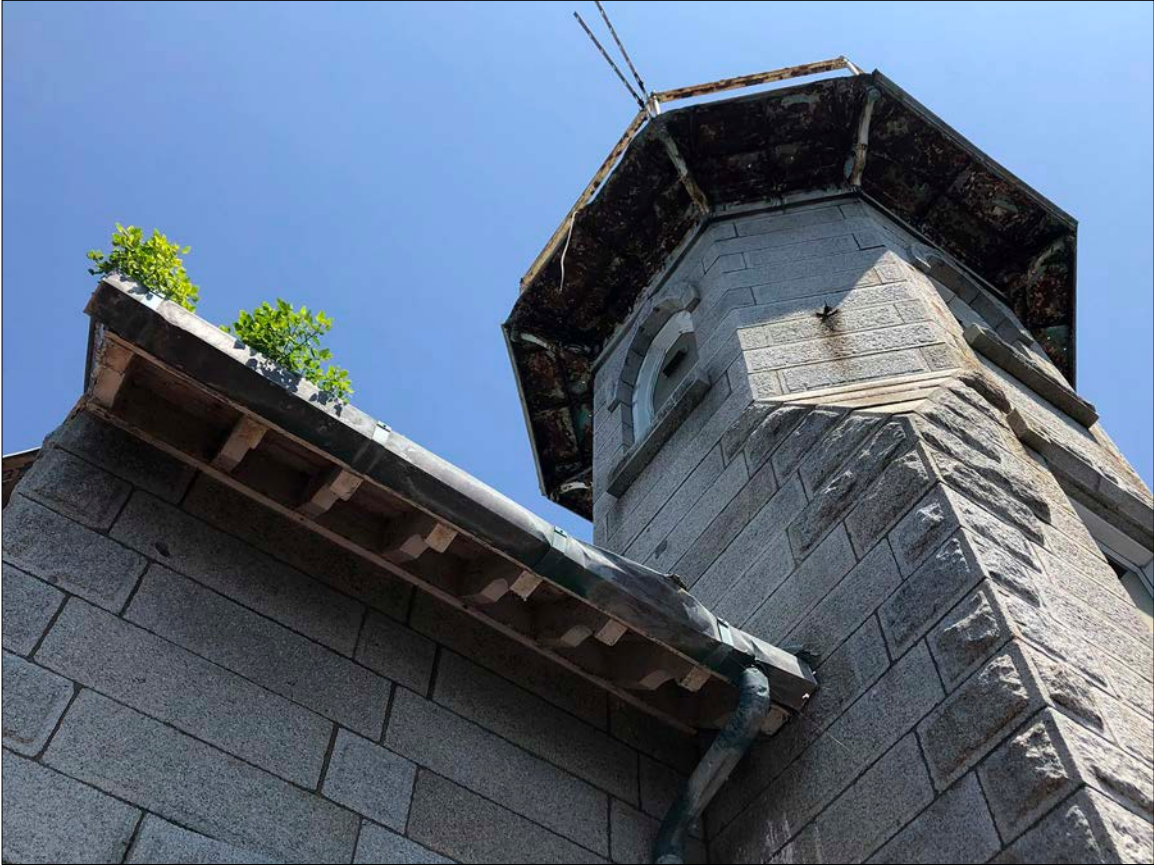
**Photo 11.** View up the west wall of the Tower and adjoining west eave. Coursed ashlar granite walls remain in extraordinary condition – a testament to their underlying technology – though the assembly possesses several Achilles’ heels: gutters, unpainted cast iron and marginally maintained windows.

- 5.1. Granite walls require selective repointing, as well as the extraction of embedded iron elements: rives, clamps, fasteners, et al. that have led to staining and cracking.

- 5.2. Embedded iron elements may be safely replaced with non-ferrous alternatives.
- 5.3. Original windows – or new windows more closely emulating the originals – need to be reinstalled throughout the Light Station.
- 5.4. Exterior paint finishes are important architectonic considerations, and vary significantly from the non-historic white finishes now present. Original hues also are more closely aligned with the stylistic elements of the resource as a whole, rendering its appearance more pleasing and unified.

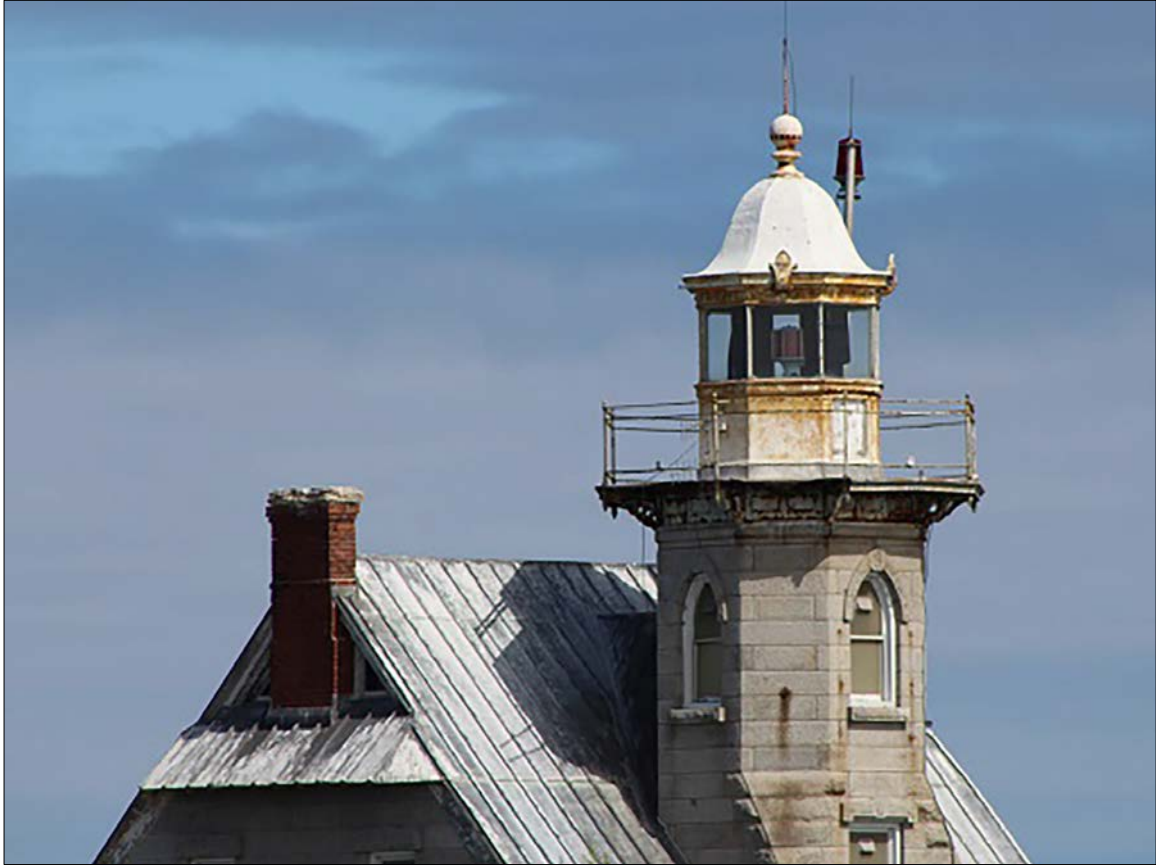
**Photo 12.** Drone view of Lantern, upper tower, chimney and south roof slope. Photo credit: Jim Tracy US Beacons.

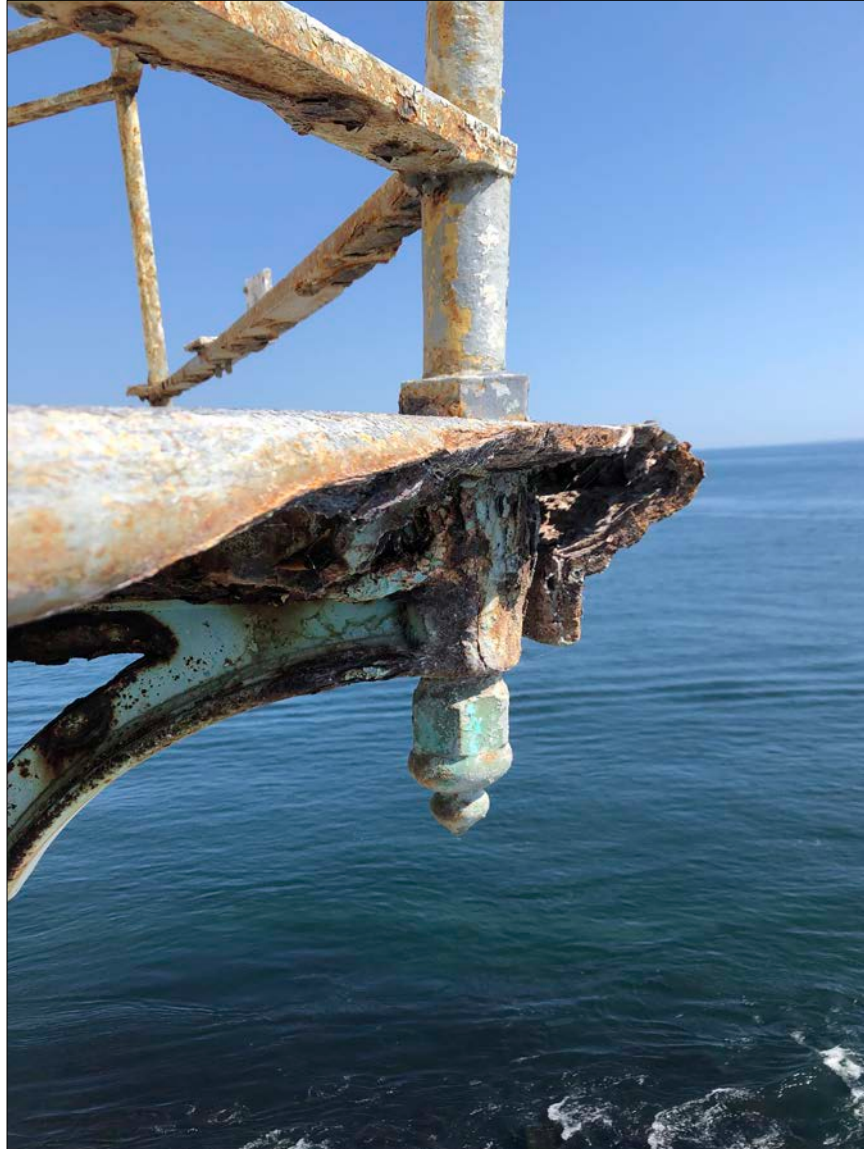
**Photo 13.** Detail of railing through-pendant fastening assembly. Though severely corroded, missing elements may be restored by recasting in iron.

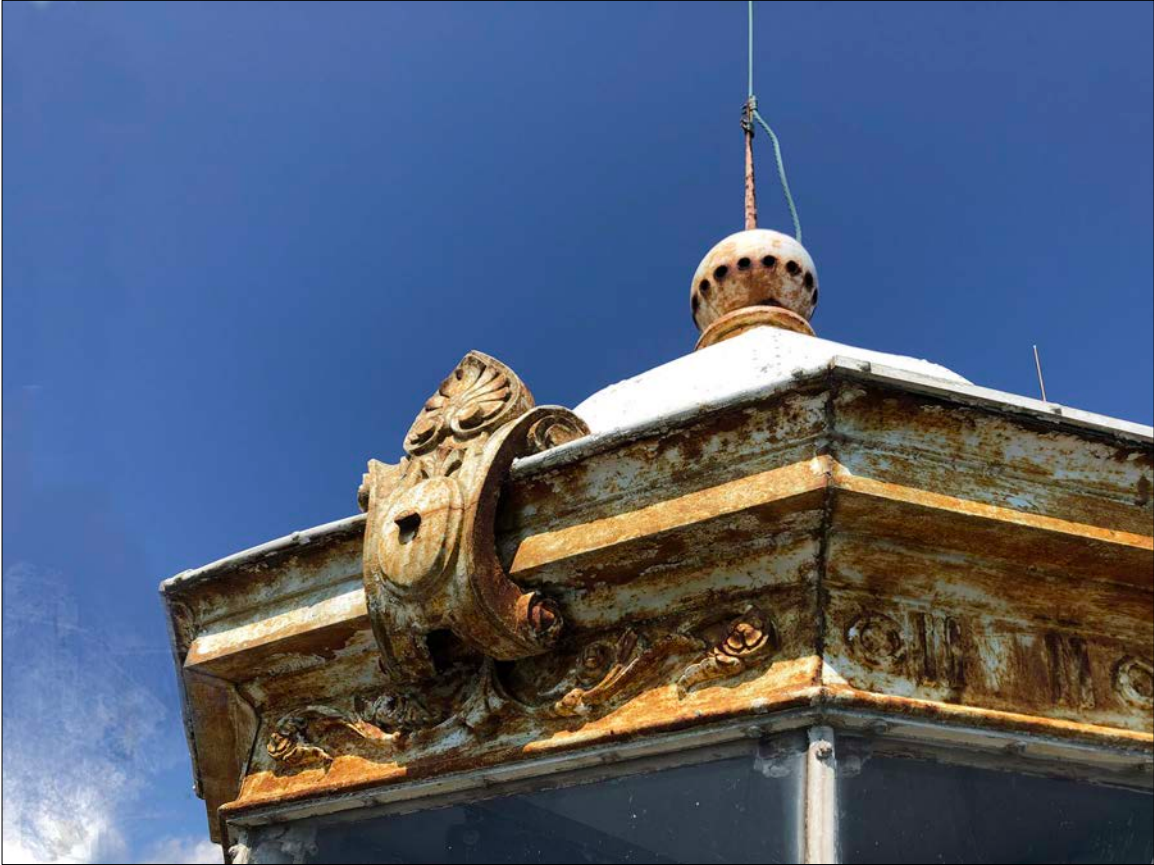
**Photo 14.** A cast iron cartouche, as well as embellishments of the lower fasciae, demonstrate the celebratory nature of Lighthouse design; these were the technological marvels of their time, expressed in architectural details such as these, as well as in literature and visual arts. Their allure is undiminished.

- 4.1. The beautiful cast iron scrolls positioned at the eaves of the Lantern's ogee dome roof are corrupted; one also is missing and must be replicated. It is anticipated that this would best be accomplished alongside all cast iron elements of the Lantern scheduled for restoration, including vent ball, spider frame, scotia eaves, glazing posts, astragals, condensate troughs, skirt panels, vents, thresholds, gallery deck plates and railing.
- 4.2. Lantern glazing (glass) requires upgrading, and this should be accomplished in strict accordance with DHS/USCG standards and protocol. WSA is familiar with materials and installation procedures so specified.

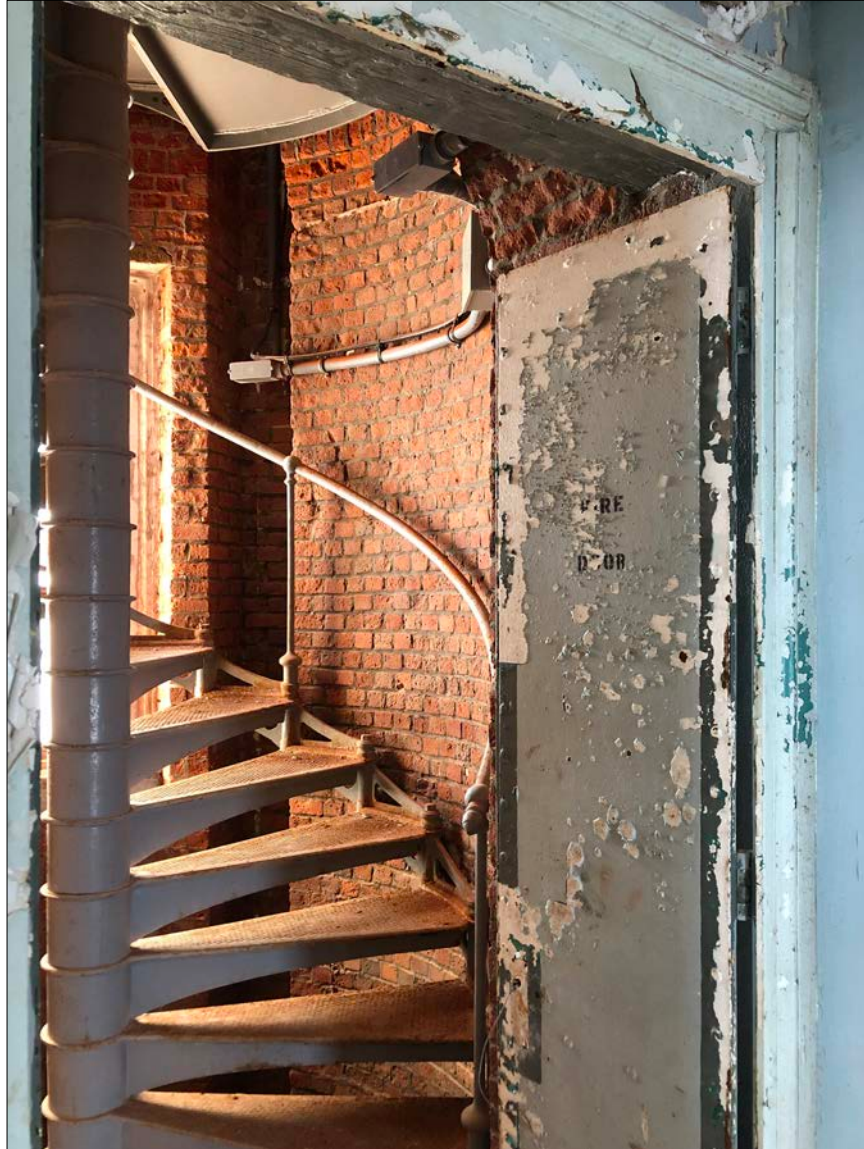
6.4. Deterioration of the interior brick of the tower stairwell is characteristic of the type of extensive damage that is often the response to layers of inappropriate interventions:

- Originating with the cast iron lantern gallery decking, lack of ongoing maintenance led to rusting that, in turn, invited “rust-jacking,” literally applying microscopic but highly intense pressures to the cast iron elements;

- In response, the cast iron plates shift or – worse – crack (both have occurred);
- More water gets in, reaching the stone below the deck;
- Mortar erodes, remains unaddressed, and ultimately more water is allowed to seep into mortar joints (both vertical and horizontal);

- Because of the massive inherent compressive strength of granite, when the water within joints freezes and expands, it moves the stones apart (i.e., they tend to not crack) and water reaches the interior;

- The collar joint between the exterior stone wall and the interior brick facing – often irregular by nature – allows water to spread widely behind the brick surfaces, where it is slowly absorbed by the brick;

- As the imbedded water begins to evaporate, it tends to favor warmer (i.e., interior) surfaces, expressing itself as dampness across the exposed brick surfaces;

- Once water begins to evaporate, it leaves behind particles of dissolved salts that have been collected from the atmosphere and its travels within the Light Station’s wall system, forming whitish blotches on the interior exposed brick surfaces;

- In reaction, the interior brick joints are aggressively pointed with a “hard” mortar;
- Hard mortars force water through the brick rather than – as intended – through the previously (and originally) more permeable joints, exacerbating the dampness and efflorescence and, in turn, deteriorating the brick itself (it begins to “sugar” as particles of brick are dislodged during the evaporation & salt deposition process;

- Harder, and more, mortar worsens and accelerates the condition, until additional remedies are sought; and, finally
- Coatings are applied, which likely will lead to the complete destruction of the wall.

**Photo 21.** Vertical circulation plays a multiple role: fire egress, convective air flow (for the wick of the original lantern, plus expulsion of warmed air during summer months that helps keep the interior relatively cool. Water ingress through the Lantern above has seeped into brick walls; evidence of brick dust is everywhere, indicating a deep process of degradation.

6.5. This process can be properly resolved by addressing the source of the problem: unpainted, and now deteriorated, cast iron exterior plates. Keeping water from getting in is the key to success for remediation/restoration programs treating water ingress.

- 2.1. DO NOT apply any coatings or other products to the interior surfaces of the brick!
- 2.2. Provide a secure weatherproofing system that encompasses the entirety of the Lantern gallery decking, down to the base of the octagonal portion of the stone tower below (approximately 8'-10' vertically). Allow the masonry materials within this enclosure to dry out naturally before next steps are taken; this will require at least 3-4 months, and may readily be monitored with field meters as desired. Once excessive moisture levels have stabilized, durable corrective measures may begin.
