Exterior Wood Deck Failures: An Almost Certain Multi-Claim Event

**By: Richard A. Rice, PE
Mutual Engineering, Inc.**

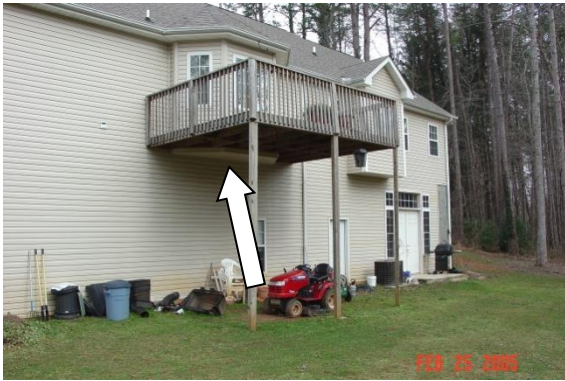
Figure 1 shows a functioning deck. The arrow in Photograph 1 indicates the ledger board. The ledger board is the portion of the deck that is attached to the main structure. If the ledger board is not properly attached to the main structure, and if it is not properly protected from the environment, the deck will fail.

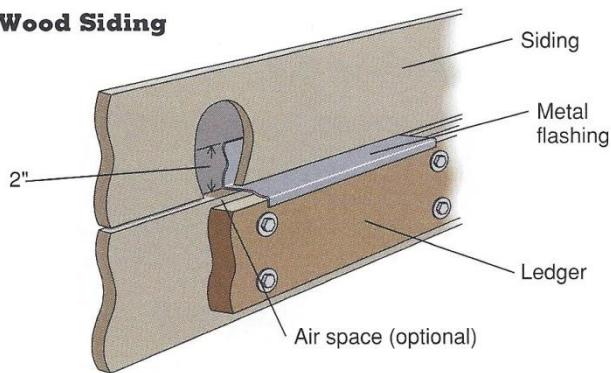
Figure 2 shows the proper installation of metal flashing over the wood ledger board where horizontal wood siding is the exterior veneer. Note that the metal flashing prevents rain water from entering behind the exterior wood siding.

Also note the heads of the lag bolts or through bolts used to attach the ledger board to the main structure.

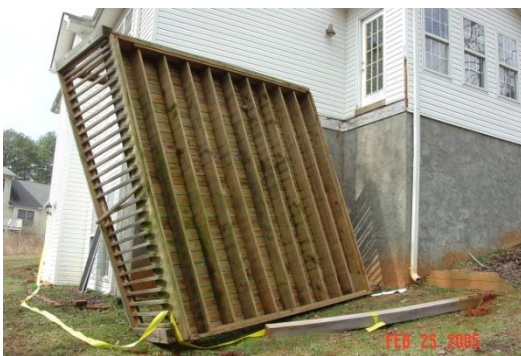
pregnant woman, and no injuries to the unborn child. Unfortunately, the real estate agent broke her back, and took months to recover. So, why did this brand new, properly flashed deck fail?

Figure 3 shows a deck failure that occurred on a brand new home. The real estate agent was showing this home to a young married couple. The wife was six months pregnant with their first child. Without warning, the deck came away from the main structure and fell onto the ground. Because the pregnant woman fell directly onto the real estate agent, there were only minor injuries to the

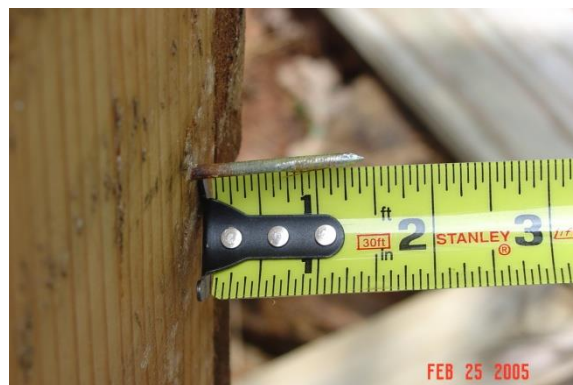
Figure 4 shows a typical, 16 penny nail that was used to fasten the ledger board to the main structure. Nails can NEVER be used this way because of the tendency of nails to pull out from the wood. The only allowable way to fasten this ledger board to the main structure was with lag bolts or through bolts.

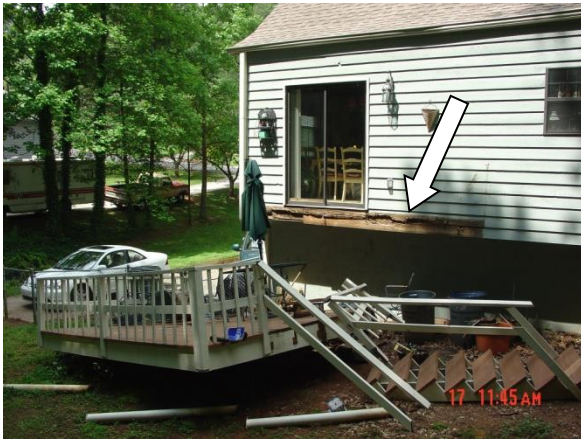
Figure 5 shows a deck failure that occurred during a family gathering. The arrow in Figure 5 shows the area where the ledger board fastened to the main structure. No metal flashing was observed. Figure 6 shows the lag bolt that was used to fasten the ledger board to the main structure. Because there was no metal flashing to prevent water from rotting the wood behind the ledger, there was no wood for the lag bolt to grip, so the failure occurred.

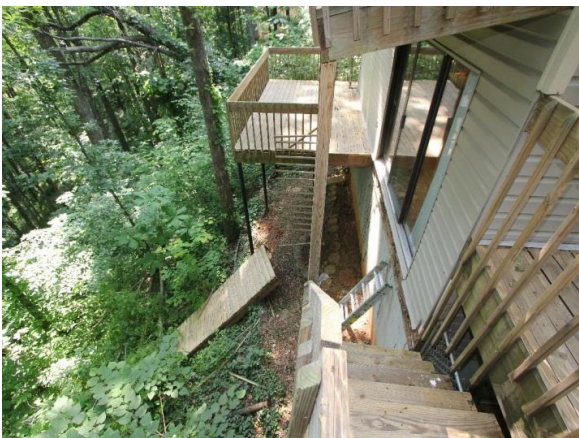
Figure 7 shows a deck failure where a family was looking at property to rent. A fifteen year old boy leapt from several steps up and landed on the deck. The deck fell away from the main structure.

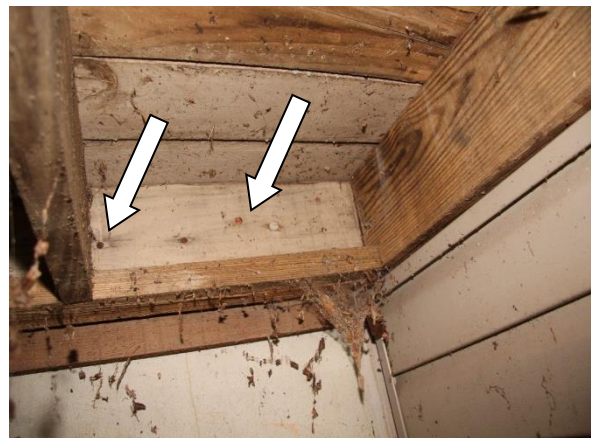
Fortunately, no one was seriously hurt. Prior to allowing the property to be rented, the property owner inspected the deck for any deficiencies. Metal flashing was noted as visible. Figure 8 shows a typical section of deck prior to the failure. The arrows in Figure 8 indicate bolt heads. Unfortunately, the length of the bolts could not be determined. A forensic investigation revealed that the bolts were not long enough. Everything looked good.
