## **Exterior Wood Deck Failures: An Almost Certain Multi-Claim Event**

**By: Richard A. Rice, PE  
Mutual Engineering, Inc.**

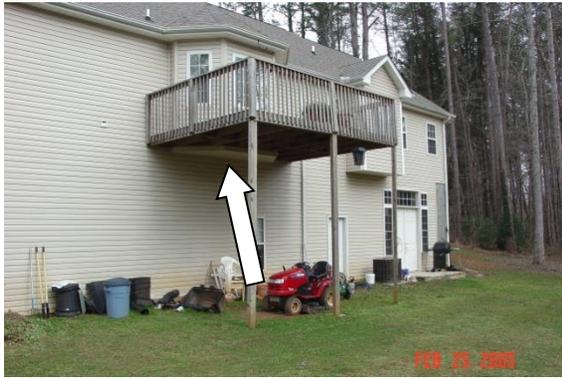
Figure 1 shows a functioning deck. The arrow in Photograph 1 indicates the ledger board. The ledger board is the portion of the deck that is attached to the main structure. If the ledger board is not properly attached to the main structure, and if it is not properly protected from the environment, the deck will fail.

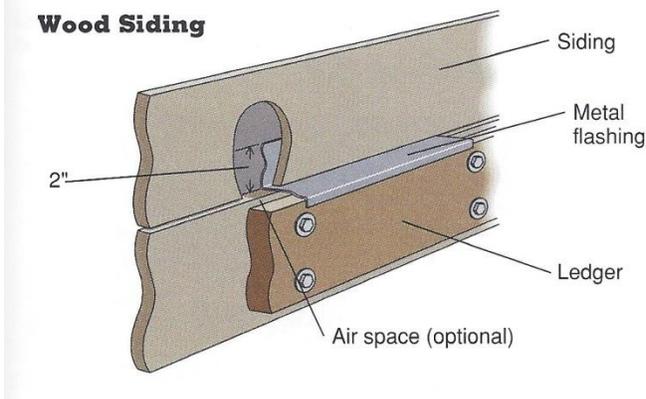
Figure 2 shows the proper installation of metal flashing over the wood ledger board where horizontal wood siding is the exterior veneer. Note that the metal flashing prevents rain water from entering behind the exterior wood siding.

Also note the heads of the lag bolts or through bolts used to attach the ledger board to the main structure.

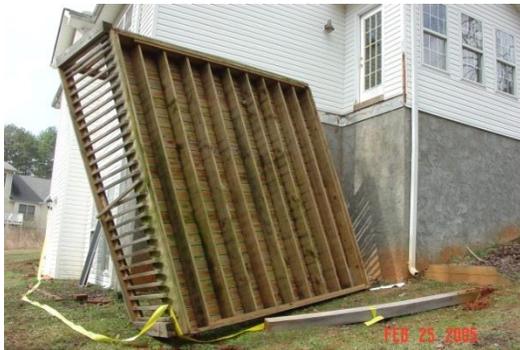
woman, and no injuries to the unborn child. Unfortunately, the real estate agent broke her back, and took months to recover. So, why did this brand new, properly flashed deck fail?

Figure 3 shows a deck failure that occurred on a brand new home. The real estate agent was showing this home to a young married couple. The wife was six months pregnant with their first child. Without warning, the deck came away from the main structure and fell onto the ground. Because the pregnant woman fell directly onto the real estate agent, there were only minor injuries to the pregnant

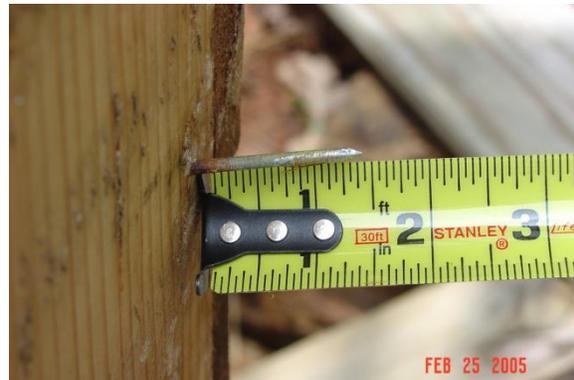
Figure 4 shows a typical, 16 penny nail that was used to fasten the ledger board to the main structure. Nails can NEVER be used this way because of the tendency of nails to pull out from the wood. The only allowable way to fasten this ledger board to the main structure was with lag bolts or through bolts.

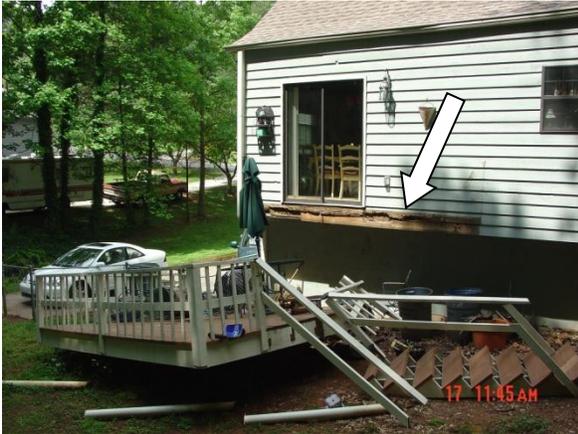
Figure 5 shows a deck failure that occurred during a family gathering. The arrow in Figure 5 shows the area where the ledger board fastened to the main structure. No metal flashing was observed. Figure 6 shows the lag bolt that was used to fasten the ledger board to the main structure. Because there was no metal flashing to prevent water from rotting the wood behind the ledger, there was no wood for the lag bolt to grip, so the failure occurred.

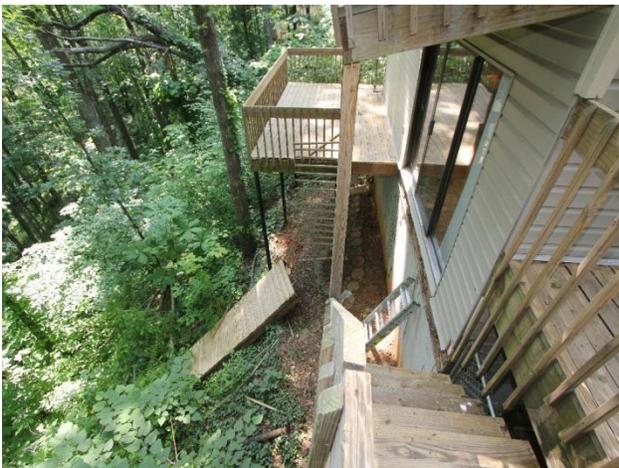
Figure 7 shows a deck failure where a family was looking at property to rent. A fifteen year old boy leapt from several steps up and landed on the deck. The deck fell away from the main structure.

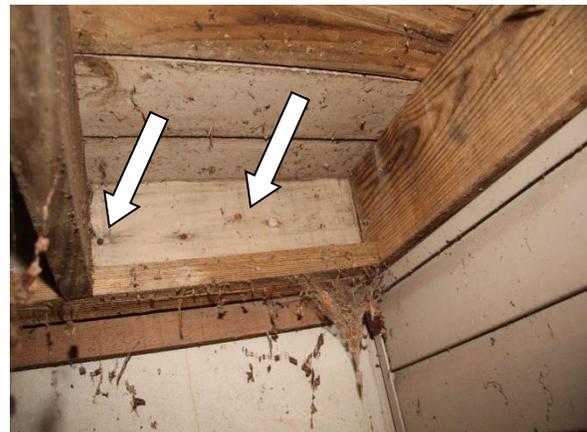
Fortunately, no one was seriously hurt. Prior to allowing the property to be rented, the property owner inspected the deck for any deficiencies. Metal flashing was noted where visible. Figure 8 shows a typical section of deck prior to the failure. The arrows in Figure 8 indicate bolt heads. Unfortunately, the length of the bolts could not be determined. A forensic investigation revealed that the bolts were not long enough. Everything looked good.
