Metallurgical Investigation - Premature Failure of Water-cooled Ductwork

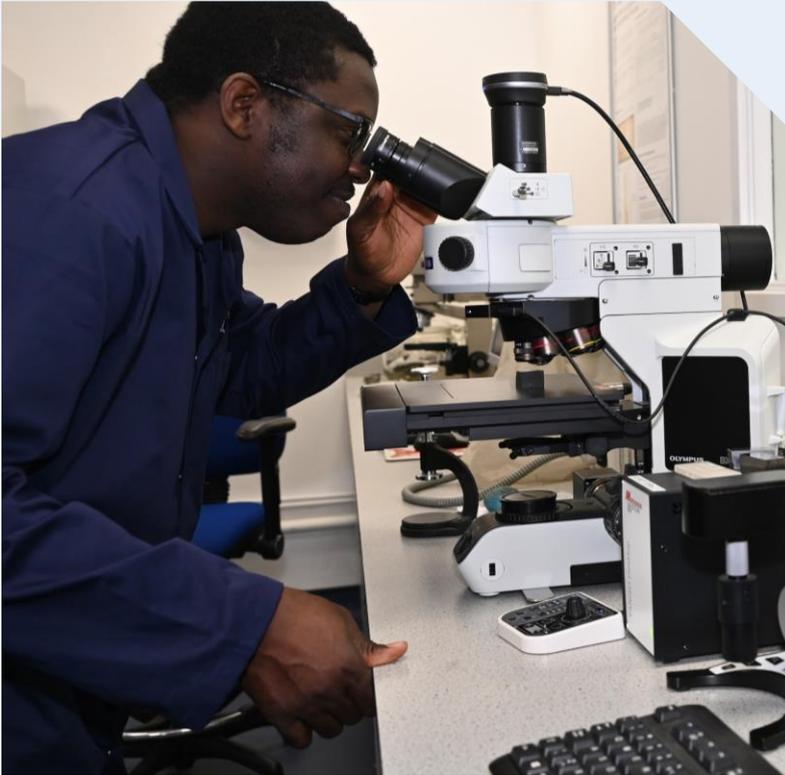
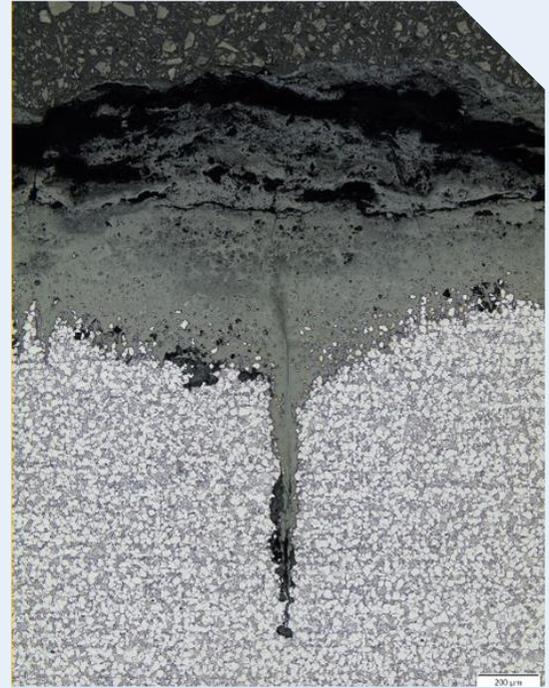
Ductwork inner wall experiencing surface corrosion and stress cracks

- The inner tube diameters were the most highly corroded areas, with evidence of inter-granular corrosion and corrosion pitting along the length of the sample surface.

- The surface of the tube was very uneven with corrosion fatigue cracks extending through the parent material.
- The tube walls appeared to have undergone expansion and contraction during heating cycles causing the brittle oxide layer to crack, and opening microcracks through the oxide layer into the metal. The newly exposed metal then oxidises; this then repeats causing the fracture to widen and deepen.

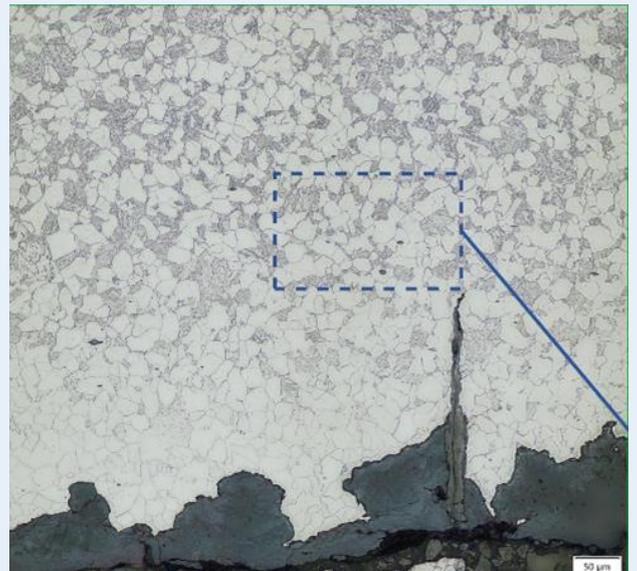
- Observation of degradation of pearlite in the mild steel may be an indication of long-term overheating (mild steel typically over 450°C).
- The presence of tubercles within the oxide on the inner tube walls indicates evidence of oxygenated feedwater.

Outerwall exhibiting surface corrosion, stress cracks and decarb band

The investigation revealed that the failure was caused by corrosion-fatigue cracking. This was predominately on the inner tube wall of the pipework and exacerbated by the formation of corrosion pits.
