June 13, 2022

William C. Wallick
Pelican Isle Master Association
435 Dockside Drive
Unit #203
Naples, Florida 34110

RE: Seawall Assessment Report

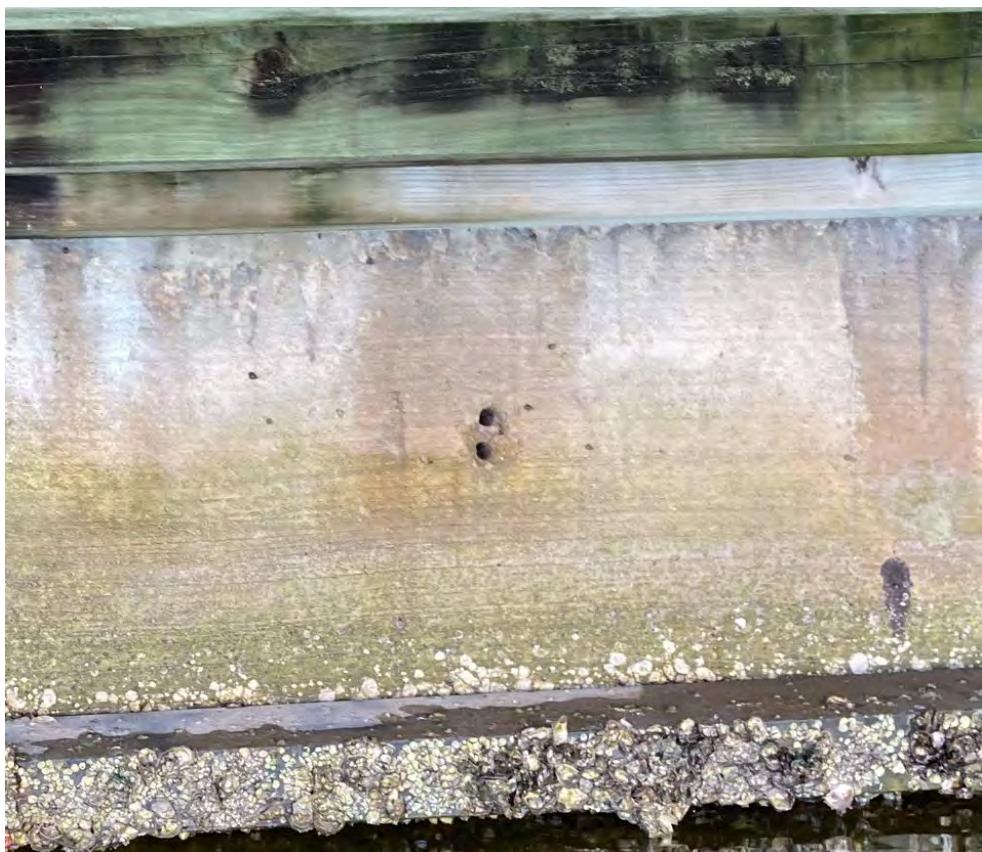
The North end of section A has had some weephole modifications done to reduce hydrostatic pressure behind the seawall by allowing water to flow through the panels. The remainder of this section has mostly original weepholes with a few extras having been drilled. While the weepholes do not have any visible obstructions, the only way to verify they are working is to observe them during a rain event to see whether they are releasing water. In 2021 the seawall seams in this area were treated with foam injection to mitigate the loss of upland soils.

Figure 3: Extra Weephole Drilled

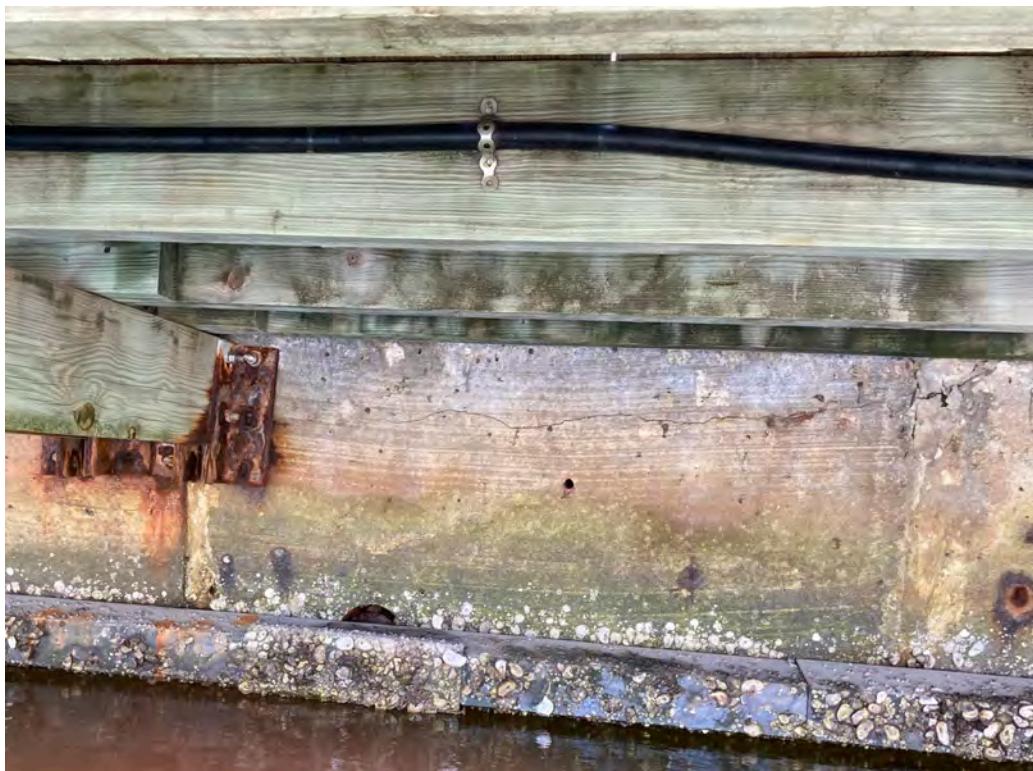
There are numerous cracks running horizontally and diagonally on some of the seawall panels, and while concerning, these defects were also identified in the 2017 report and do not appear to have worsened since then. In addition, there are multiple cracks in the seawall cap. The smaller, hairline cracks that can be seen running perpendicular to the shoreline in multiple locations along the cap are caused by expansion/ contraction and are typical in concrete seawalls. These are not of concern unless they expand to larger than 1/8". However, at the two directional changes in this section, more significant cracking can be seen (see figure 5). These were not mentioned in the previous report so it is unclear as to whether they are new. They should be monitored for changes.

Figure 4: Horizontal Seawall Panel Crack

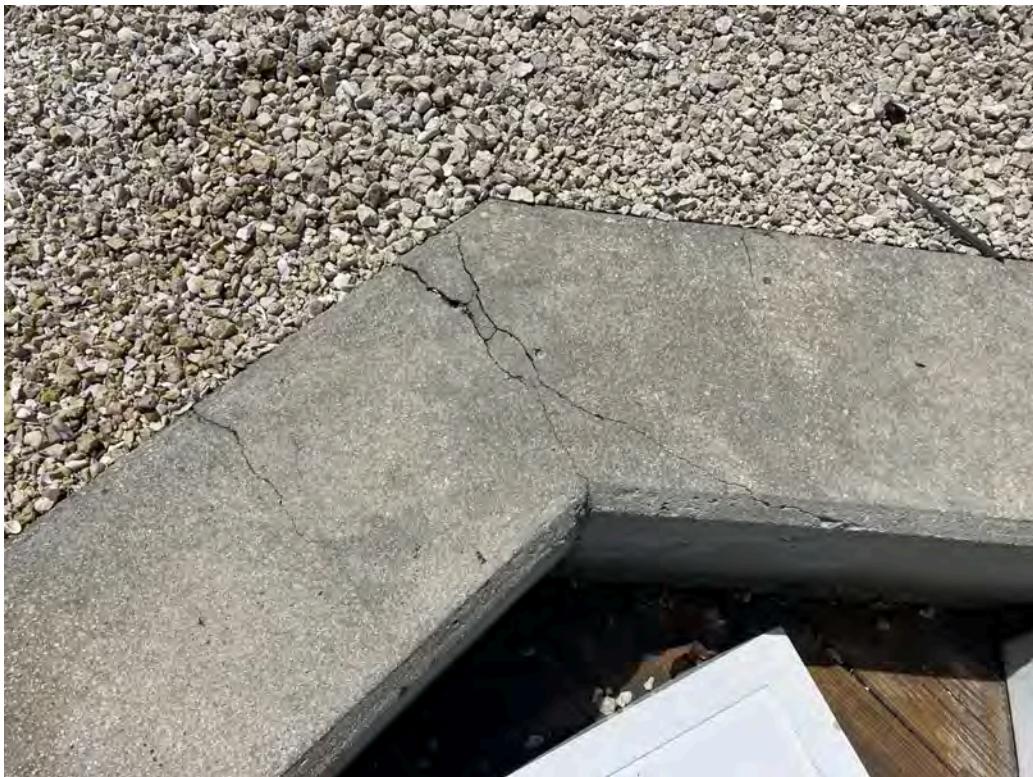
Figure 5: Seawall Cap Crack at Directional Change

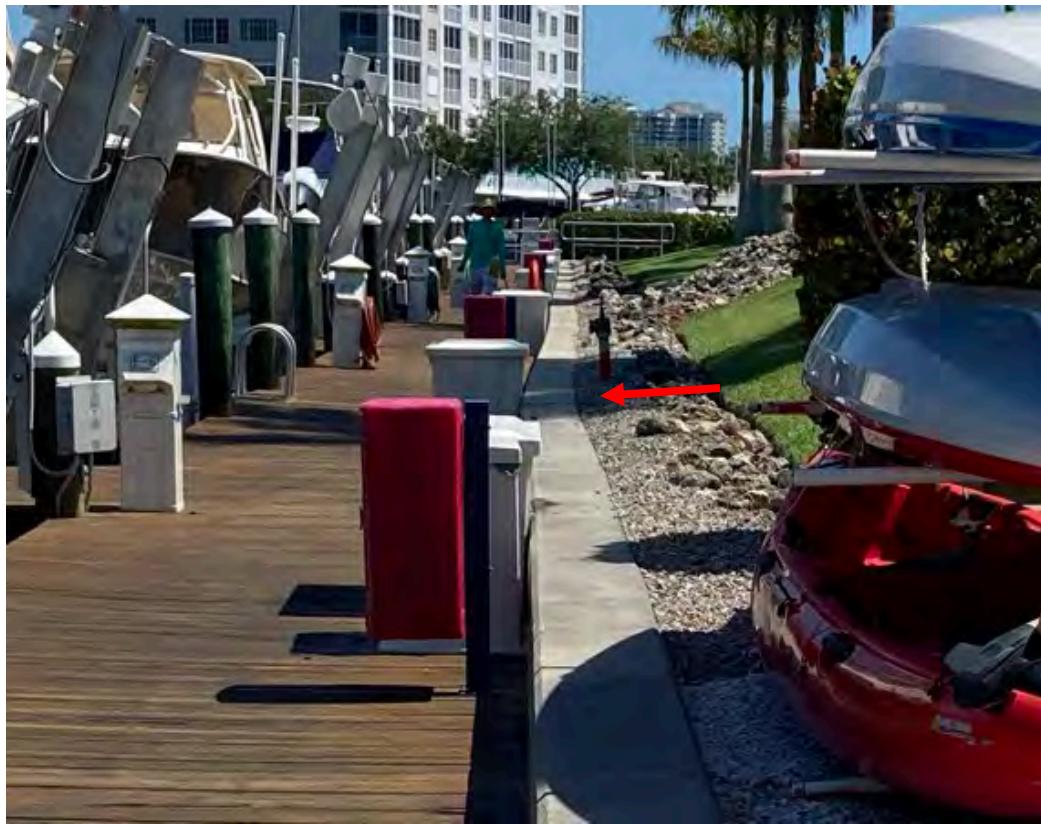
The tiebacks were not dug up during this noninvasive assessment and were therefore not checked. However, the cap appears to wander (not straight) at a location just south of the kayak racks, indicating that the wall has moved out, possibly due to a tieback failure. As discussed in the previous report, there has been a waler beam installed on the face of the seawall panels to add supplemental support. It is unclear as to whether movement in the cap occurred before or after the waler was added.

Figure 6: Seawall Cap Bowing Outward

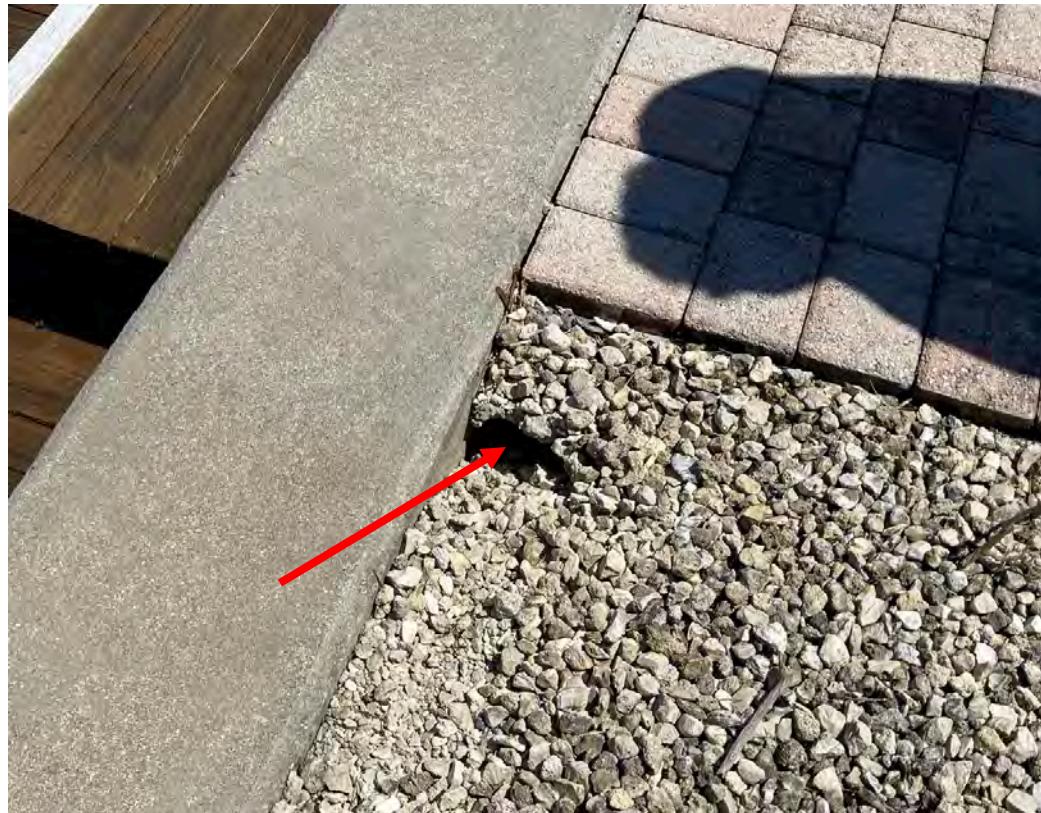
Figure 7: Minor Loss of Backfill Behind Cap

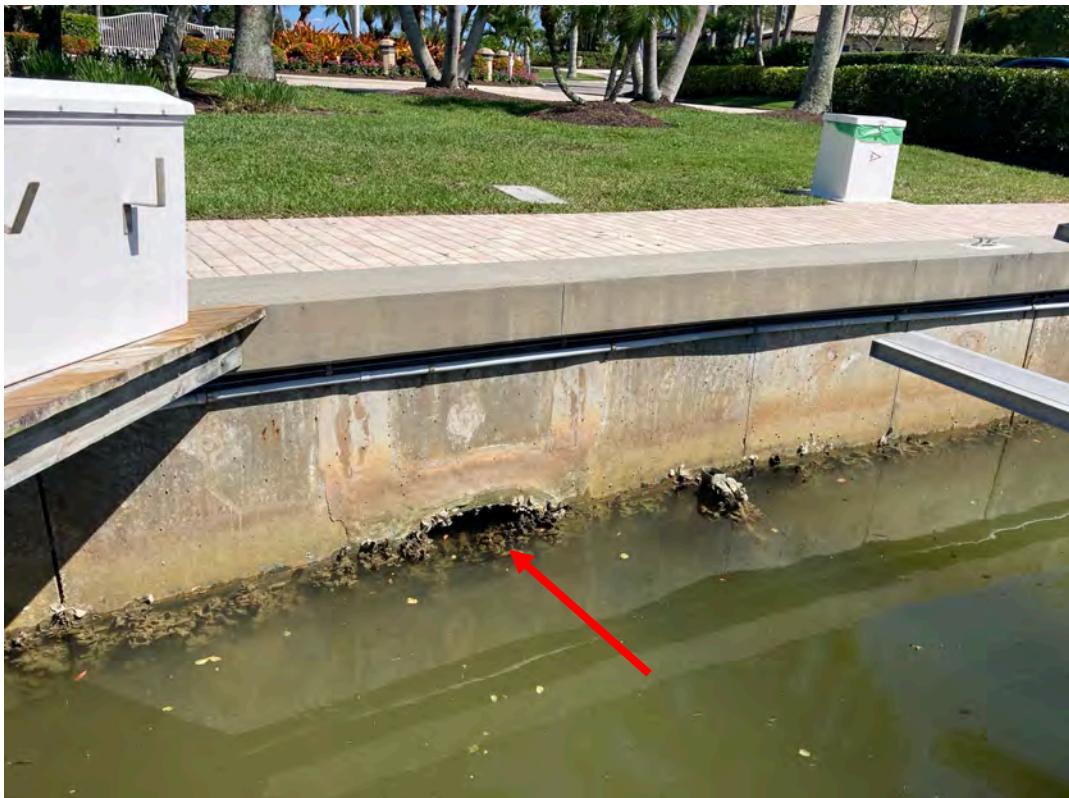
This section includes the seawall inside the basin and up around the northeast peninsula. Findings are consistent with those of the last report; the seawalls inside the basin and on the north side of the peninsula are in fair condition with no defects noted (they are only ranked fair due to the age). The wall is straight and true with no signs of rust bleeding or significant cracking. However, there is one stormwater pipe in the basin that does not appear to have been cleaned out recently as it has accumulated a lot of growth. This can cause upland failure of the stormwater system and can lead to seawall damage.

Figure 8: Stormwater Pipe Inside Basin

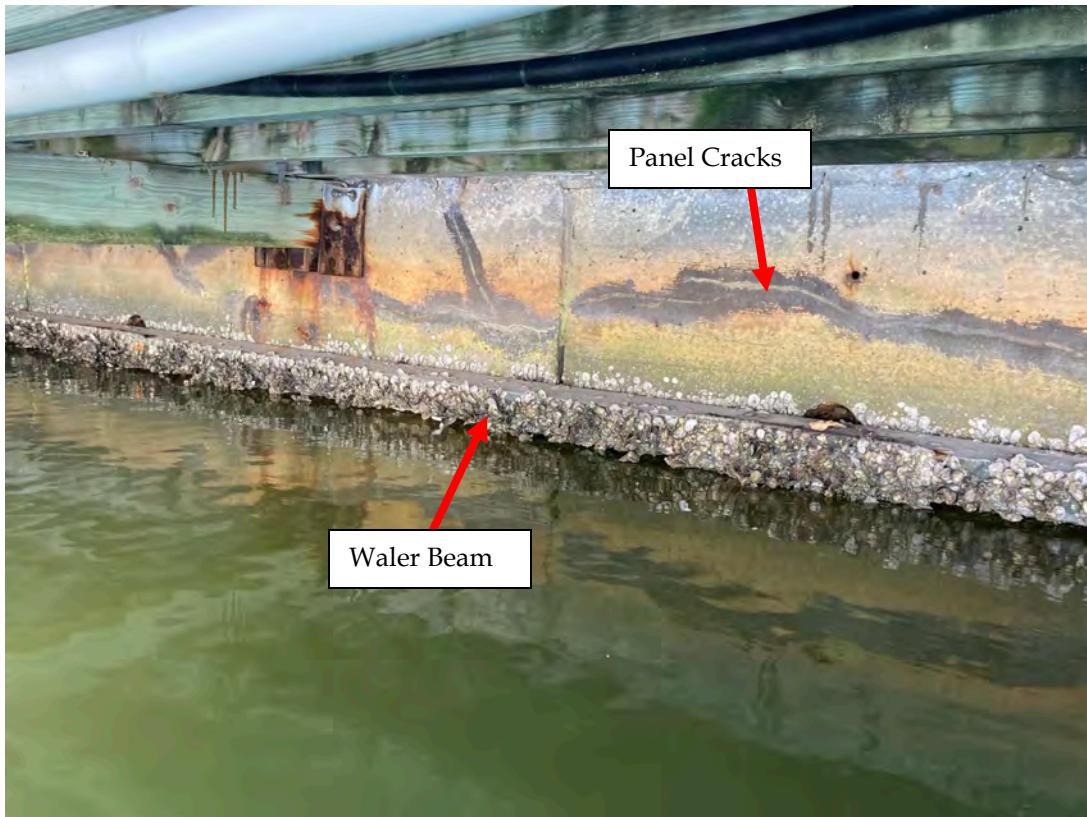
Along the east run of this seawall, there is a composite waler with supplemental tieback rods installed. Above the waler there are numerous horizontal cracks in the panels that have been patched with grout. Both the waler and the patches appear the same as in the 2017 photos.

Figure 9: Grouted Panel Cracks

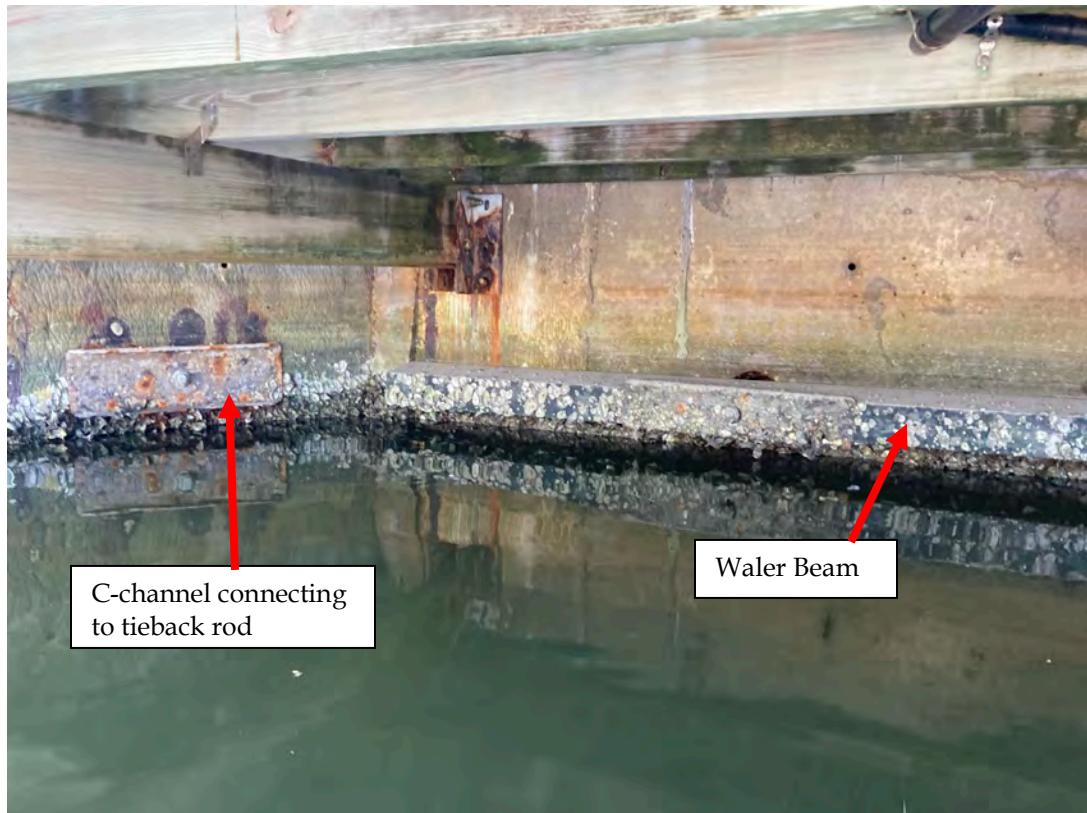
Figure 10: End of Composite Waler and C-channel for a Helical Tieback

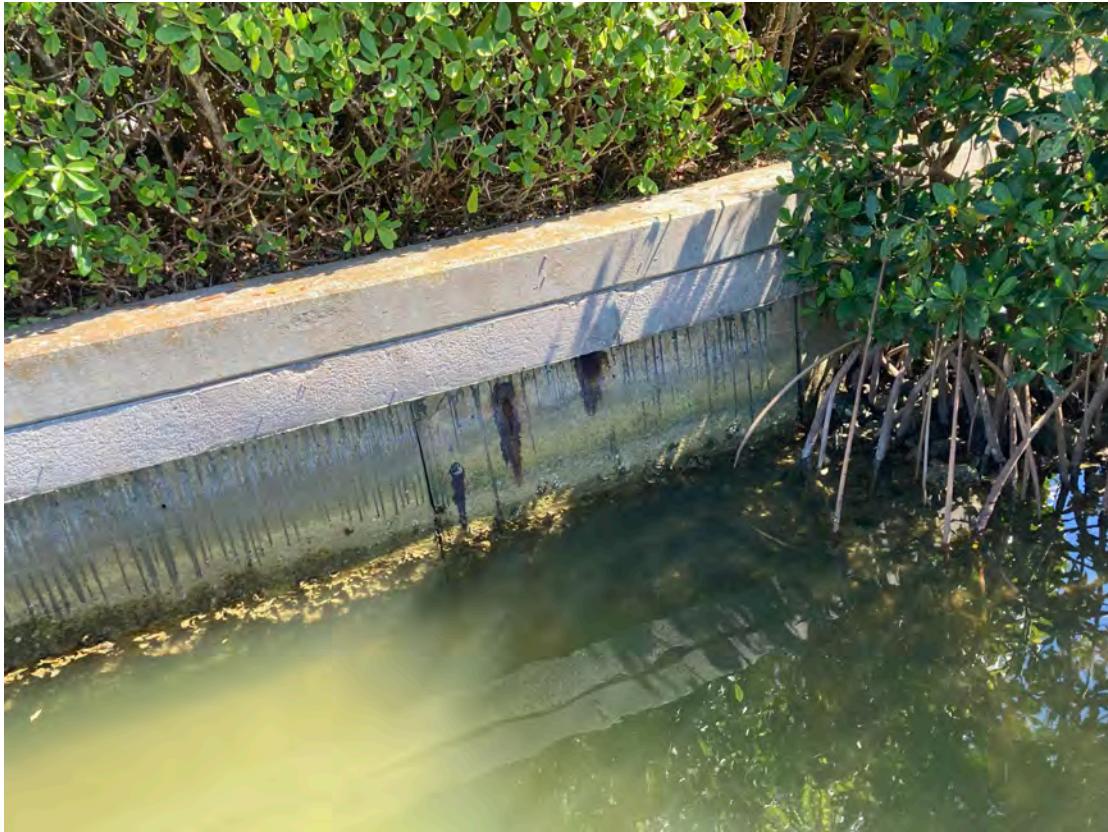
A few defects were noted in this section such as rust bleeding and panel cracking. These were also present in 2017 and haven't noticeably worsened. Comparing photos, it is apparent that the stormwater pipes here have since been cleaned out and had most of the barnacle growth removed.

Figure 11: Minor Rust Bleeding (seen in 2017 report as well)

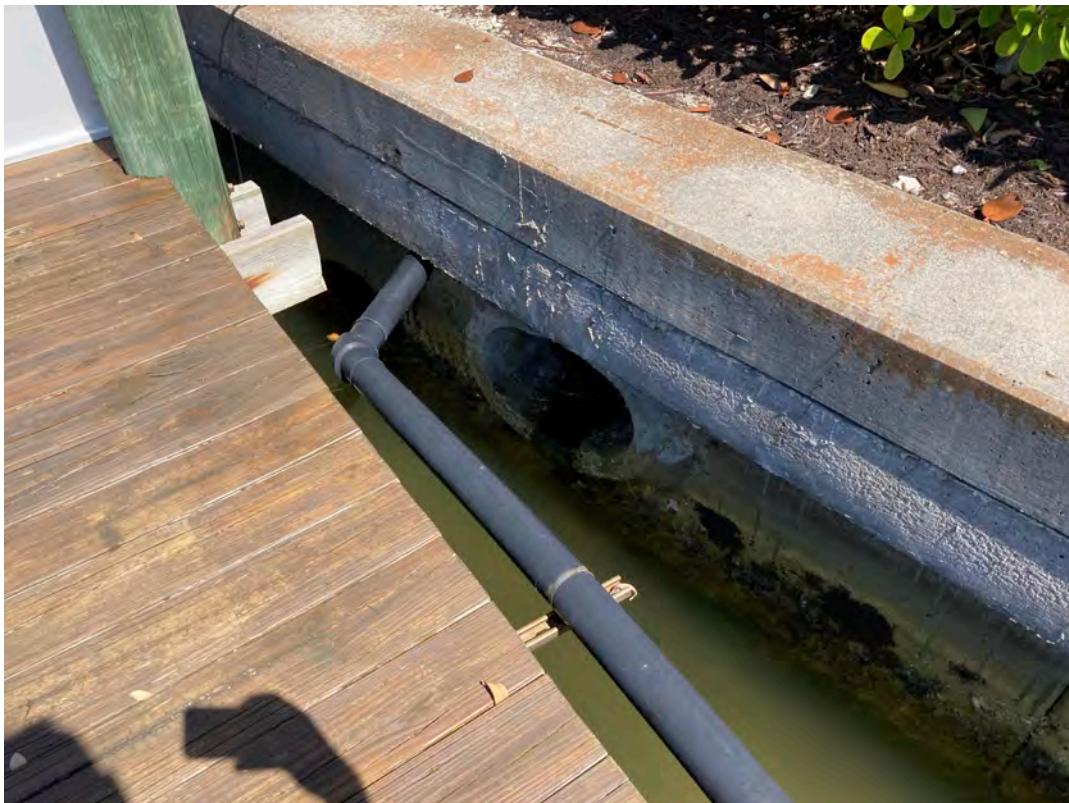
Figure 12: Stormwater Pipe

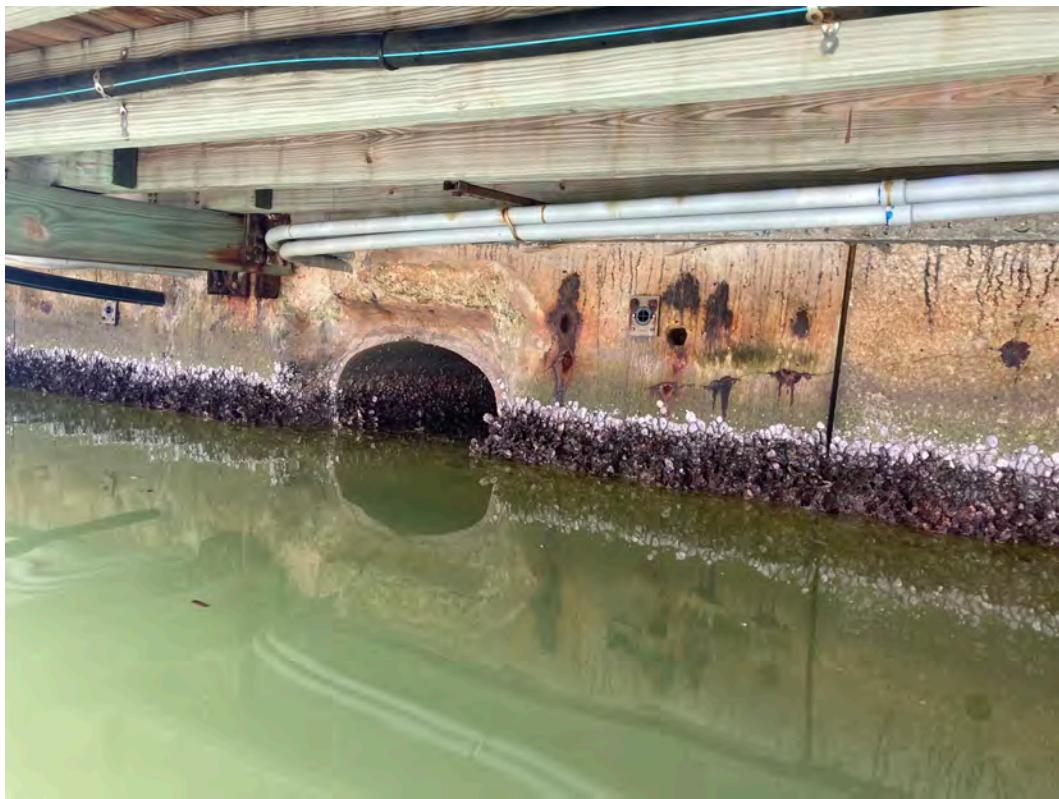
Figure 13: Stormwater Pipe, Panel Crack, Rust Bleeding (seen in 2017 report)

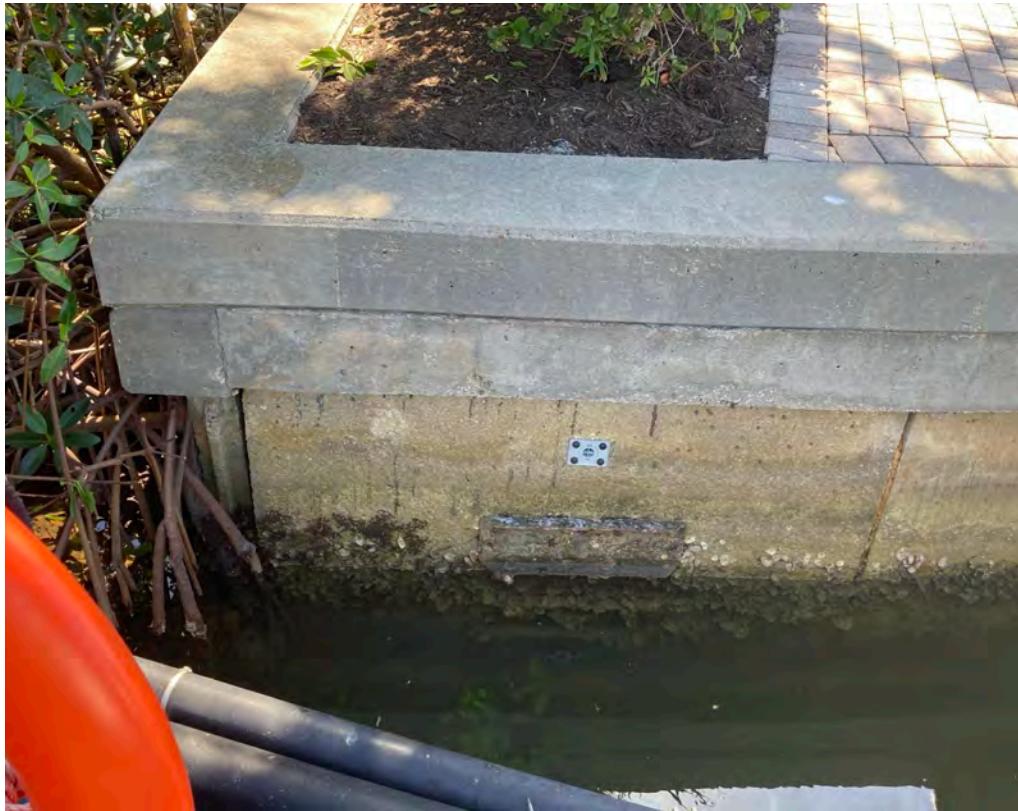
Figure 14: Seawall C East Termination, Helical Tieback Channel and Weephole

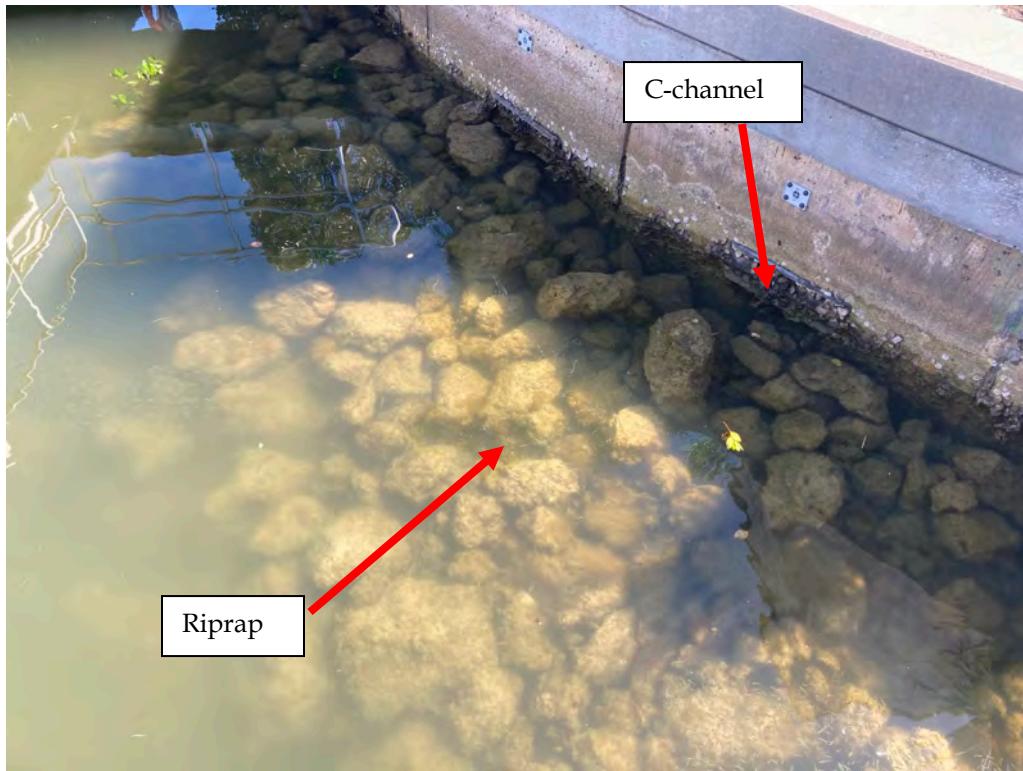
The previous report noted panels toward the east end of this area had rotated out at the bottom. In 2021, there has been riprap installed to help stabilize the base and prevent further movement (see figure 15). The figure also shows the galvanized steel channels that connect the supplemental tieback rods to the face of the seawall. Unlike the riprap, these were present in 2017 and have remained intact, although difficult to see due to barnacle growth. This area was also treated with foam injection in 2021.

Figure 15: Riprap Installed in Response to Seawall Base Kickout Identified in 2017

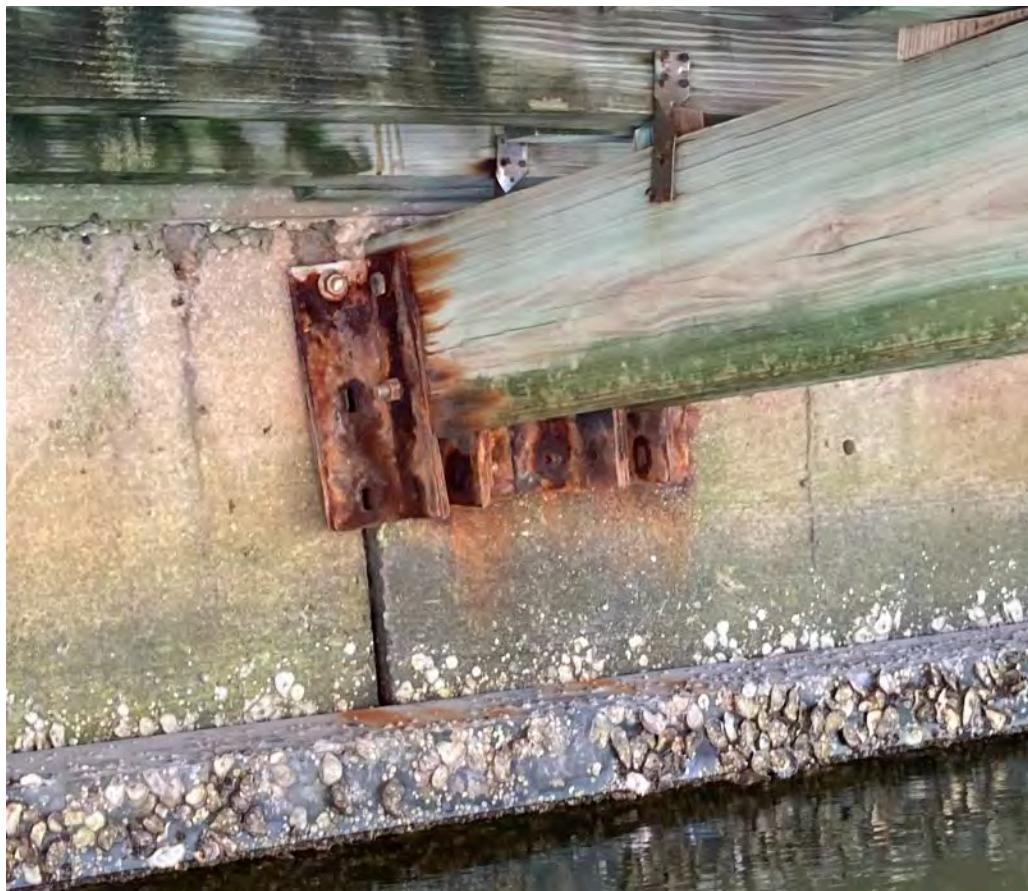
In the case of the fixed docks that run adjacent to the seawall, there is only one row of pilings and the backside of the dock is supported by steel hardware that fastens the cap timbers to the concrete seawall panels. The downside to this design is that the dock's structural integrity relies on the condition of the seawall. Additionally, most of this hardware is severely corroded (see figure 17). The bolts and nuts holding the cap timbers to the piles are stainless steel and most of them are in good condition, showing signs of rust staining but no structural corrosion was found.

Figure 17: Hardware Connecting Fixed Dock to Seawall Panel

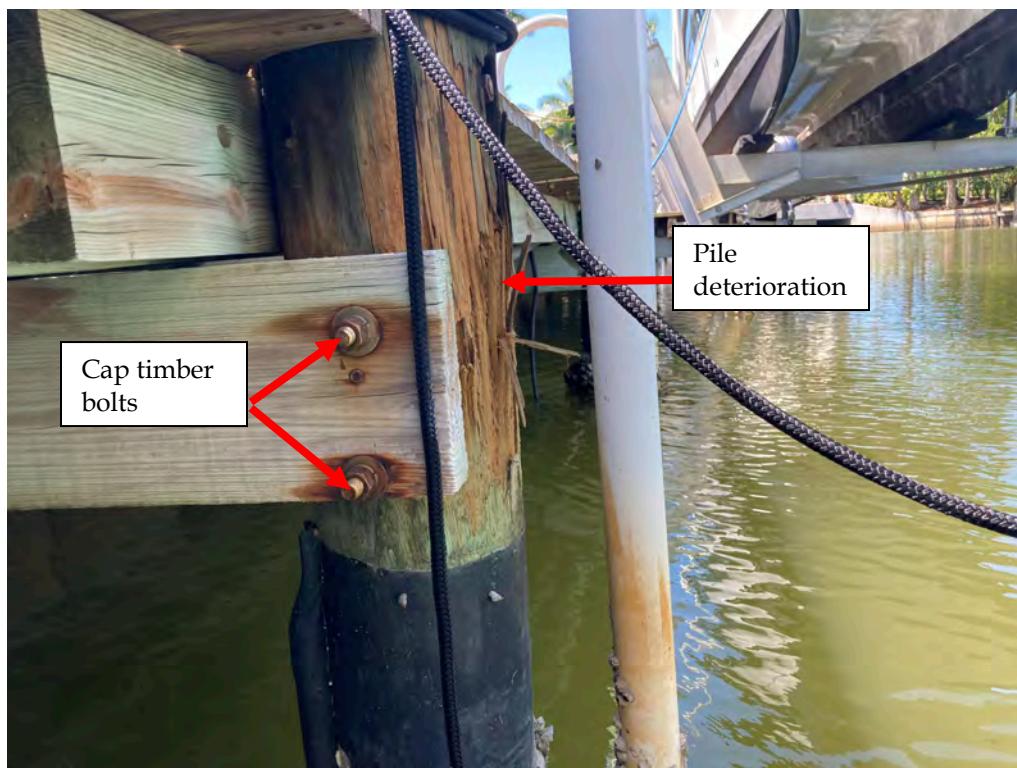
The condition of the wood pilings range from fair to poor. Almost all of the pilings show some level of deterioration, indicated by the orange, fuzzy areas directly above the vinyl wrapping. This is typically either caused by dry rot or saltwater wicking into the wood and creates a soft spot in the wood. Figure 25 shows one of the worst pilings, and a close up of another deteriorated pile can be seen in figure 18. A few of the piles have had a concrete collar formed around them as a temporary repair.

Figure 18: Close Up Pile Deterioration, Dock Framing

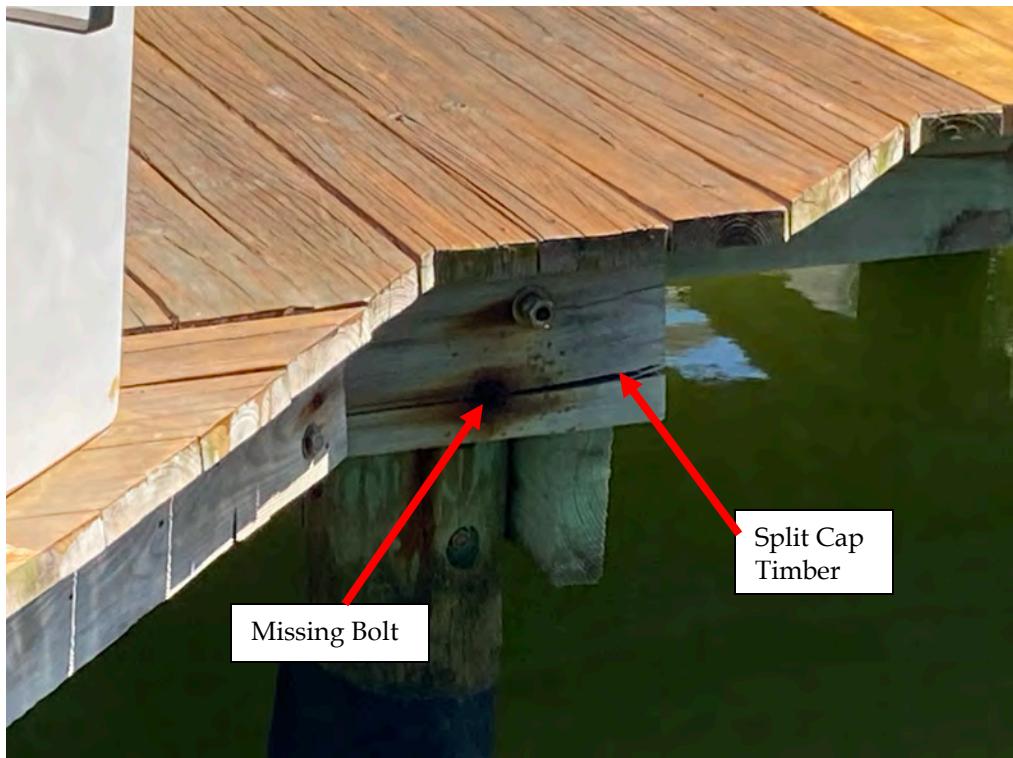
The dock framing (stringers and cap timbers) was in fair condition. A few boards were splitting down the center, one of which is shown in figure 19 along with a missing cap timber bolt. The decking was replaced in recent years and has been maintained well but is warping significantly in certain areas, presenting a tripping hazard. Several boards appear to have been replaced. The broken board photographed in figure 22 appears to have happened recently and should be replaced as well.

Figure 19: Dock Framing - Split Lumber and Missing Bolt

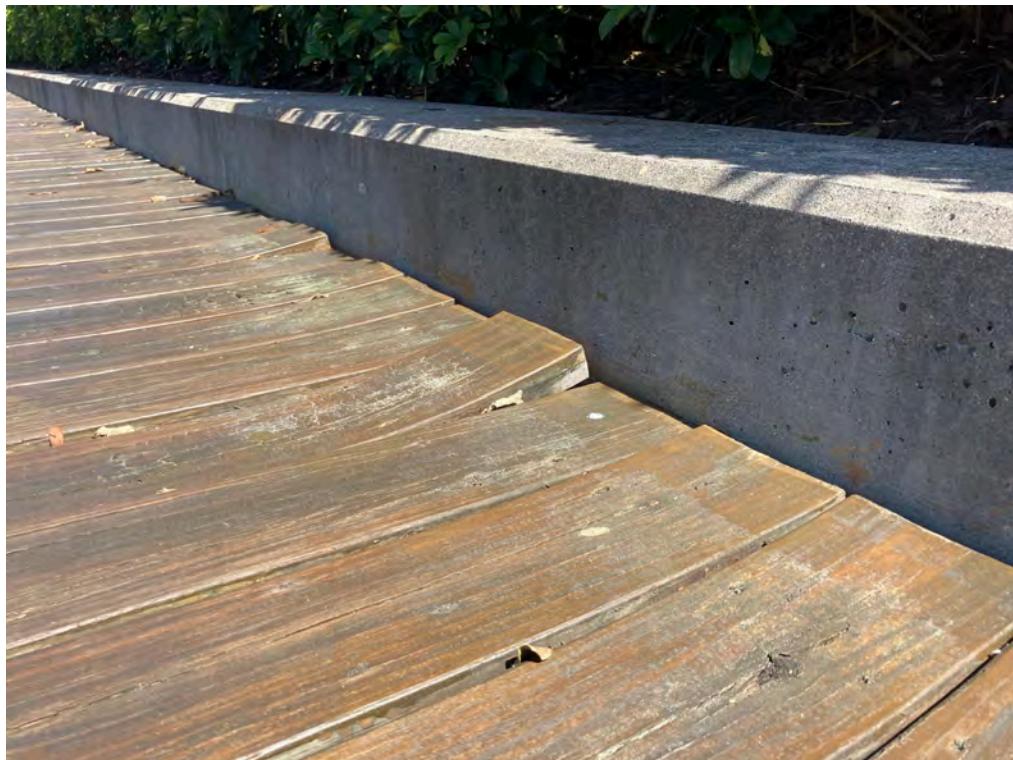
Figure 20: Warped Deck Boards

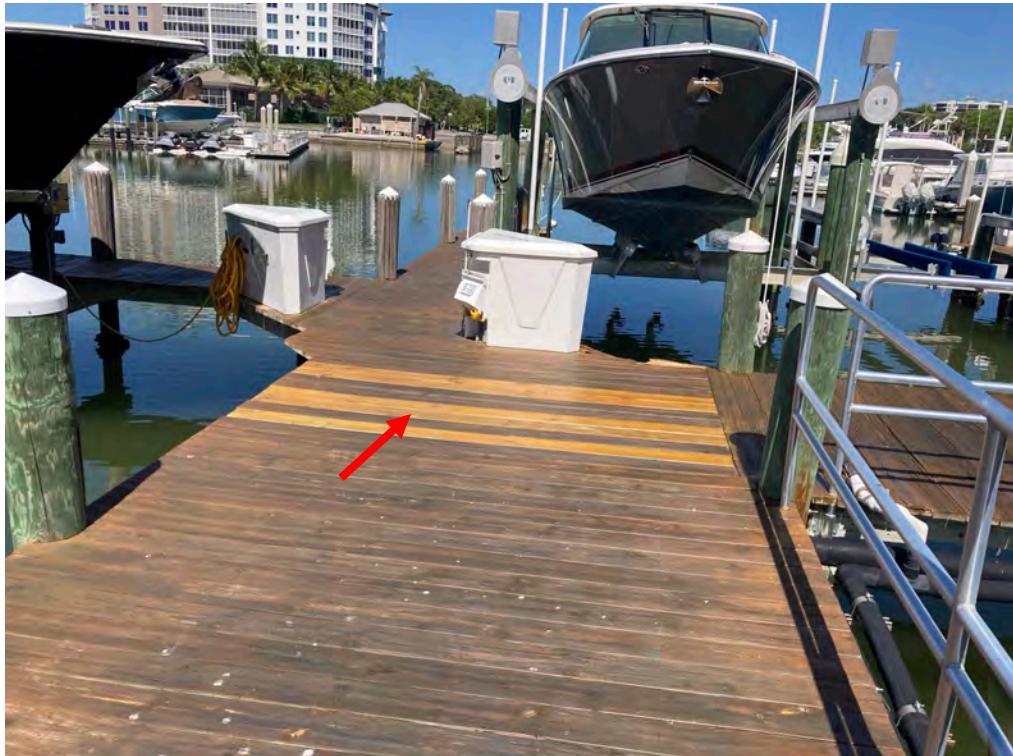
Figure 21: Recently Replaced Deck Boards

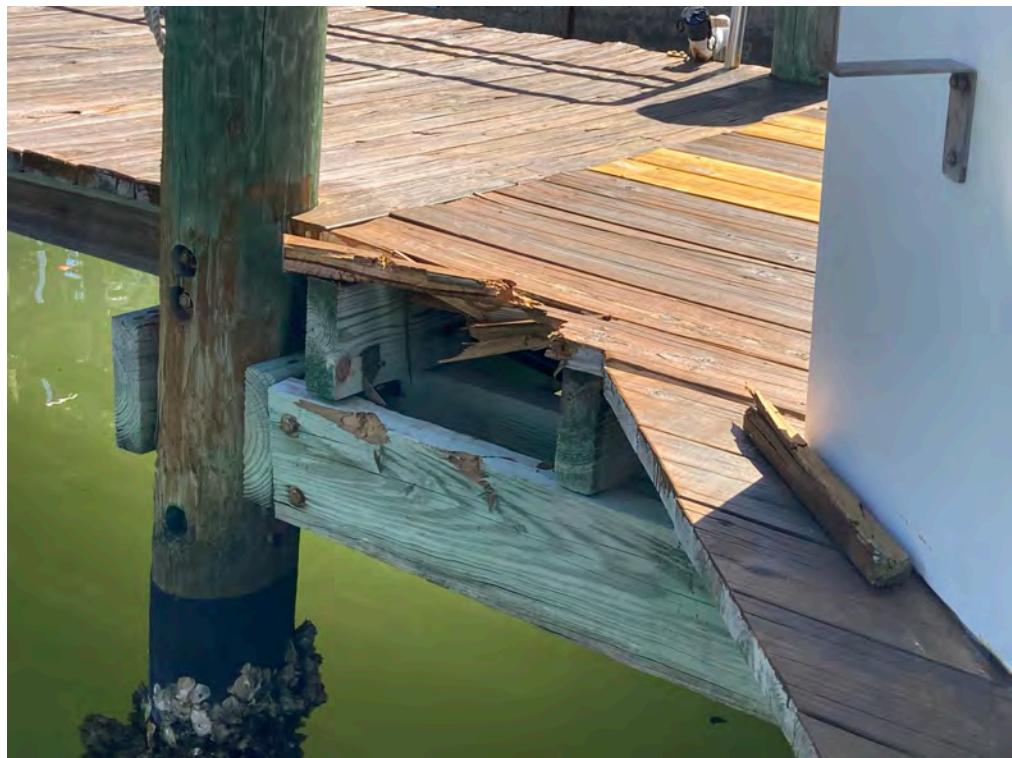
Figure 22: Broken Deck Board

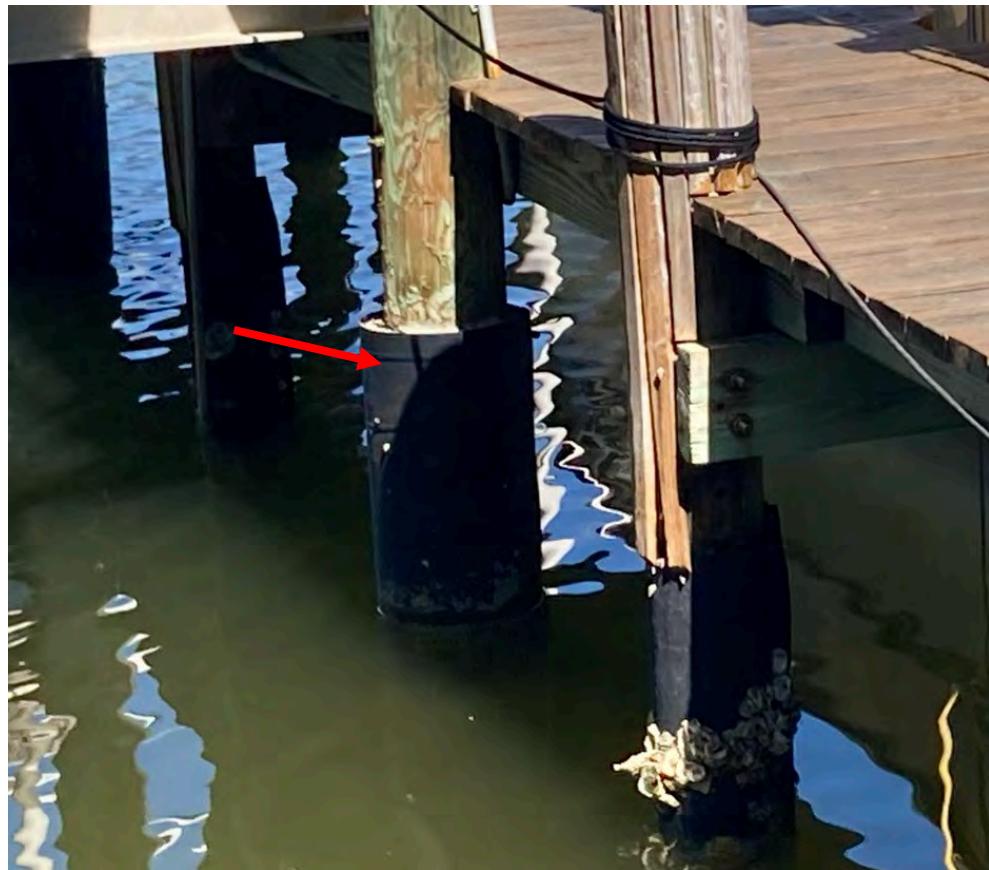
Figure 23: Pile Repair (concrete poured inside sleeve around the pile)

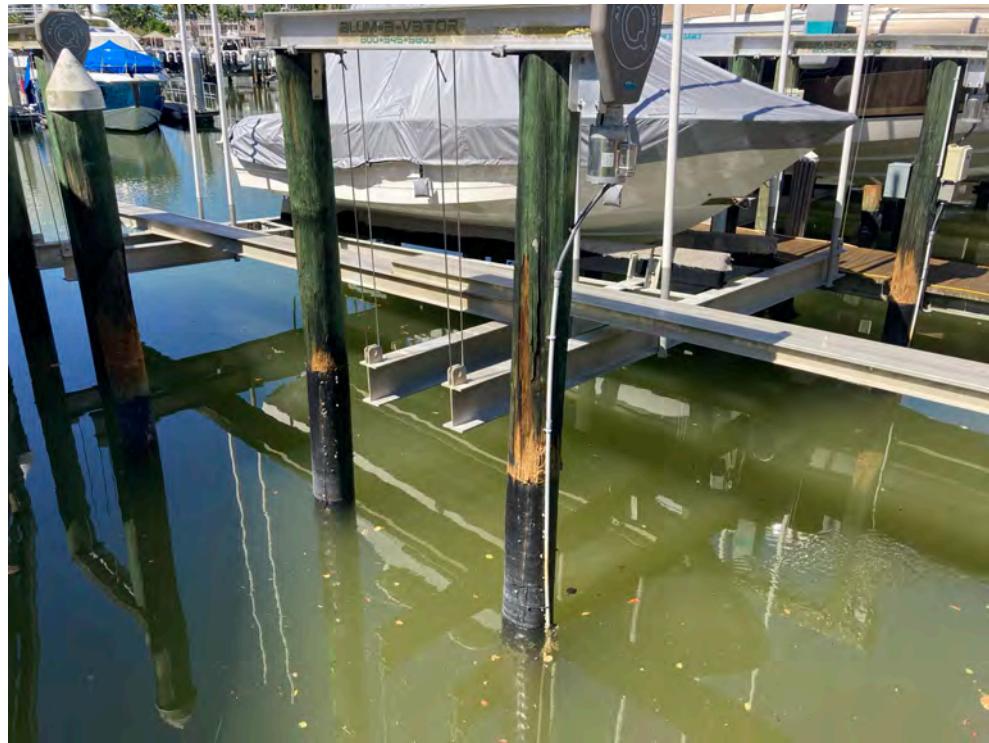
Figure 24: Detriorated Boatlift Piles

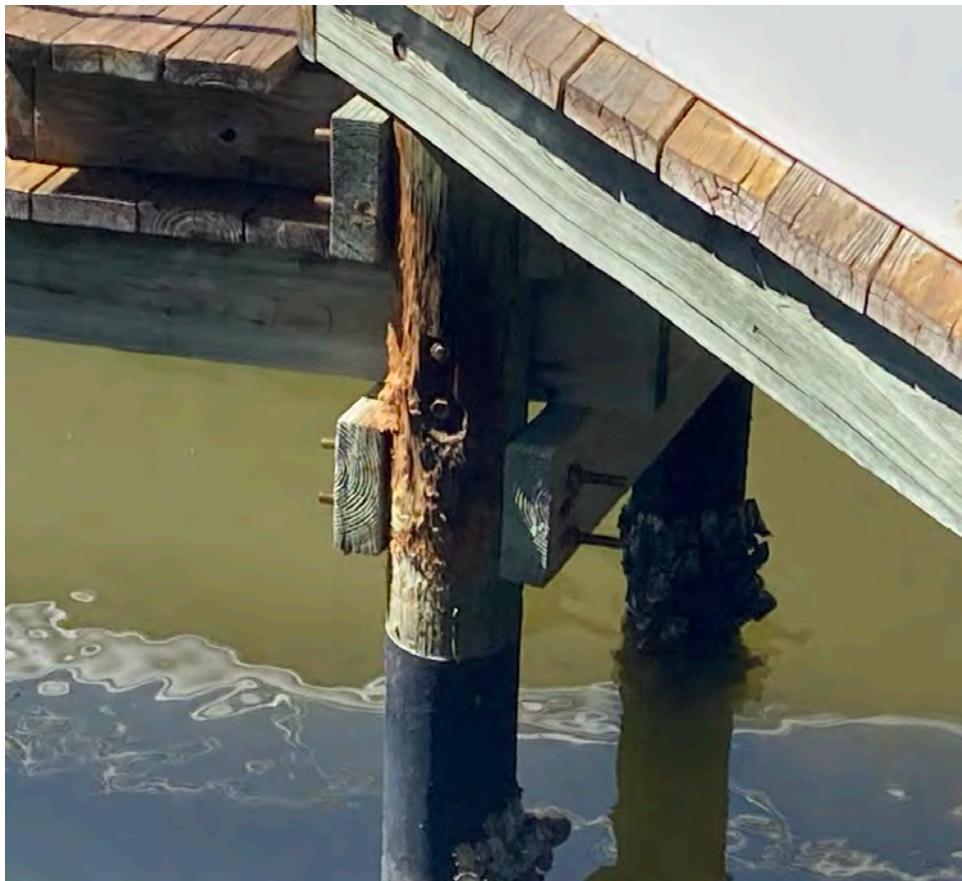
Figure 25: Severely Deteriorated Dock Pile
