Re: Westhampton Landings Co-op  
3001-3050 Mitchell Road  
Westhampton Beach, NY 11978

RE: Roof Assessment

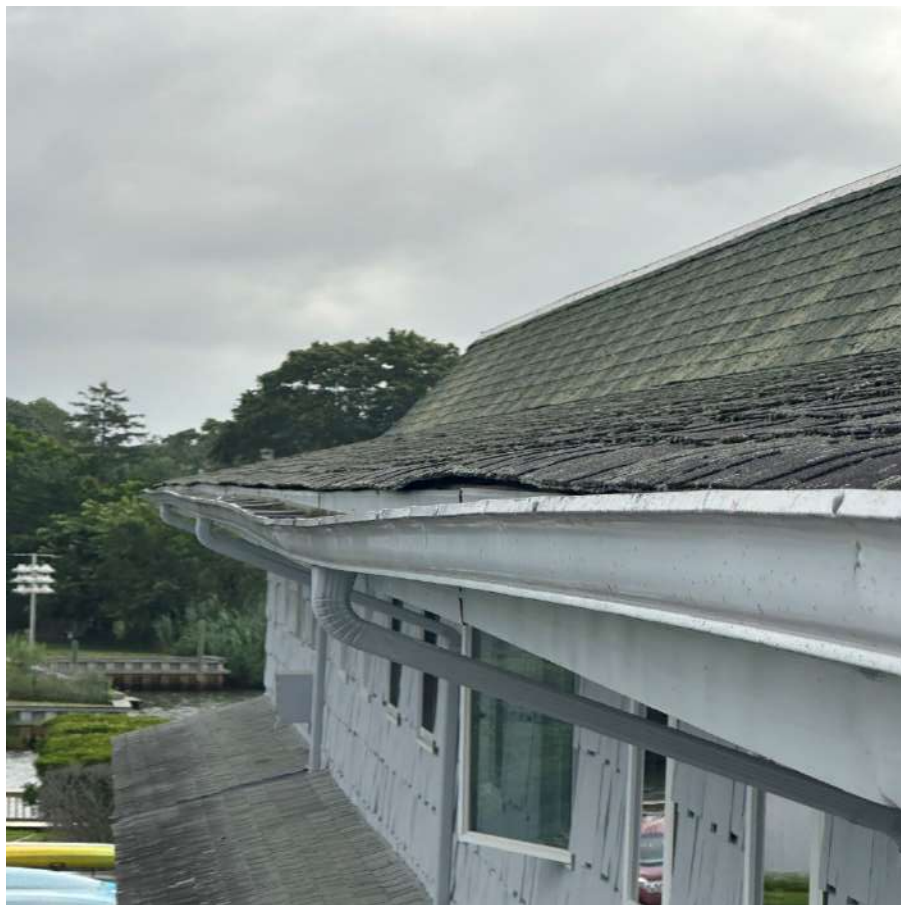
P-1 Gap at Fascia and Curling Shingles

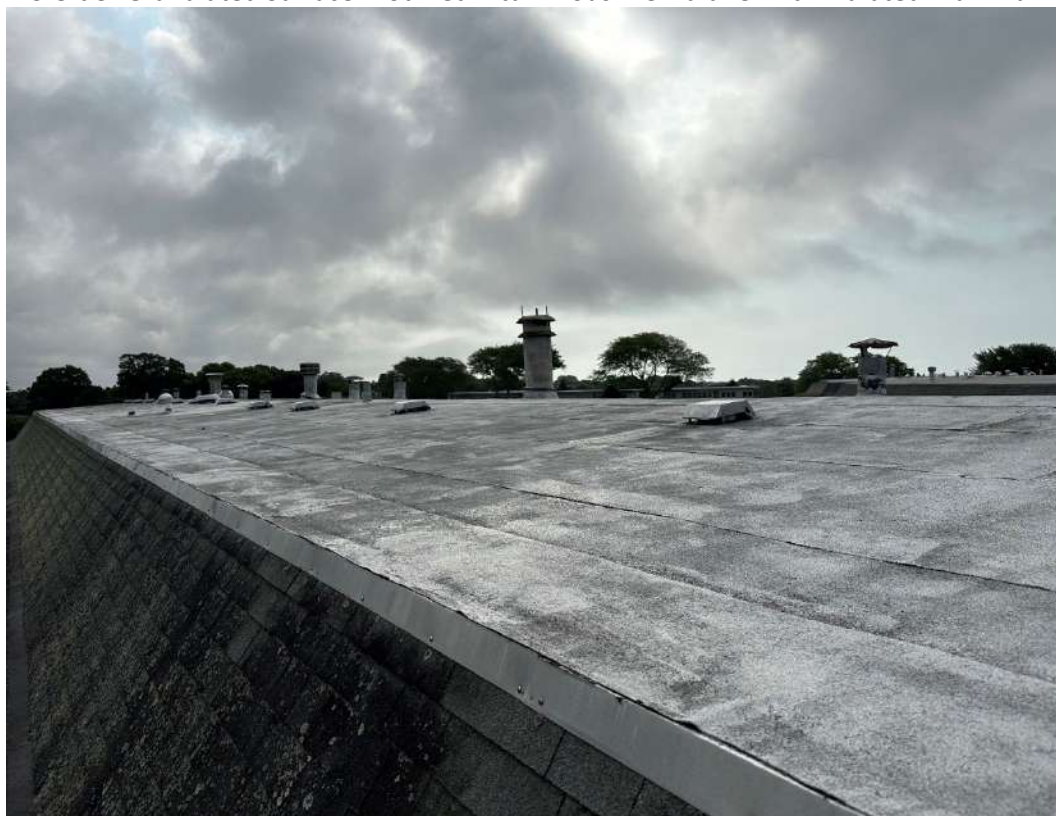
P-3 Older Granulated Surface Modified Bituminous Membrane With Fibrated Aluminum Coating

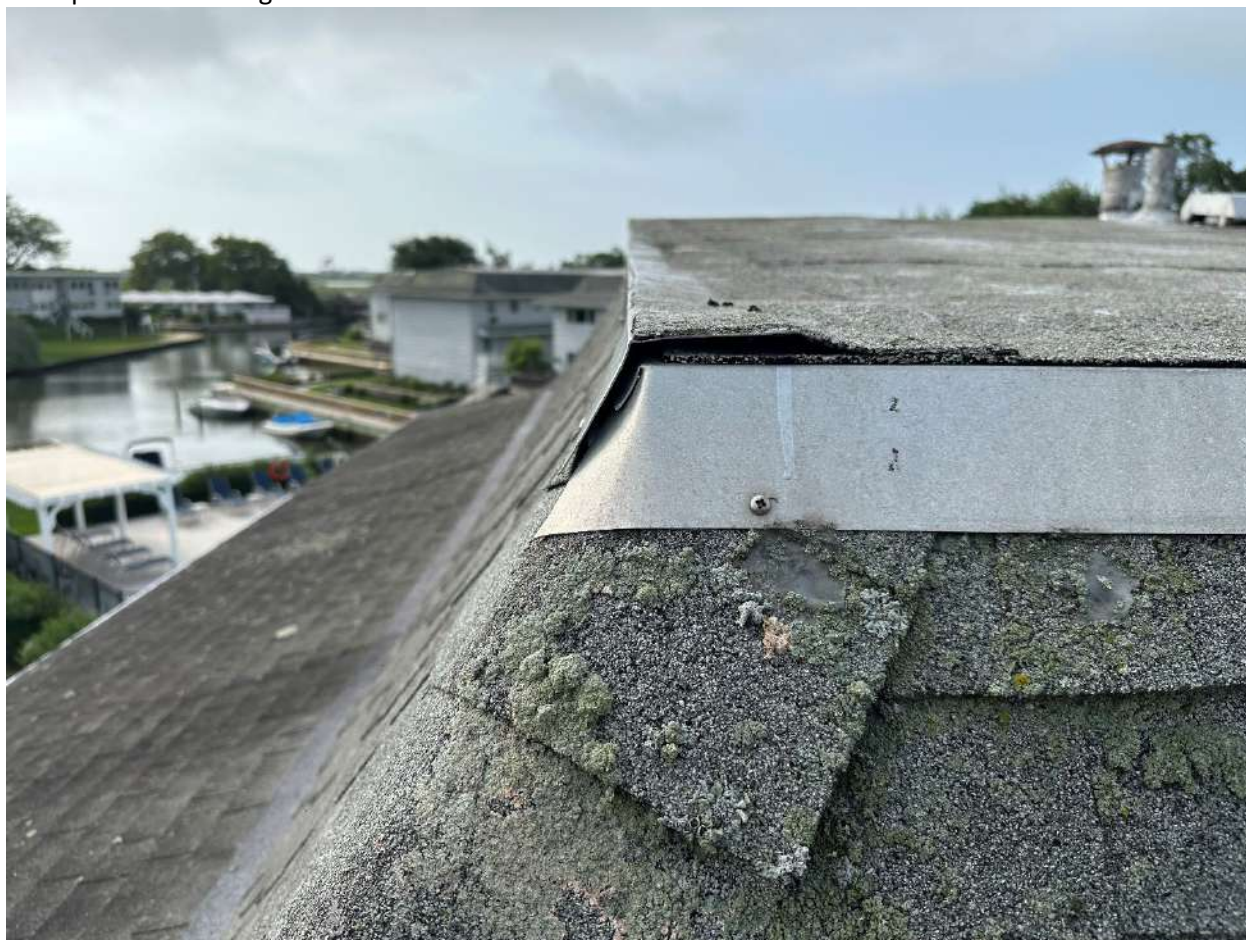
P-5 Open Seam At Edge Metal

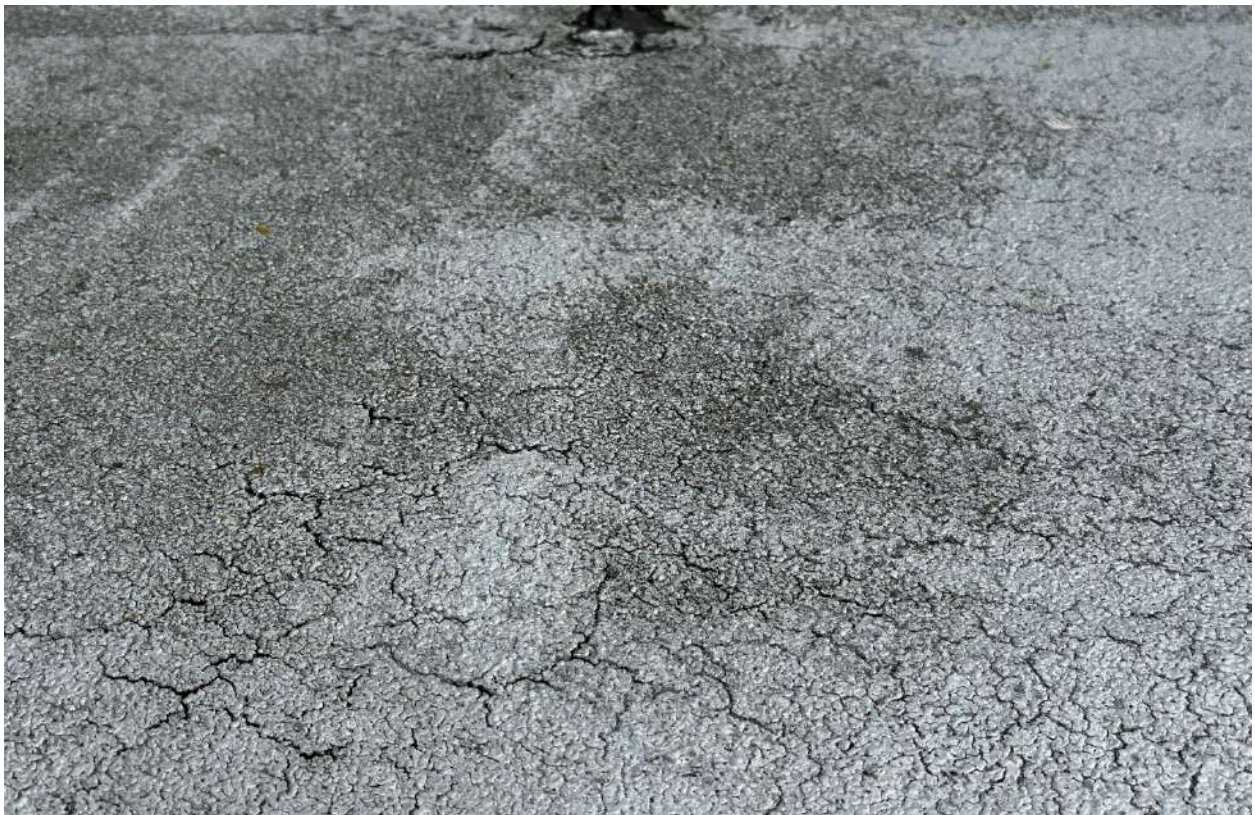
P-7 Alligatoring of Membrane

To try and extend the remaining useful life of alligatored modified bituminous roof membrane requires the application of a heavy-duty elastomeric or fiber-reinforced liquid coatings that can bridge interconnected micro-cracks and restore UV protection. The exact product(s) to use and varied warranties available would need to be explored further. GAF manufactures silicone roof coatings such as GAF Unisil II.

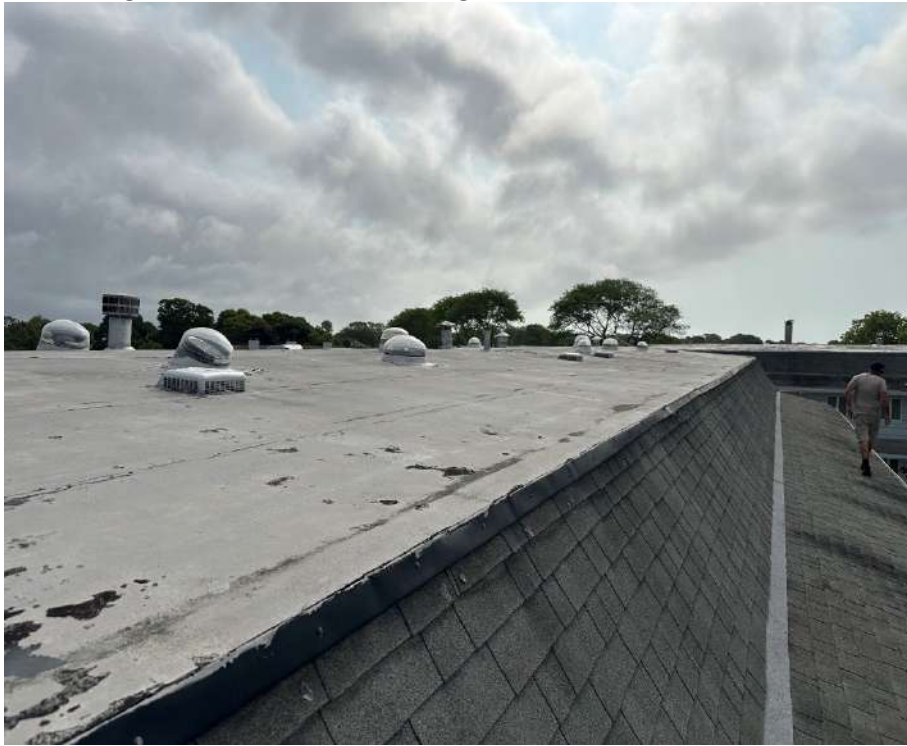
P-8 Peeling Fibrated Aluminum Coating

and will ultimately manifest themselves as leaks. As previously discussed, the fibrated aluminum coating is peeling and on the smooth bituminous membranes there is therefore no UV protection. Therefore, removing any loose coating followed by application of a fibrated aluminum coating will add a little more life to the existing smooth membranes.

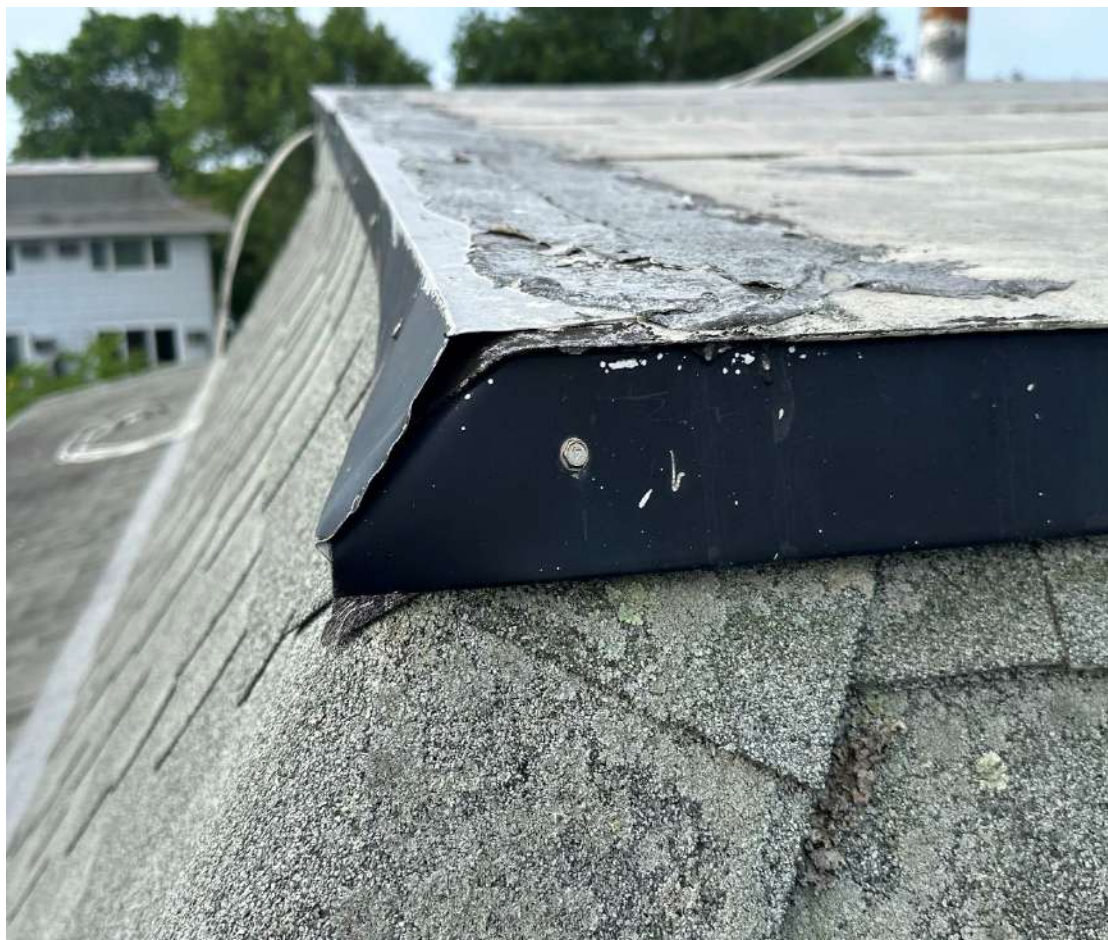
P-12 Corner Edge Metal Gaps

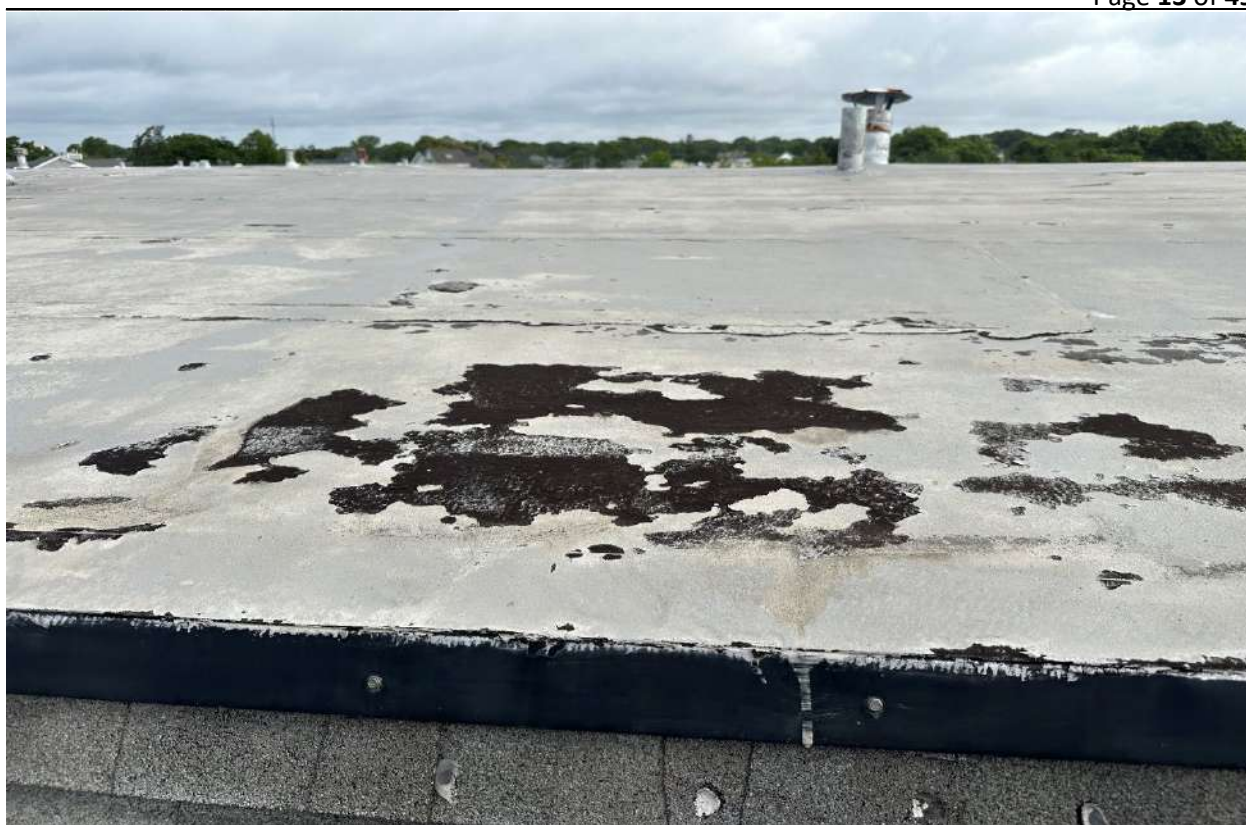
P-14 Depression

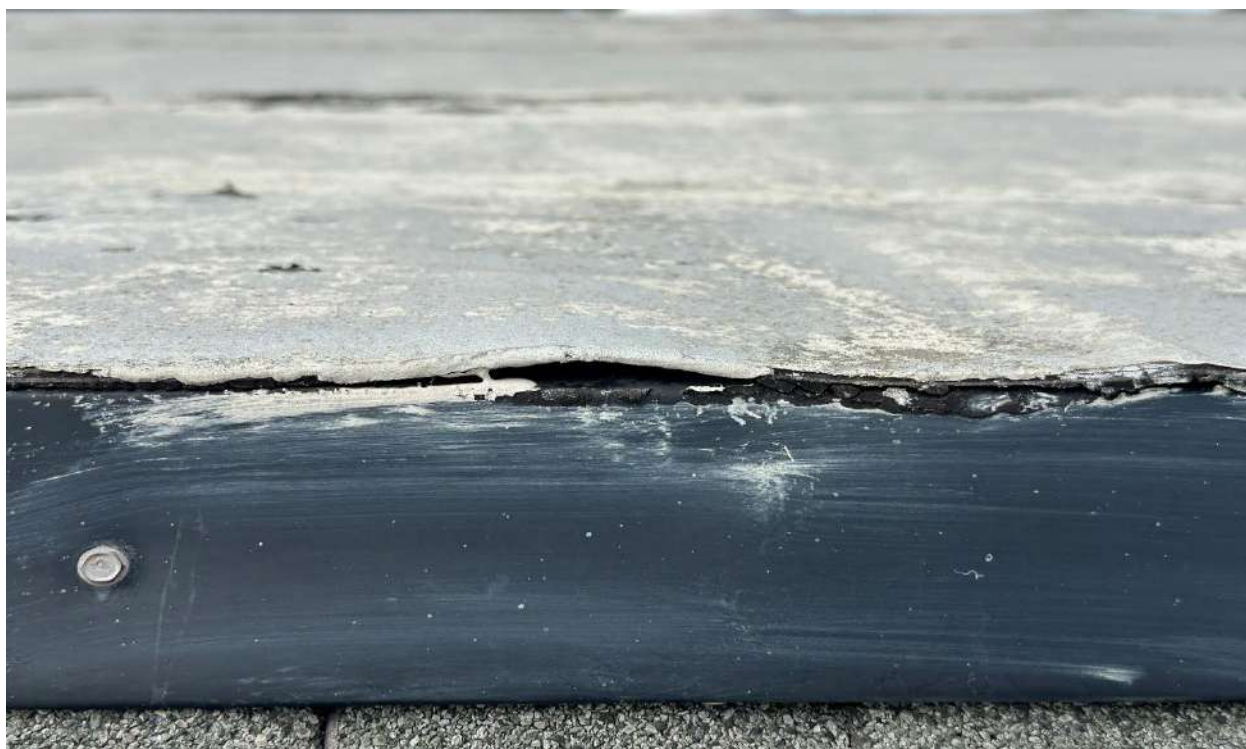
P-15 Opening in Membrane at Edge Metal

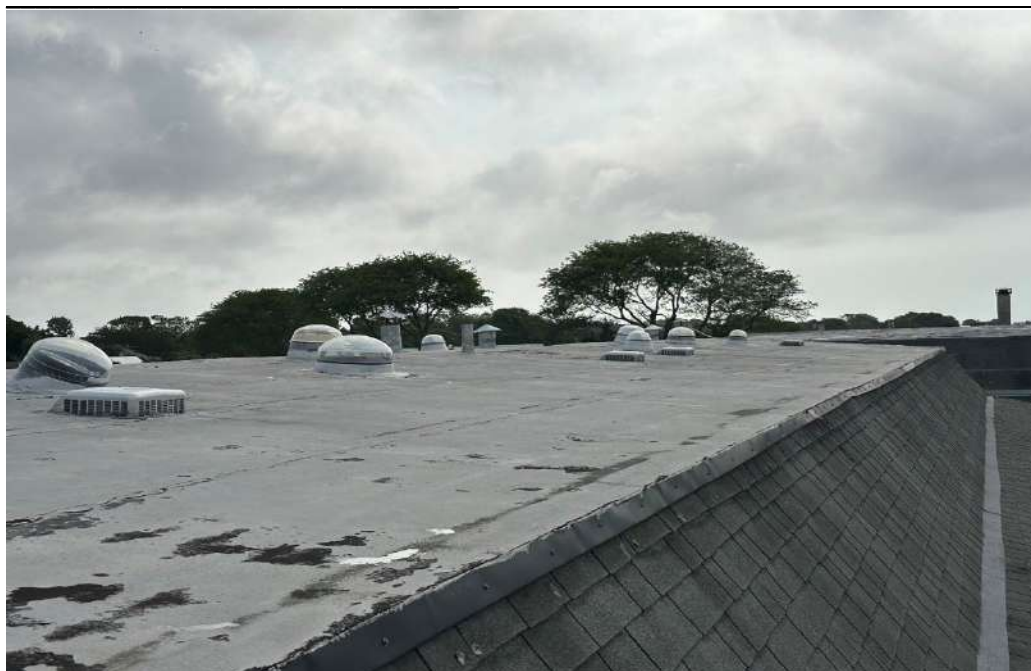
P-16 Peeling Fibrated Aluminum Coating

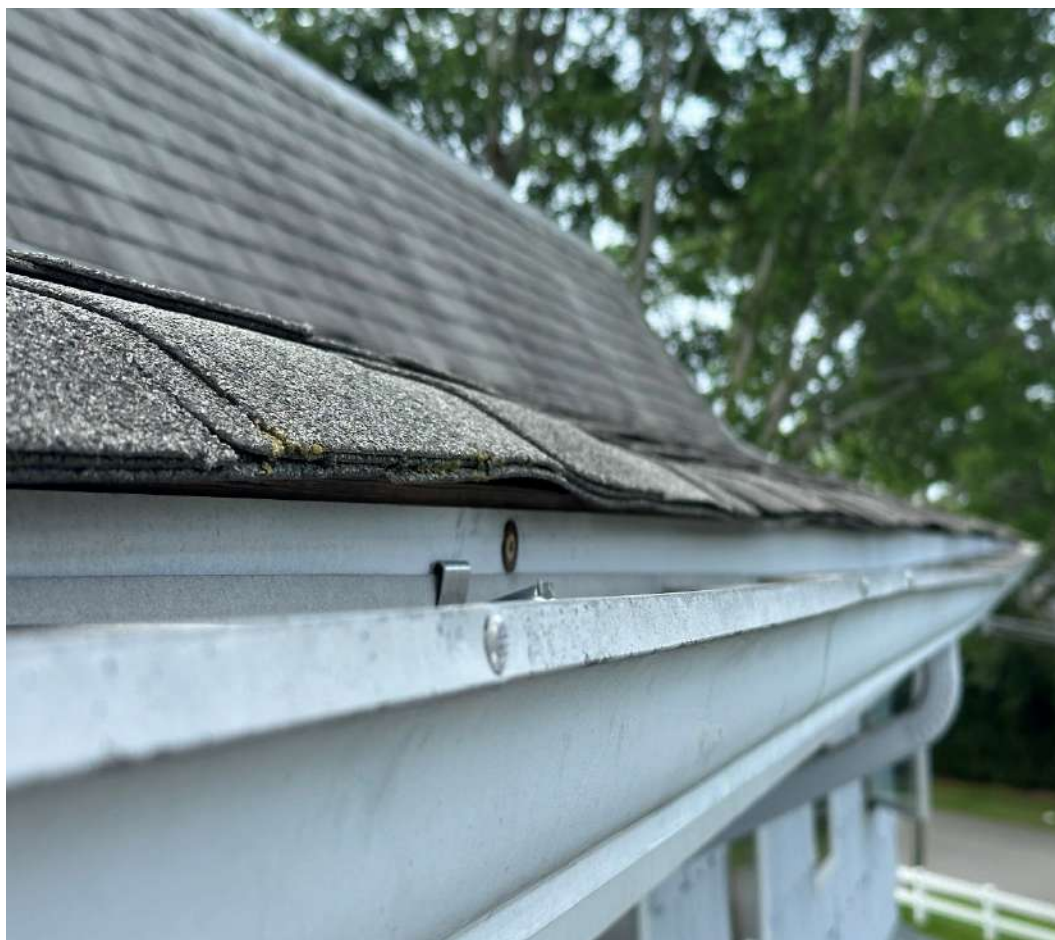
P-17 Gap at Fascia Exposing Sheathing

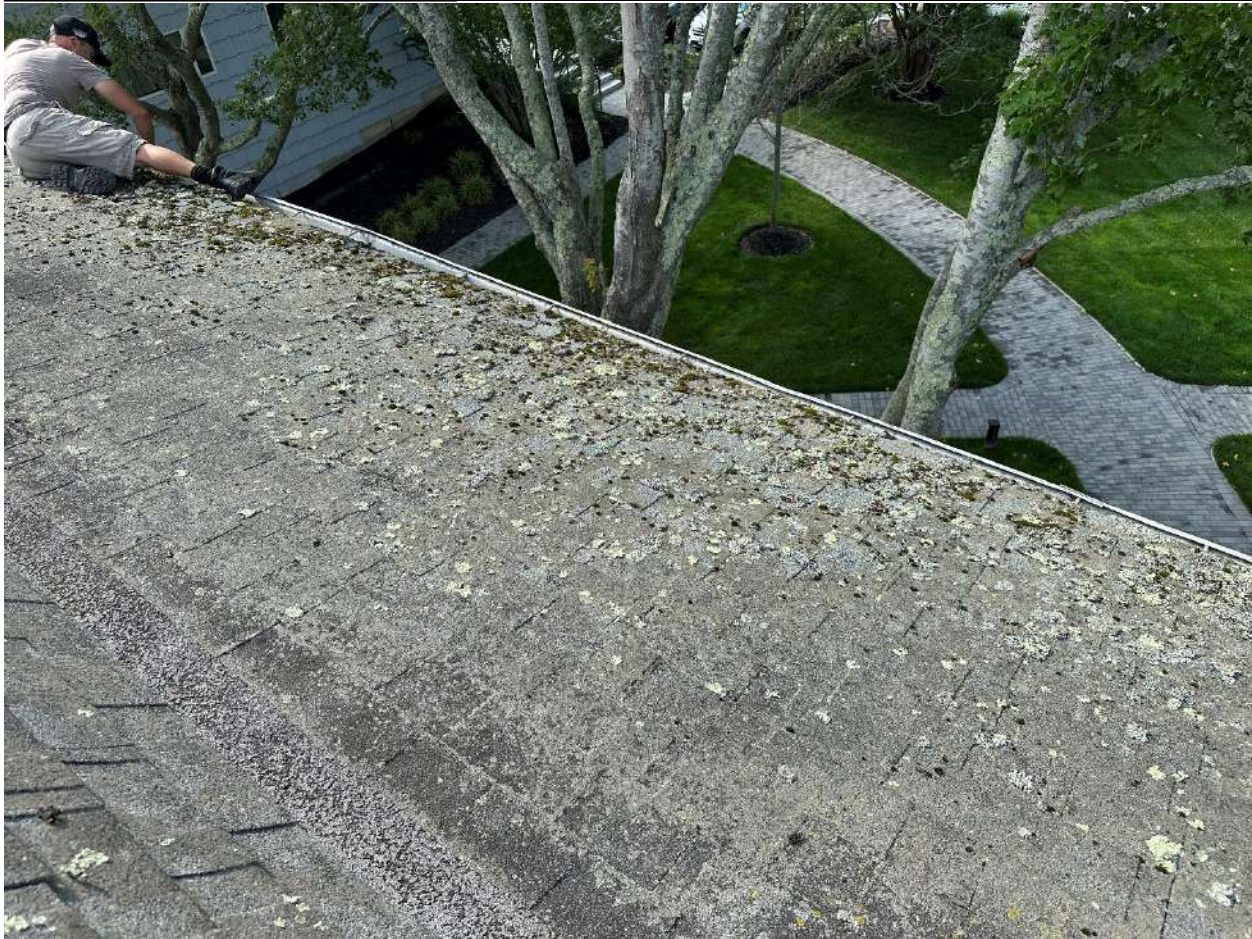
P-23 Gutters With Leaf Matter

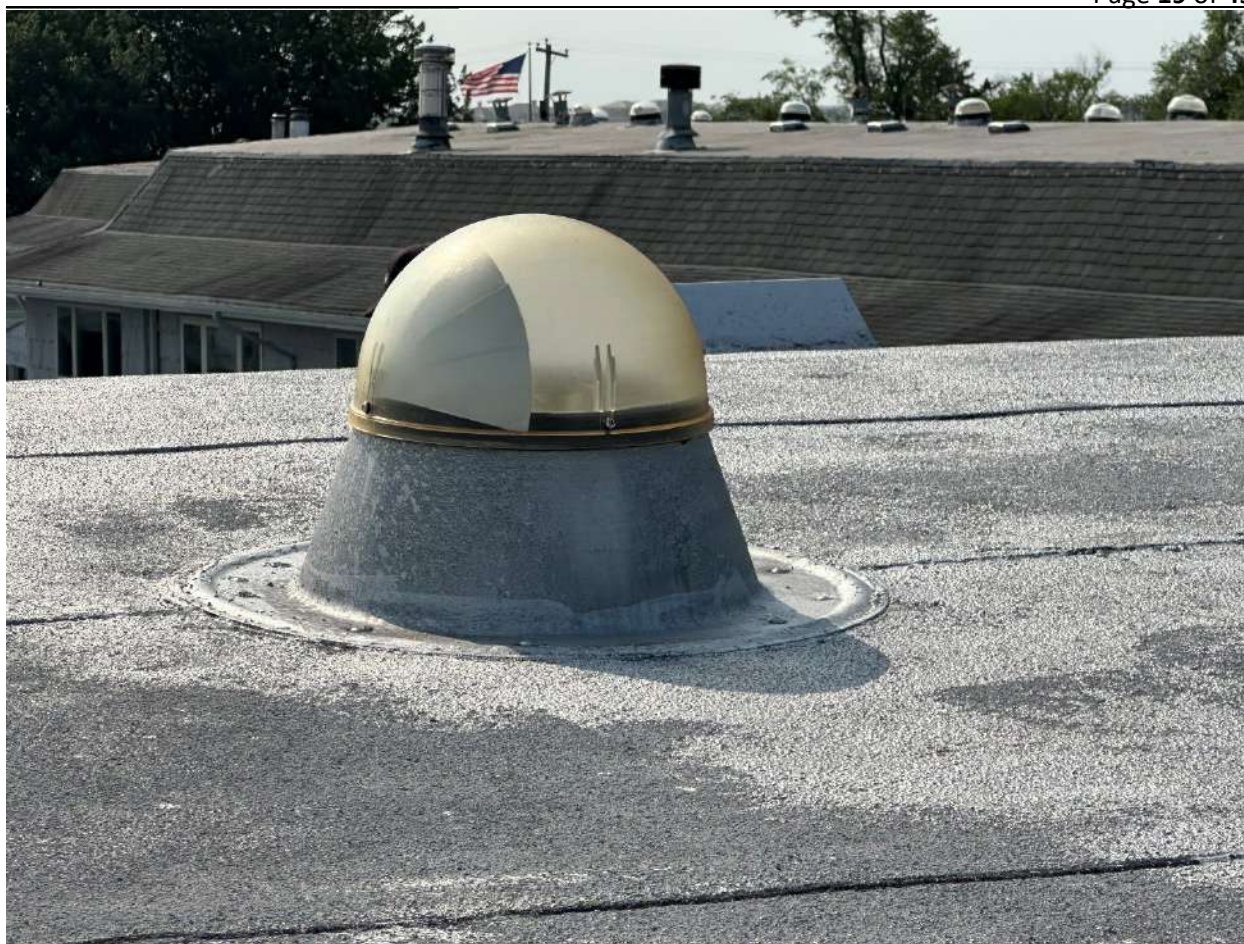
P-25 Solar Tube Skylight with Missing Flashing

Some of the solar tube skylights did not appear to have flashing at the base ring some with exposed fasteners. A new base flashing should be applied where missing. Also, some of the edge metal where the flat roof transitions to the steeply sloped shingle roof has unsealed and loose fasteners as well as some openings in the corners. These openings could allow water penetration under the membrane and should be repaired to ensure a tight seal. It should be anticipated that approximately ten (10) percent of the underlying roof sheathing plywood roof deck will be rotted. Rotted roof decking can sag and no longer adequately support the membrane. Some depressions were observed suggesting that some of the decking is rotted.

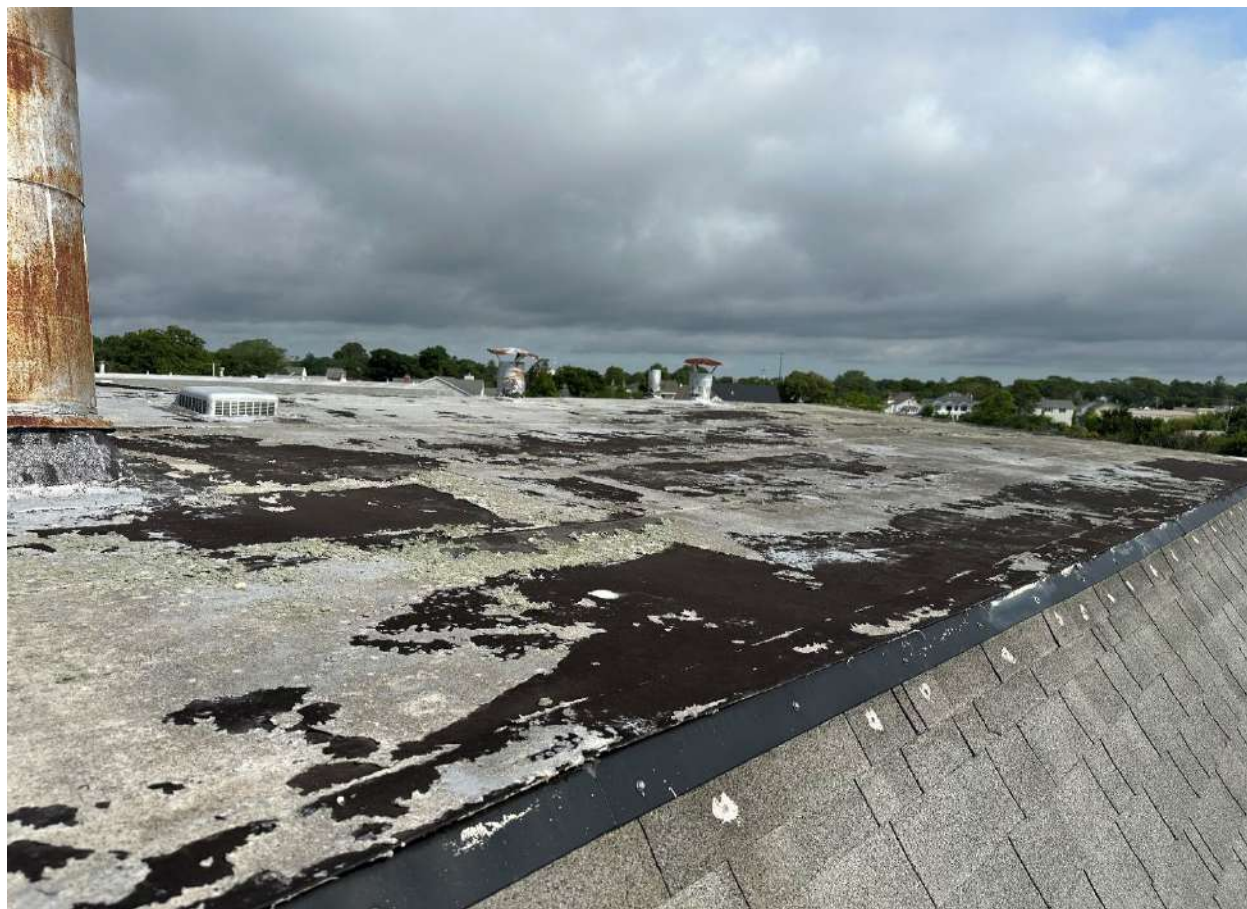
P-29 Peeling Coating

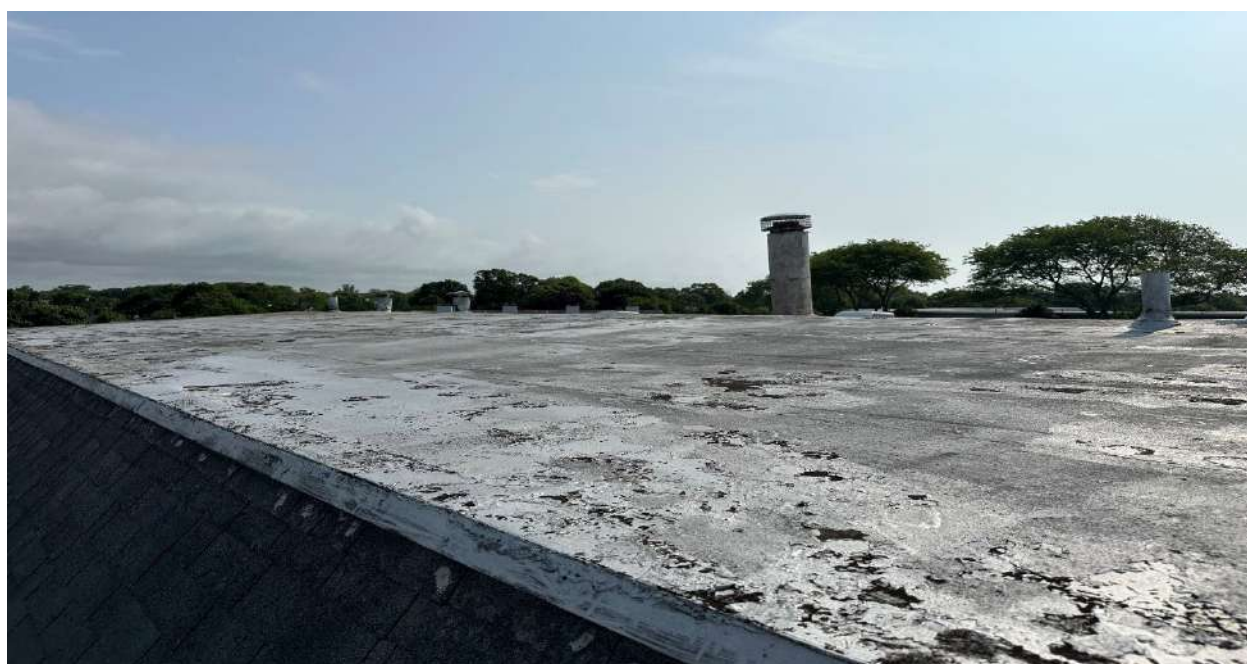
P-30 Peeling Coating

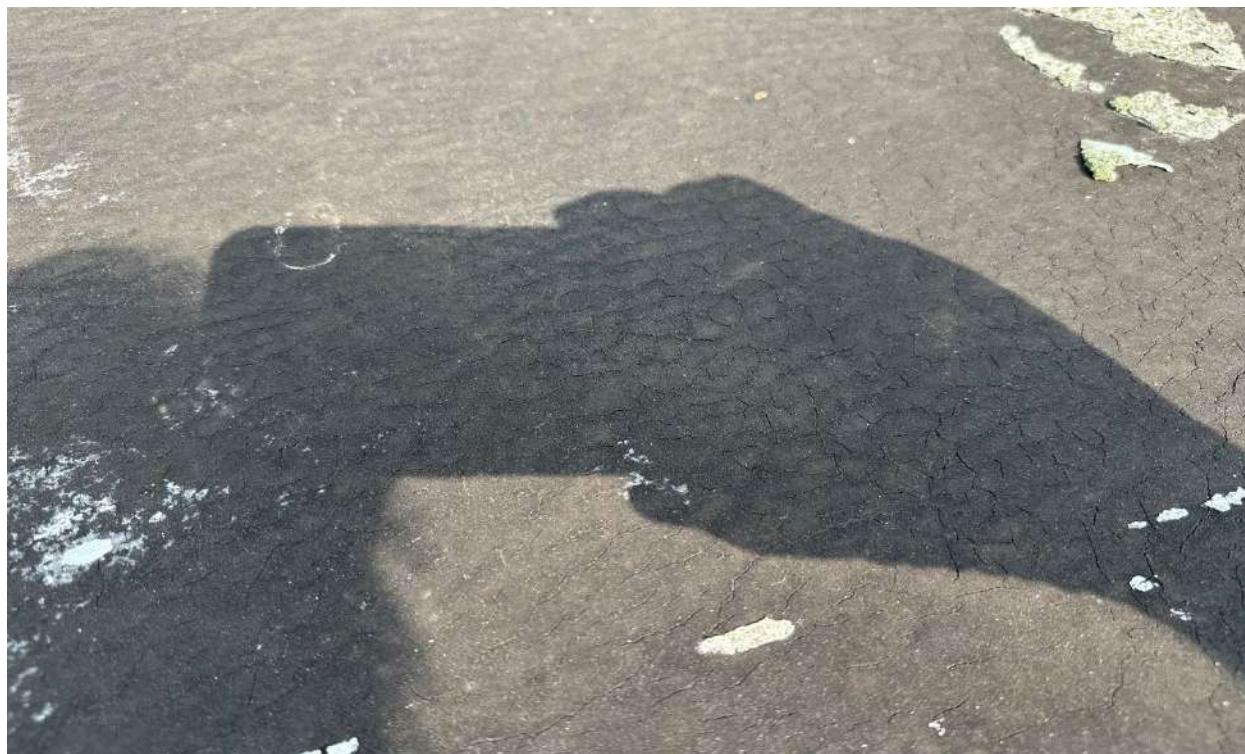
P-31 Alligatoring in Membrane

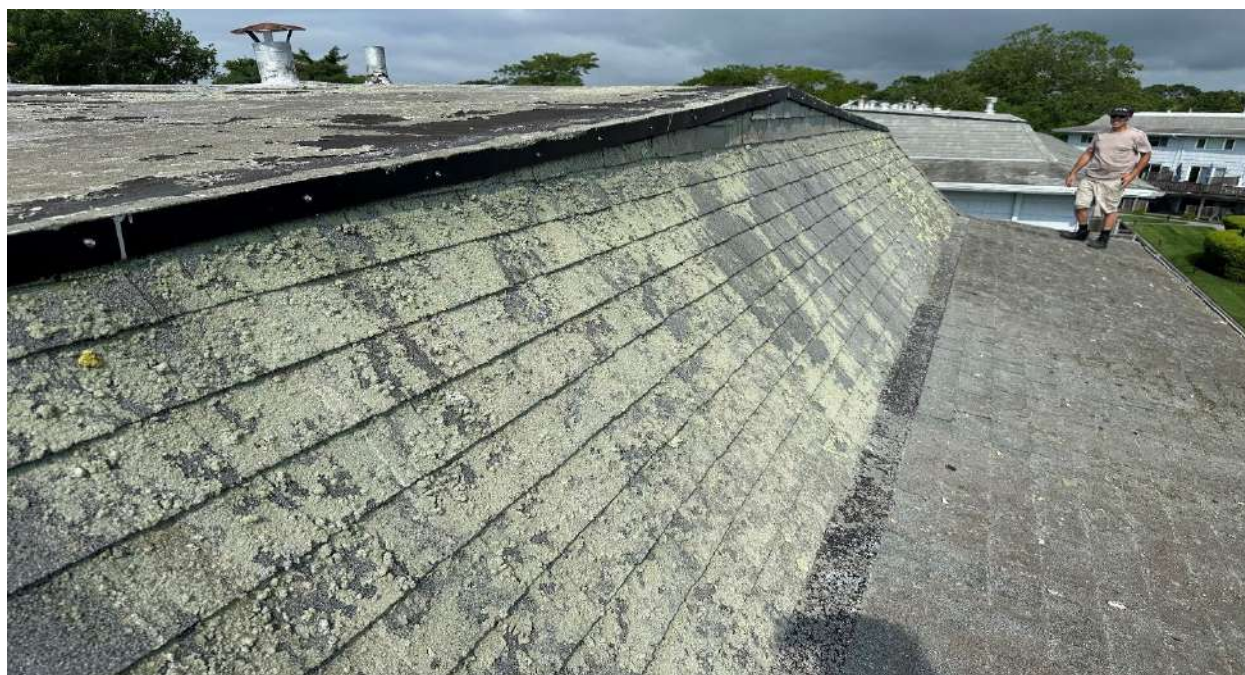
P-32 Algae Growth on Shingles

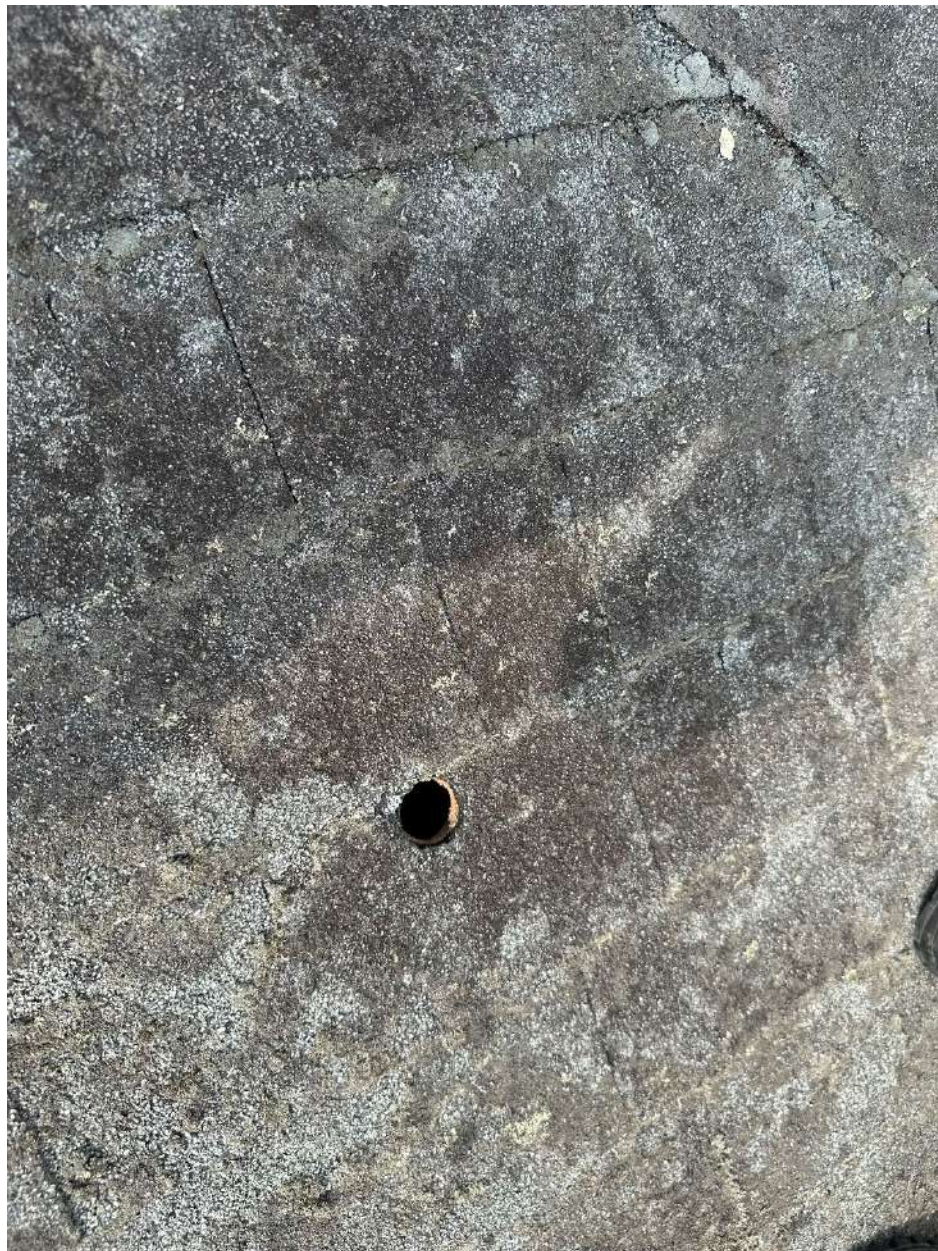
P-33 Hole Drilled Through Roof

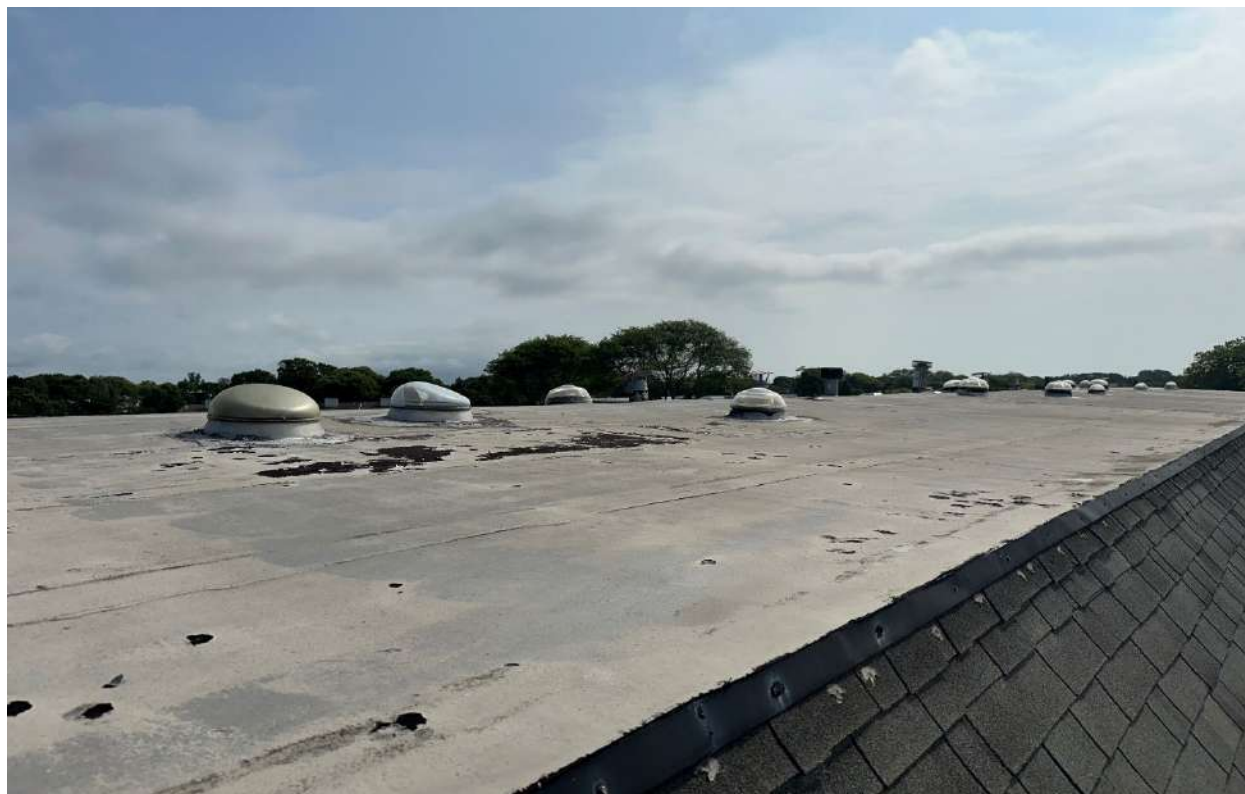
P-36 Peeling Fibrated Aluminum Coating

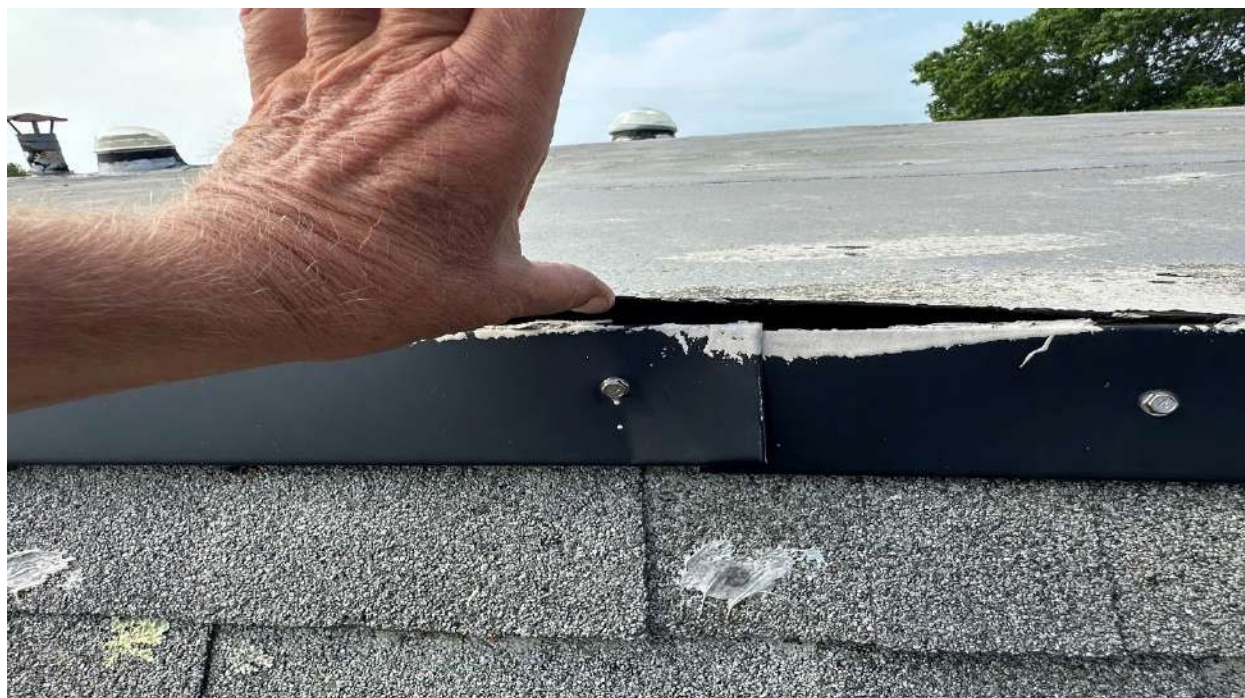
P-37 Opening in Membrane at Edge Metal

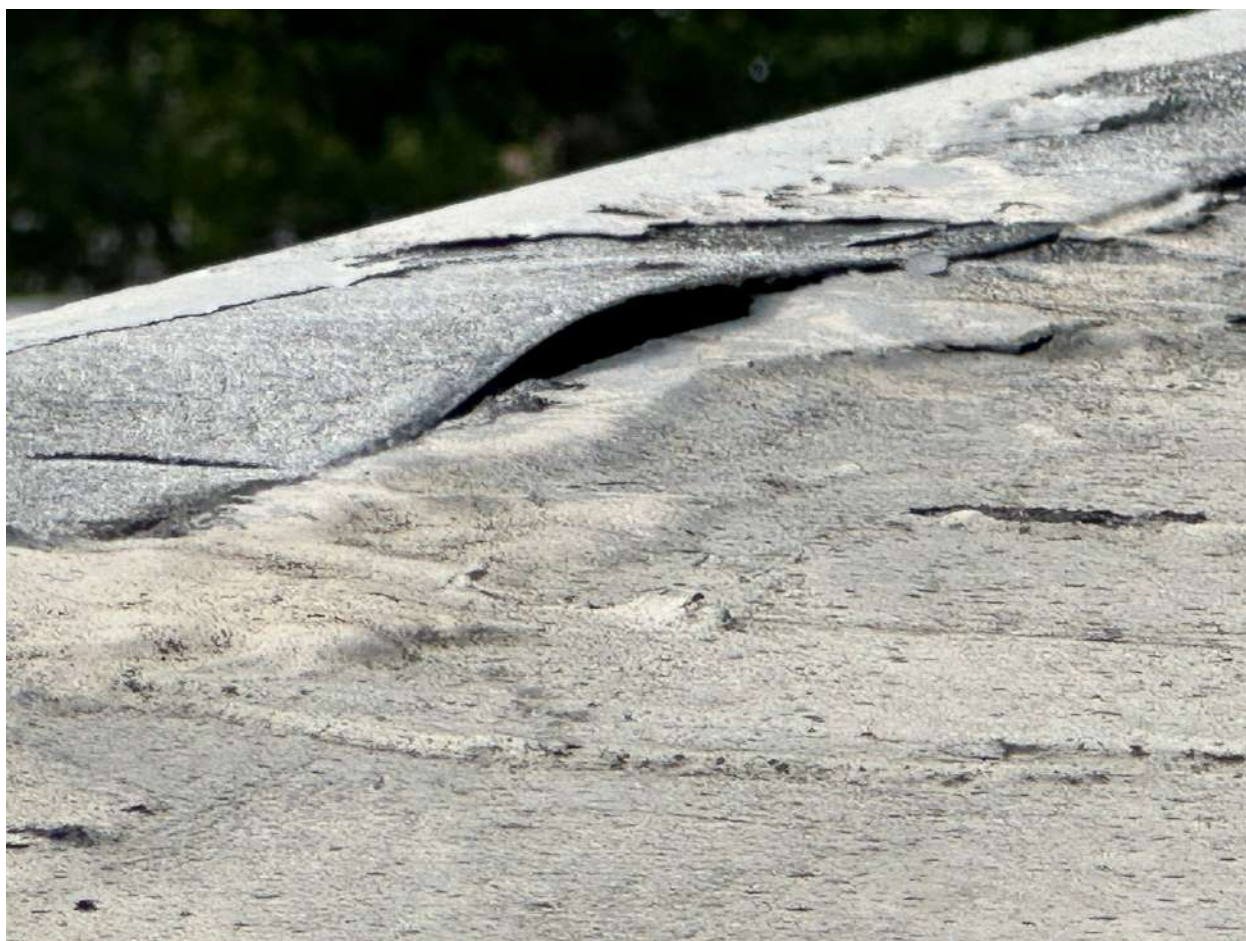
P-41 Fish mouth in Membrane

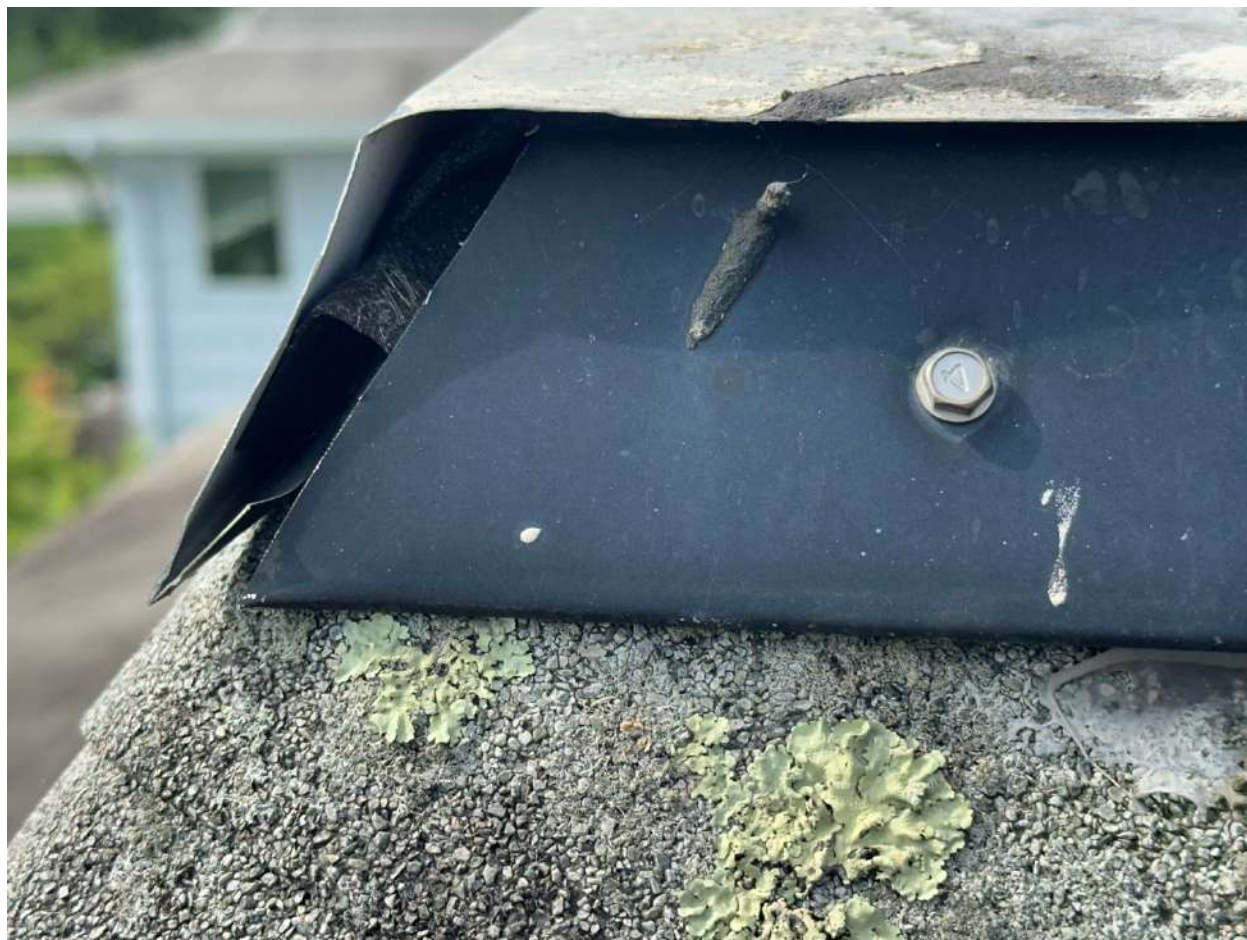
P-42 Opening in Edge Metal Corner

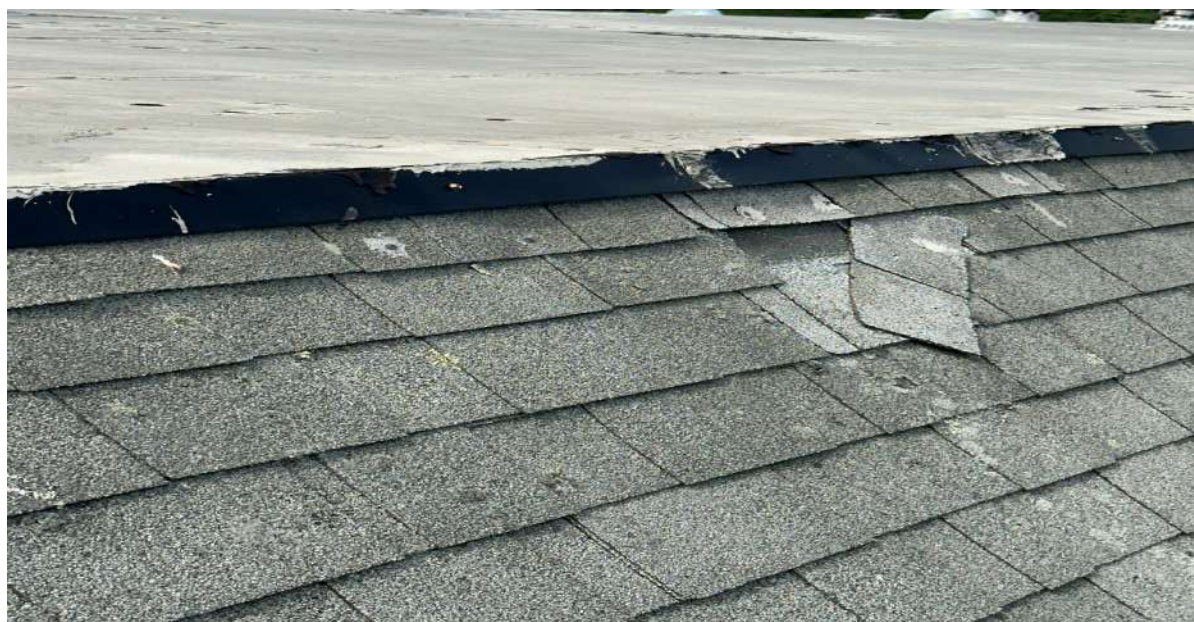
P-43 Delaminating Shingle

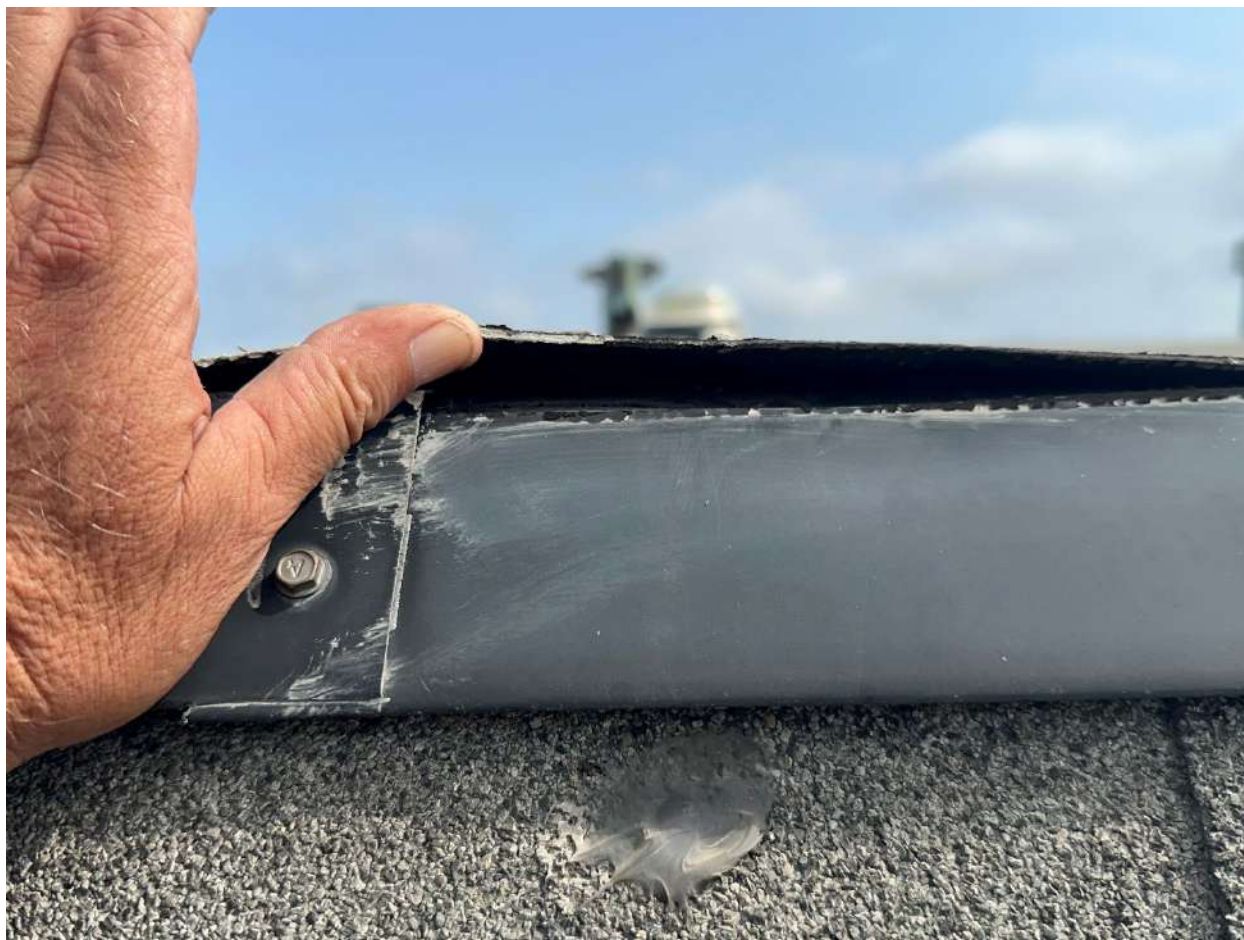
P-46 Opening in Edge Metal
