Re: Westhampton Landings Co-op  
3001-3050 Mitchell Road  
Westhampton Beach, NY 11978

RE: Roof Assessment

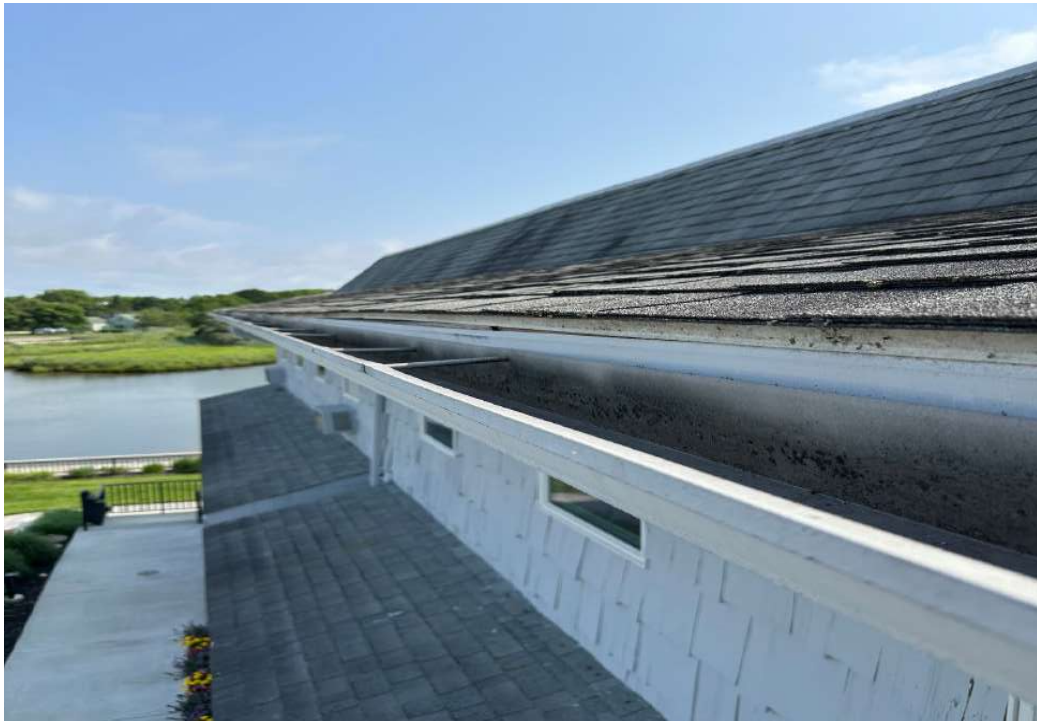
P-65 Gap at Shingle at Fascia Exposing Sheathing

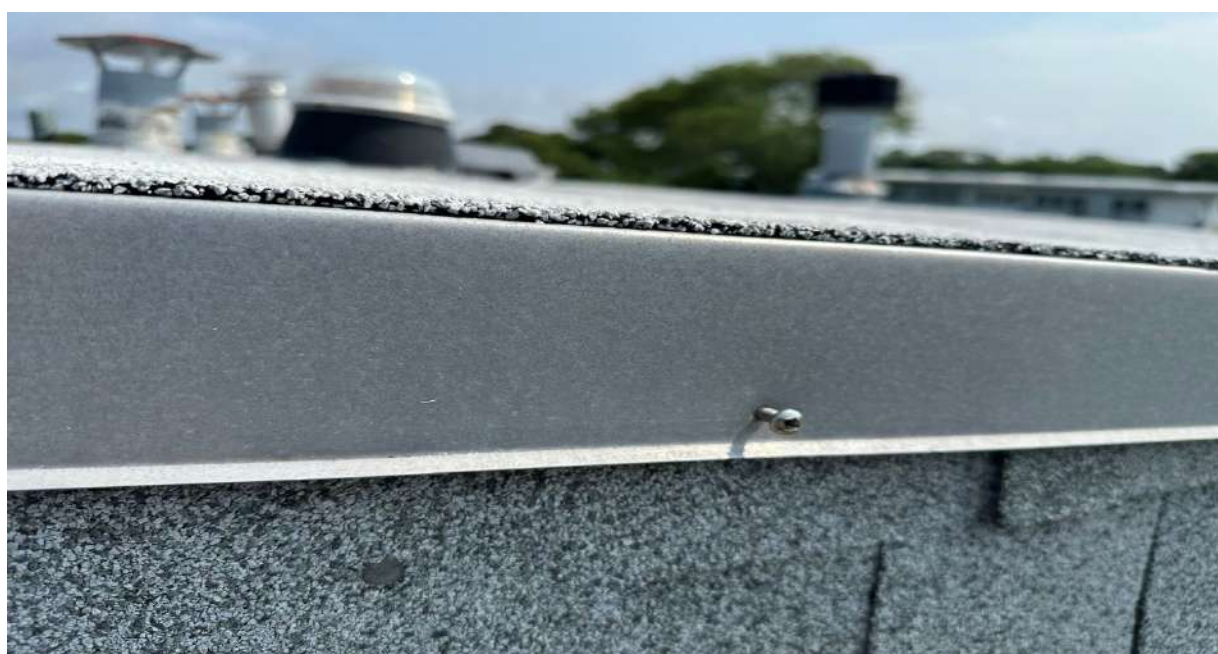
P-68 Exposed Edge metal Fastner

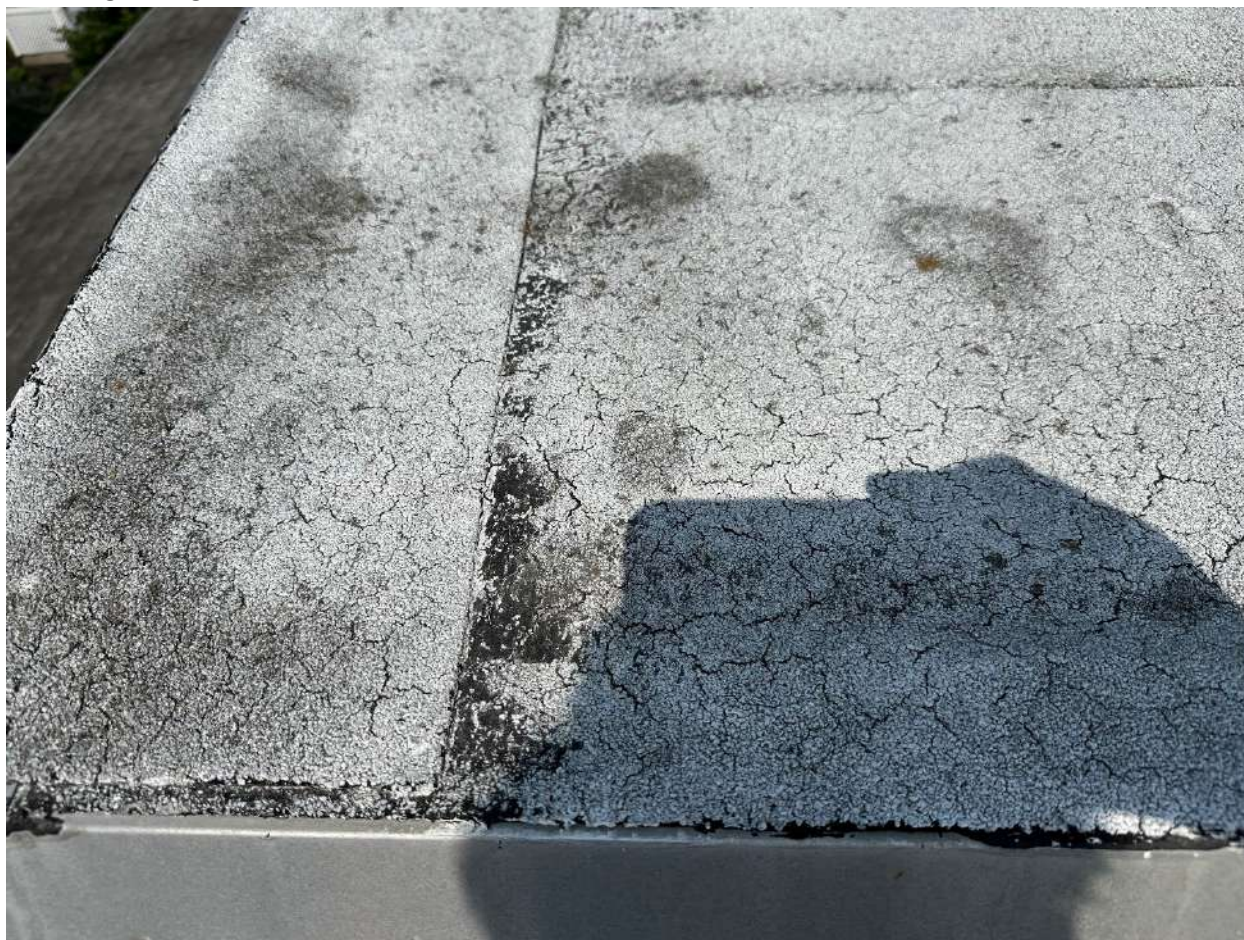
P-69 Alligatoring in Membrane

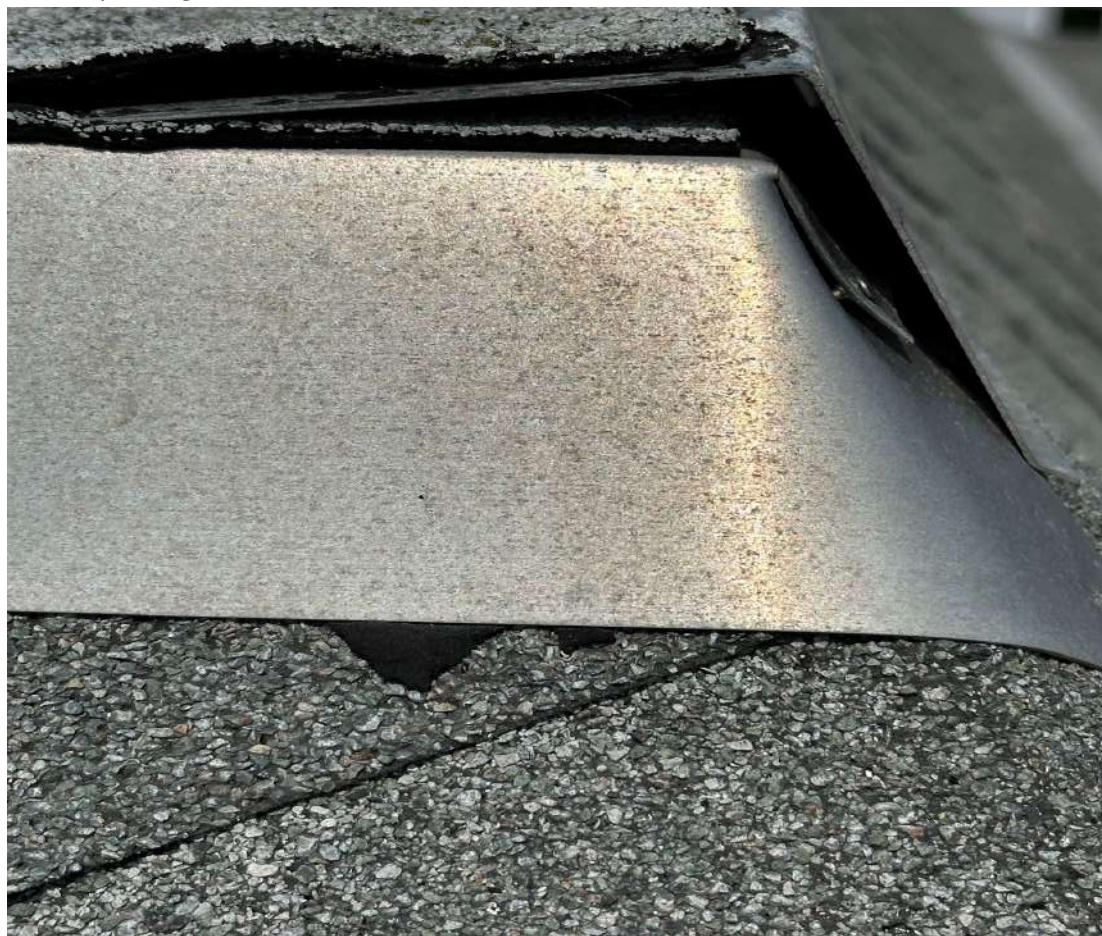
P-71 Gap in Edge Metal

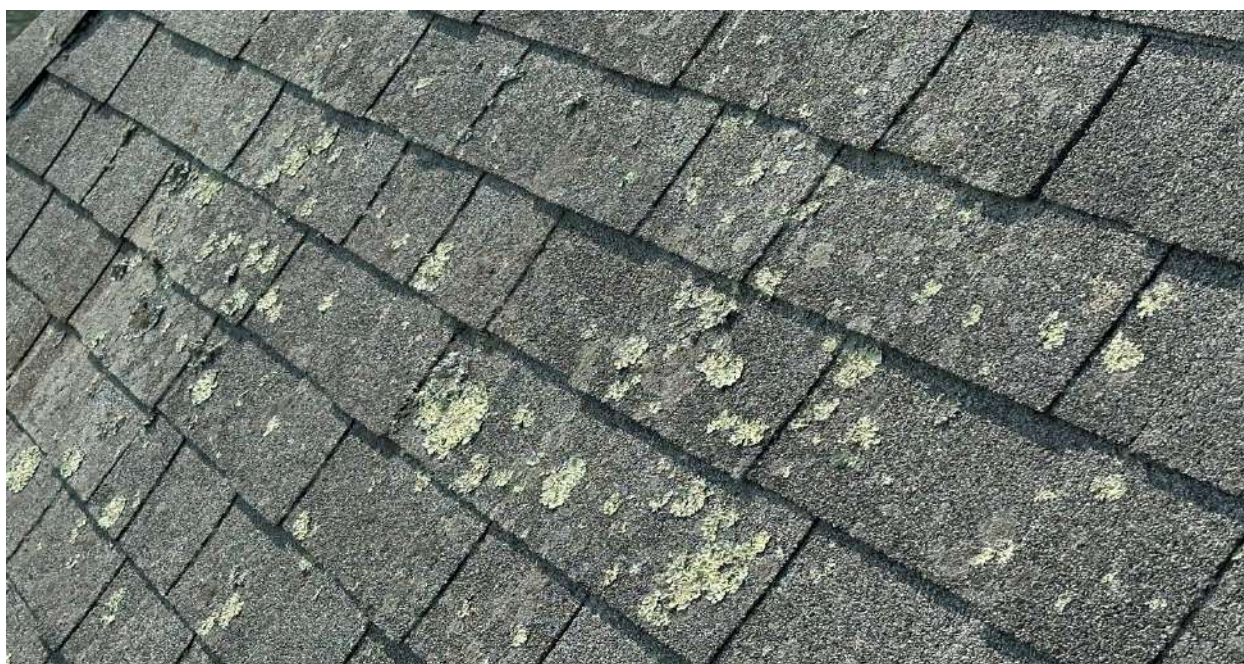
P-72 Algae Growth on Shingle

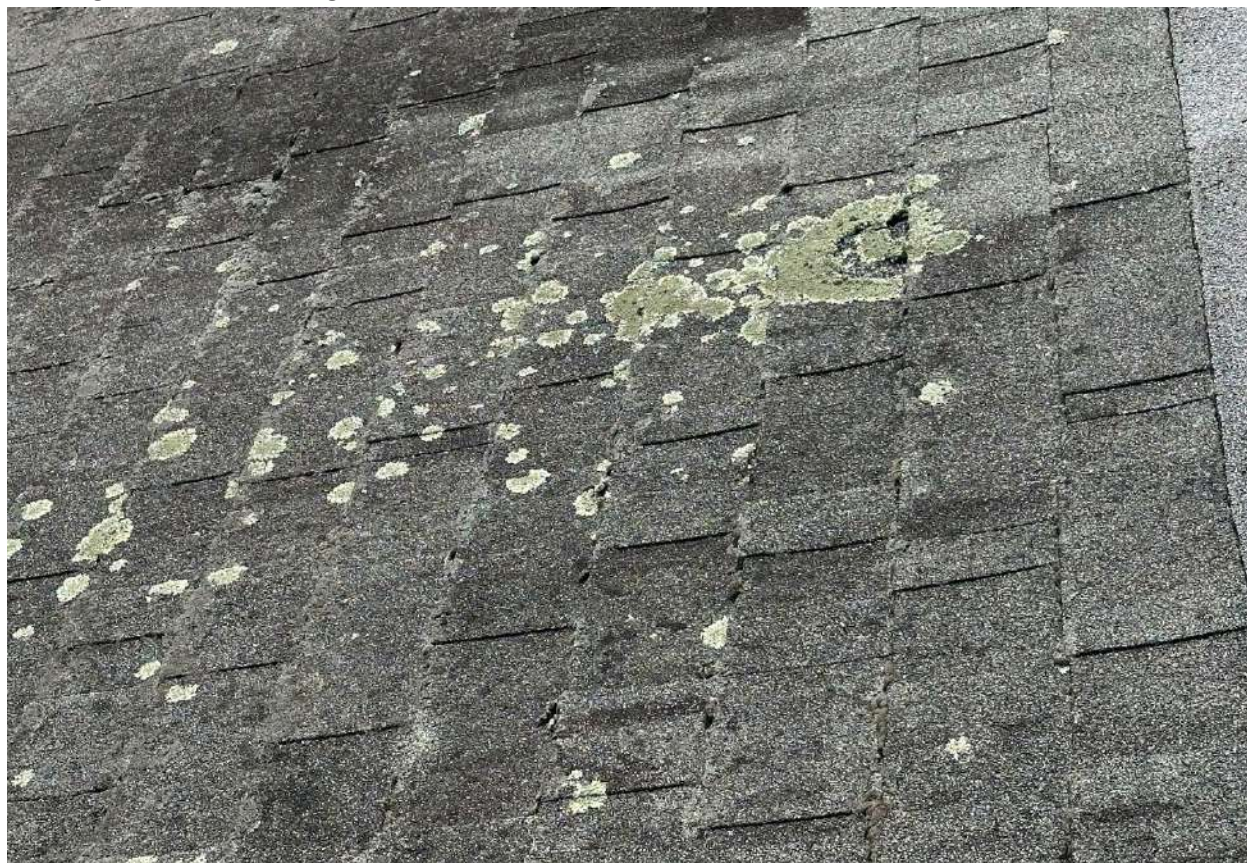
P-73 Algae Growth on Shingle

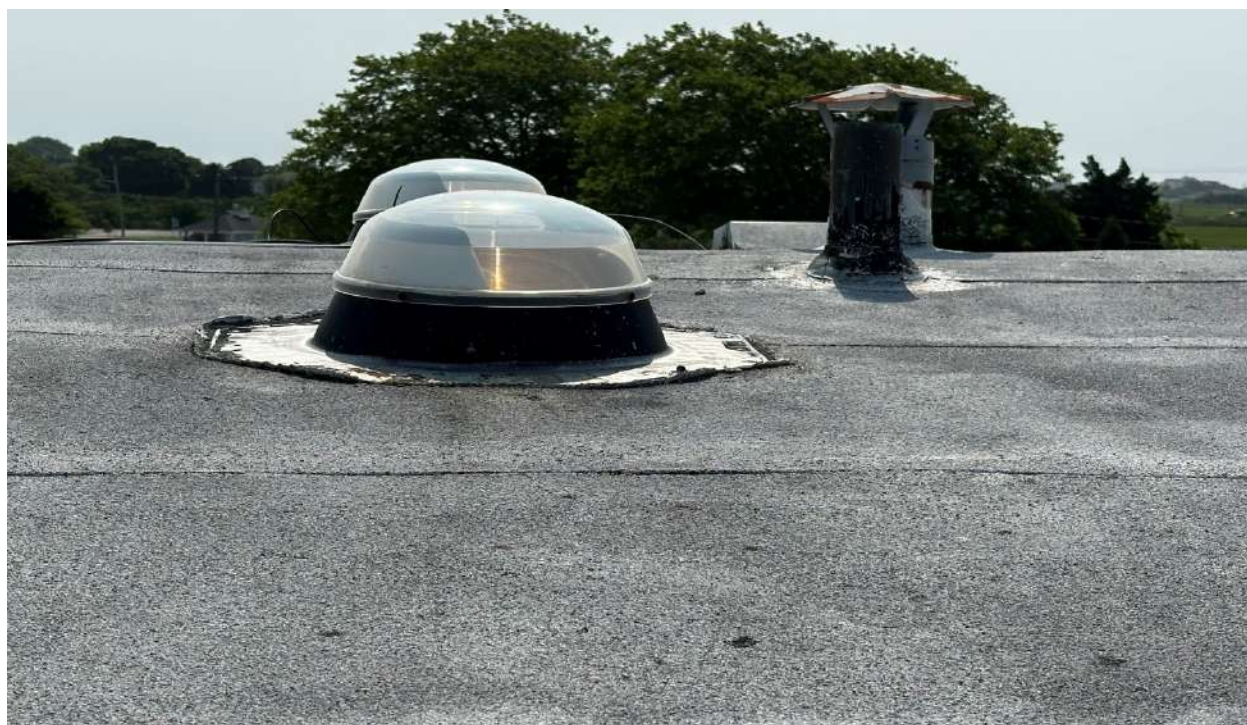
P-74 Solar Tube Skylight Un-flashed

Some of the solar tube skylights did not appear to have flashing at the base ring some with exposed fasteners. A new base flashing should be applied where missing. Also, some of the edge metal where the flat roof transitions to the steeply sloped shingle roof has unsealed and loose fasteners as well as some openings in the corners. These openings could allow water penetration under the membrane and should be repaired to ensure a tight seal. It should be anticipated that approximately ten (10) percent of the underlying roof sheathing plywood roof deck will be rotted. Rotted roof decking can sag and no longer adequately support the membrane. Some depressions were observed suggesting that some of the decking is rotted.

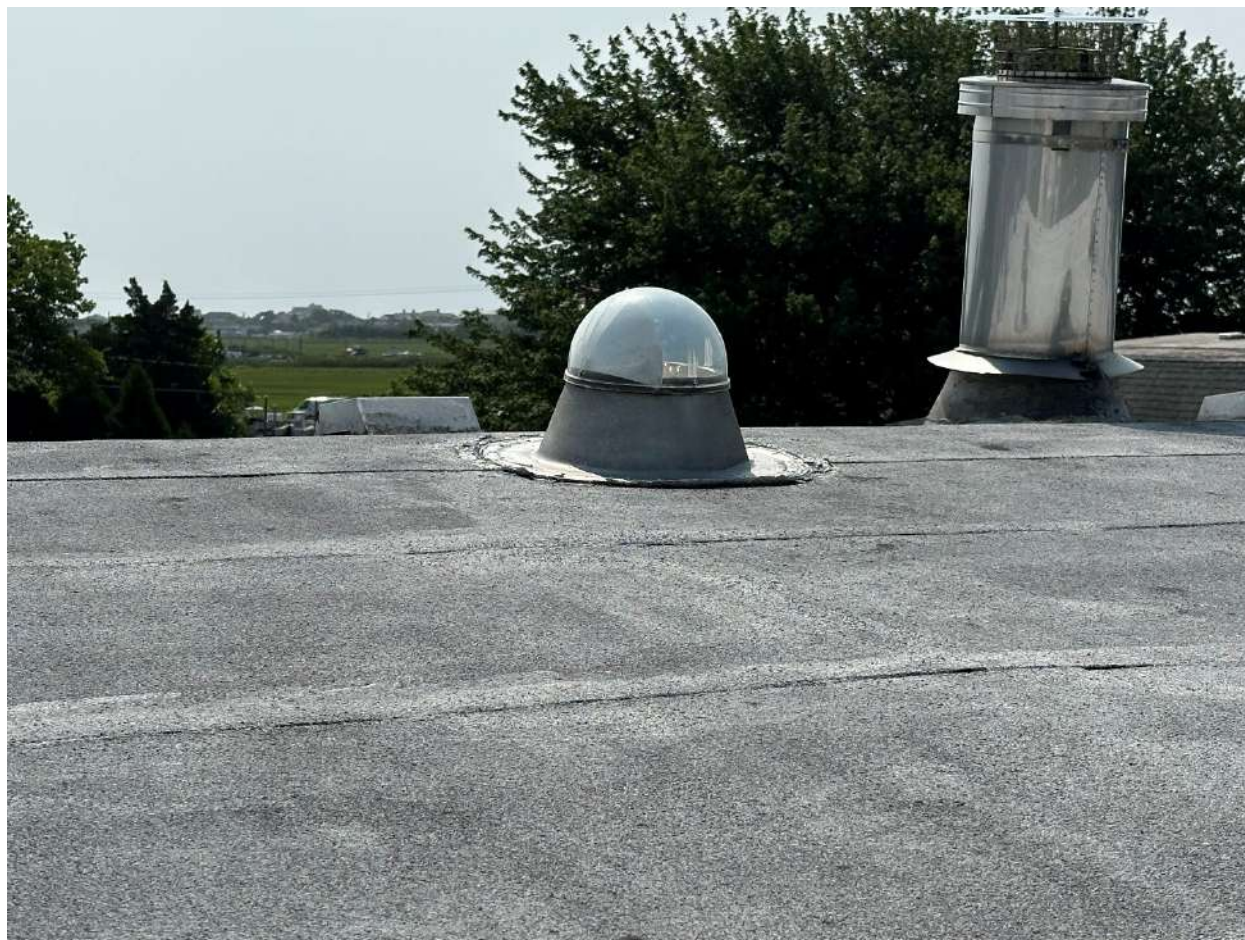
P-75 Solar Tube Skylight Un-flashed

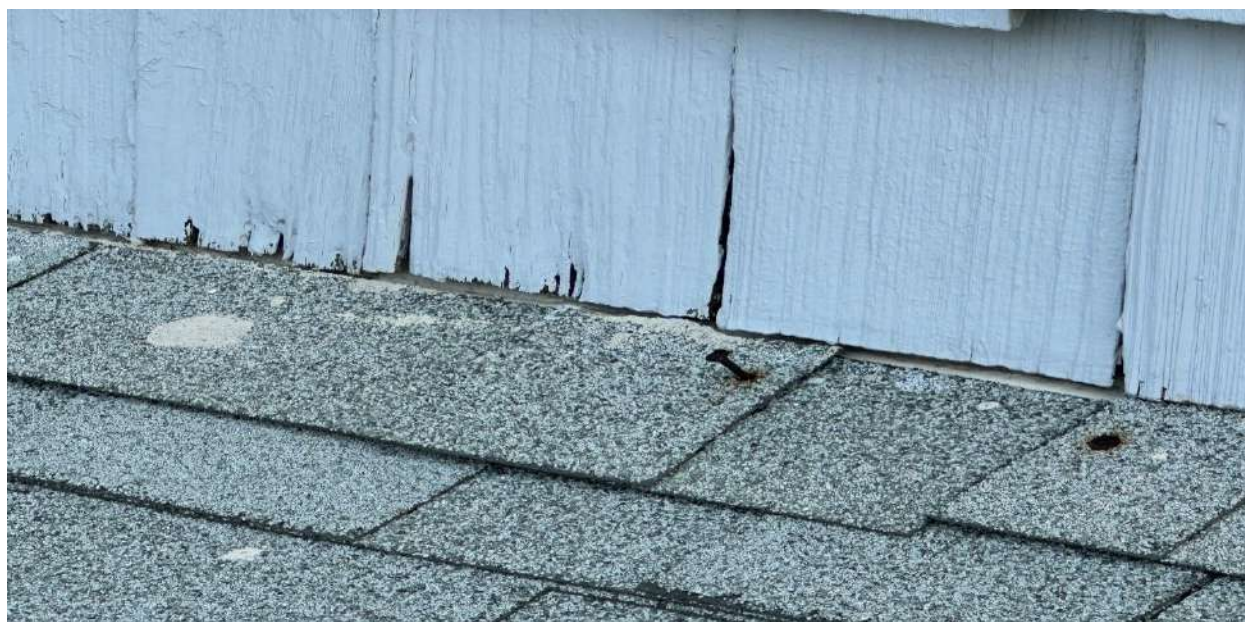
P-76 Rusted Exposed Shingle Fastener

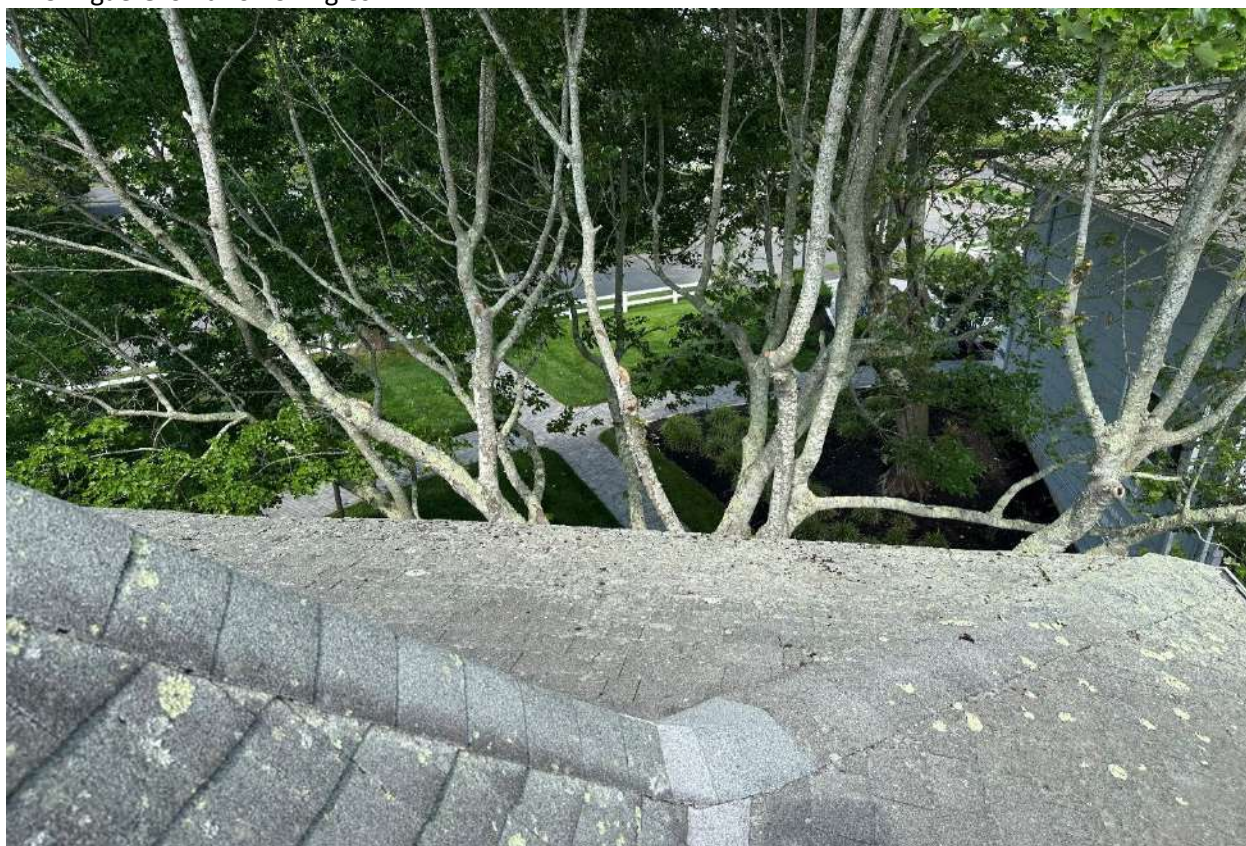
P-49 Algae Growth on Shingles

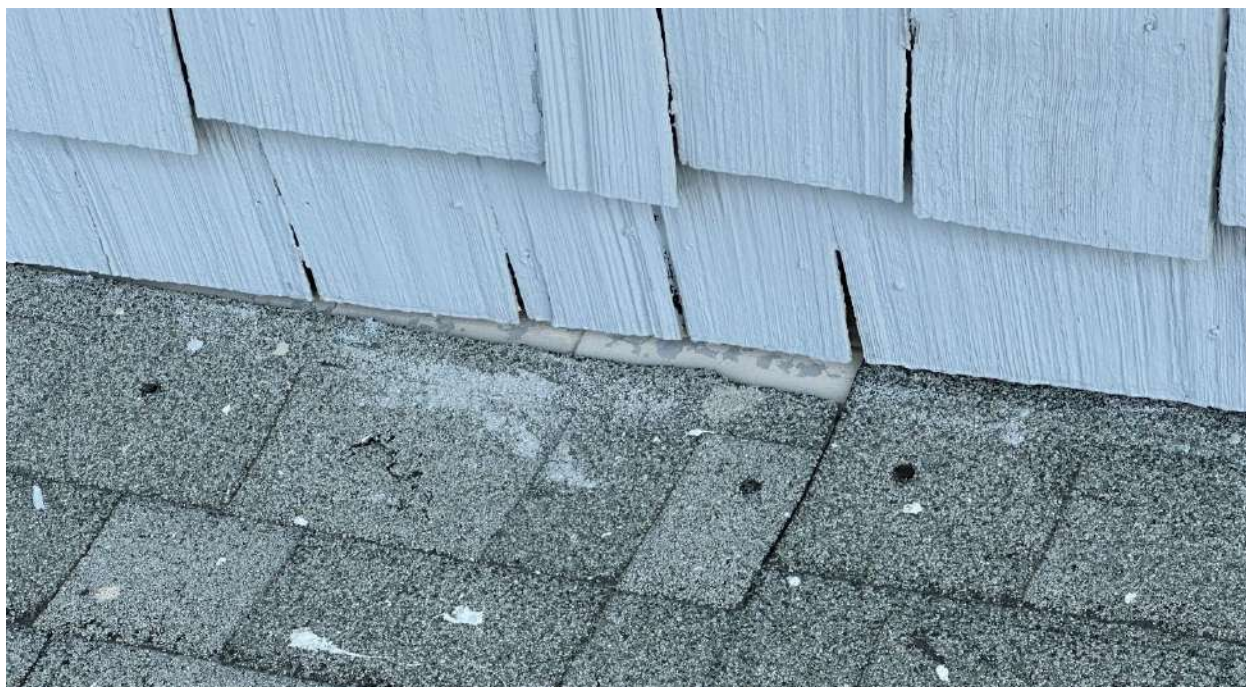
P-50 Loose Shingle and Exposed Fasteners

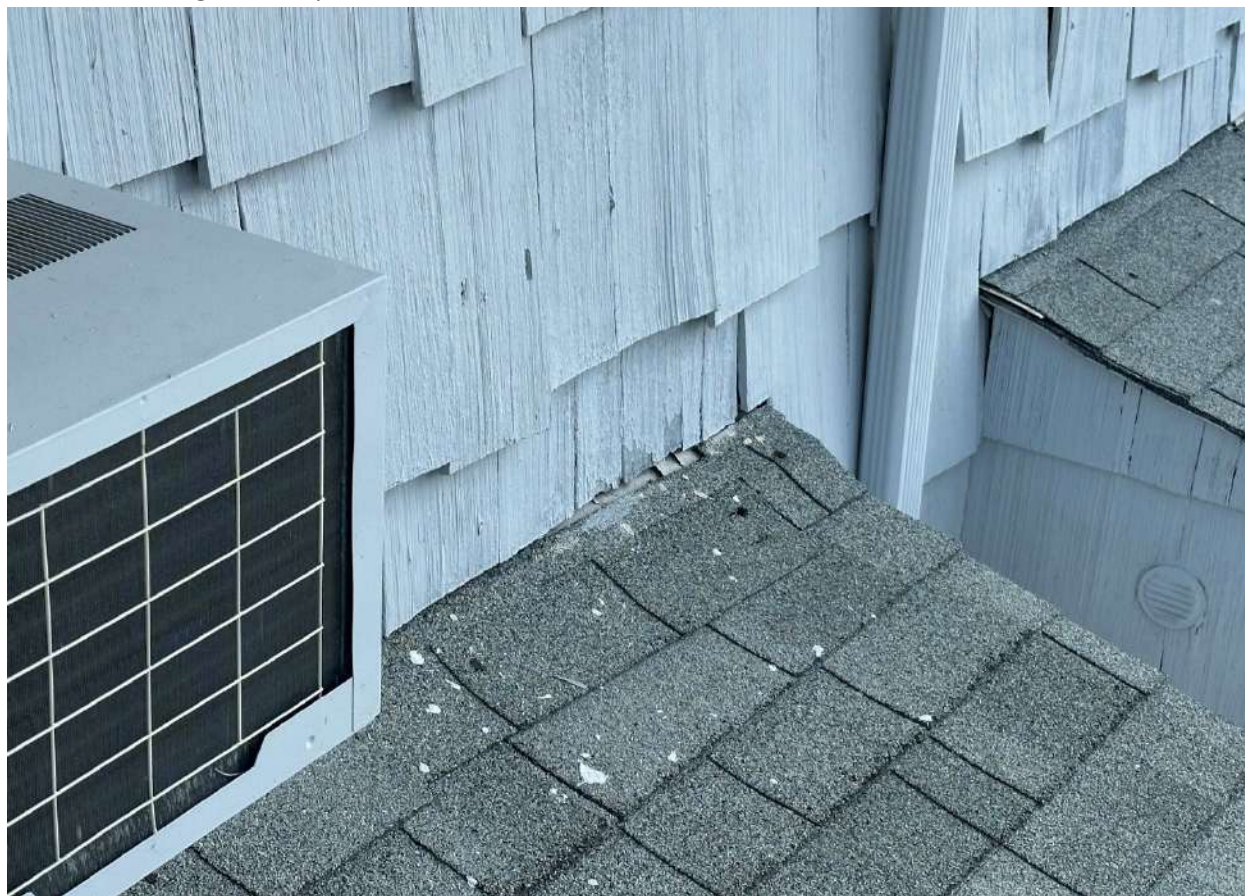
P-51 Loose Shingle and Exposed Fasteners

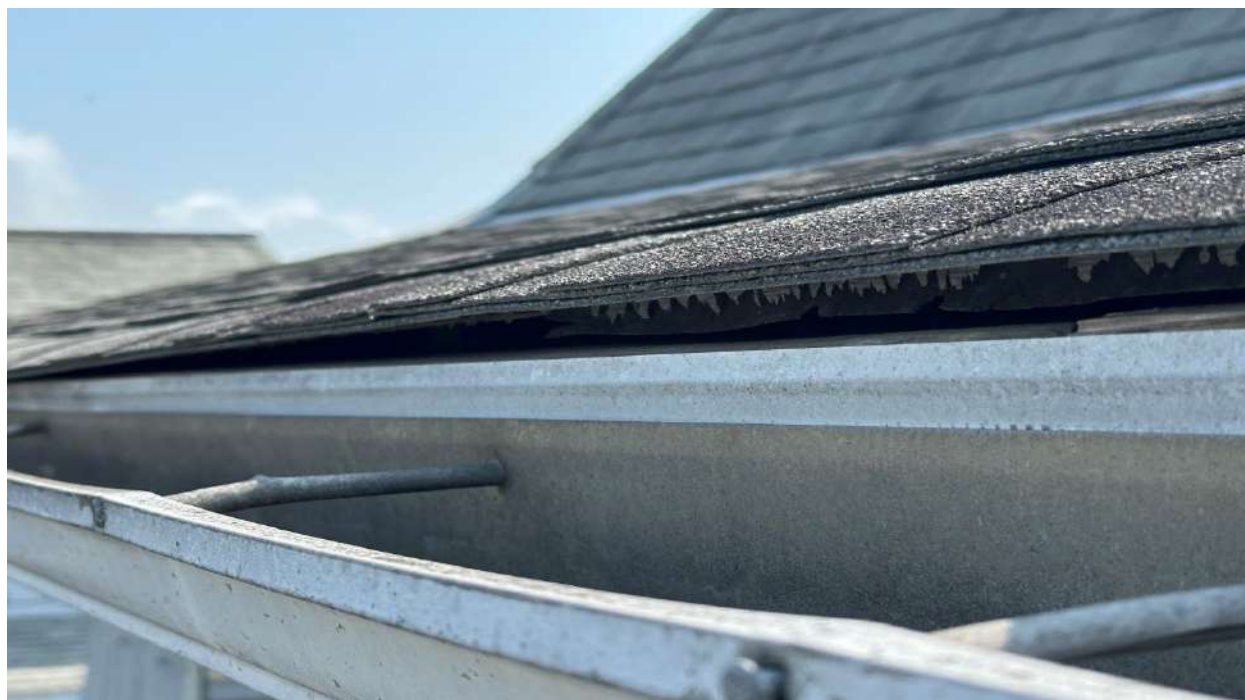
P-52 Gap at Shingle at Gutter exposing Sheathing

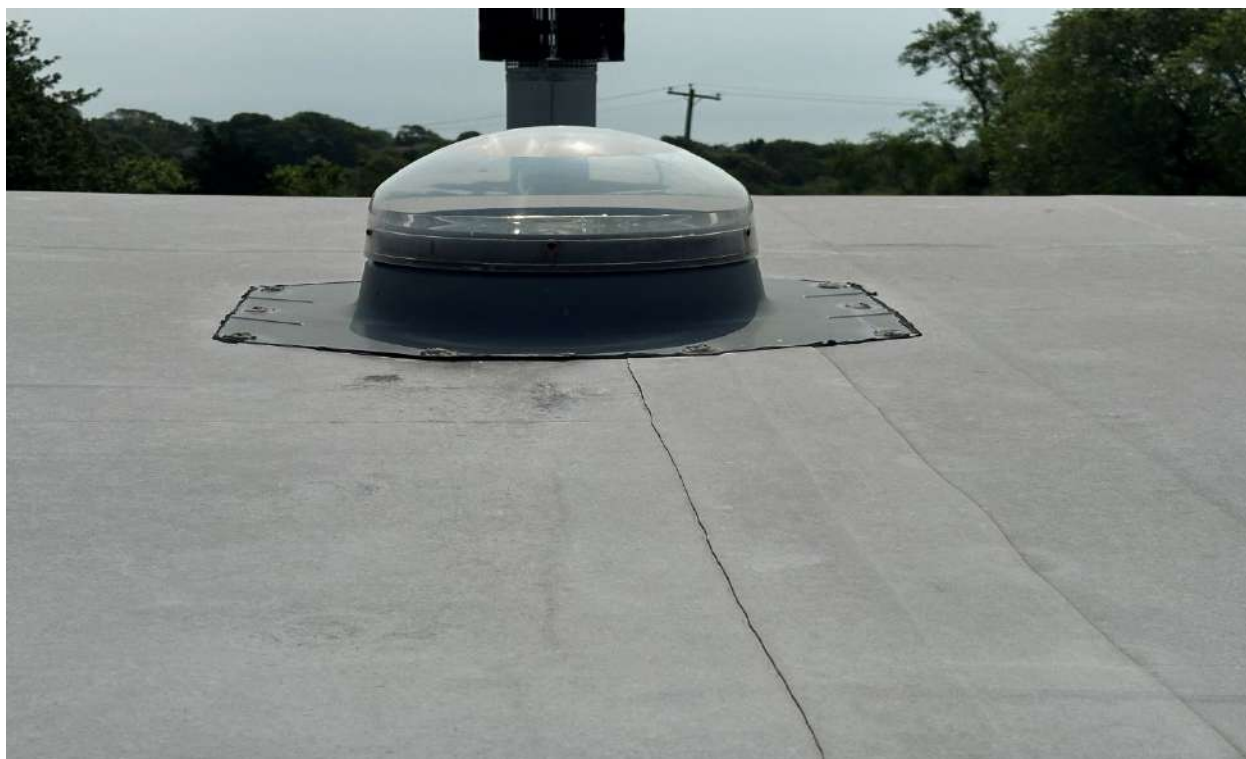
P-54 Solar Tube Skylight Missing Flashing

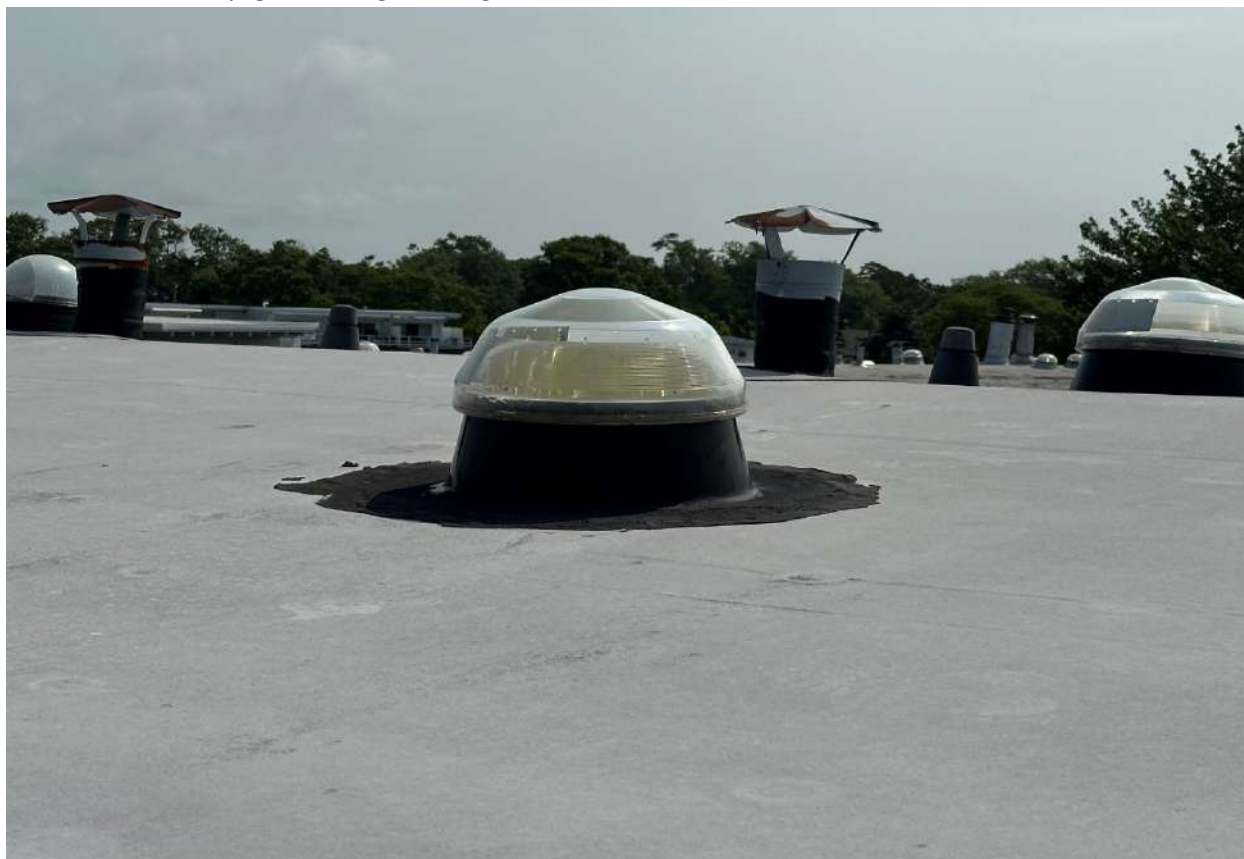
P-55 Solar Tube Skylight Missing Flashing With Tar

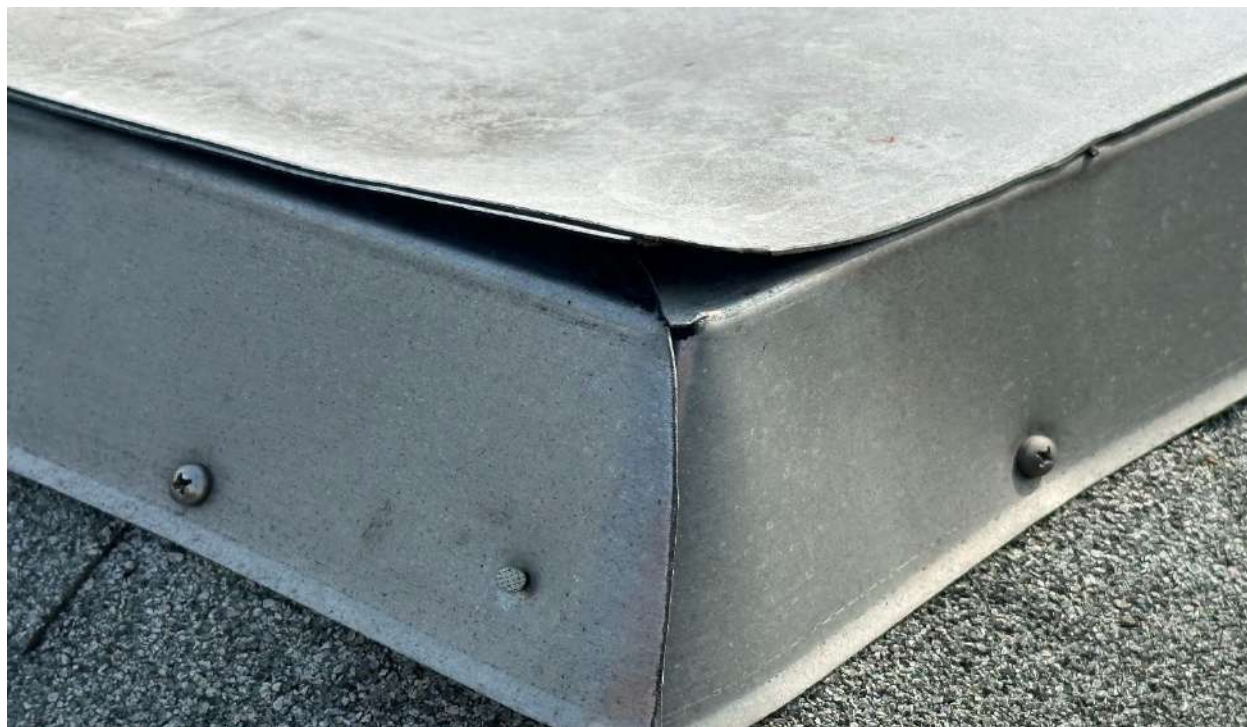
P-57 TPO Delaminating From Edge Metal

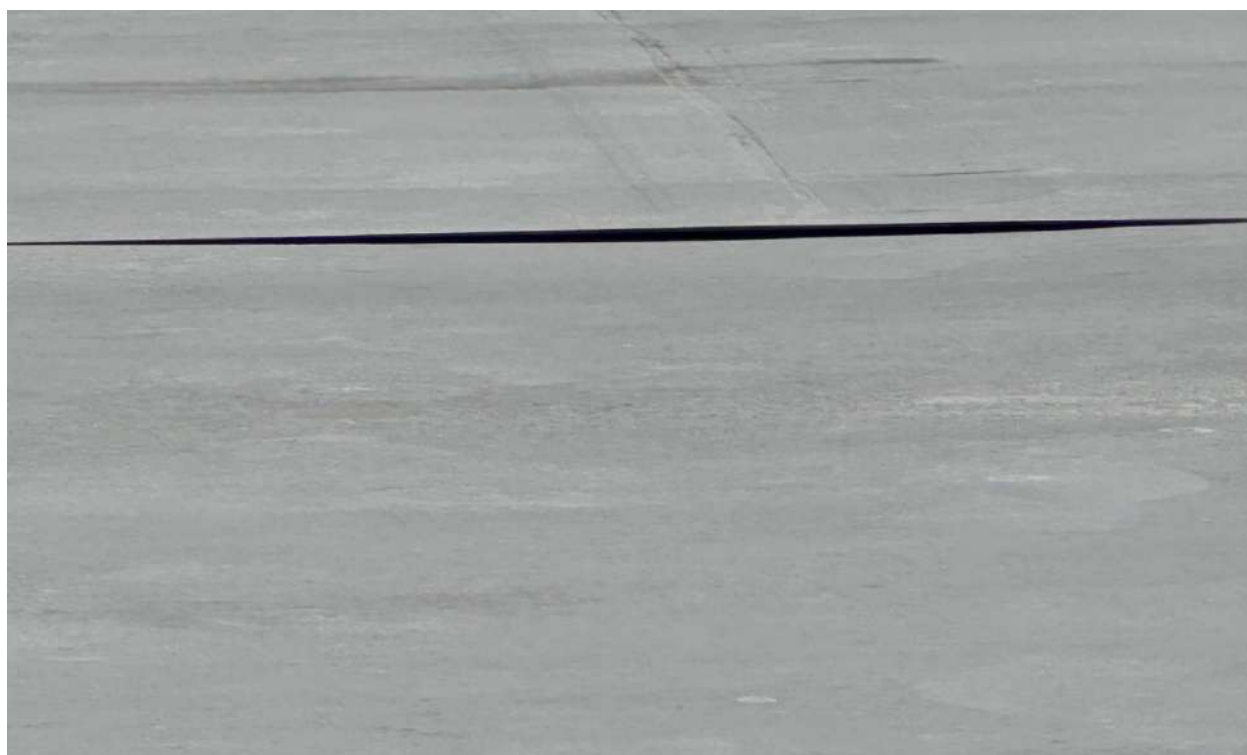
P-58 Fish mouth in TPO Membrane

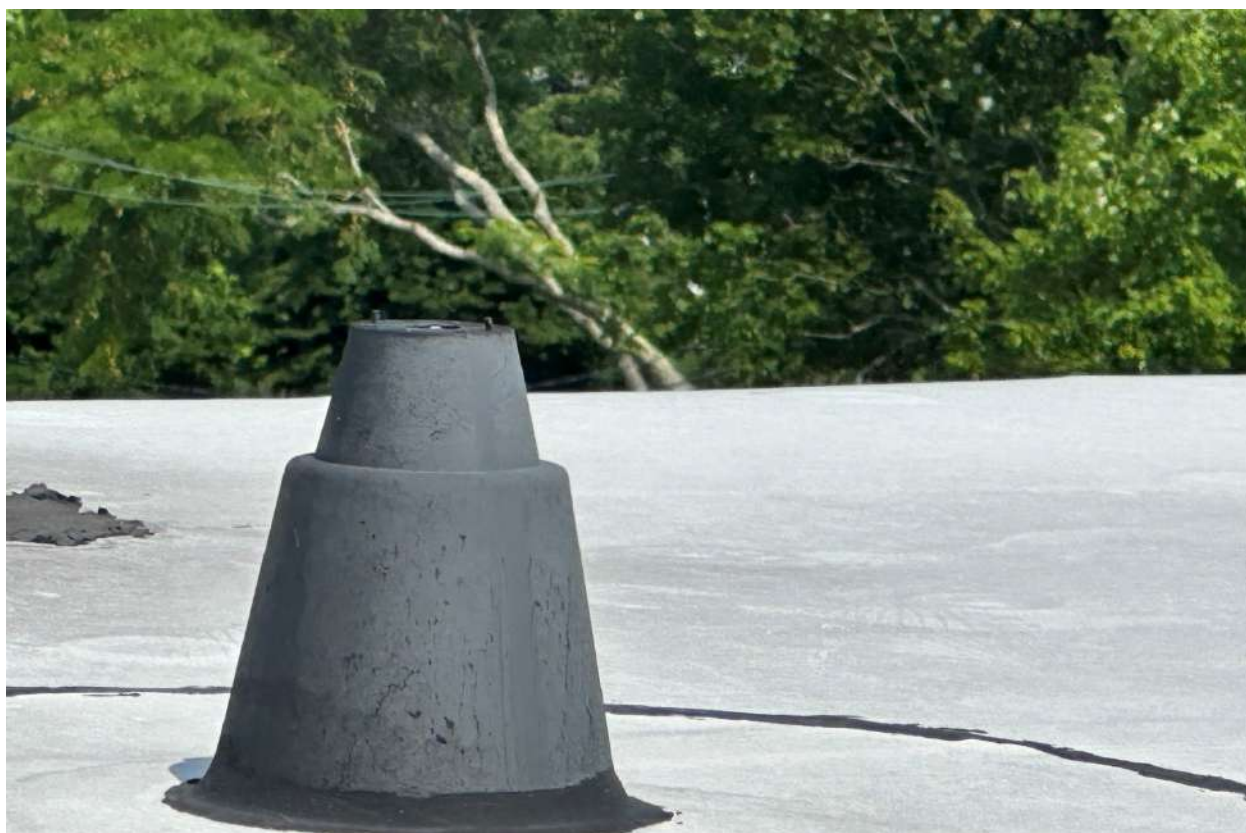
P-60 Relief Vent Cap Missing

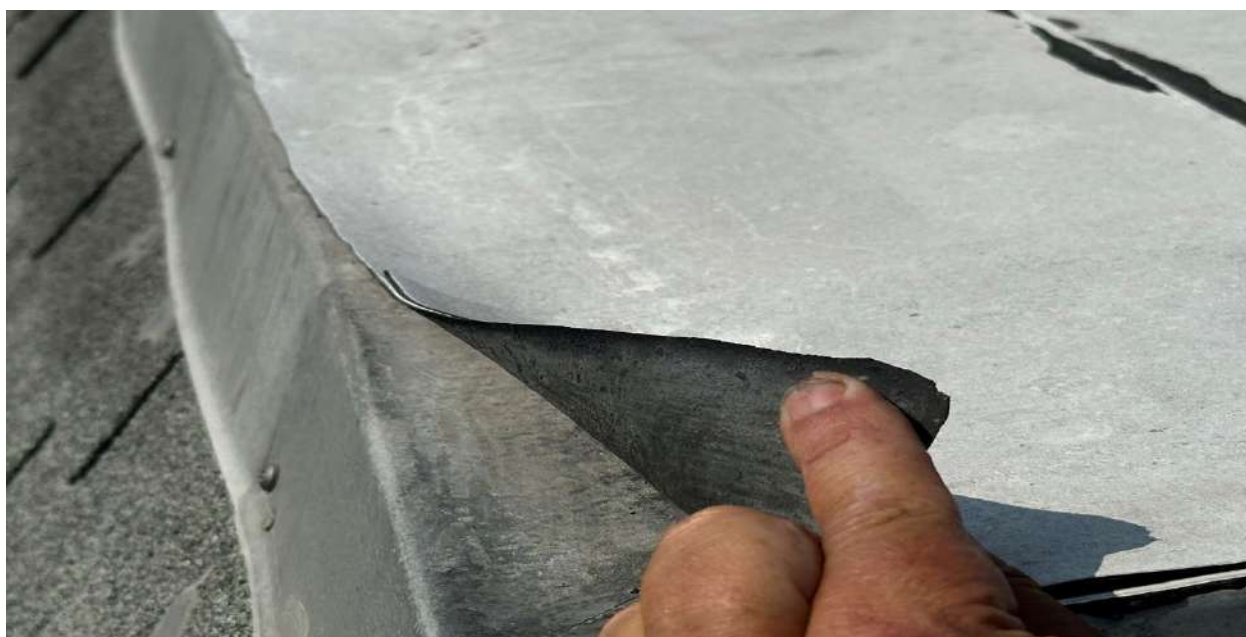
P-62 TPO Delaminating From Edge Metal

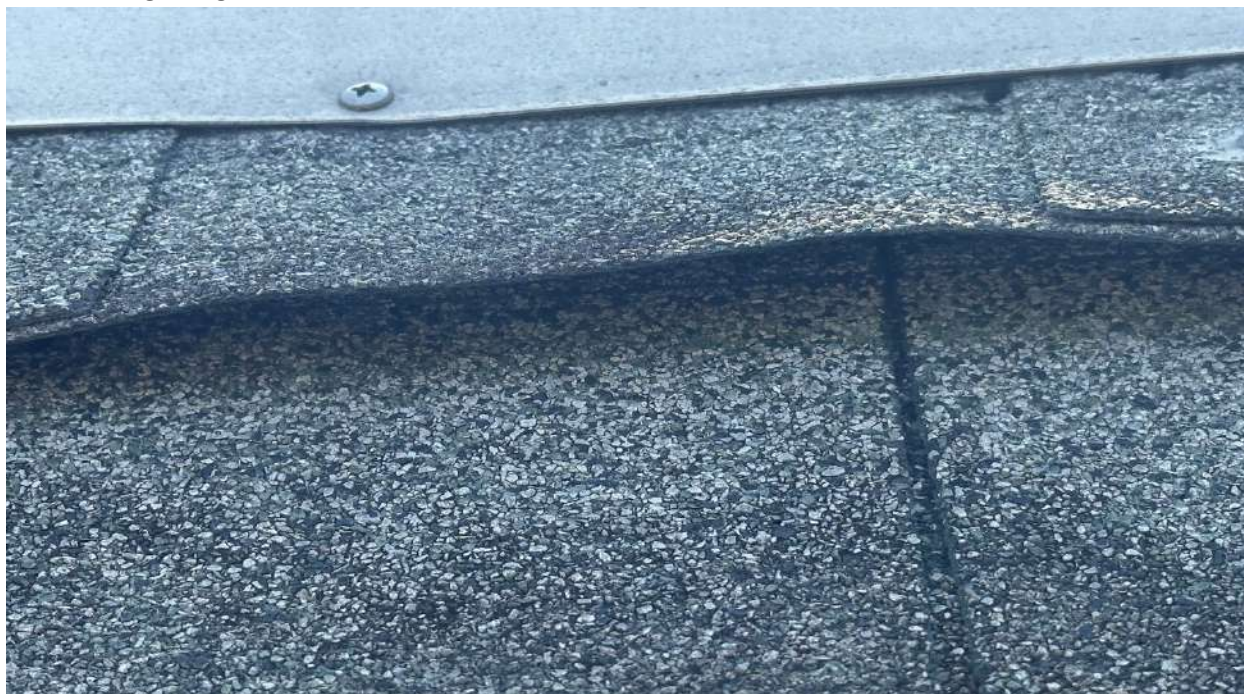
P-63 Curling Shingle

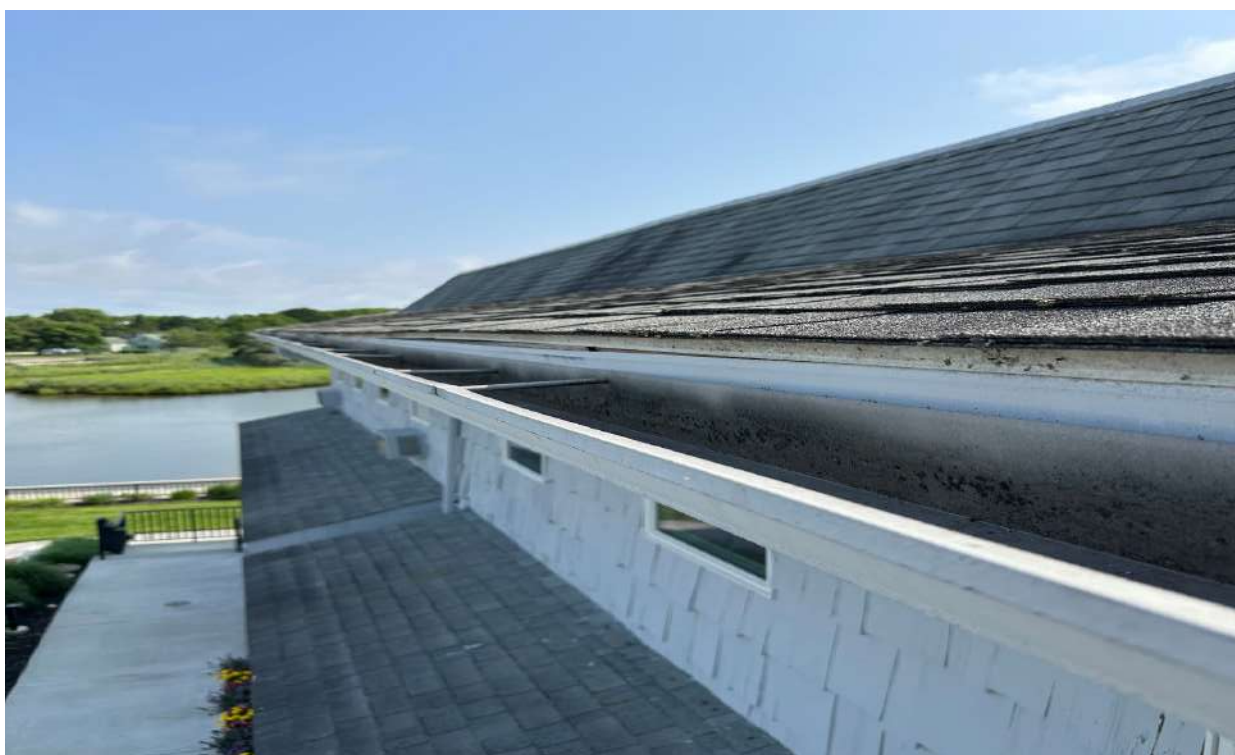
P-64 Gap At Shingle At Gutter Exposing Sheathing

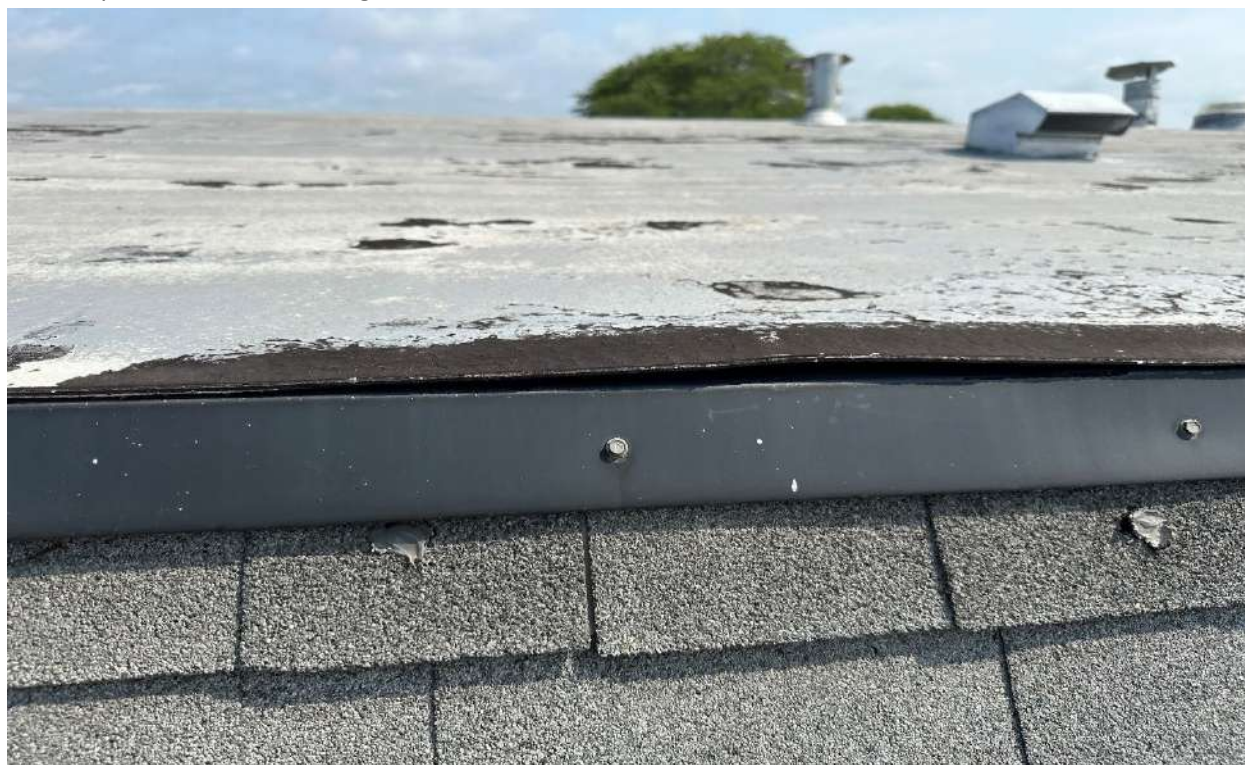
P-78 Gap At Membrane At Edge Metal

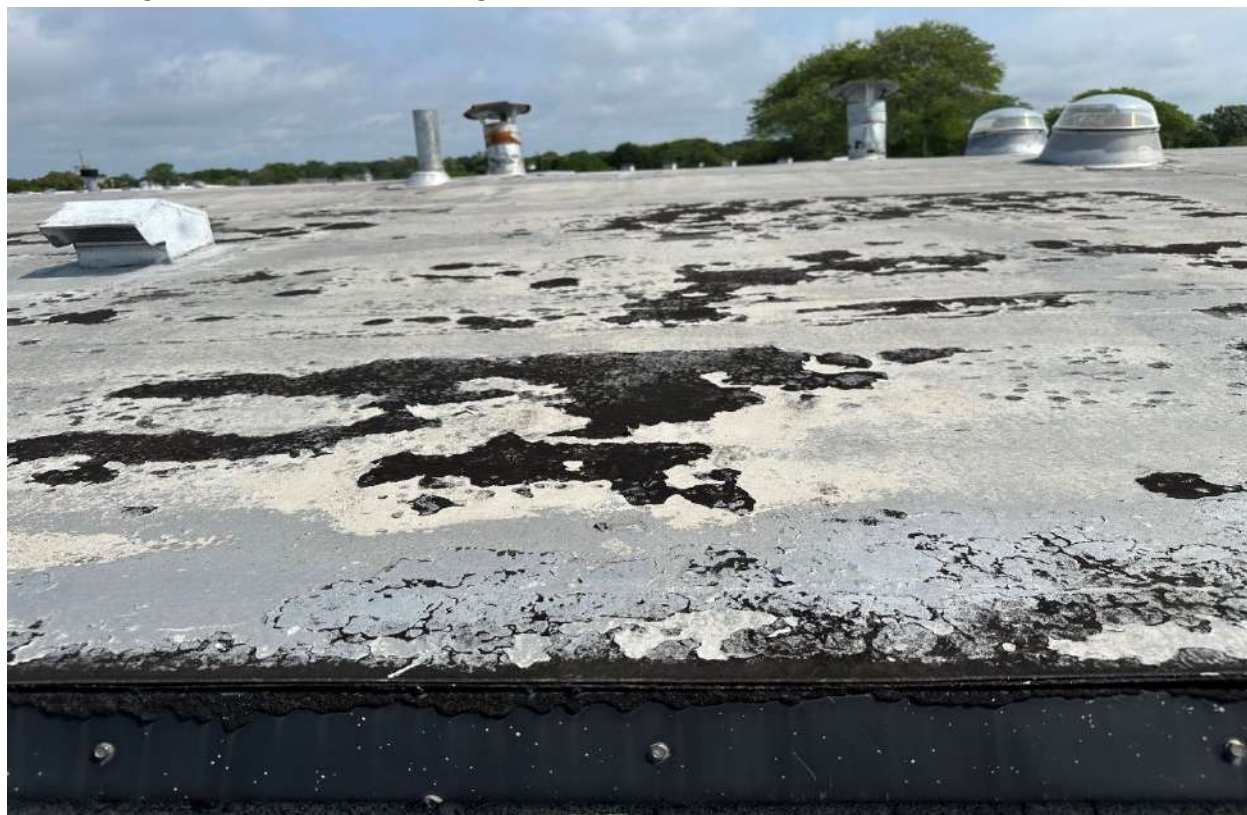
P-79 Peeling Fibrated Aluminum Coating

and will ultimately manifest themselves as leaks. As previously discussed, the fibrated aluminum coating is peeling and on the smooth bituminous membranes there is therefore no UV protection. Therefore, removing any loose coating followed by application of a fibrated aluminum coating will add a little more life to the existing smooth membranes.

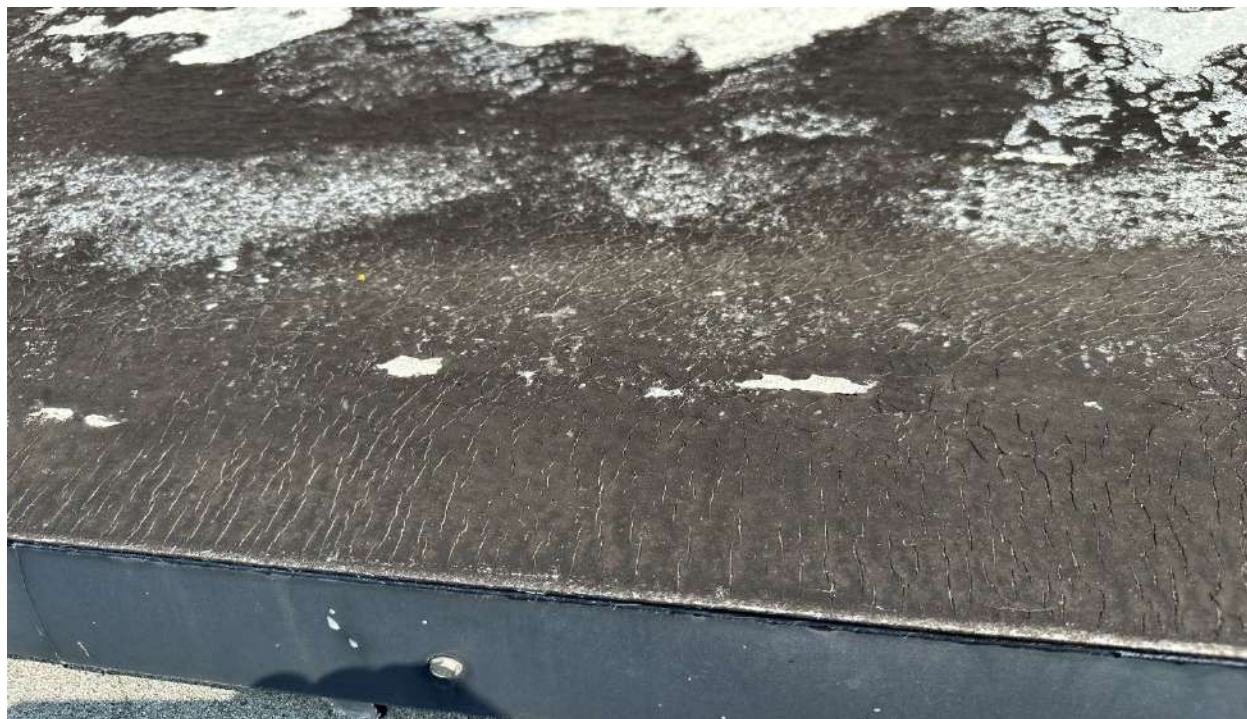
P-80 Alligatoring Membrane
