Re: Westhampton Landings Co-op  
3001-3050 Mitchell Road  
Westhampton Beach, NY 11978

RE: Roof Assessment

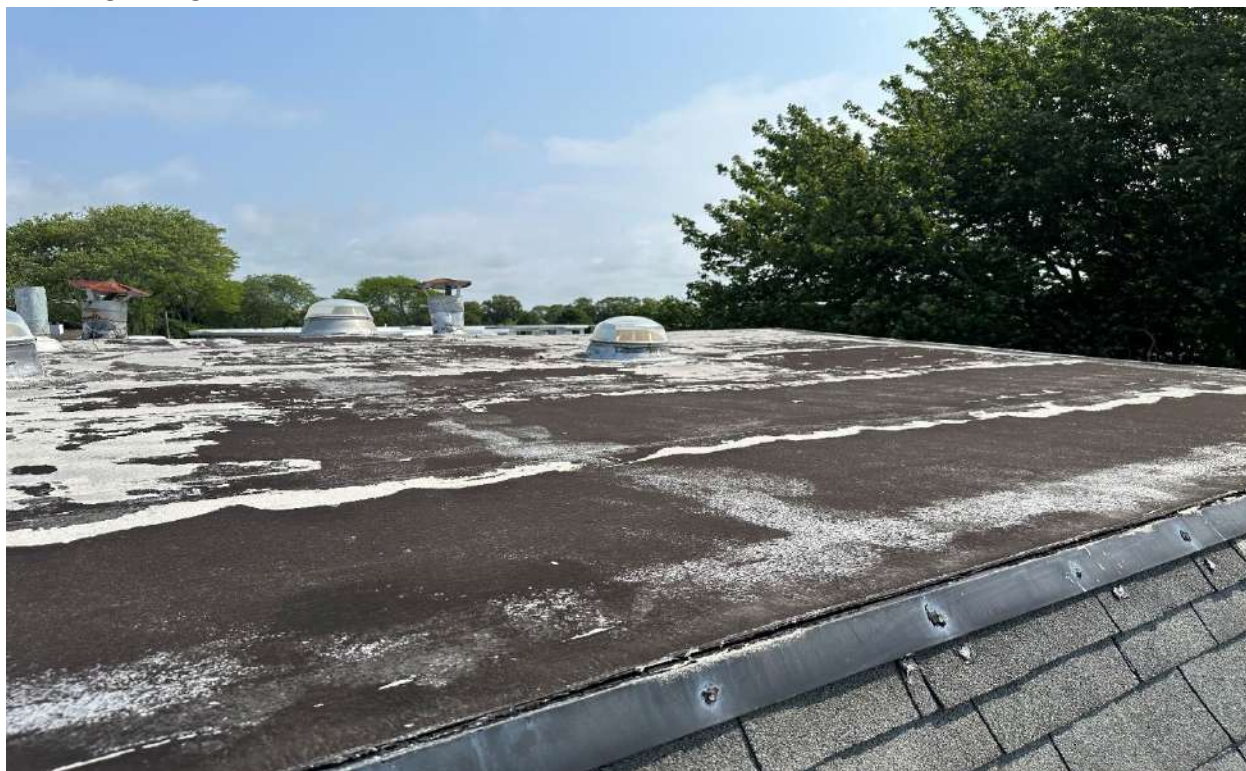
P-81 Alligatoring Membrane

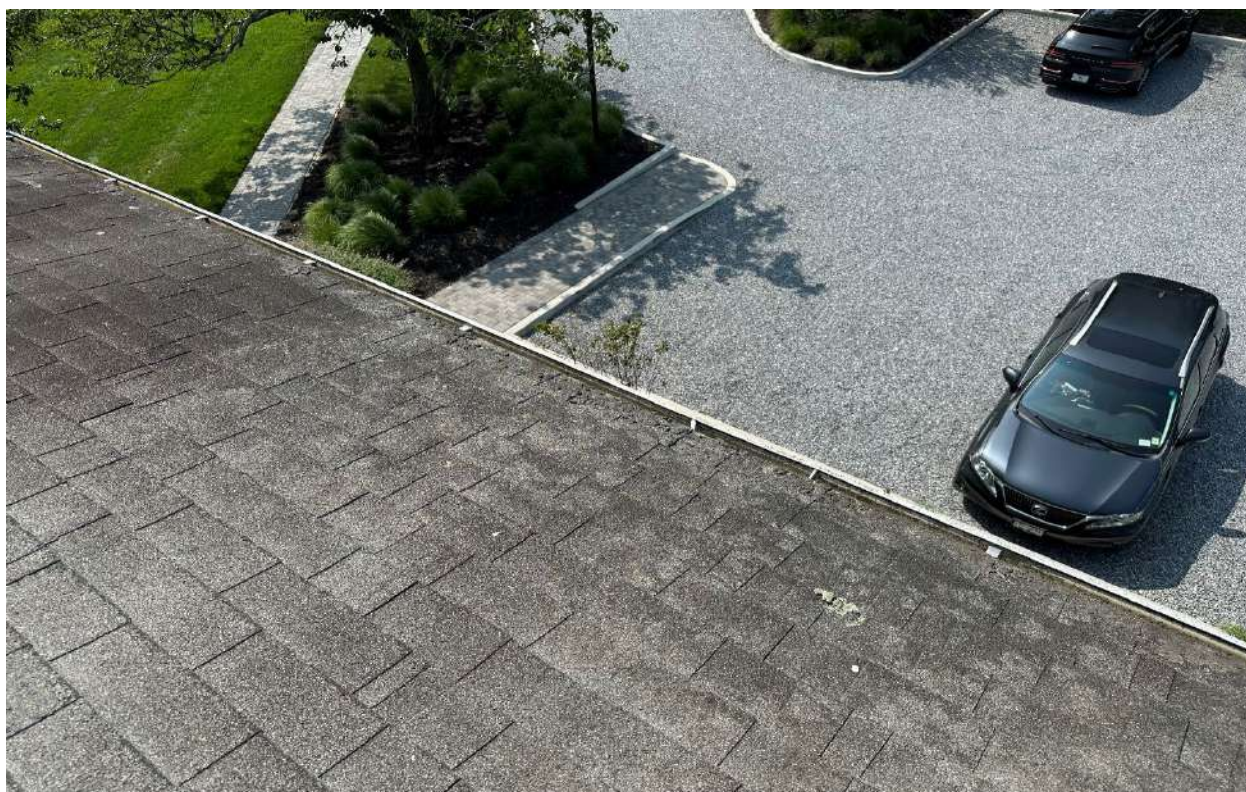
P-82 Algae Growth On Shingles

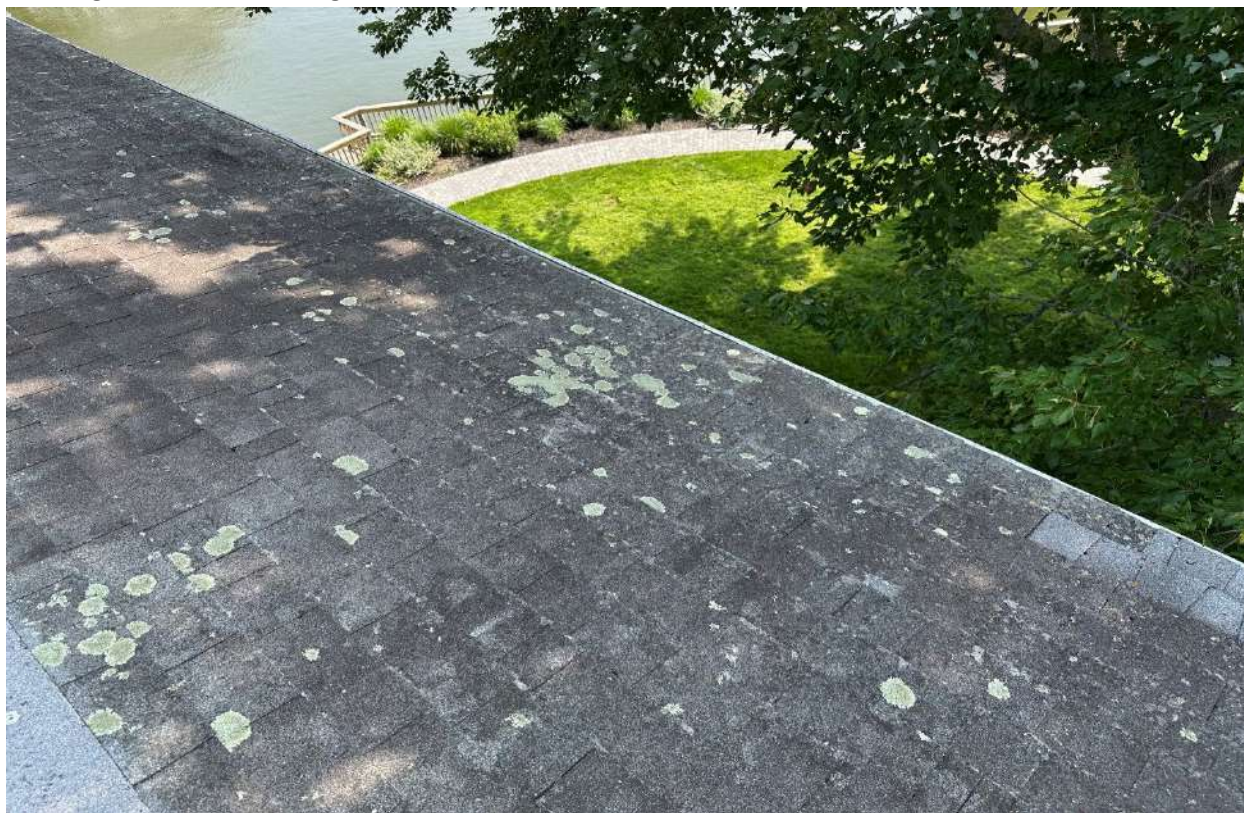
P-83 Algae Growth On Shingles

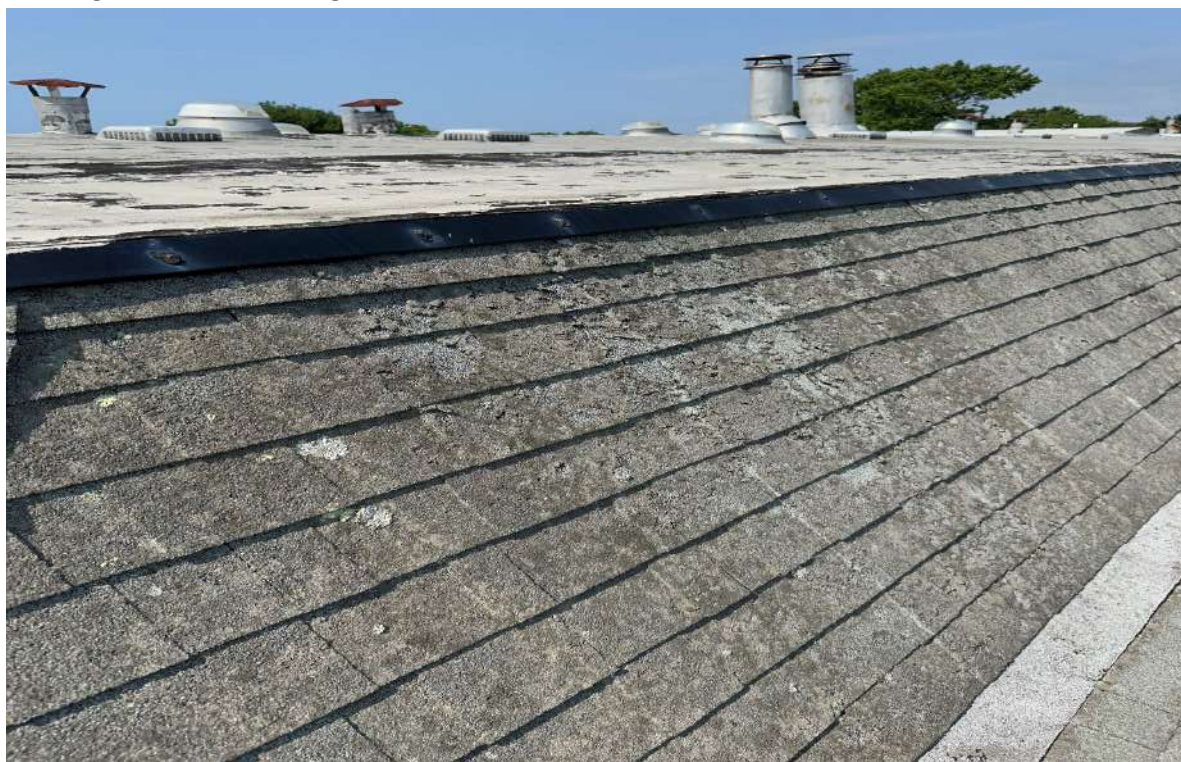
P-85 Algae Growth On Shingles
