Year: 1949

Make: Ford

Model: Custom Woody

V.I.N # 8BA-3405DB

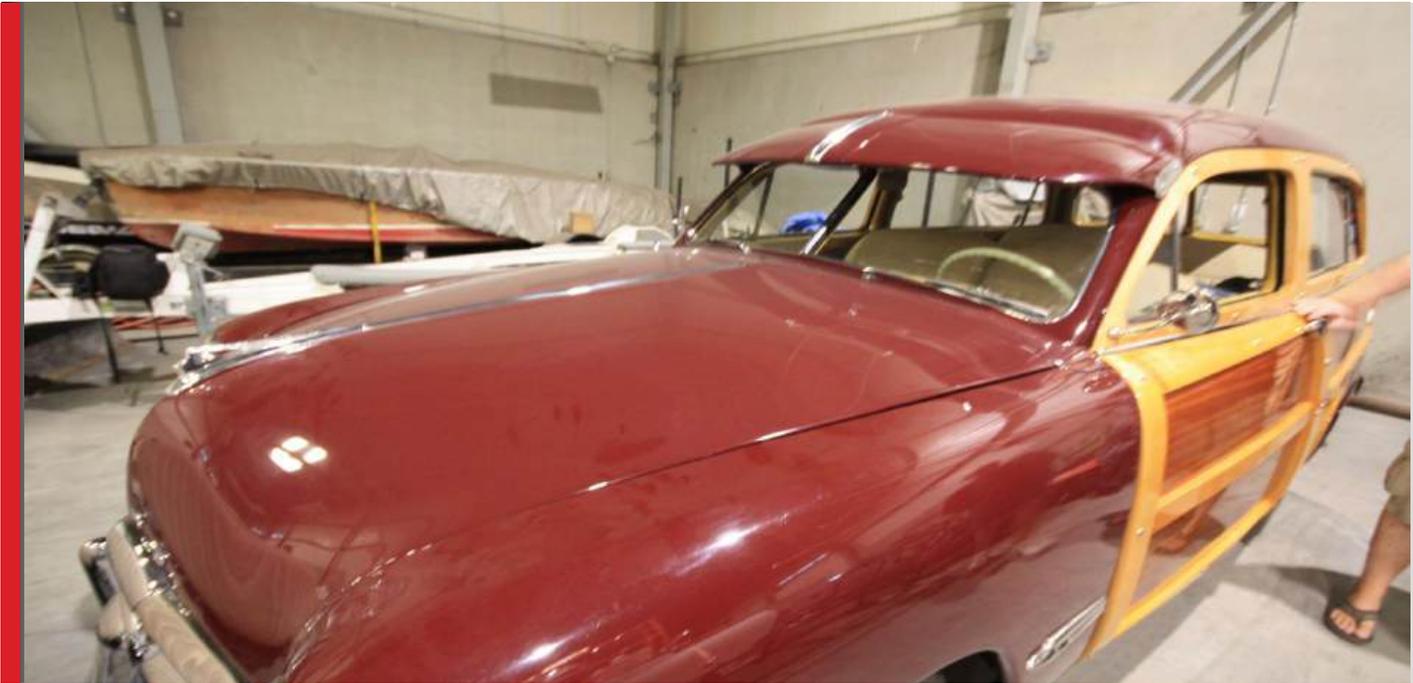
Paint and body work was completed, 2009, at Big Johns Auto Body, Los Angeles, CA.. This was a professional, quality body shop under the present owners direction project. Respray paint utilized was base coat, clear coat application.

The Owner’s labor was utilized for the removal, installation of bumpers, fenders, moldings, exterior components, etc. This was a frame up restoration that included the frame, chassis and body being sandblasted to bare metal , painted and then detailed.

Original steel body panels were utilized as they were in Very Good condition to begin with. All of the wood (Hard White Maple) has been replaced by well known Wood’N Carr of Signal Hill, No considerable or excessive body filler or dents evident.

Condition Rating	Comments
Paint & Finish	2	Maroon Color done in Base/Clear
Panel Alignment	2	Panel fit and gaps are Very Good
Trim	2	Replaced as needed
Weather-Stripping	2	Newer
Paint Chips/ Scratches	2	No major marks showing in the finish
Body Work	2	New parts and Wood (maple)
Corrosion	2	Removed and Repaired

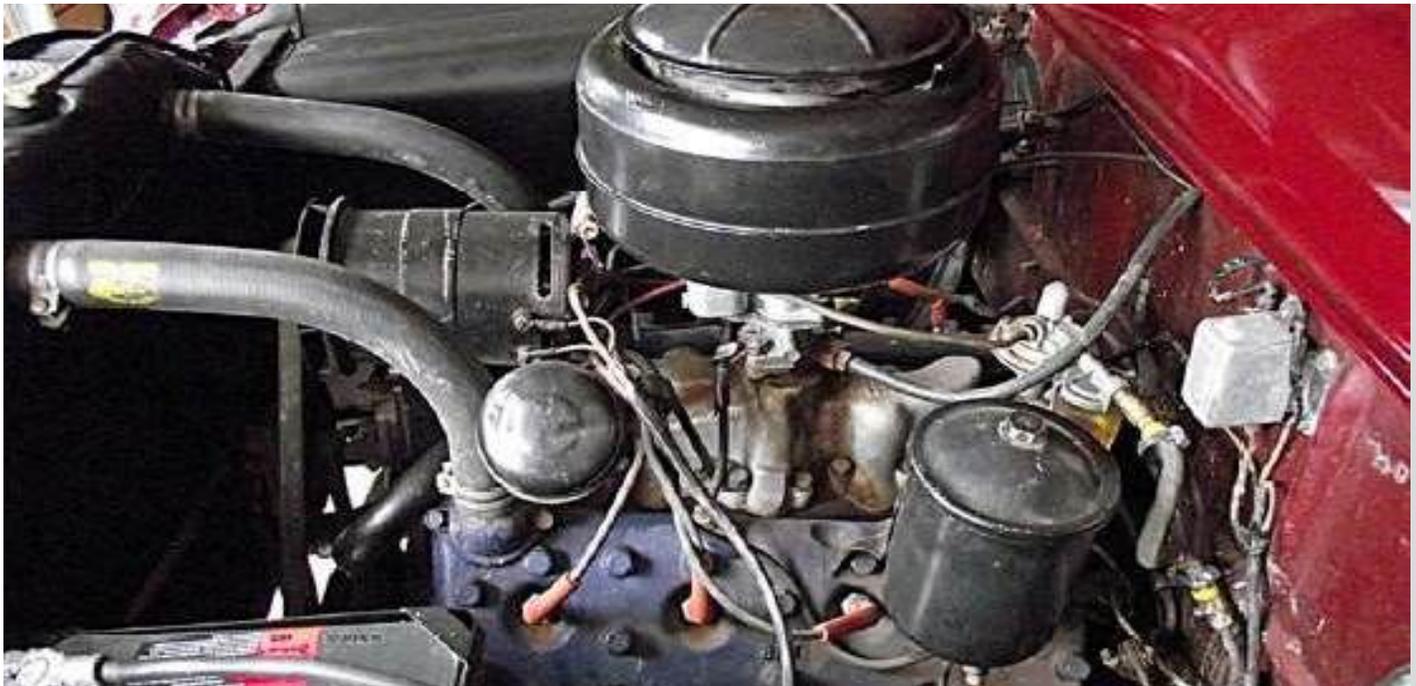
Underneath the hood lies the 239 cu/in Flathead V8 engine mated to the Original 3 speed manual transmission with Overdrive. The rear differential is the Ford 8" with 3.91:1 gears. Engine was completely rebuilt including the cylinder heads with New components. The cooling system has been upgraded to a larger 4 core radiator, hoses & water pumps. Supplying the fuel is done with the # 85A carburetor and fuel pump. These upgrades were all done in 2009. Exhaust system is the stock cast manifolds mated to 2" exhaust pipes with a New exhaust tip. No modification has been performed to the drive train and still runs beautifully. Engine compartment is clean and tidy with no signs of leaks. The undercarriage is tidy and completely solid as well.

Condition Rating	Comments
Manifold	2	Stock
Intake	2	Stock
Air Cleaner	2	Original
Polished Parts	2	Original
Engine Paint	2	Restored
Under Carriage	2	Original
Battery	2	Replaced
Cam	2	Stock

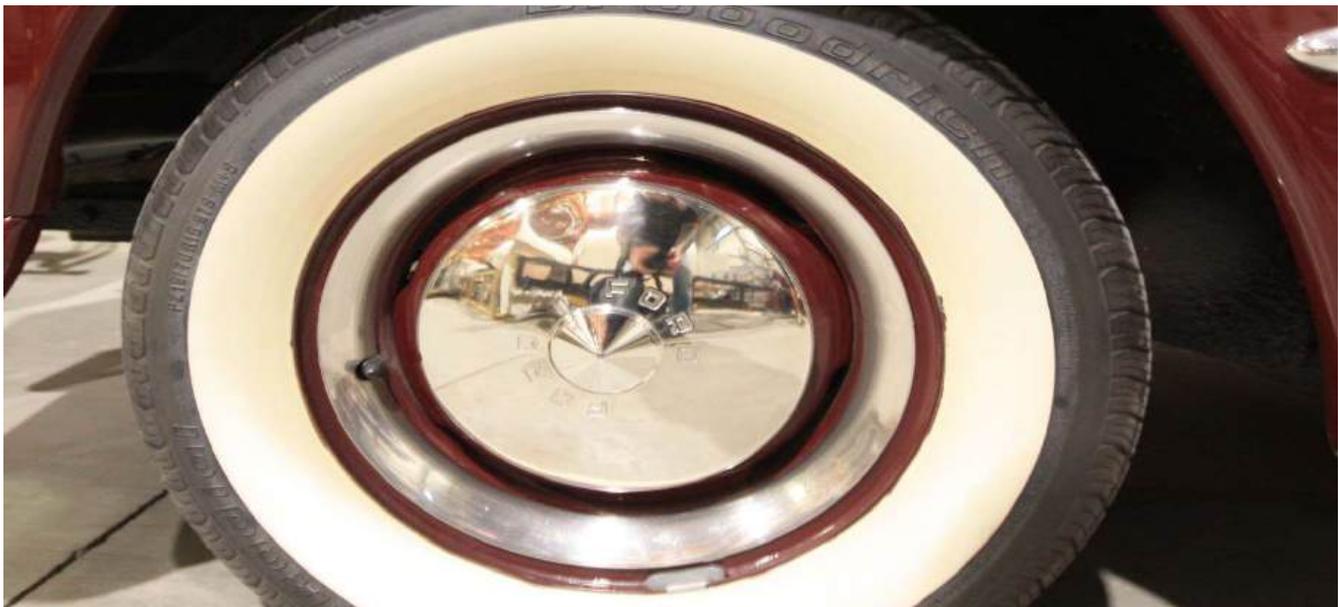
Condition Rating:	Comments :
Tire		2	BF Goodrich White Wall
Rims		2	Steel
Drum/Disc	Left & Right	2	Drum
Brakes	Left & Right	2	Rebuilt completely in 2009
Custom

- Mounted on the painted to match Steel wheels are the BF Goodrich P215/70R15" White Walls.
- Tires were replaced in 2009 and show no signs of wear or damage to the sidewalls. Tires will need to be checked for age related
- Newer centre caps & beauty ring are clean and free of any damage .
- Major, suspension work completed during the restoration.
- New front and rear springs installed as well as the OEM front and rear shocks.
- New king pins, control arms, pitman arm, tie rod ends, idler arm etc. have been replaced.
- New rubber bushings were installed as well as a New steering box and wheel bearings.
- Wheel alignment was completed after all of the work performed.

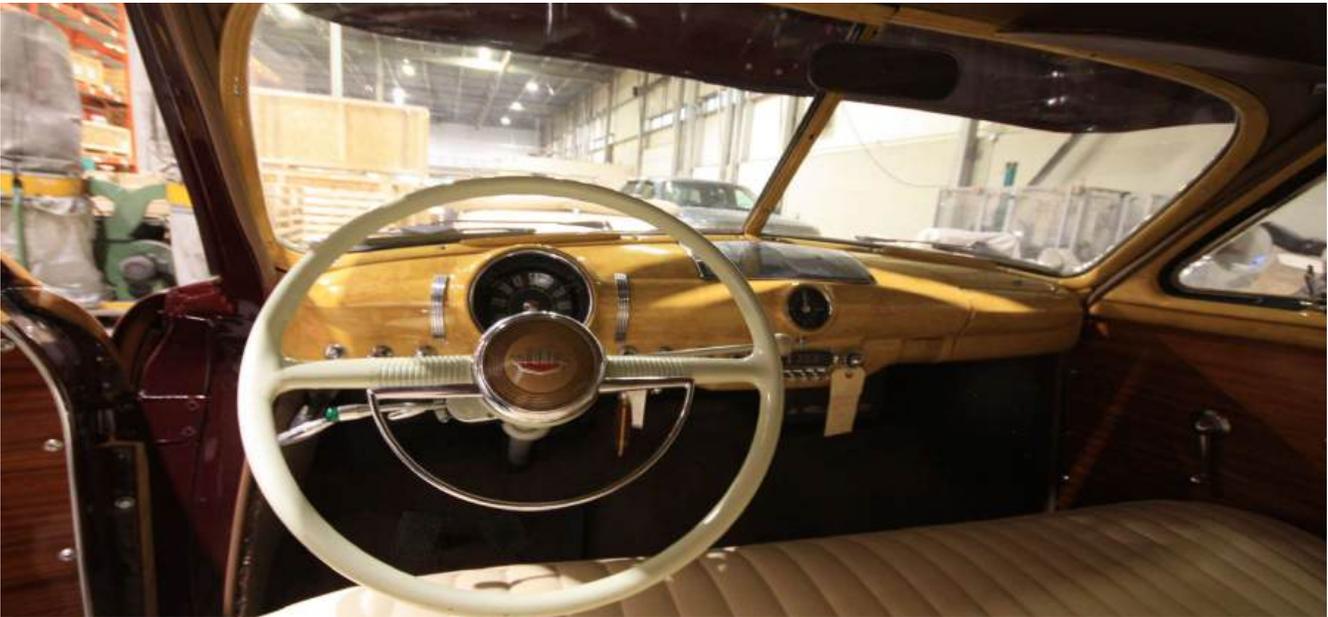
Dash

A New Tan color Interior is done in Leather has been reupholstered and shows beautifully when opening the door. The dash is Hand Painted wood grain that looks like Birds Eye Maple The Metal door panels and the rest of the Interior wood panels are done in Philippine Mahogany veneer ribbon grain.

The Original Steering wheel has been restored with no cracks or separation. All of the chrome dash bezels and trim are in Very Good condition.

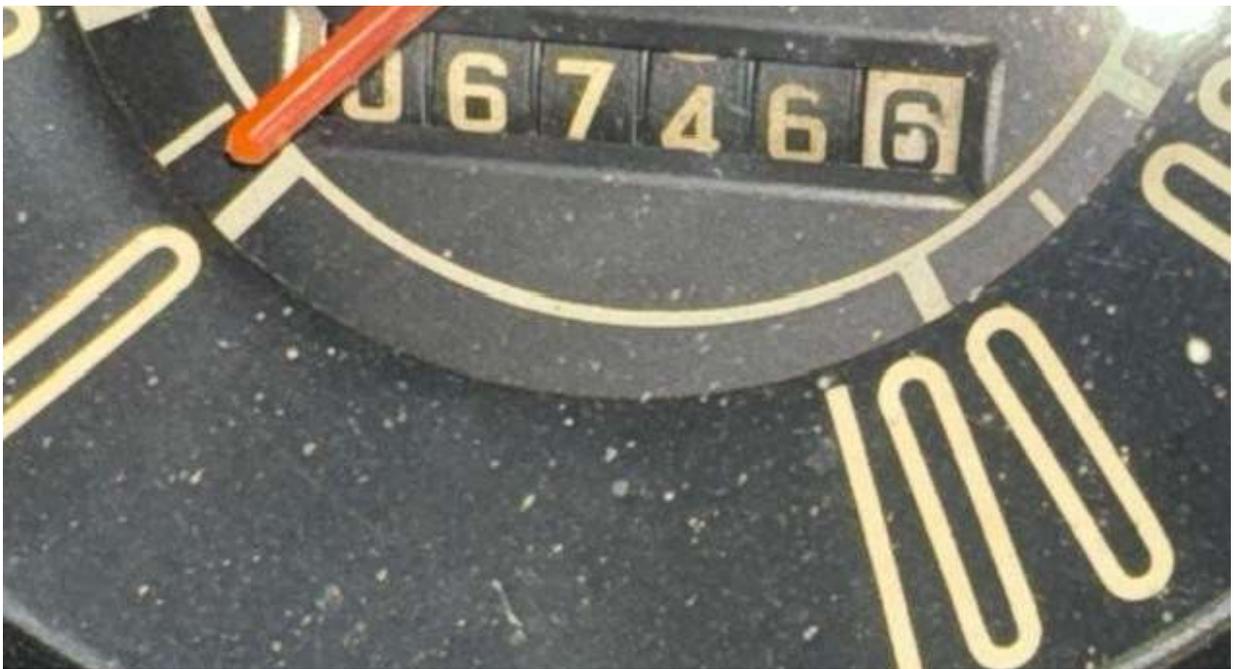
Odometer Reading

Mileage showing at the time of the Appraisal is 6746 Miles since the restoration.

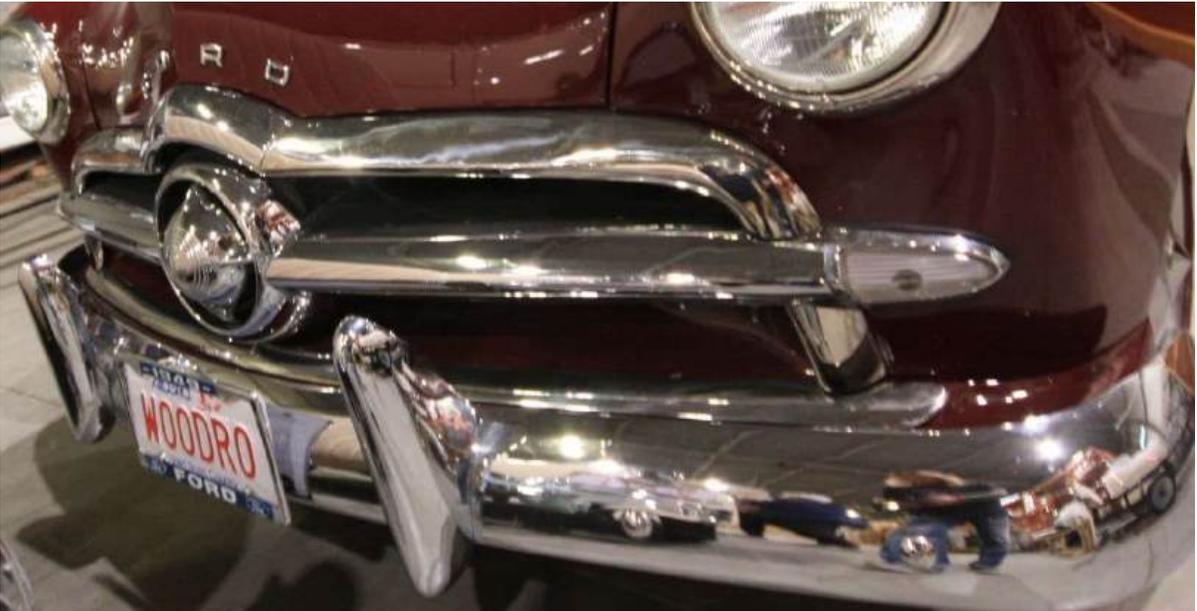
Bumpers

Front and rear bumpers have been re-chromed and have an excellent fit and finish that show well. All trim pieces are present and have a brilliant finish. Front lights are free of cracks. Front grill show no signs of fading or cracking and has a beautiful glow to it.

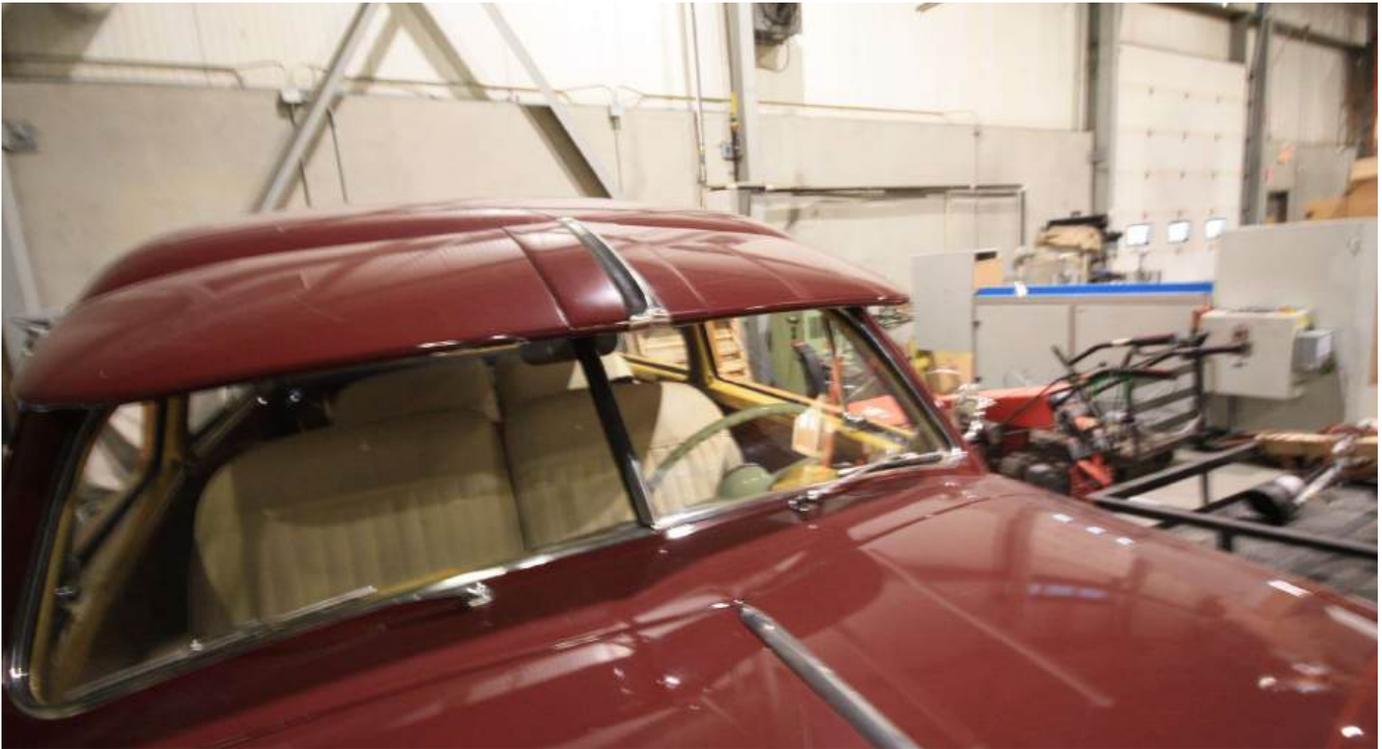
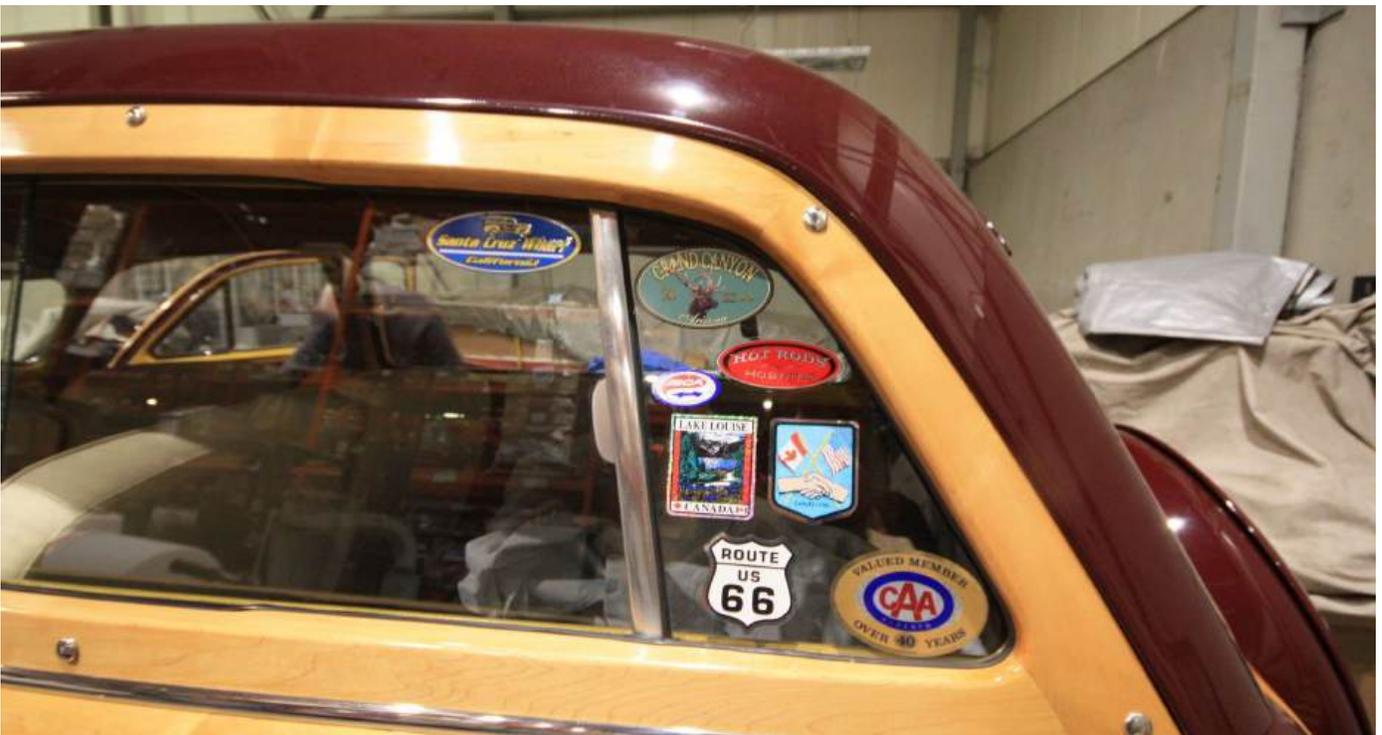
Trim

Window moldings and body moldings are bright and shiny with no signs of damage or dents and are in Very Good condition. Glass is all Original and there are no cracks, stone chips or scratches to the Glass.

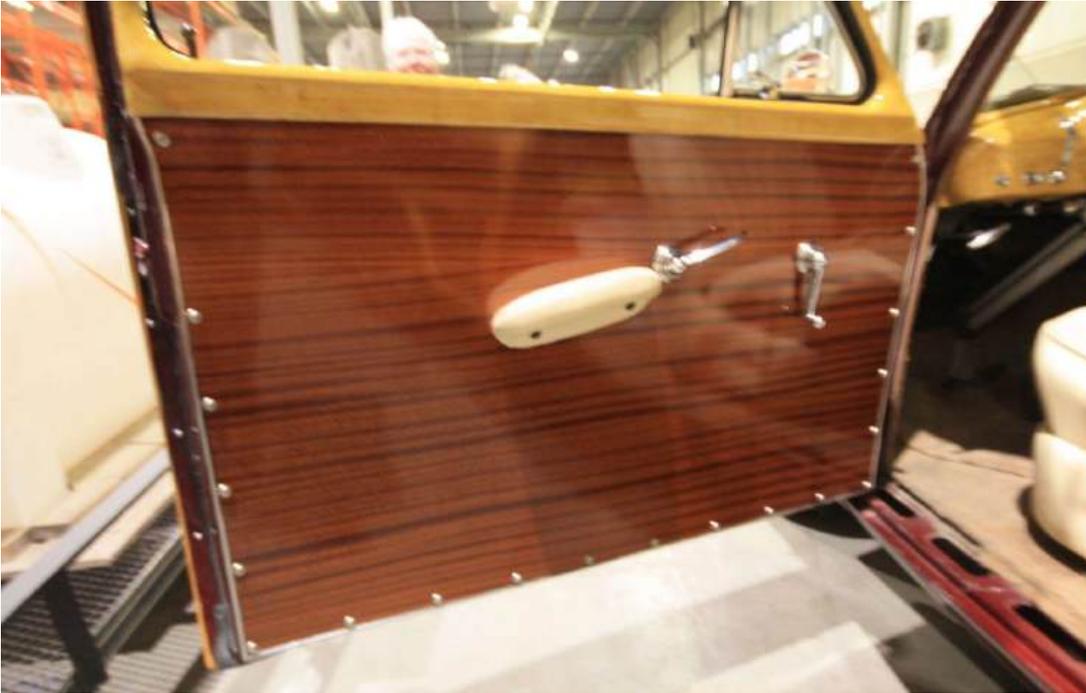
Panels

The Panel fits is good with uniform gaps and no pinch points. Doors open and close easily, with no sagging or binding. The manual windows crank up and down effortlessly. The weather-stripping surround the doors needs to be installed. The glass is in Very Good condition with no signs of drying, tearing or shrinkage.

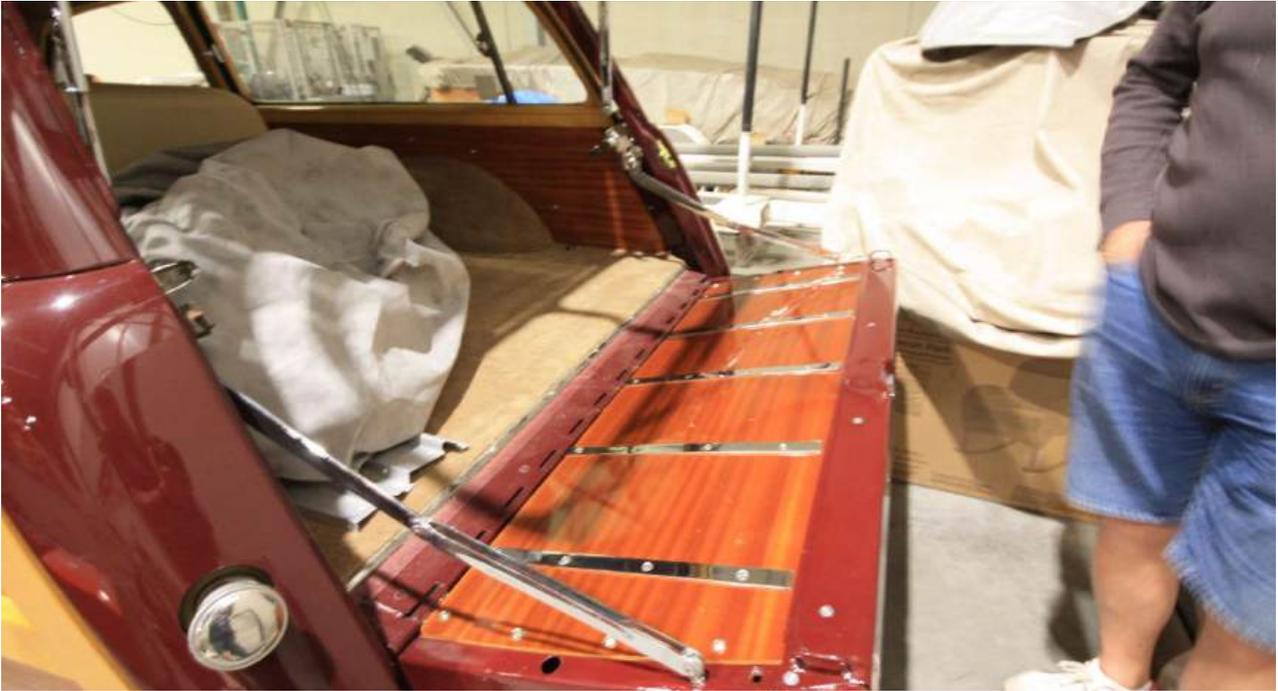
Rear Seating

This vehicle is not equipped with the rear facing “suicide seat”. The cargo appears to have been used except for storing the car cover.
