# POINT LOMA LIGHTHOUSE RECALLED TO LIFE

By Kim Fahlen

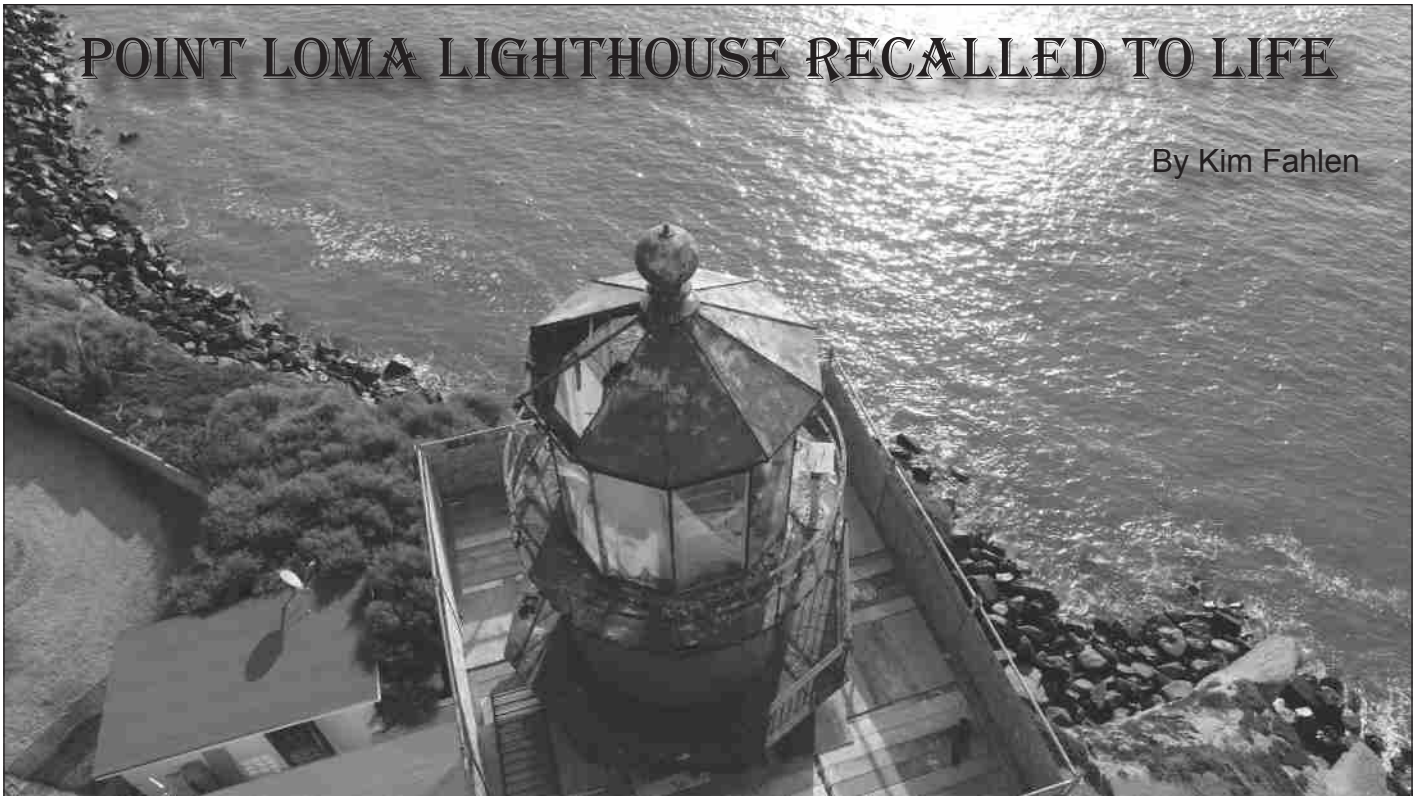
Early demolition reveals why the original USCG assessment and scope of work would be significantly altered. Drone image courtesy of Ryan Strack.

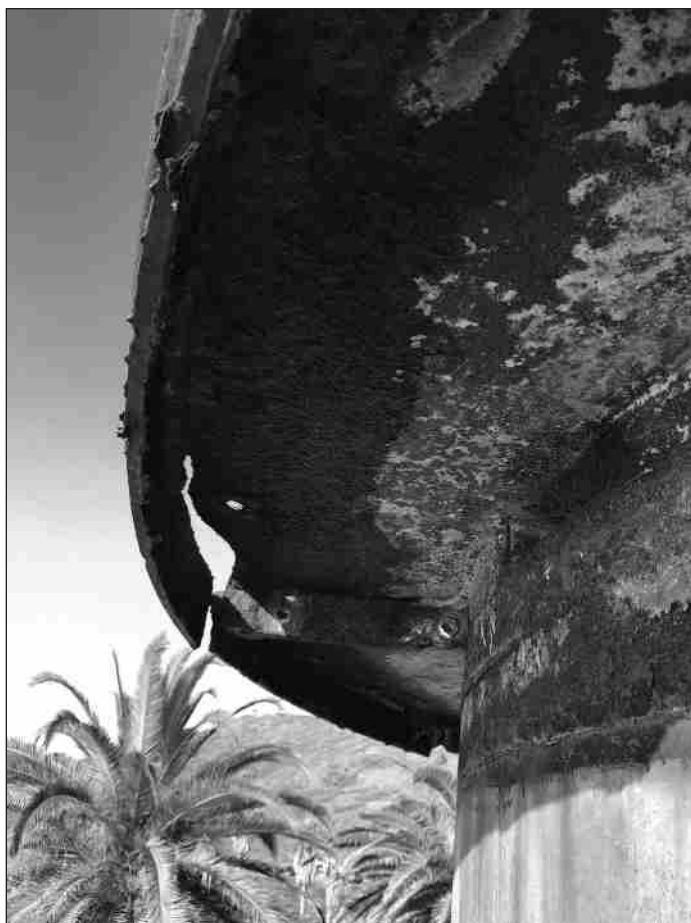
Left: Before its removal, damage shown here on the underside of lantern gallery decking is typical of the condition of much of the cast iron of the lighthouse. Restoration required an estimated 20,000 pounds of recast iron components. Courtesy of Ryan Strack.

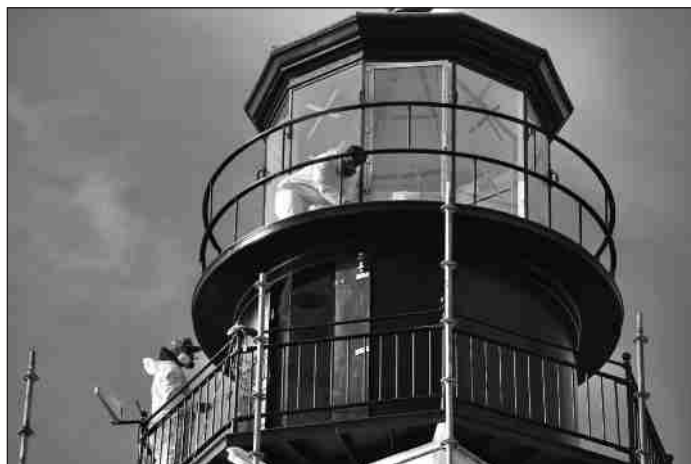
Below: With lantern removed, deterioration is impressive. This cracked top level of the rusty white stair cylinder will be replaced. Stairs lead to the lantern watch room where just one floor plate remains. Support beams still carry the lower gallery deck plates, all of which will be recast. Courtesy of Ryan Strack.

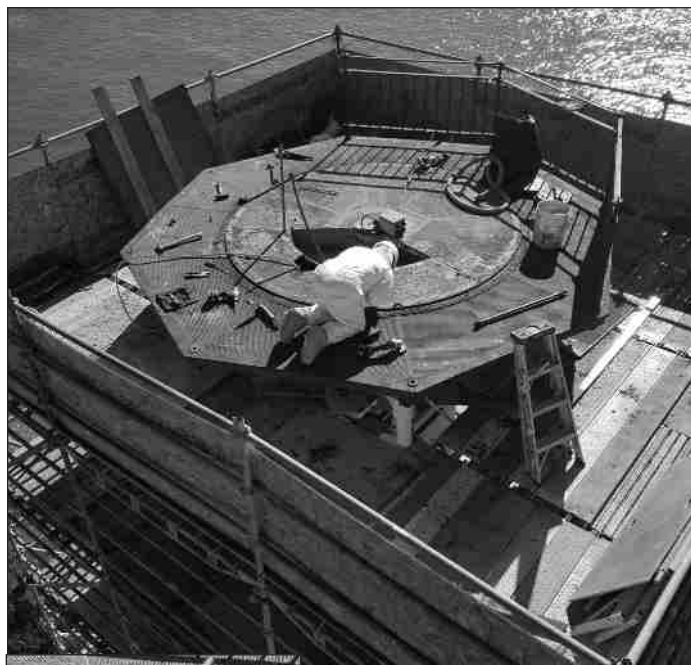
Above left: Revert to the watch room floor, sans black barrel, circled by lower exterior gallery plates. Looking at the central support column left of Ryan Strack's head, note the fracture (close-up left) where it separates from the deck. The circle above it is the footprint of the Fresnel lens pedestal. Courtesy of Neil Gardis.

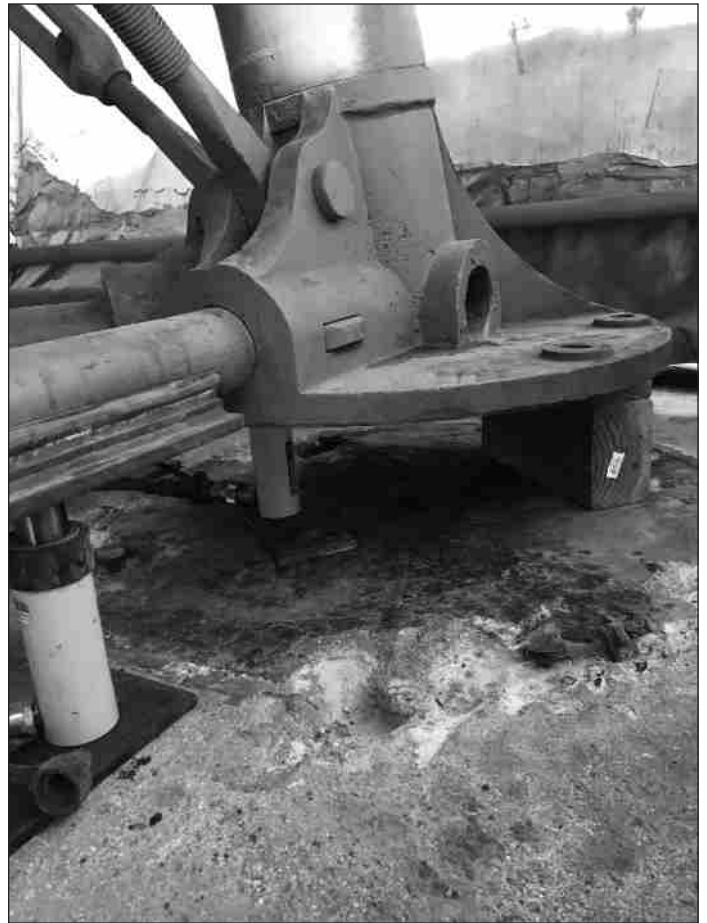
Replacing footings was the most difficult aspect of restoration. Once the weight of the lantern was gone, the foundation base plates were jacked, one by one in turn, but only by  $\frac{1}{4}$  inch. More than that could not be trusted. It took 40- and 60-pound air hammers and a 1,000-pound "Come Along" to break and heave away the disk plates. Concrete under them had to be dug out in order to drill in three-foot steel anchors, which were then epoxied. Photo courtesy of Ryan Strack.

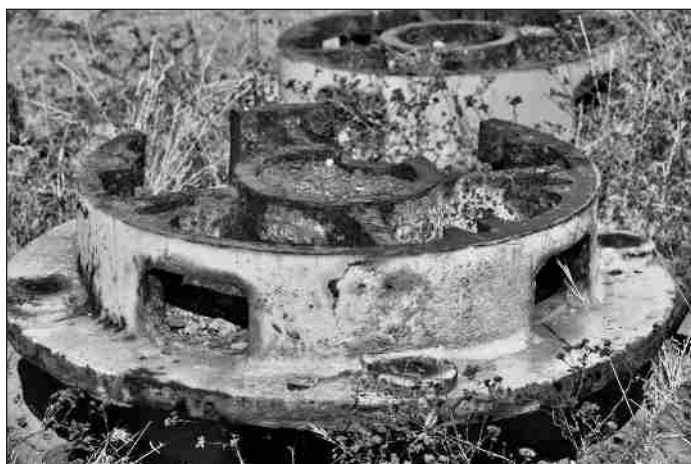
Our feet would hurt and we'd lean, too, if standing in shoes worn as these! Deterioration of the foundation disk plates was severe and added to a three-degree lean of the tower. But somehow, it was a really sorry thing to witness these—and all the other cast away castings—in the boneyard after their 128 years of service.

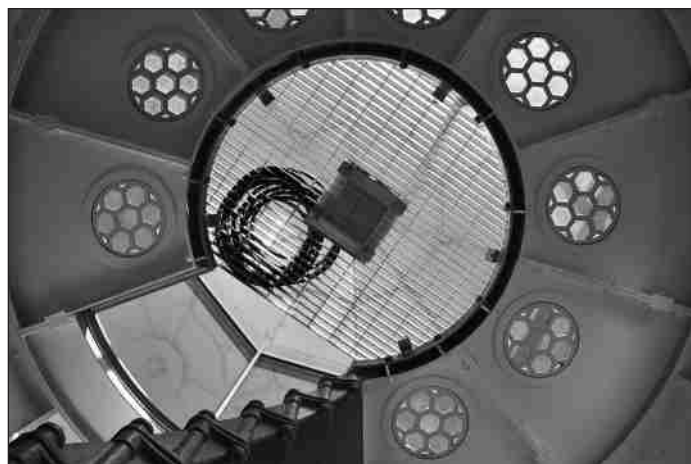
Just as crowning the roof with the vent ball on the exterior gave a meaningful sense of pride of accomplishment, so, too, the seating of the deck prisms in the interior. Some original amethyst glass prisms could be saved and reinstalled in their circular frames. Many were too chipped and cracked to salvage, others were missing, so new prisms were fabricated. The coiled cable awaits USCG installation of the LED array. Then it will be a real lighthouse again! Photos courtesy of Kim Fahlen.
