# Intake Exhaustion

A clever intake manifold solution ends the cycle of excessive oil consumption

## AFTERMARKET CASE STUDY

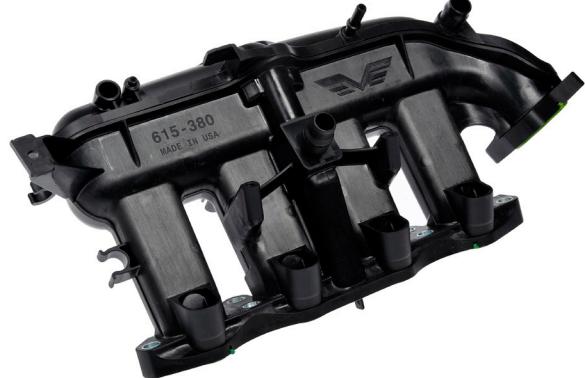
**615-380**

***Dorman's OE FIX intake manifold takes care of the inherent problem in the OEM design, but the team's engineers discovered the troubles didn't end by just replacing the manifold.***

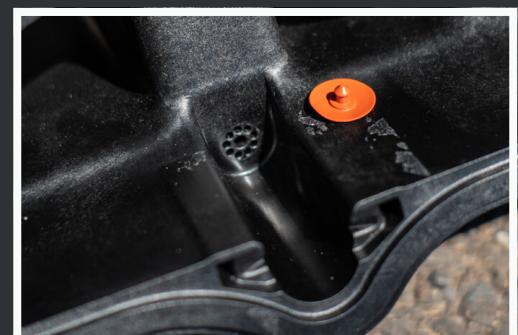
## PLASTIC INTAKE MANIFOLD

### OE Problem:

The original integrated umbrella PCV diaphragm becomes dislodged over time, resulting in multiple engine trouble codes and damage to PCV diaphragm in the valve cover.
