# Oak Creek Watershed Restoration Plan

## *Instream Survey Progress Update-Fall 2016*

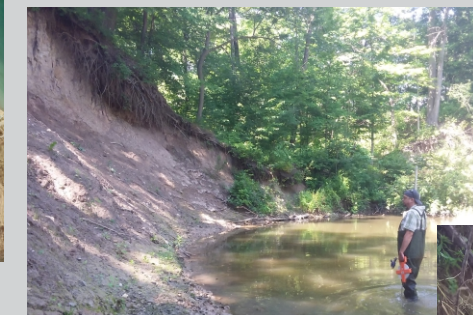
### Large Woody Debris Jams and Accumulations

The presence and quantity of large woody debris (LWD) was recorded in both cross-section surveys and at large accumulations. LWD plays a vital role in the hydraulic, geomorphic, and biological function of streams. In general, LWD in a stream is good as it provides essential food and habitat for aquatic organisms. In some cases, however, LWD can form massive jams that span the entire width of the stream or block a culvert, altering the path of the stream or leading to flooding concerns and fish passage obstructions.

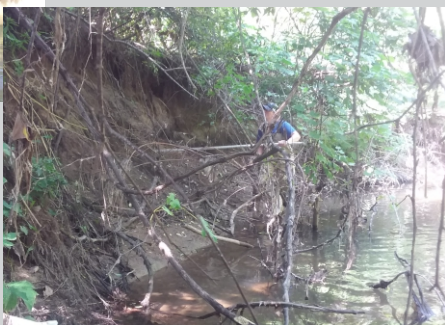
### Streambank Erosion Assessment

43 streambank erosion sites--ranging from moderate to severe erosion--were documented along the portion of the mainstem of Oak Creek that was surveyed in the summer and fall of 2016. At each site, measurements of length, maximum height, and average depth of eroding bank were collected. The sites were also mapped. These measurements will allow SEWRPC staff to estimate the amount of total suspended sediment and phosphorous that is entering the Creek from bank erosion.
