**Re: BAR2026-00238 – OHAD-Request for alterations at 121 North Fairfax Street-  
September 2, 2026.**

## Memorandum

**To:** John Richards, Historic Alexandria  
**From:** Willie Graham  
**Re:** Proposed Replacement of the Carlyle House Roof  
**Subject:** Historical Basis and Preservation Case for Retaining a Wood-Shingle Roof

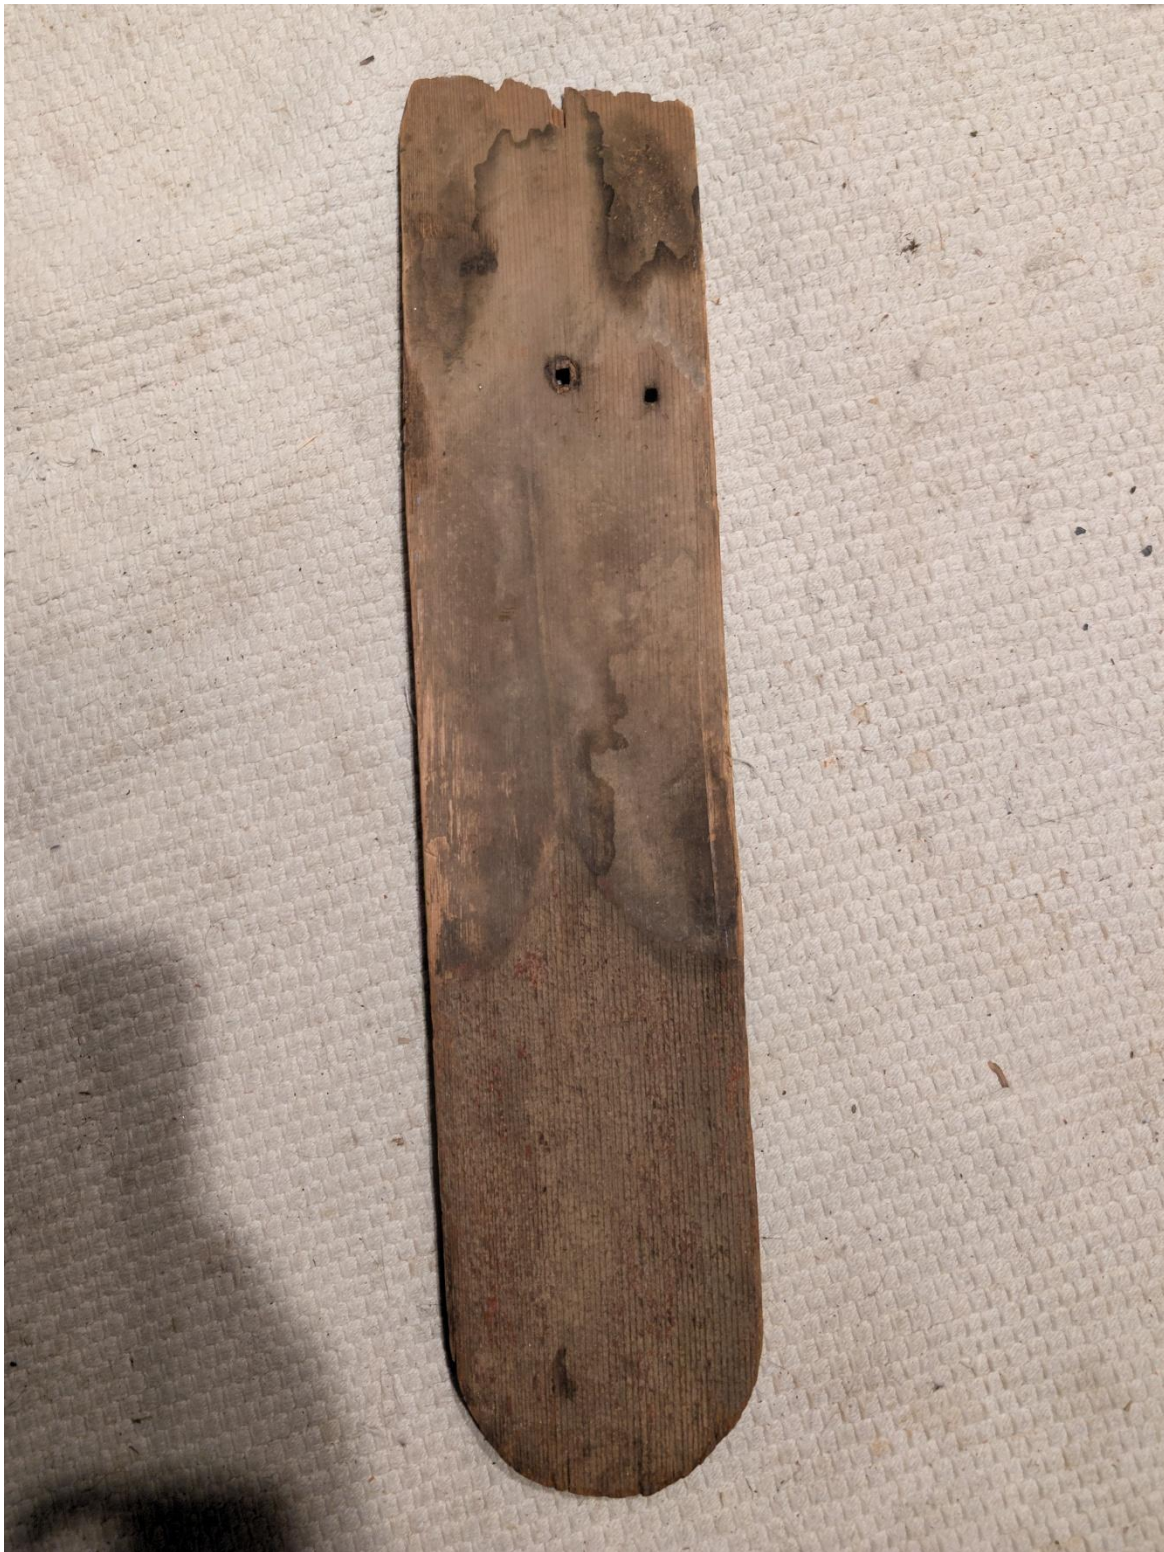
Staff discovered a wooden shingle discarded in the attic during an earlier reroofing campaign and provided it to dendrochronologist, Mick Worthington, for examination. The shingle is made of Atlantic white cedar, a highly durable regional species and one commonly used in Virginia during the eighteenth century. A single shingle is difficult to date securely by dendrochronology, and in this case particularly so because the surviving one does not retain its waney edge, or final growth ring beneath the bark. Even if its tree rings can be matched to a chronology, the analysis may establish only the last surviving growth year rather than the exact felling date. Its inability to yield a precise dendrochronological date, however, does not diminish the substantial information the shingle provides about date, material, form, fabrication, exposure, fastening, and finish.

The shingle's dimensions and form are consistent with eighteenth-century Virginia practice. It measures approximately 17¾ inches long and just under 4 inches wide, with weathering indicating an exposure of about 6 inches. Its rounded butt is equally significant. In a large sample of surviving Virginia roofing shingles, approximately 84 percent were made with round butts (see Willie Graham, "Exterior Finishes," in the *Chesapeake House: Architectural Investigations by Colonial Williamsburg*, ed. by Cary Carson and Carl L. Lounsbury, 286-311). The Carlyle example therefore corresponds precisely with the dominant Virginia roofing tradition of the period.

Early or original surviving shingle from the Carlyle House. Photograph by Mick Worthington, 2026.

The most defensible replacement for the Carlyle House would be a roof of round-butt Atlantic white cedar shingles matching the general appearance and dimensions of the surviving historic example. If suitable Atlantic white cedar cannot be acquired, bald cypress would be an appropriate alternative. It was also commonly used historically in the region, is visually similar, and can perform comparably well.

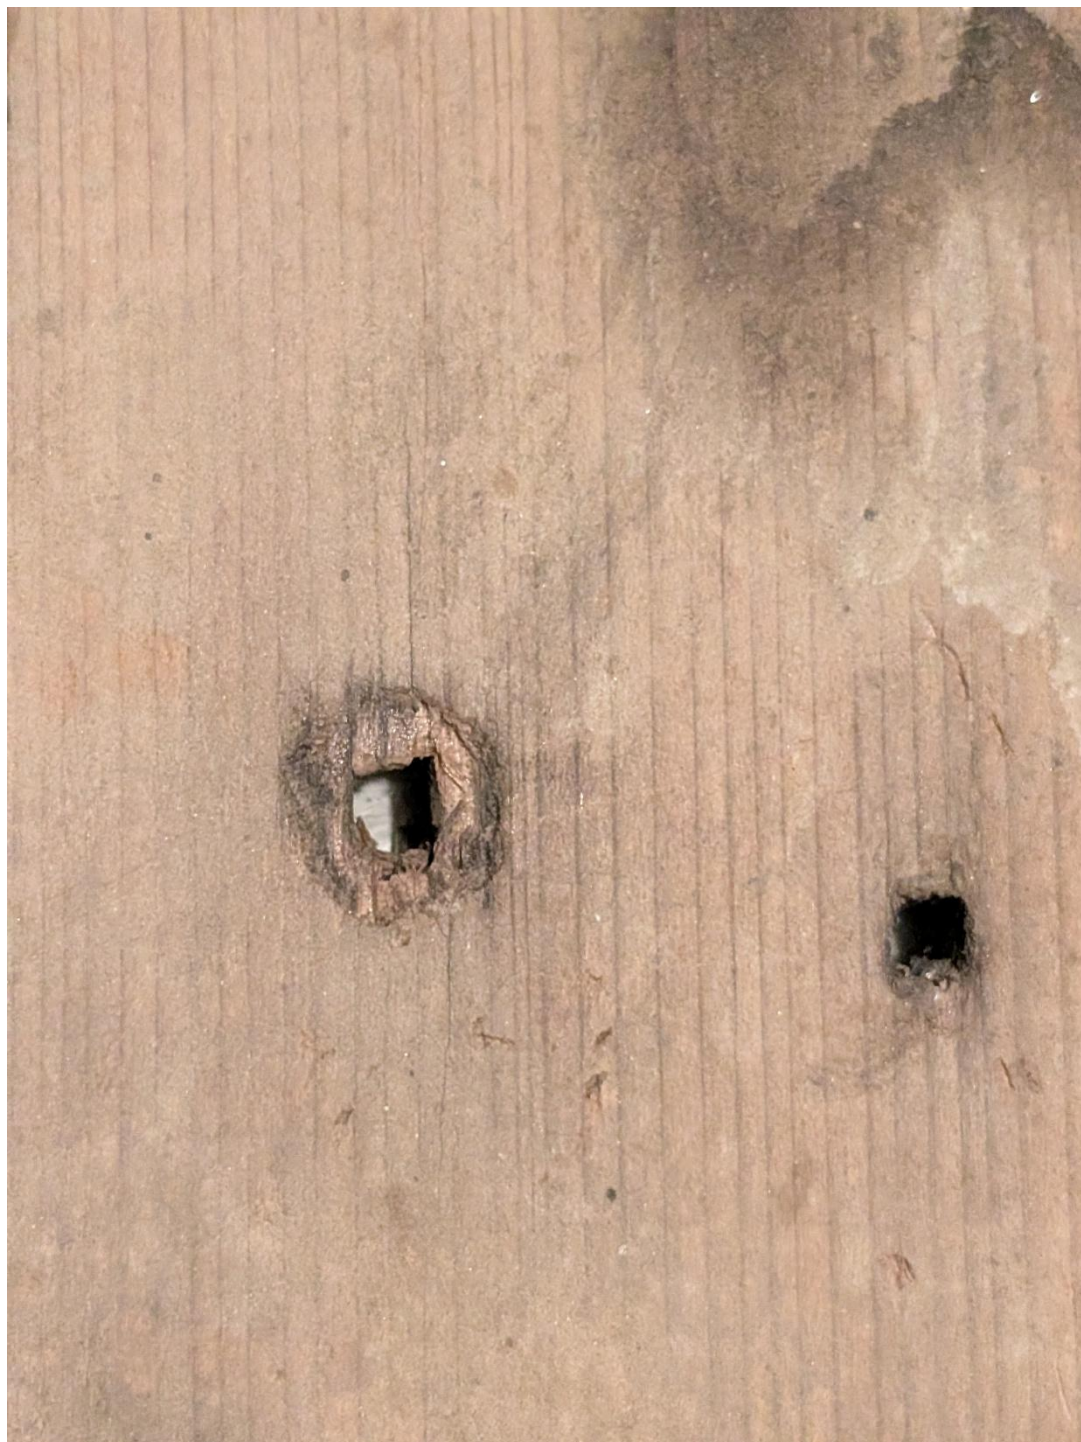
Perhaps the most persuasive feature of the recovered shingle is the evidence left by its original fasteners. Although the nails themselves do not survive, their head impressions remain visible in the wood and are consistent with hand-forged rose-head nails, the overwhelming standard for eighteenth-century shingle fasteners.

This provides an important chronological clue. Alexandria adopted machine-cut nails comparatively early, and small nails—especially those used for shingles and plaster lath—were among the first applications in which cut nails offered significant economic advantages. That transition was underway around 1800 and in the first years thereafter. An early-nineteenth-century roof could still have been fastened with rose-head nails, but that probability diminished quickly in the opening decade of the 19<sup>th</sup> century as cut nail use became widespread.

Detail of nail holes and impression of rose head nails made into the wood. Photograph by Mick Worthington, 2026.

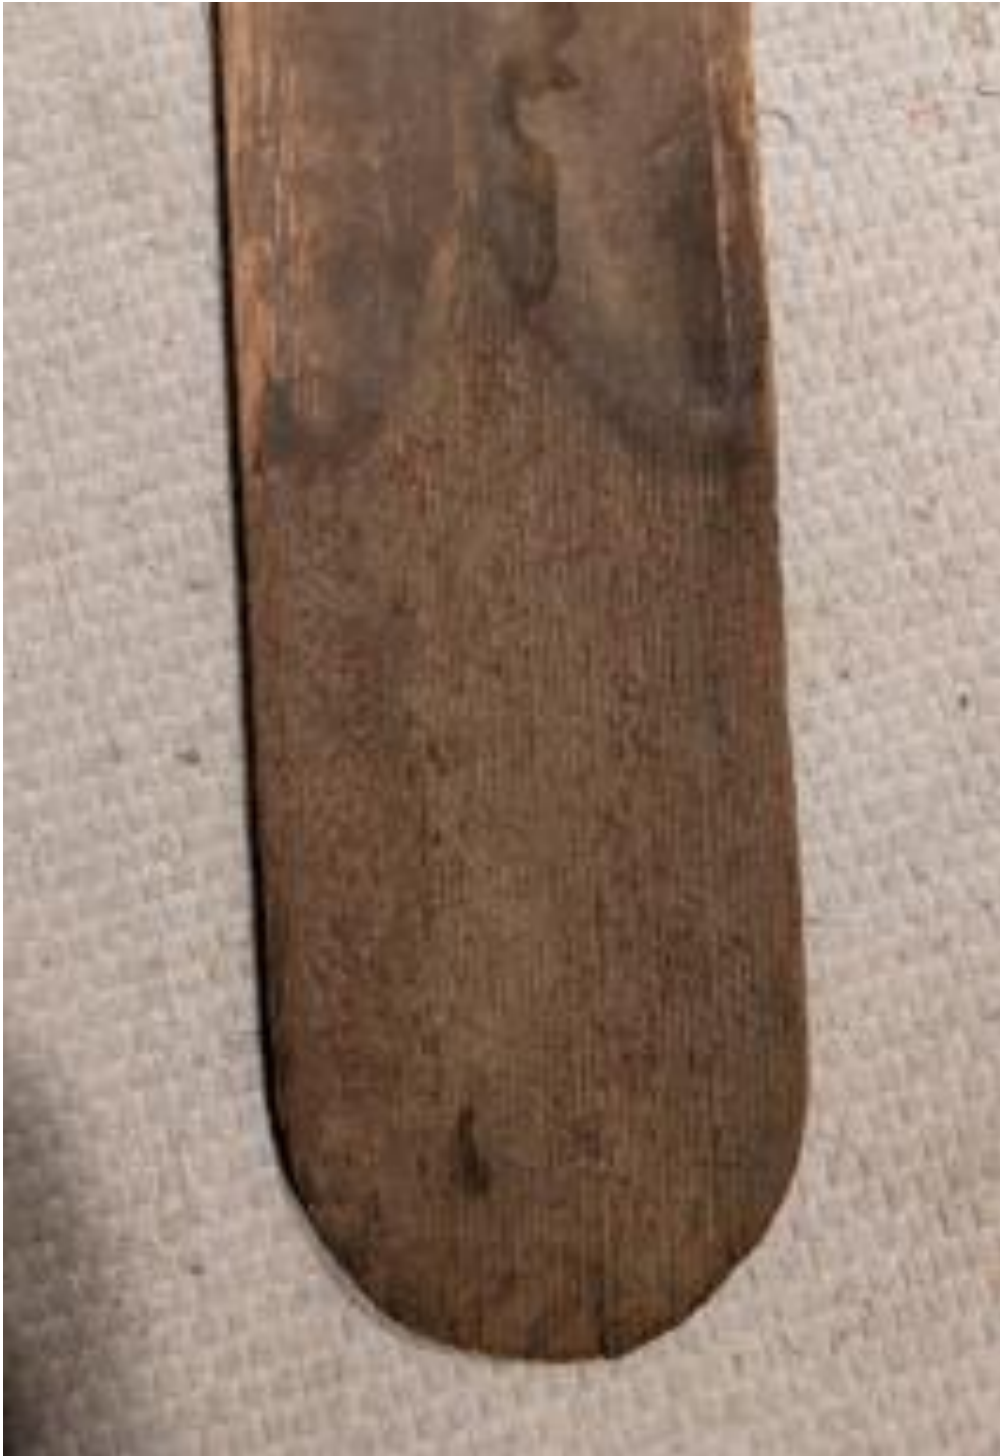
The wear visible on the shingle indicates that it remained in service for a considerable period. After the exposed surface had weathered, the shingle was painted a reddish-orange or reddish-brown color, almost certainly as a maintenance treatment intended to extend its useful life. This corresponds closely with the broader Virginia evidence. Nearly 45 percent of the historic Virginia shingles I have examined or recorded were painted

Detail of wear on lower edge off shingle and subsequent paint—likely Spanish brown or possibly red lead. Photograph by Mick Worthington, 2026.

The surviving Carlyle shingle therefore offers an unusual opportunity not merely to reproduce the general form of the historic roof, but potentially to reproduce its historic finish as well. A qualified paint analyst should examine the surviving coating microscopically to identify its original color and composition as closely as possible.

I would consider painting the new Carlyle roof reddish brown to correspond with the finish preserved on the historic shingle, subject to microscopic paint analysis. Modern latex and acrylic coatings that create relatively impermeable films should be avoided because they can trap moisture within wooden shingles and shorten, rather than extend, service life. A qualified paint analyst should work with the project architect to identify a coating system compatible with both the historical evidence and the moisture behavior of the wood.
