When Unlimited Designs, Inc was awarded the restoration contract for the [Artesian Springs Project](#), we knew that we were in for a challenge!

In March 2015 Parleys Partners hired a structural engineer to assess the tower and evaluate the structural integrity of both the concrete base (tank) and the steel signage tower atop the tank. Small modifications were required to be made on the tank itself and steel super-structure but the old cast-in-place concrete Art Deco crown that capped off the concrete tank was deemed as "not structurally sound" moving forward. At that point, it was determined that having Unlimited Design take a mold of the old Art Deco crown would not only be more cost-effective than trying to reinforce the old crumbling crown, that was originally made out of precast concrete, but that it would be much lighter and the GFRP replacement would last much longer.

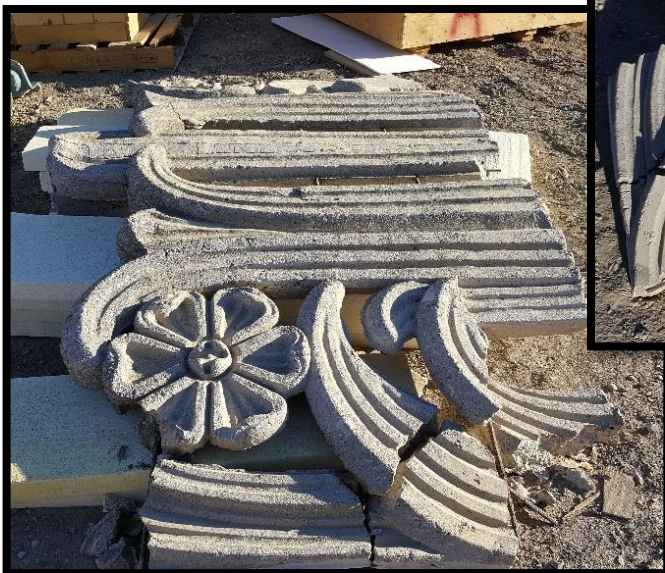
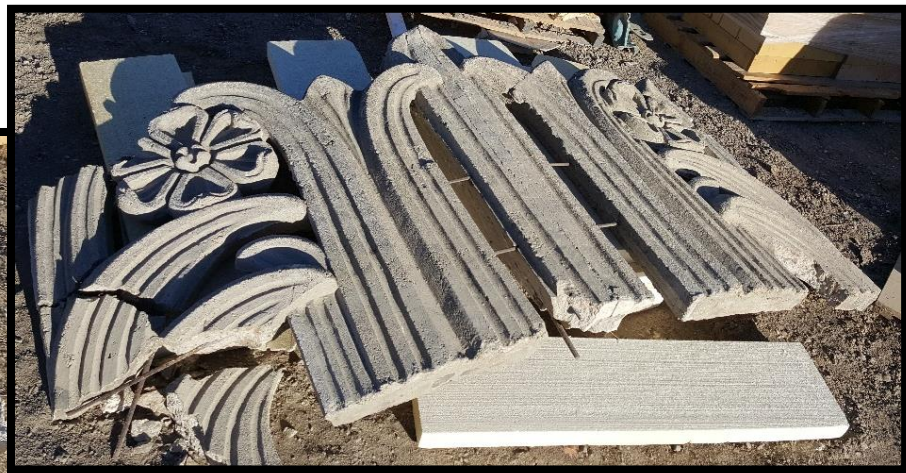
The added challenge was, how do you demo panels that are

almost 90 years old, without completely destroying them? The answer, VERY CAREFULLY! The tower itself was originally built in the late 1920's. It was

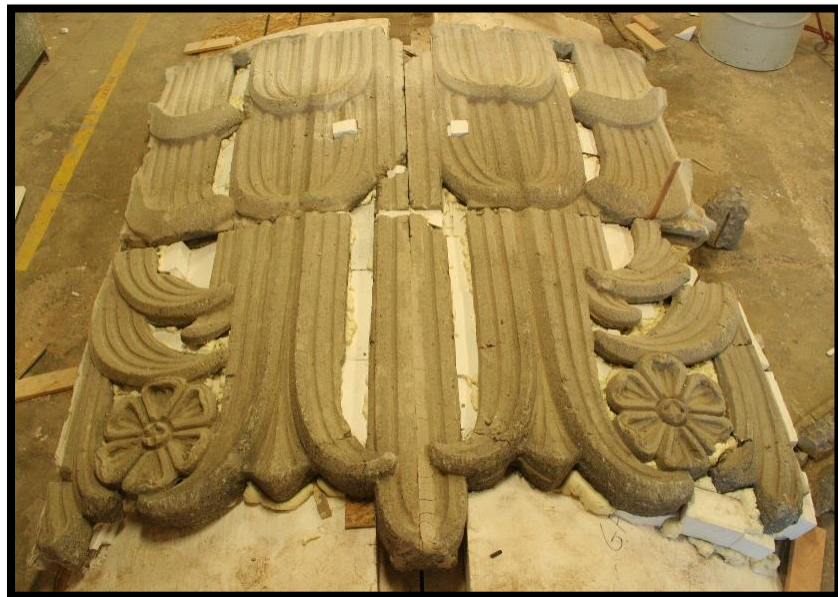
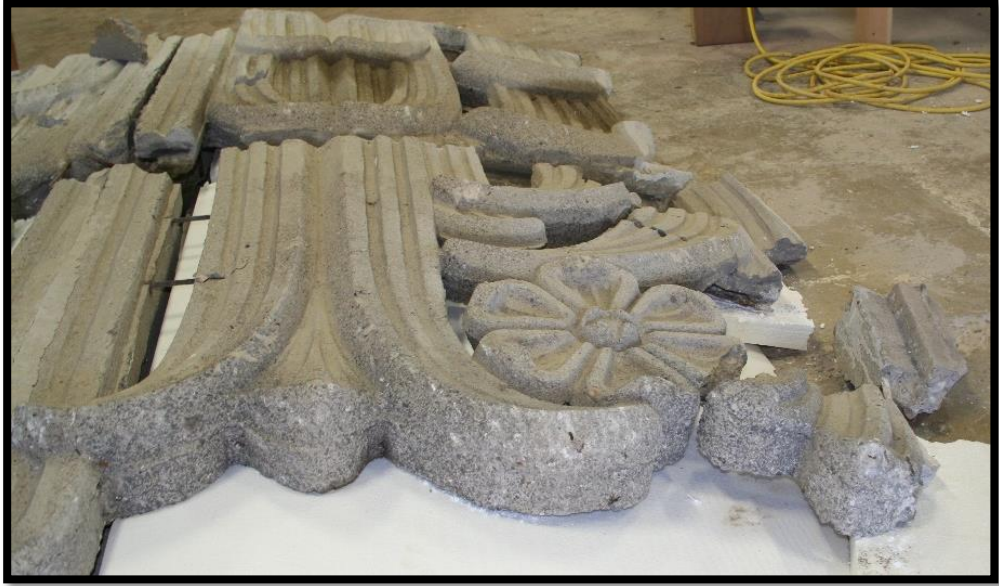
Once we got the panels back to our shop, we needed to lay them out so we could begin the reconstruction process.

We had to treat the individual, demoed pieces, like they were pieces of a gigantic jigsaw puzzle!

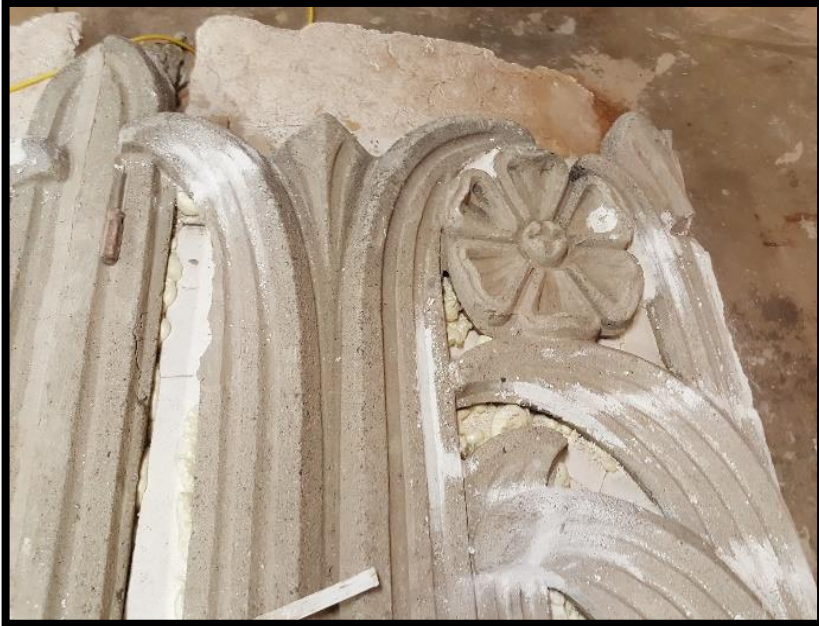
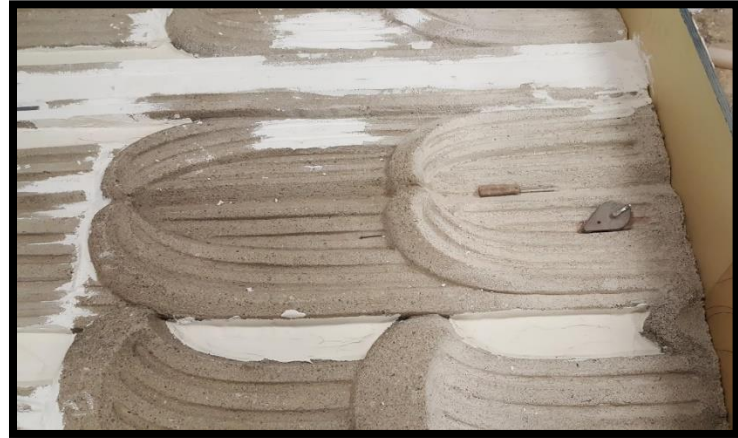
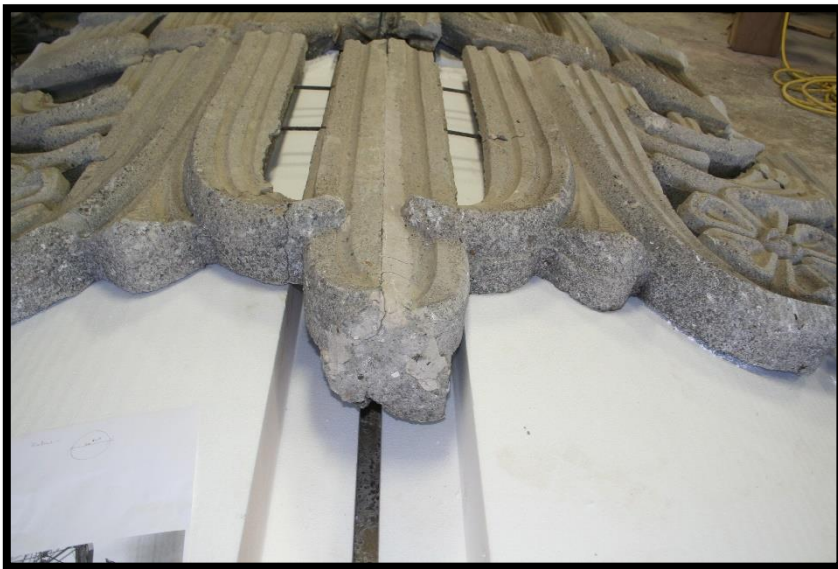
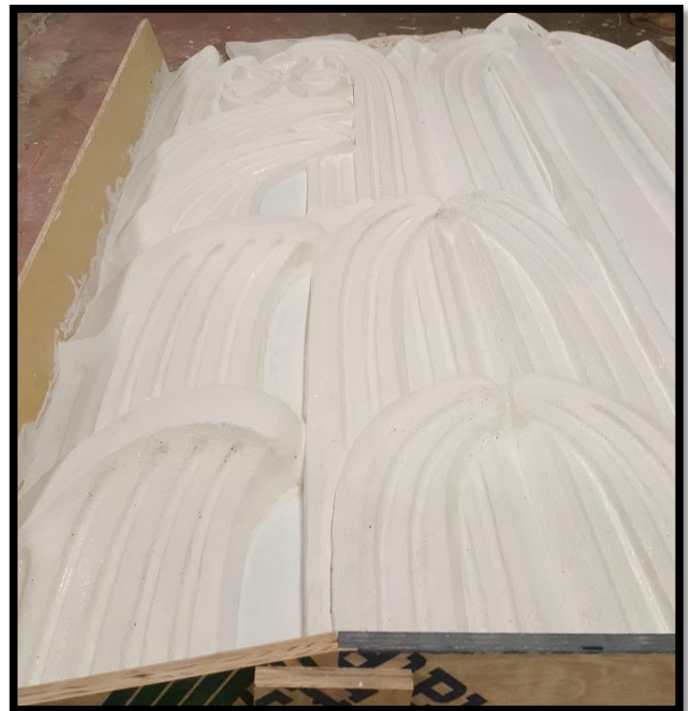
Unlimited Designs skilled craftsmen got right to work, reconstructing these panels, by filling in holes, re-sculpting missing details, and piecing back together parts, that time and weather had taken their toll on.

The original pieces had huge pieces of actual rock within their structure, along with thick pieces of rebar, that held everything together.

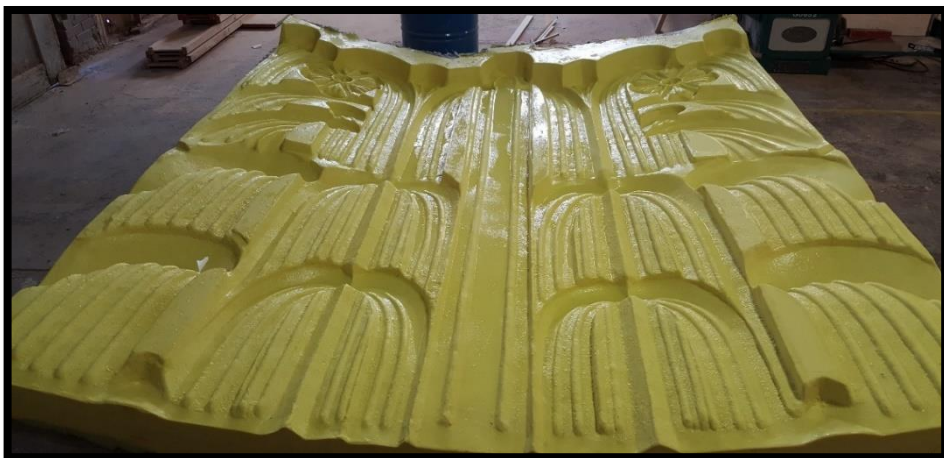
From these refurbished pieces, our team was able to create a rubber mold, with a fiberglass mother mold, to ensure that everything held its true shape. We were then able to cast new panels.

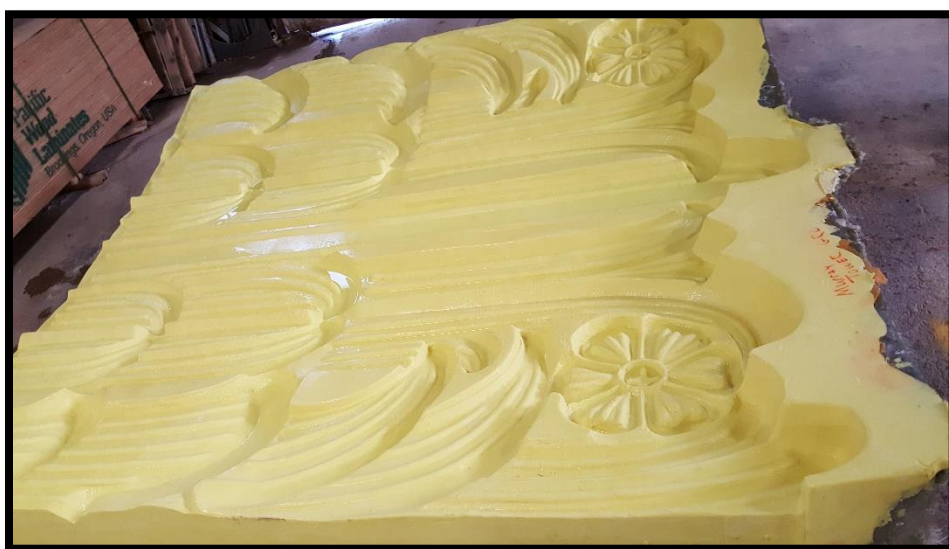
When we were pulling the new rubber mold, off of the reconstructed pieces, great care had to be taken to ensure that the original detail of the panels was maintained, without tearing this gigantic mold.

It took three men just to pull the mold from the reconstructed parts!

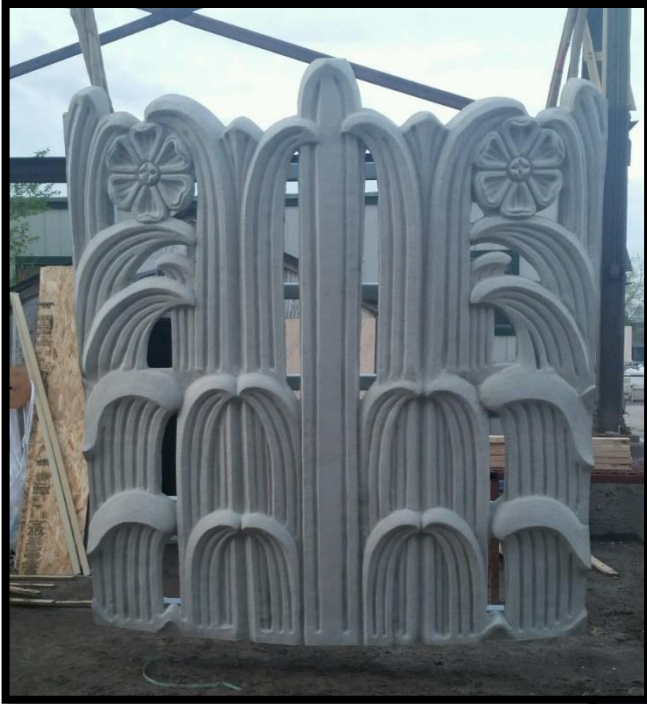
The results were absolutely stunning!

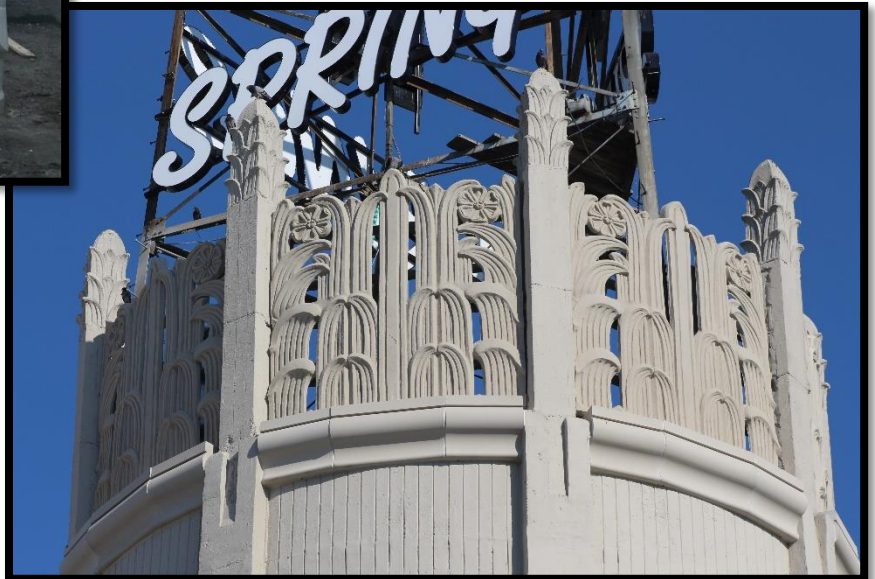
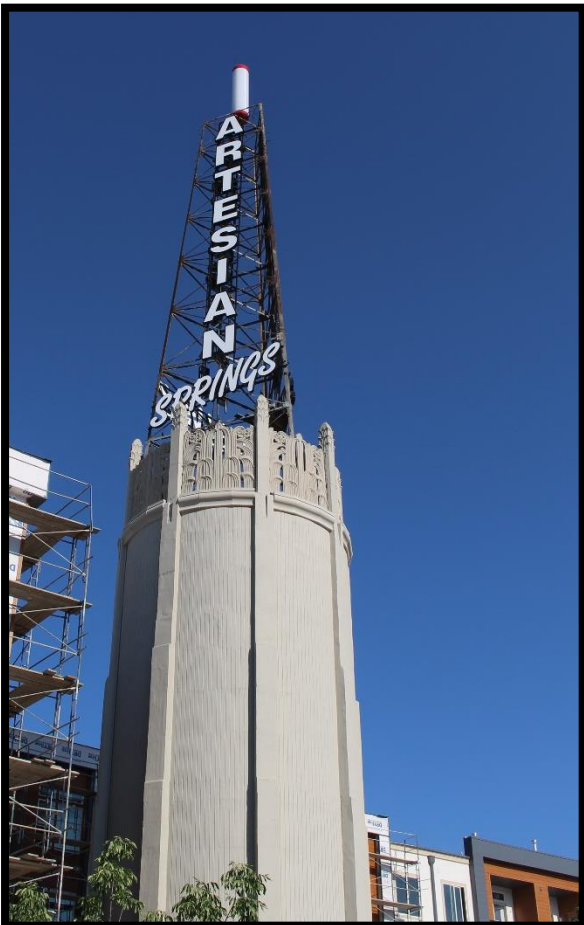
The signage on the tower has been modified to read "Artesian Springs" from "Artesian Water Murray Laundry" to identify the vibrant new apartment development. The Artesian Springs Apartments itself is a 3-phase apartment development that is still under construction and that when complete will be comprised of 378 highly-energy efficient luxury affordable apartment units.
