# Sewer Corrosion Caused by Bacteria-by Ed Pennypacker

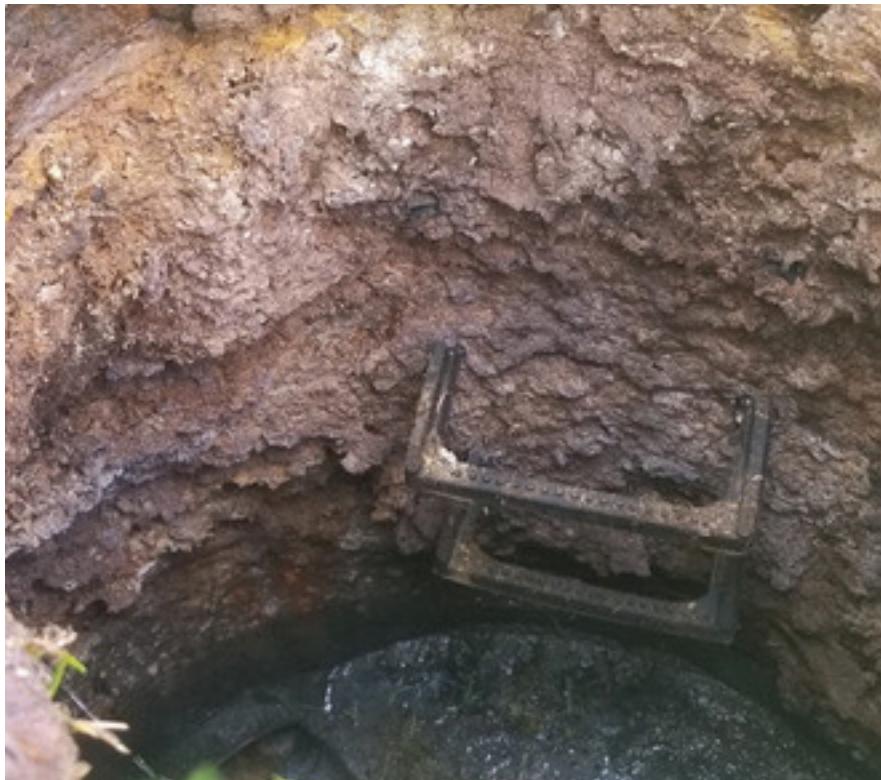
In 2016 the city of Blacksburg, Virginia decided to replace damaged manholes. As shown on the left, the concrete has been attacked to the extent that the structure is physically compromised. These bacteria (*Thiobacillus*) need certain conditions to thrive. When concrete is new, the surface pH is around 13. As time passes that drops to about 9. At that level of alkalinity, the bacteria cannot establish a colony. But add moisture and sewer gas and the surface pH can drop to where the bacteria can live. The first of them arrive at pH 8 and they remain until the surface becomes more acid reducing the surface to pH4. As they live their waste,

The waste reacts with the concrete, particularly attacking the weak spot, Calcium Hydroxide, which is converted to mushy gypsum. The picture above is typical of a manhole in its last stages.

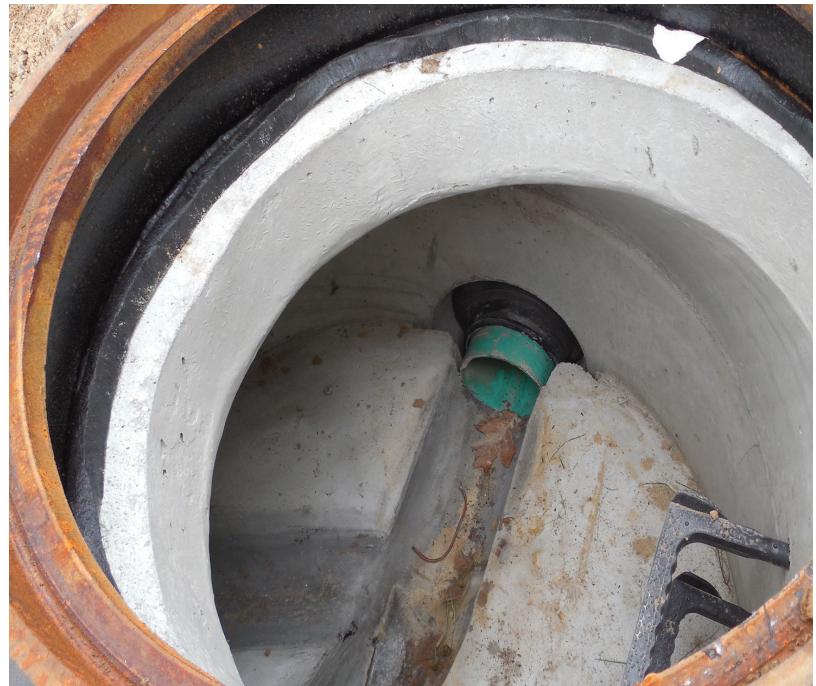
Blacksburg bought new manholes in 2016, made with ConBlock MIC as an additive. If it works the manholes will not be corroded by thiobacillus bacteria like the old ones.

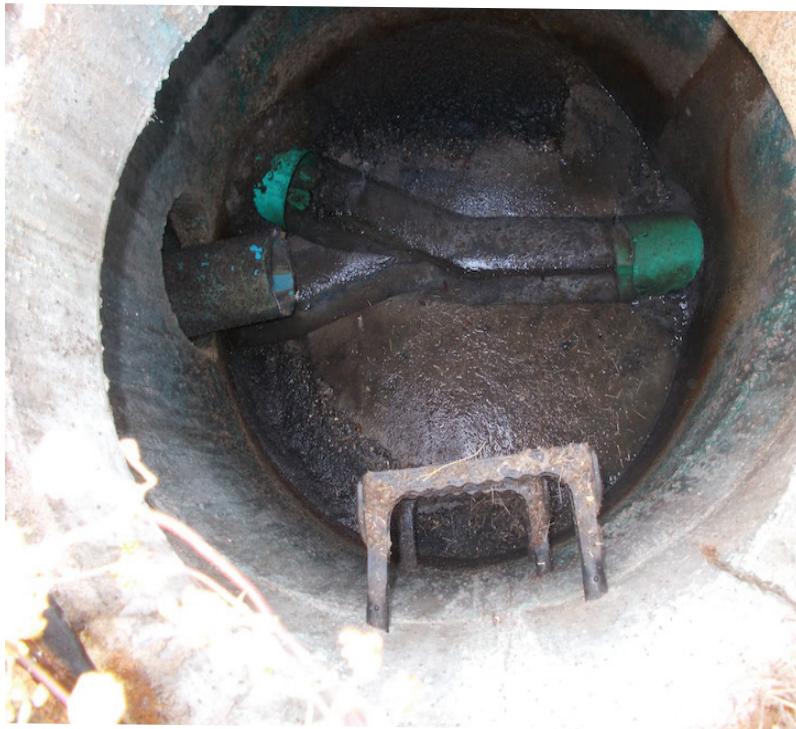
The same manhole as seen in 2022. No visible damage. The ConBlock MIC works.
