# 2026 NCBC WEBINAR SERIES

## Unducted Epoxy-Coated Strand in Practice: The Laurel Fork Bridge

# **EPOXY COATED STRANDS INSTALLATION**

# ASTM A882 Epoxy-Coated PC Strand Manufacturing & Testing

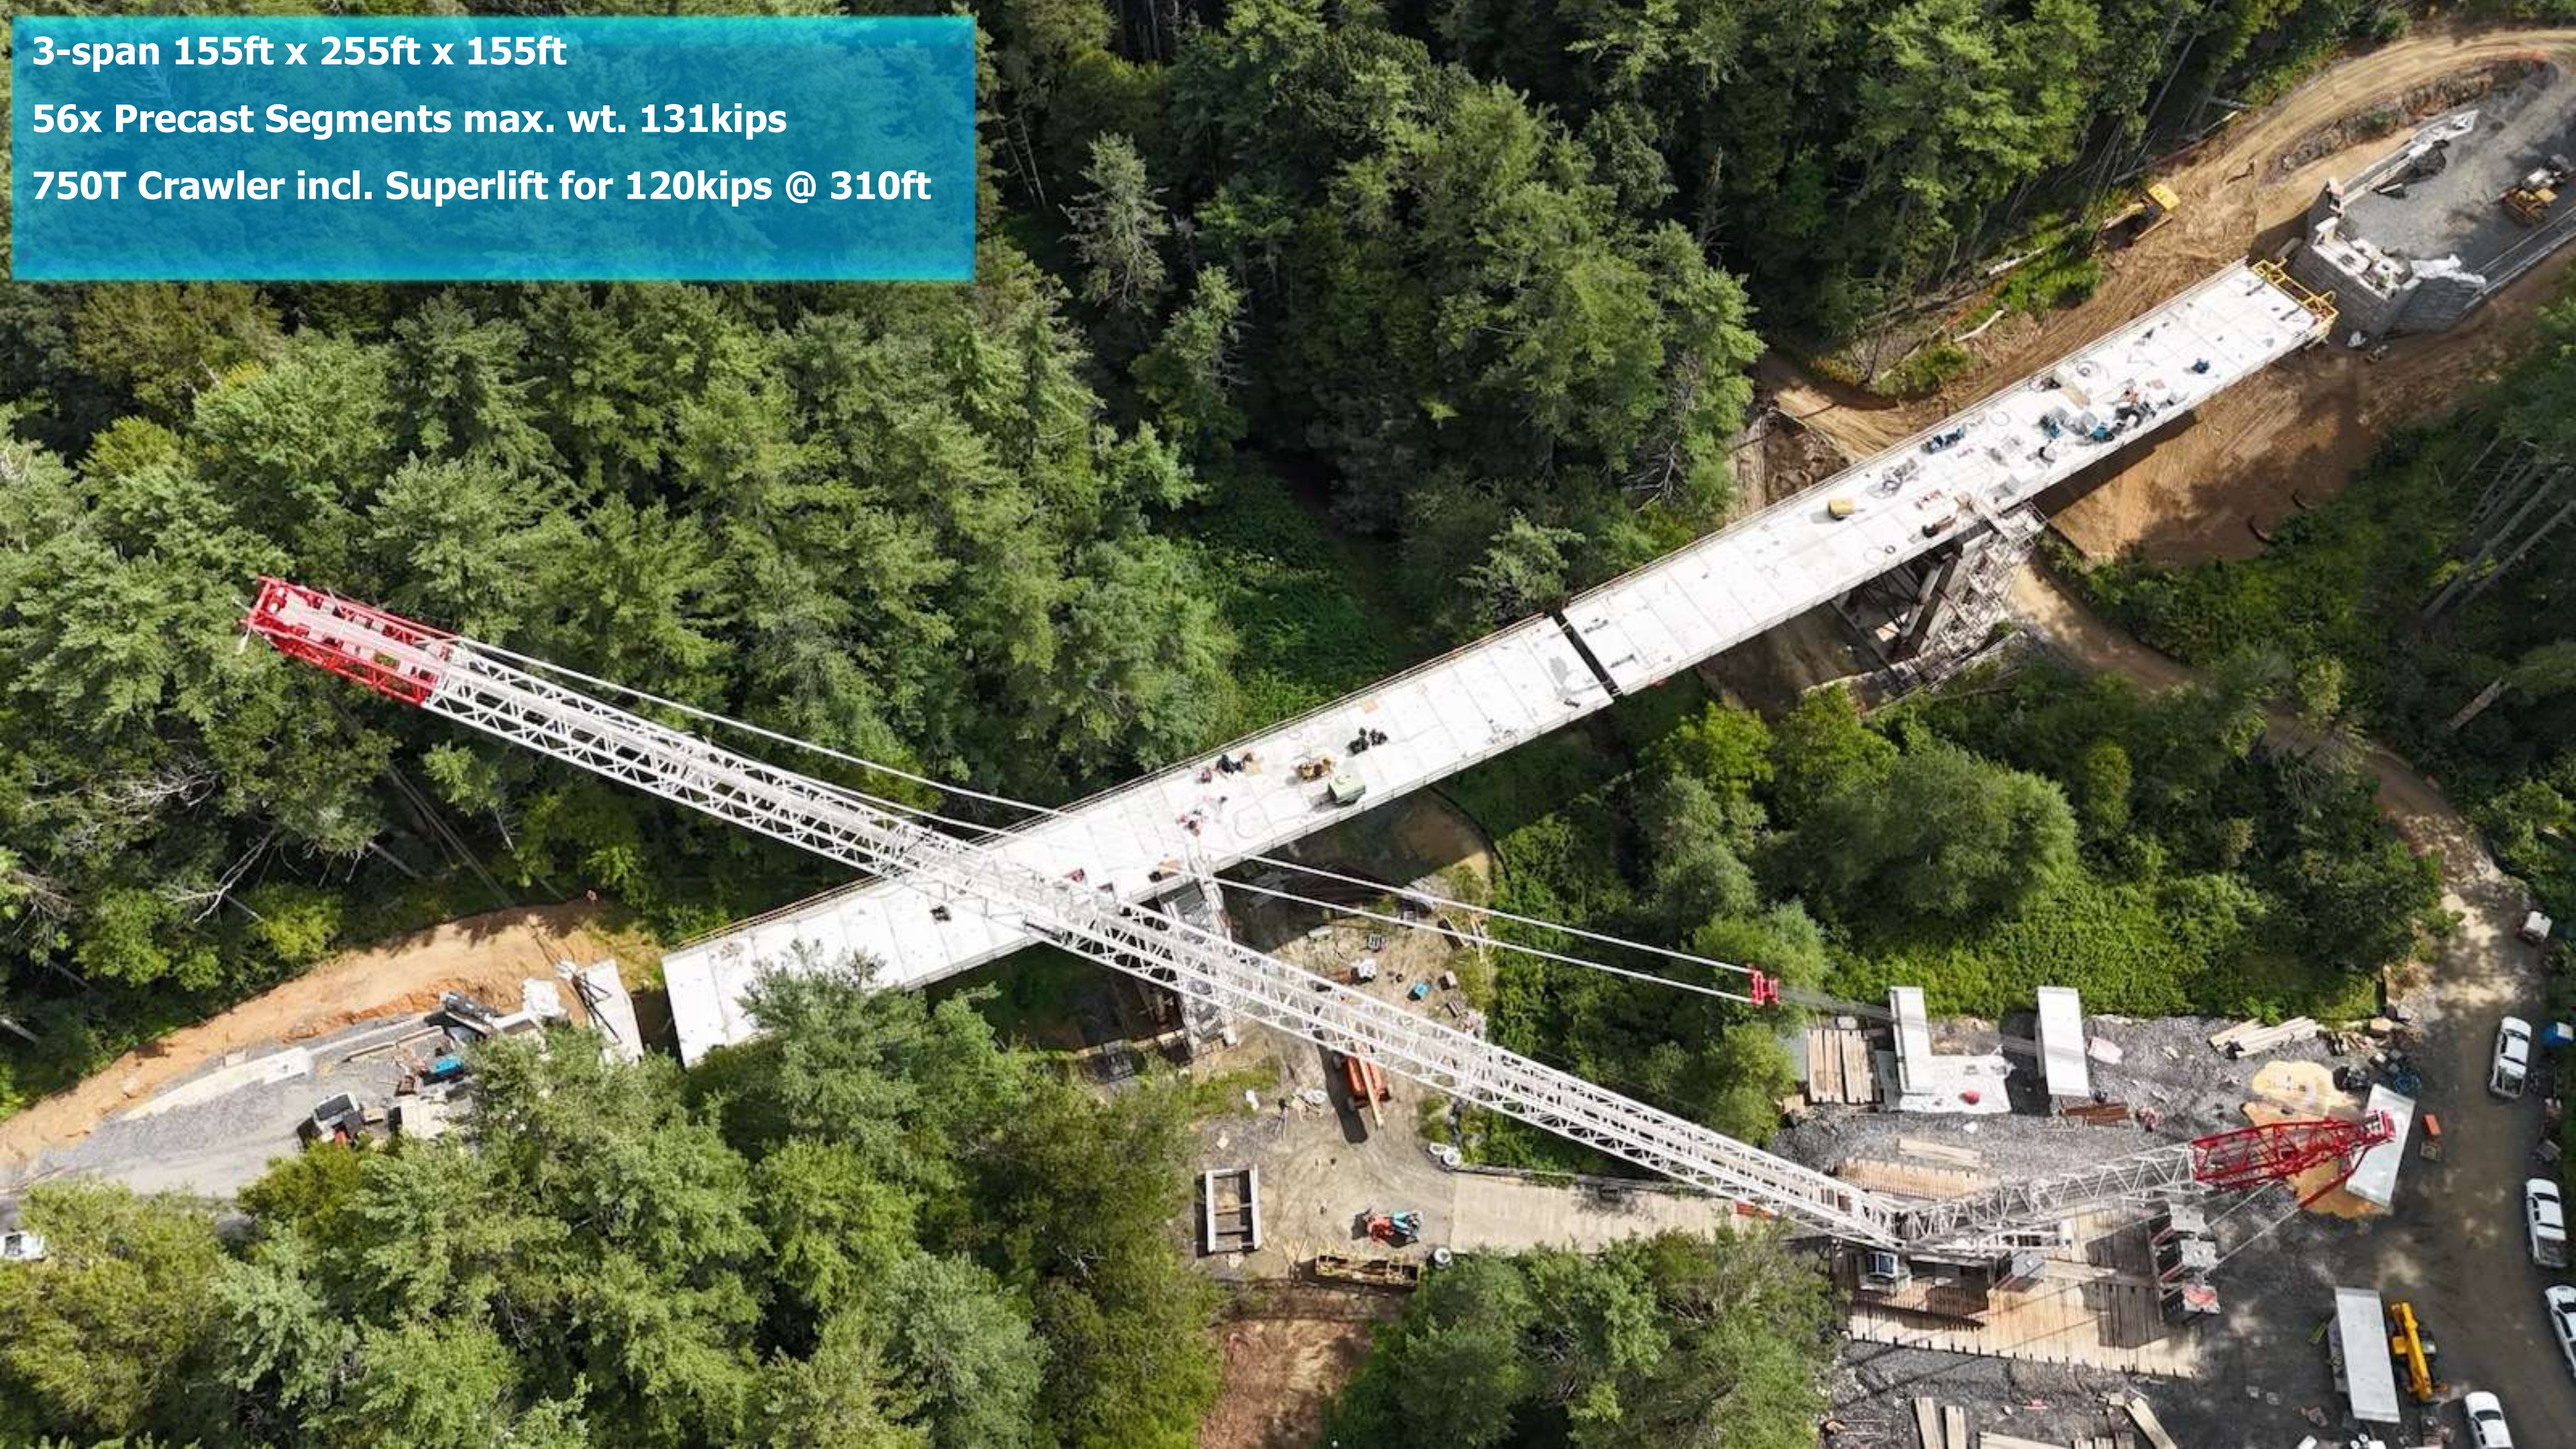
**3-span 155ft x 255ft x 155ft**  
**56x Precast Segments max. wt. 131kips**  
**750T Crawler incl. Superlift for 120kips @ 310ft**

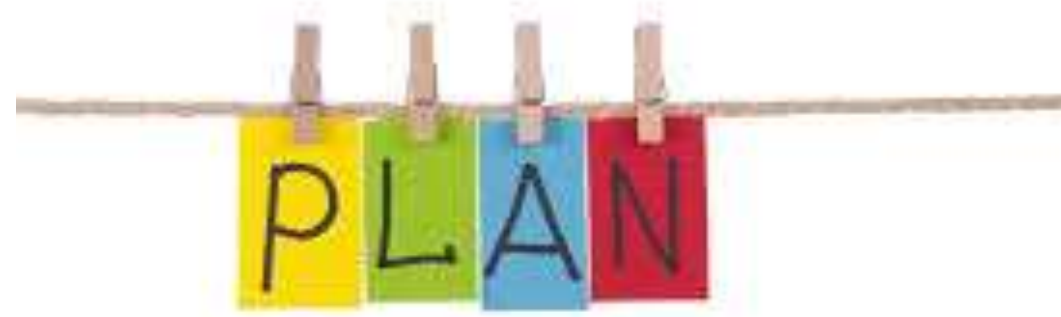
# ECS ANCHOR HEAD

- The VSL ECS anchorage utilizes:
  - Standard anchorage components
  - Oversized bearing plate
  - ECS wedges
- Not option in Laurel Fork. Anchorages already cast into segments
- VSL designed and tested project specific anchor head
- Tests performed with independent lab results were:
  - Fatigue
    - 1x test 500,000cycles from 60% to 66% GUTS range
    - 1x test 50 cycles from 40% to 80% GUTS range
  - Tensile
    - 1 full scale static tensile test. Result pass @ 97.8% AUTS [101.7% GUTS]
- VSL detailing constraint - compatibility with installed ECI6-12 system

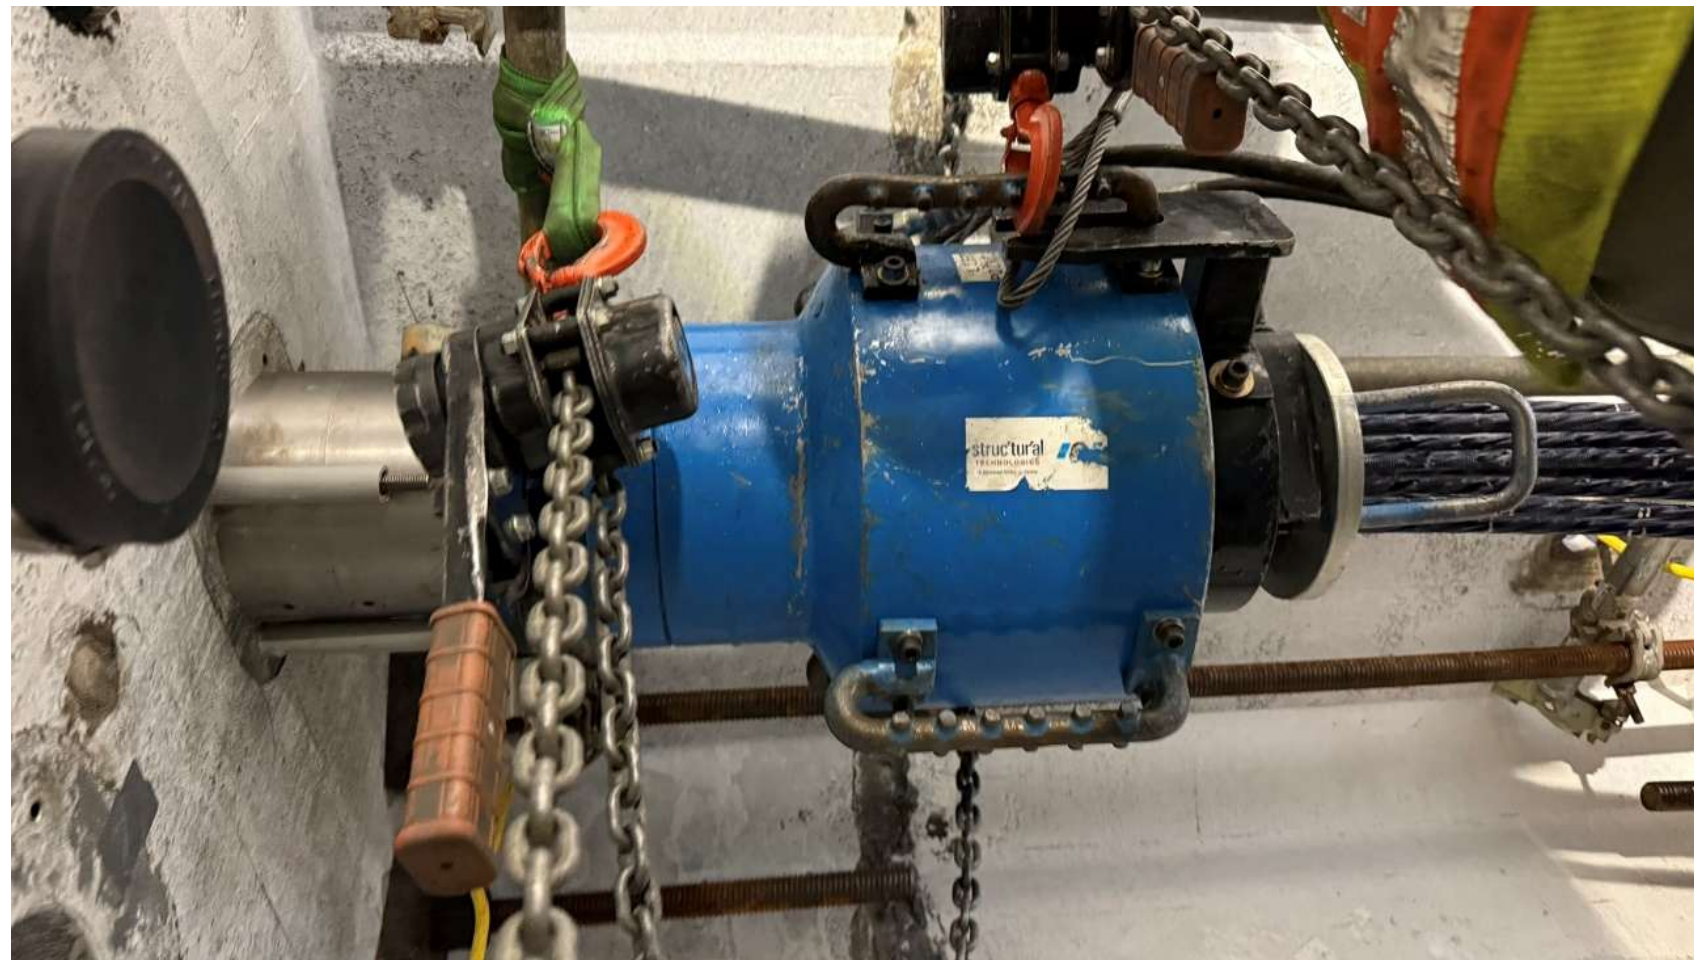
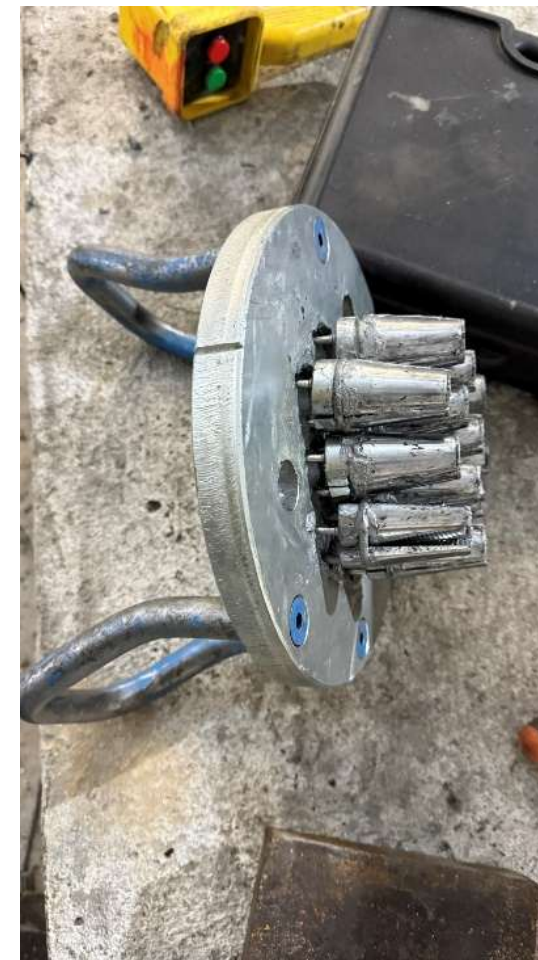
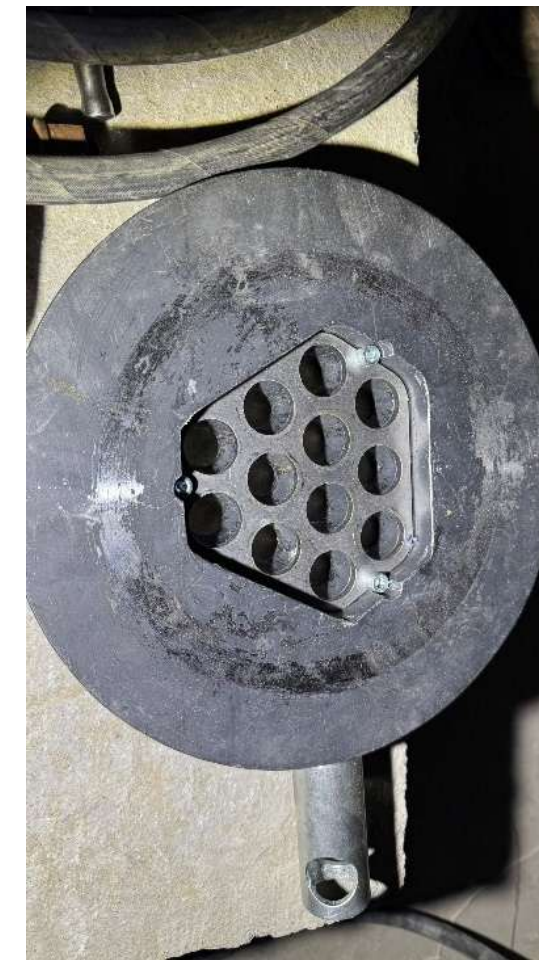
# EQUIPMENT

- Installation and stressing equipment to accommodate existing fleet
- Utilization of VSL ZPE460 SA 6-12 stressing jack
  - Modifications included gripper plate, gripper wedges, recess plate

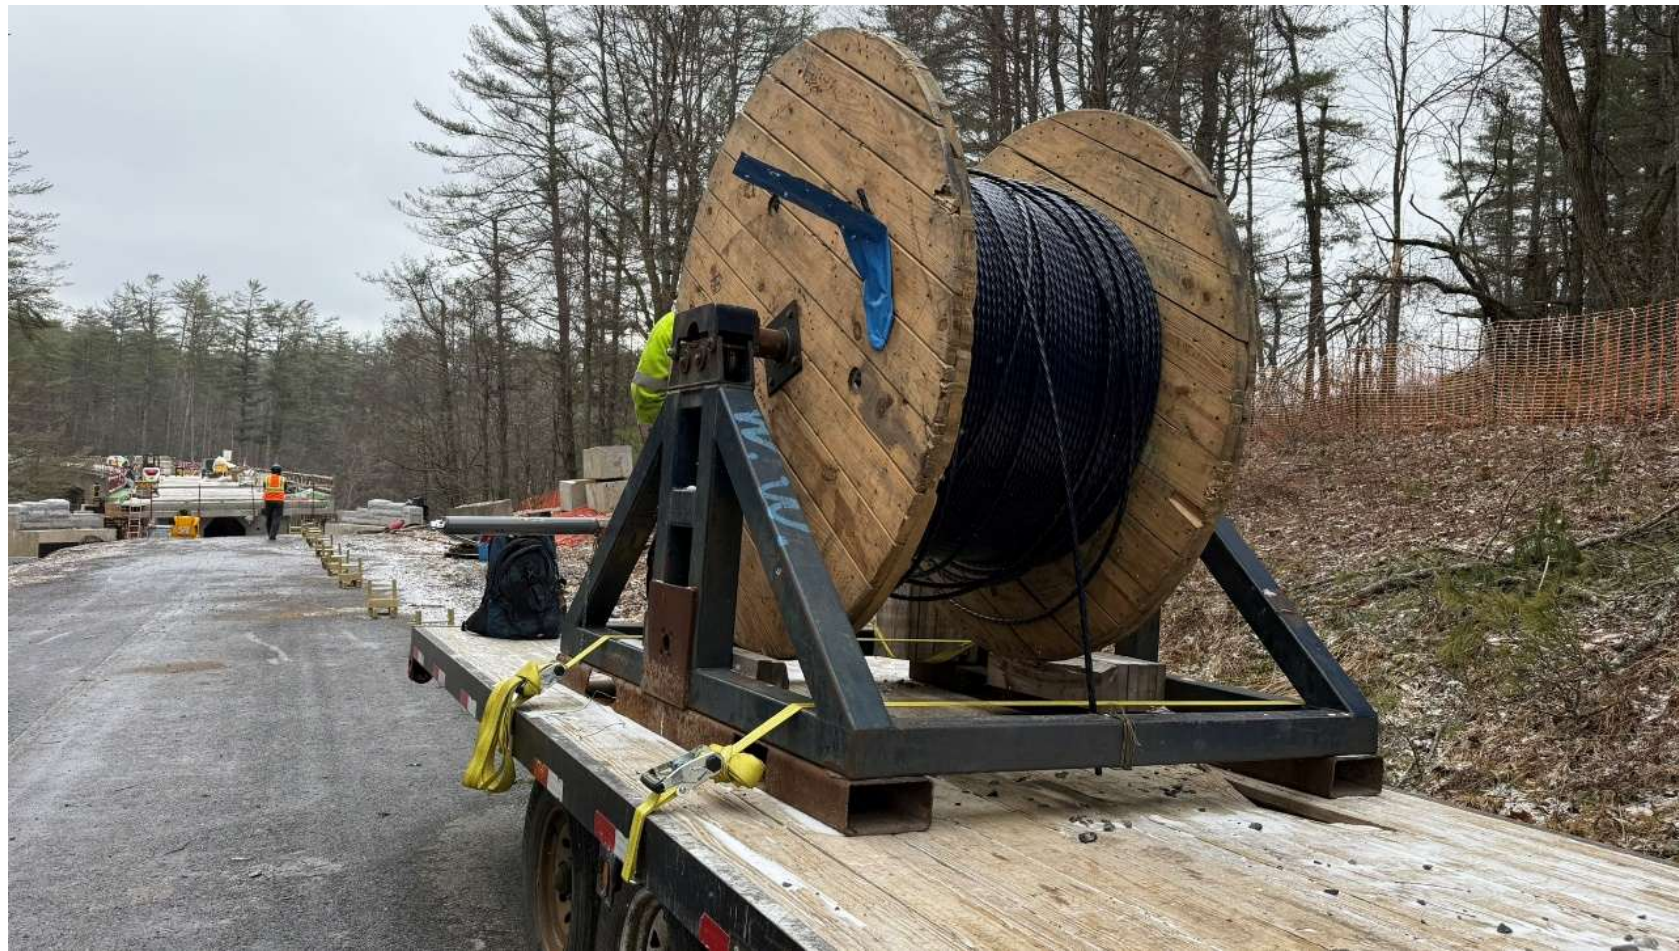
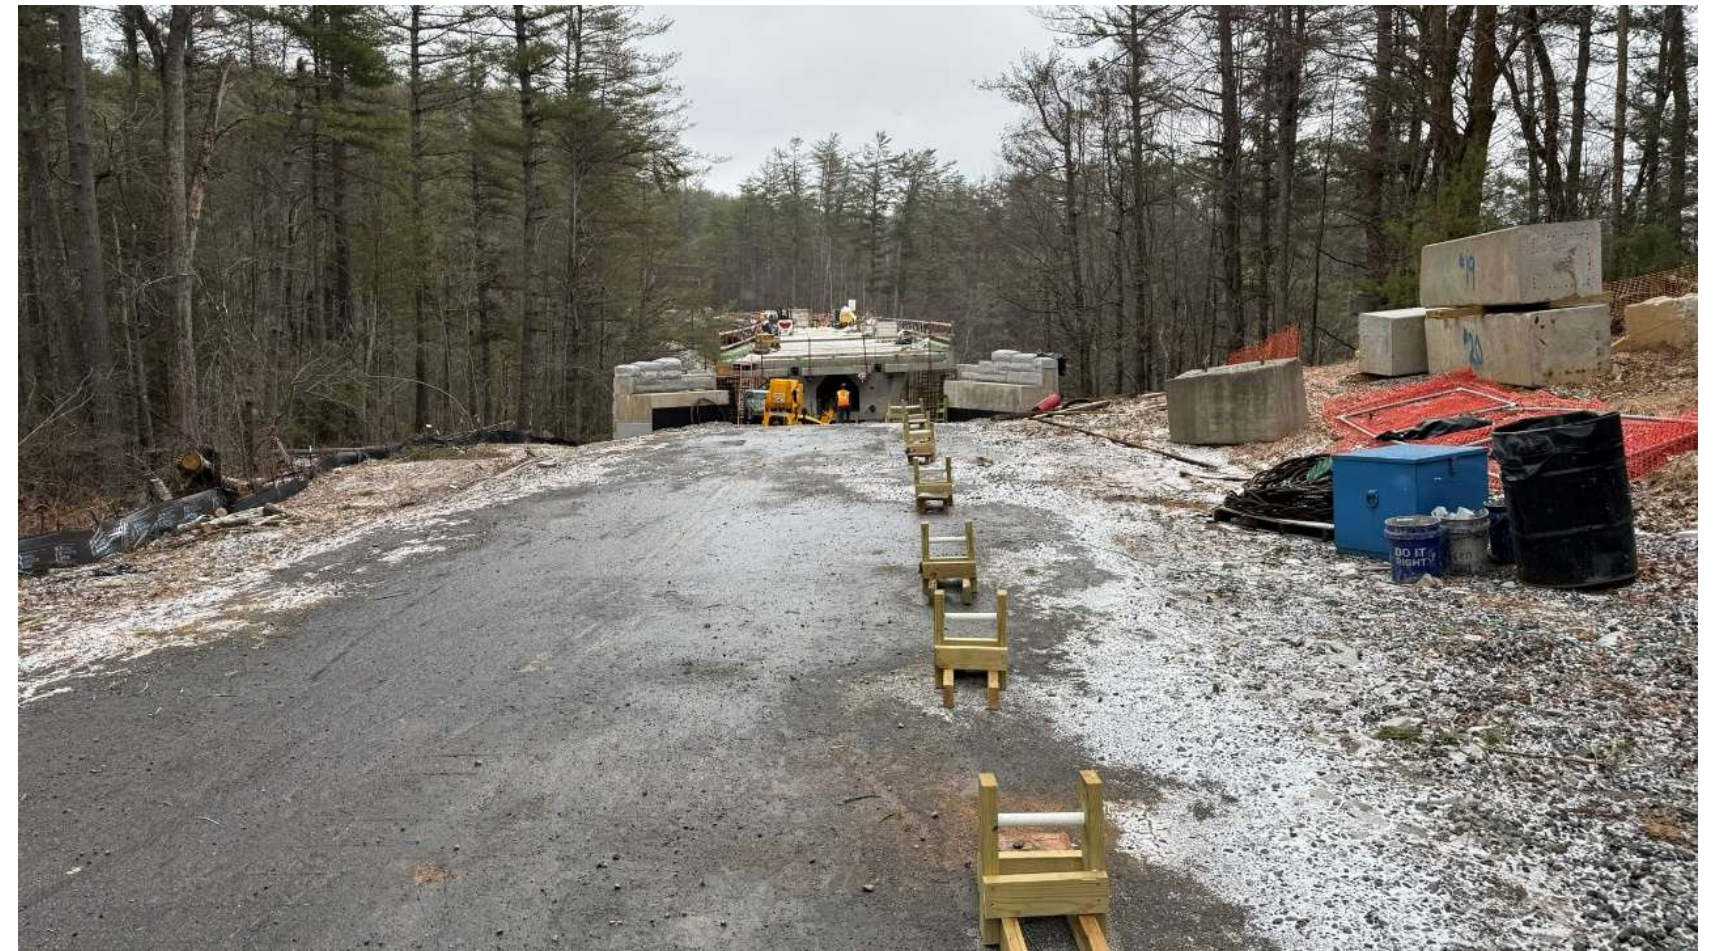
# INSTALLATION METHOD

- Importance of construction site conditions / constraints
- Strand delivered on wooden reel
- Uncoiling of strand and preventing contact with objects
- Various options for ground / strand contact protection depending on site conditions

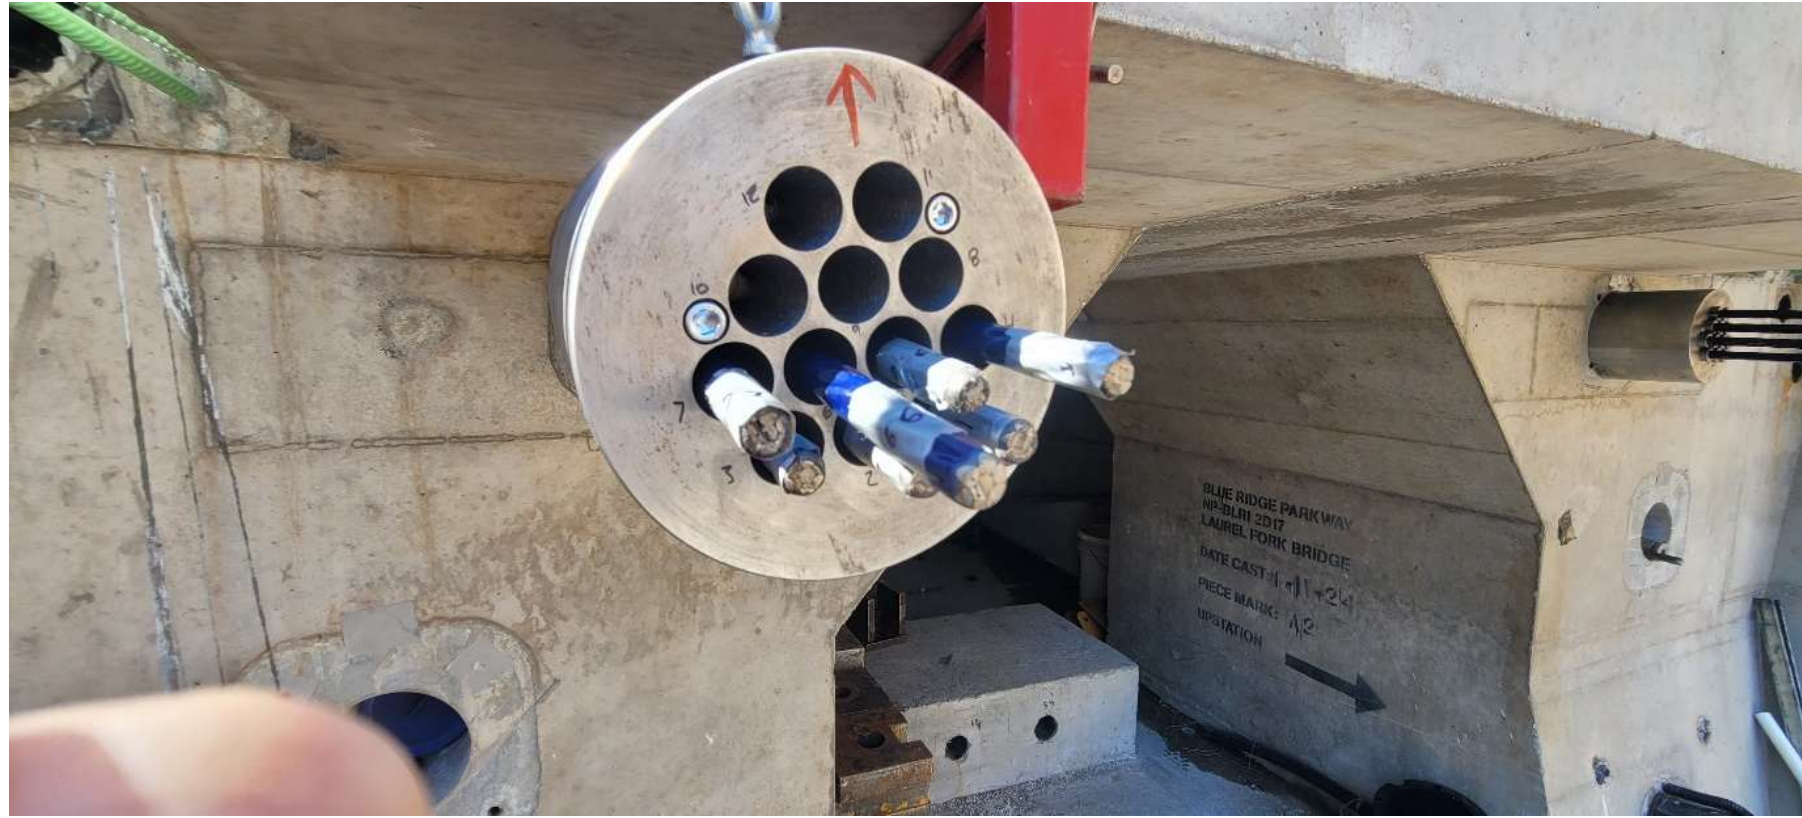
- Anchorage wedge cavities and strands identified

- Taping and containment once bundled

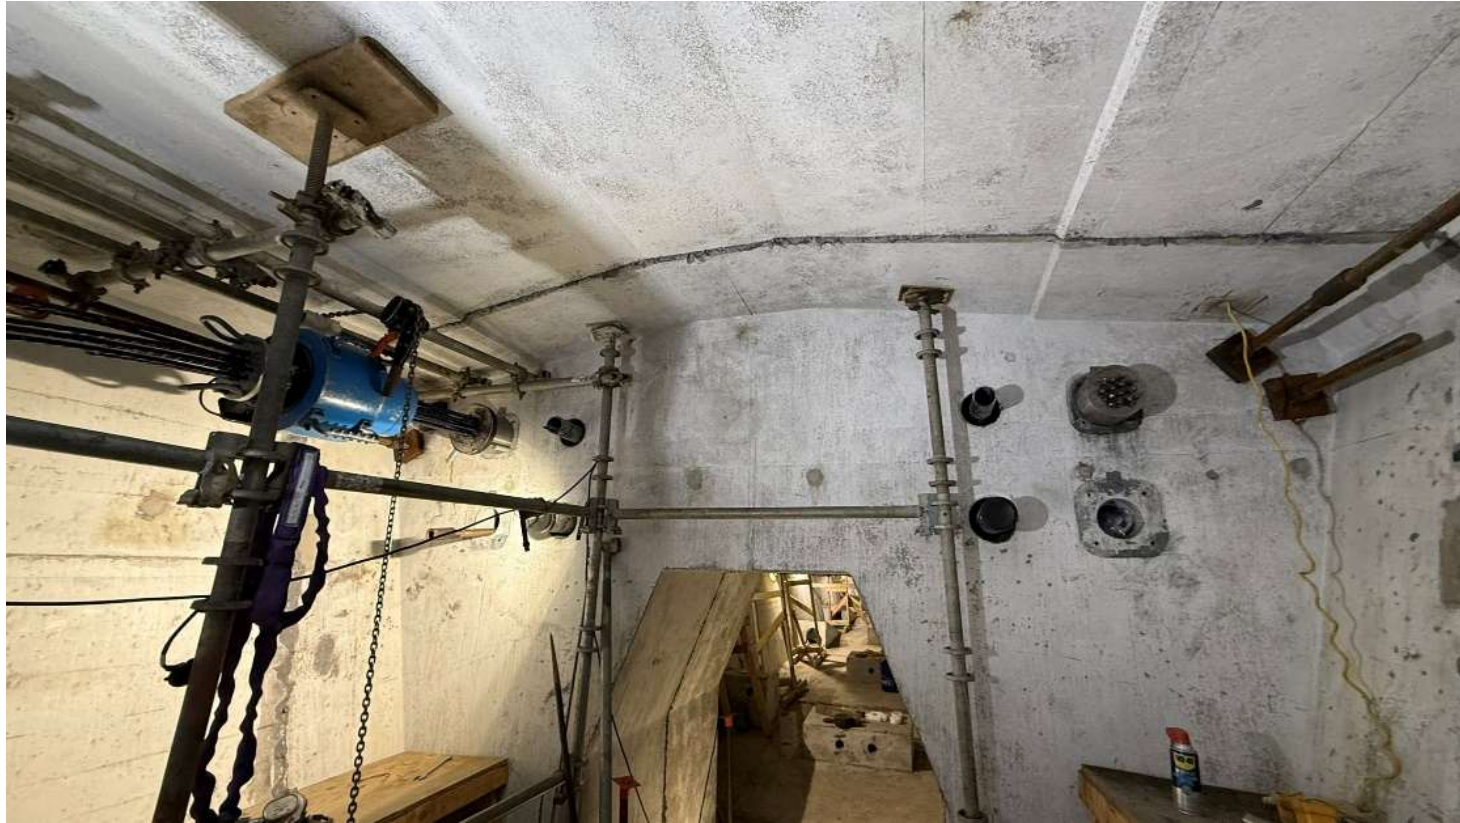
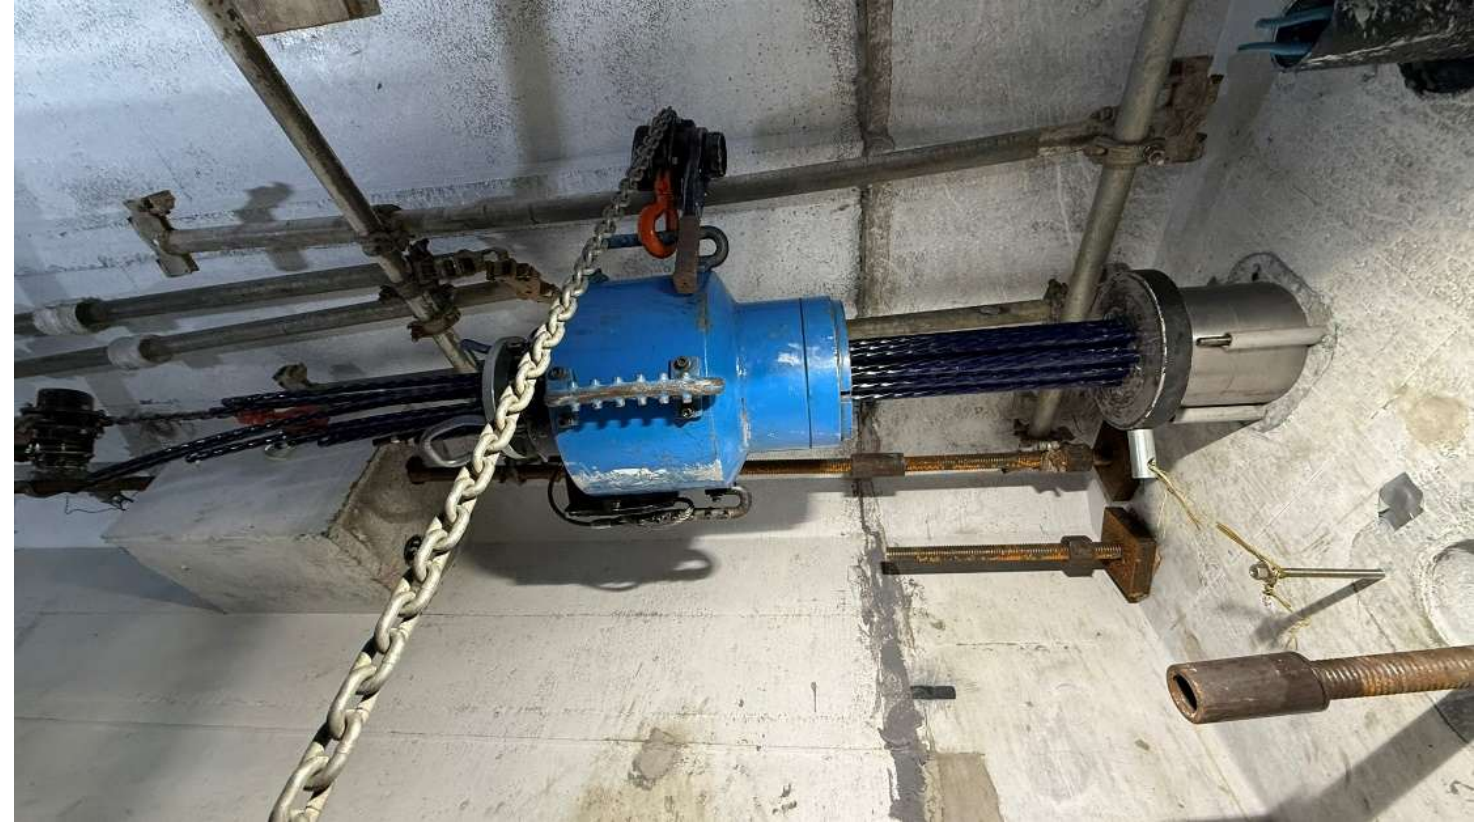
# STRESSING PROCEDURE

- Existing PT equipment with 4" stroke
- Evaluation of recess plate depth
- Design, test and implement specific wedge grippers
- Modify wedge gripper plate to accommodate new wedge grippers
- Additional wedge seating inspection steps

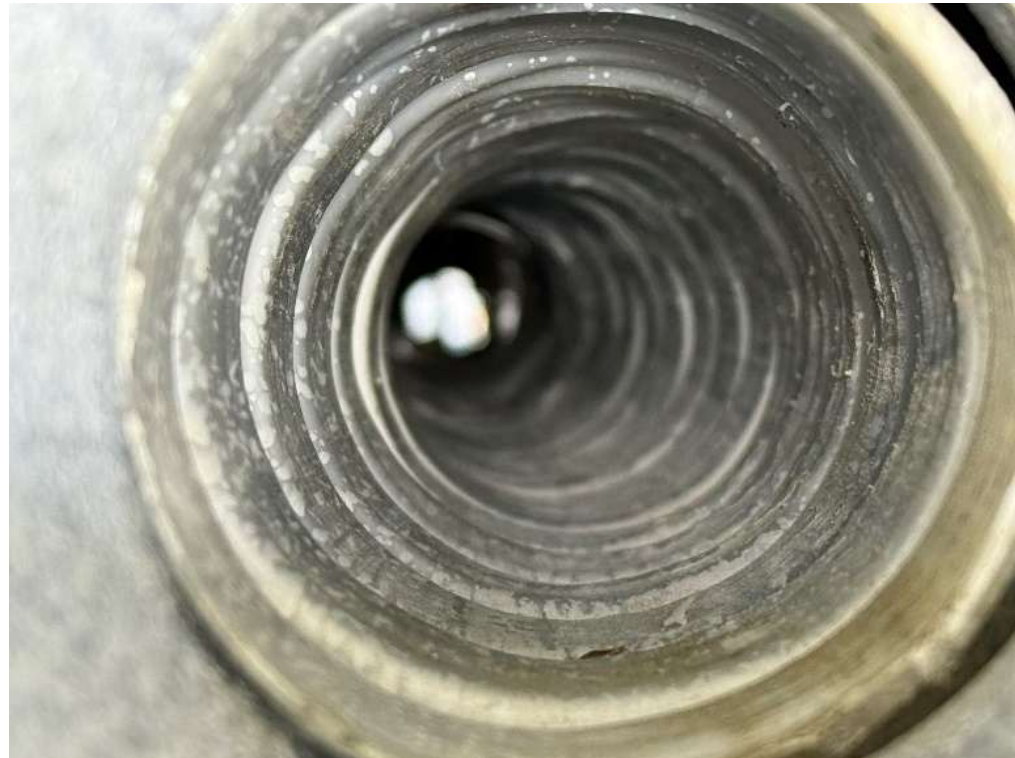
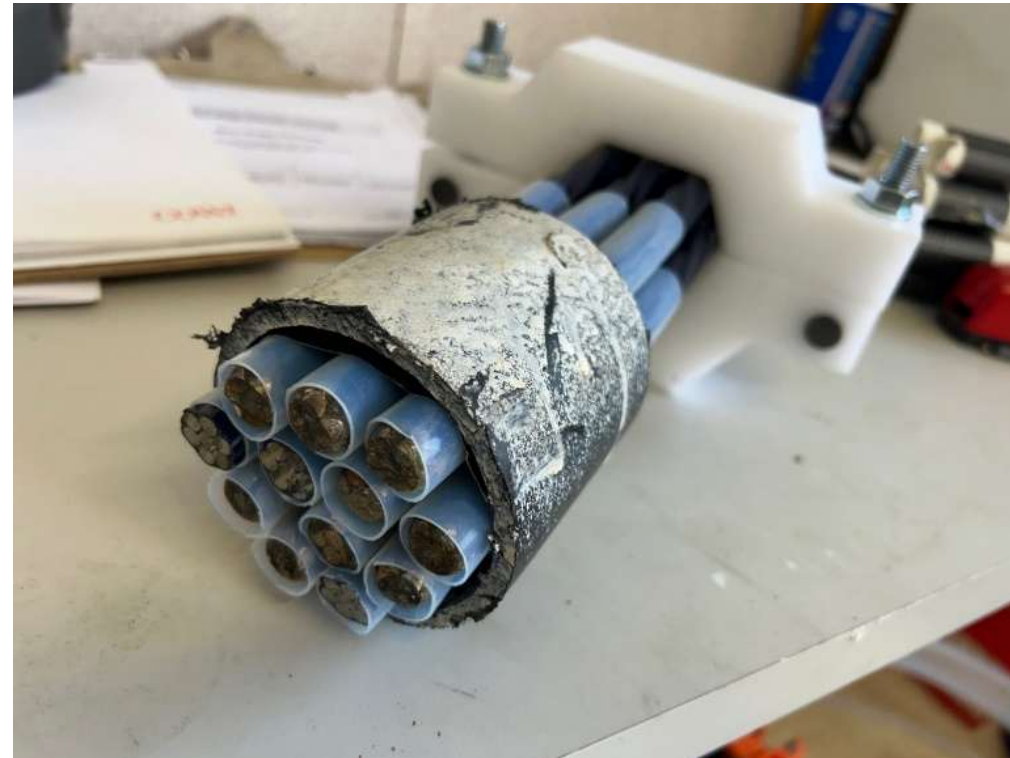
- Challenges:
  - Tight ducts at pier heads and deviator blocks – epoxy protection procedures difficult
  - Segmental joint mis-alignment resultant in reduction in void space for strand
  - Rubbing of epoxy coated strands on epoxy coated strands during install
  - Repair procedure and materials availability
  - Anchor protection cap installation constraints due to previous ECI system
  - Stressing operation – time to perform / wedge seating

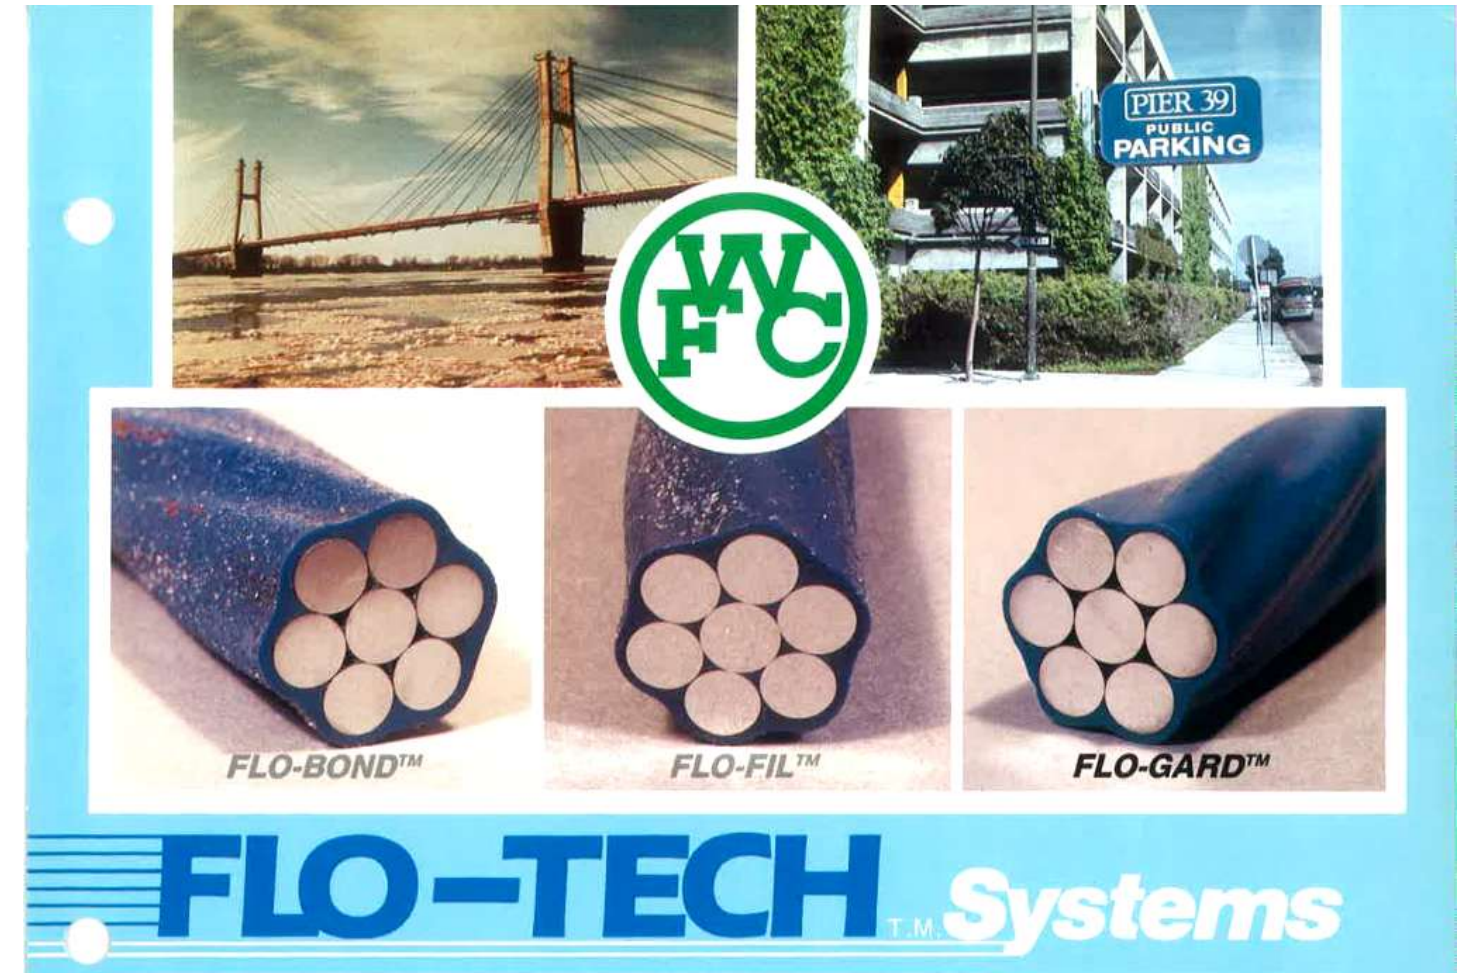
- **1981** - Invented by Florida Wire & Cable in the USA as ***Flo-Gard***<sup>™</sup>
  - 1<sup>st</sup> version had epoxy coating **only on outside** of strand
  - Originally patented by Florida Wire & Cable
    - *Patent has now expired*
- **1991** – Added to ASTM as A882
- **1992** (est) – ***Flo-Fil***<sup>™</sup>
  - 2<sup>nd</sup> version of epoxy-coated strand developed with epoxy coating **on inside and outside** of strand
- **Filled only** - Only produced and sold as **Filled** epoxy-coated strand now
- **Current Global Standards**
  - ISO 14655 1999-12-15 (International)
  - JSCE-E 141-2023 (Japan)
  - ASTM A882/A882M - ~~2020~~ **2026** (USA)
    - Max relaxation reduced from 6.5% down to **3.5%**
    - Epoxy **adhesion requirements increased** to ensure durability

**Source:** Circa 1990's Florida Wire & Cable sales brochure

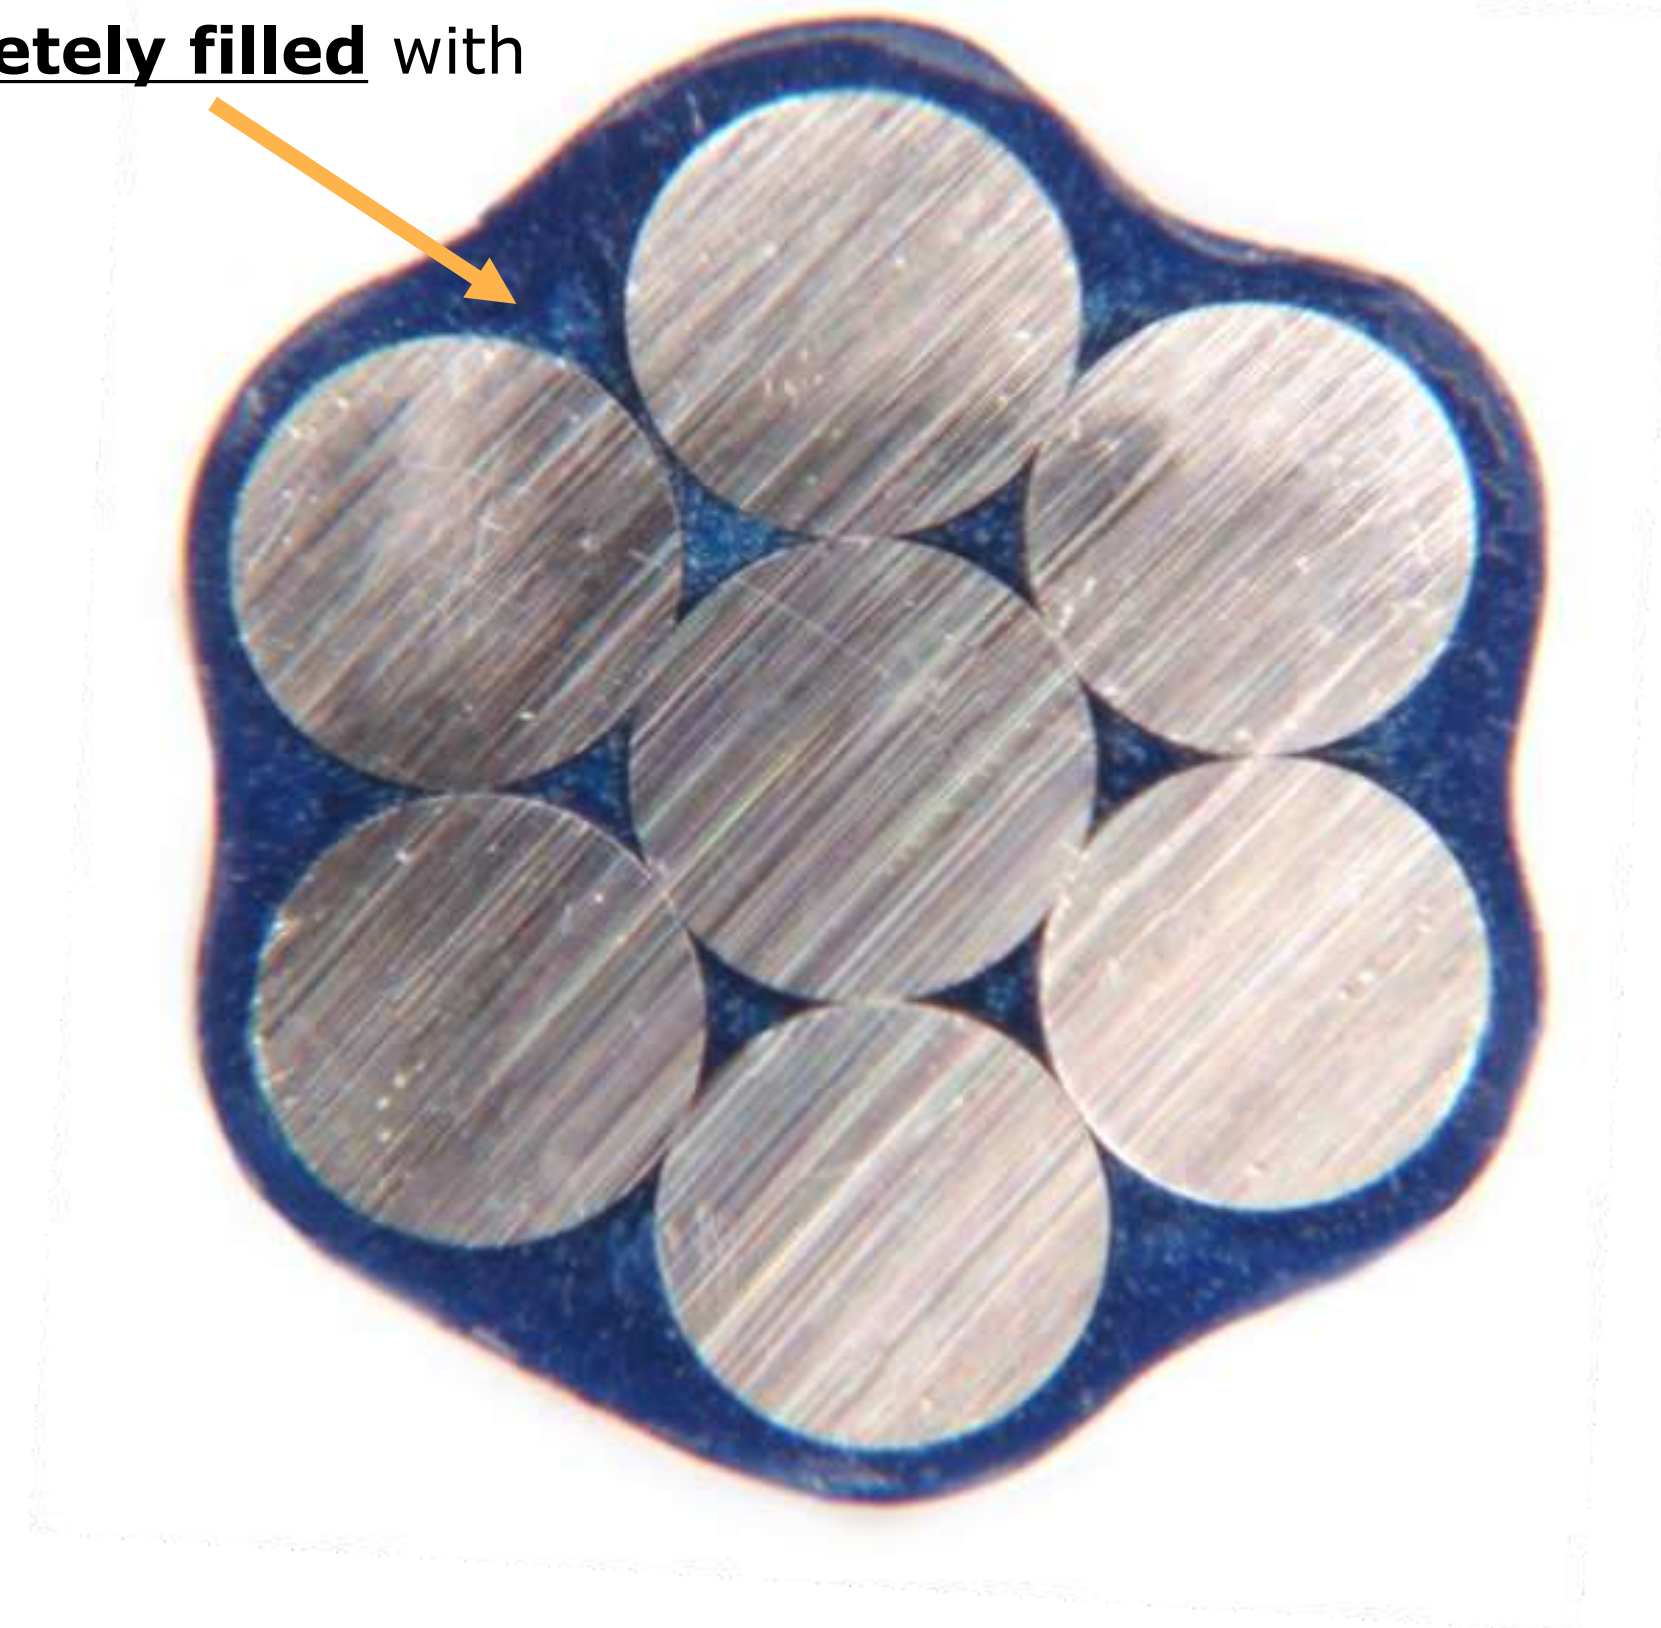
Each wire individually  
coated & all internal voids  
completely filled with  
epoxy

Each wire **individually** coated & all internal voids **completely filled** with epoxy

**Coating thickness** @  
crown of wire:  
15 mils – 45 mils  
(0.38 mm – 1.14 mm)

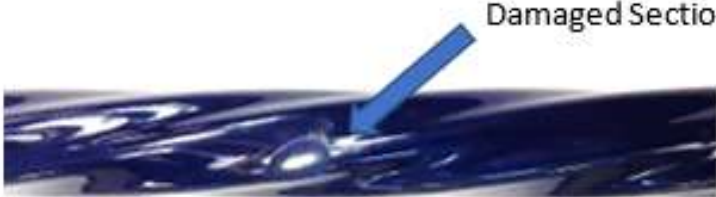
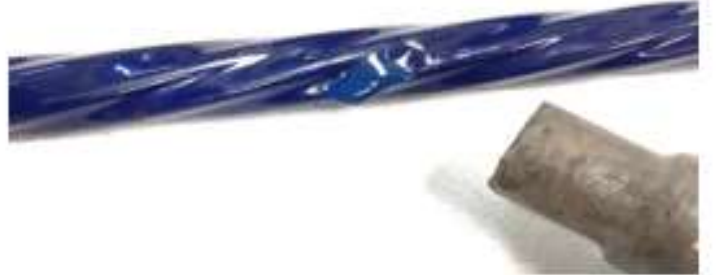
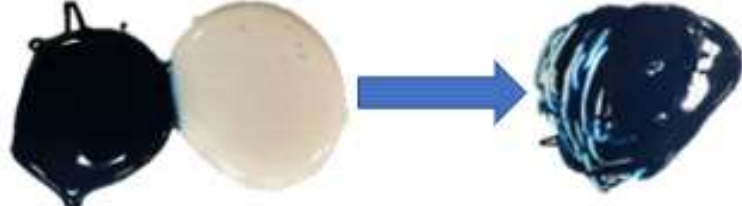
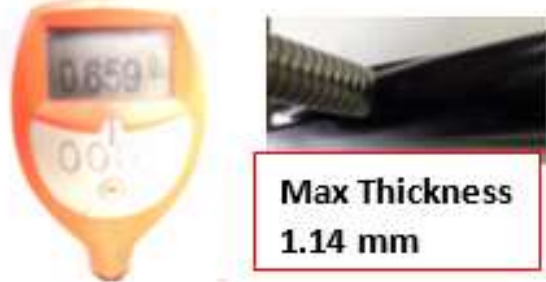
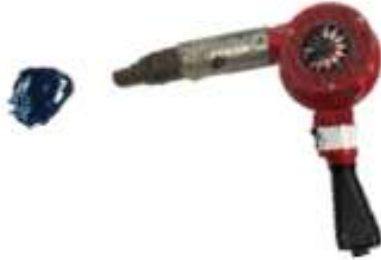
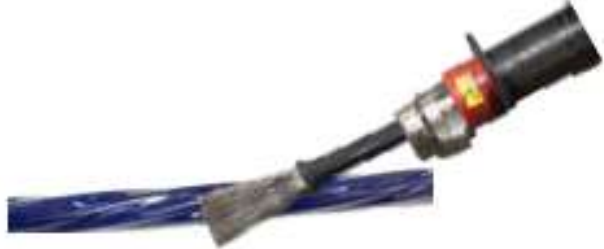
## Epoxy Repair Procedure Using 2-Part Epoxy Resin

| Step 1 | <b>Clean and dry surface:</b><br>Remove all oil, grease, dust and loose, damaged coating from the area to be repaired | | Step 5 | <b>Apply heat to patch with heat gun:</b><br>Hold heat gun approximately 2 inches away and heat patch for 25-30 seconds. Move heat gun around to insure consistent heating of patch. Let patch stand for about two minutes. Check for tackiness. Repeat until patch is no longer tacky to the touch. | |
| Step 2 | <b>Mix equal amounts of Part A with Part B:</b><br>Mix on a disposable surface until uniform color and consistency is achieved. DO NOT mix below 40°F. | | Step 6 | <b>Check thickness of patch:</b><br>Use Elcometer® 456 tool (or equivalent) to measure the epoxy + patch thickness at the crown of the wire at the patch location. If thicker than 1.14mm use the rotary tool to remove material until thickness is between 0.38 mm - 1.14mm | |
| Step 3 | <b>Heat mixture with heat gun:</b><br>Recommended heat gun with output of 800°F to 1000°F. Heat up for about 10 seconds then mix (repeat if needed). The mixture will have the consistency of a thick syrup when it's ready to be used. | | Step 7 | <b>Check patch continuity:</b><br>Use the hand-held holiday detector at a setting of 3KV to ensure there is no leak on the patch. | |
| Step 4 | <b>Apply patch to strand:</b><br>Apply mixture to damaged section of strand with a disposable object such as a small spatula or trowel. | | | | |

- *Epoxy can be repaired in the field using this same procedure.*
- *Epoxy patches have the same or better adhesion and corrosion resistance as original epoxy coating.*

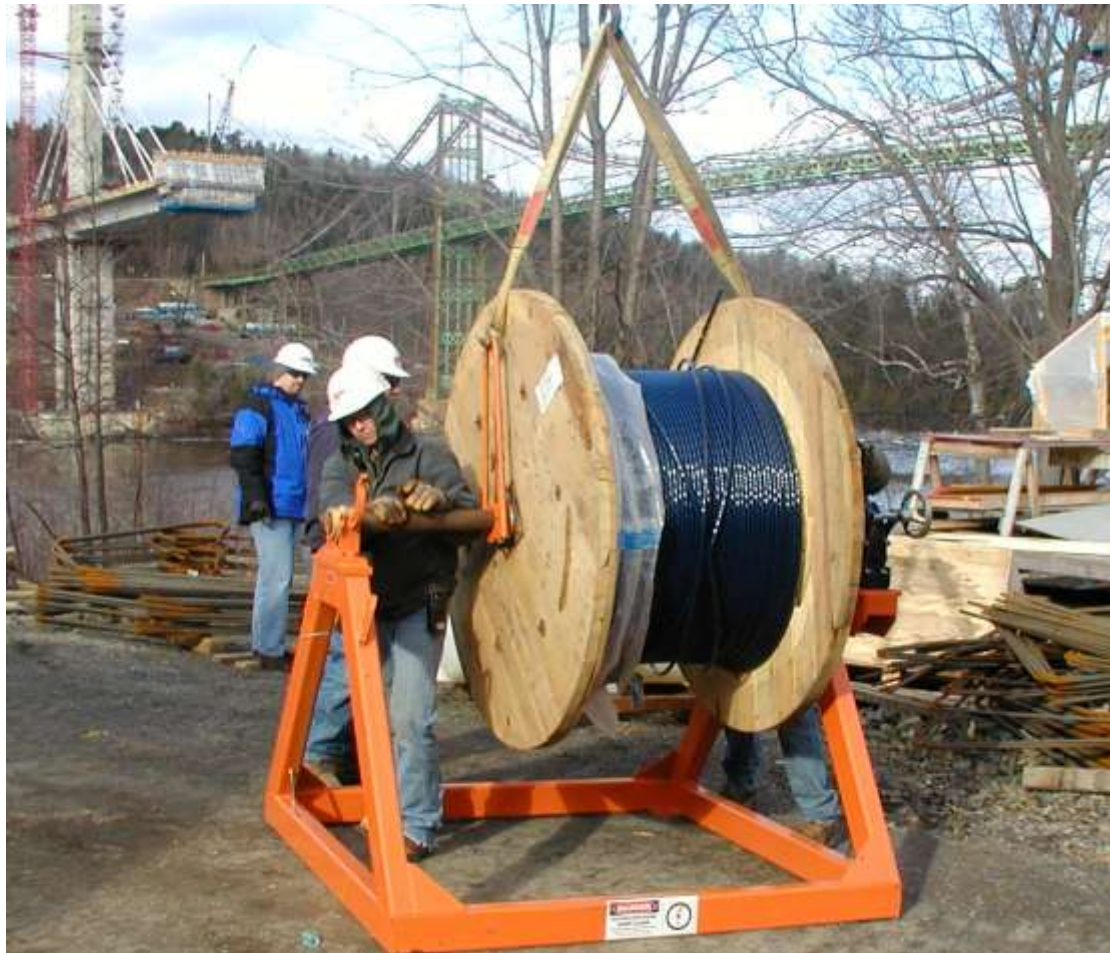
# Epoxy Coating Comparison: PC Strand & Rebar Handling

Epoxy-coated strand is shipped and handled in the field using protective wooden spools.
