# 2026 NCBC WEBINAR SERIES

## Unducted Epoxy-Coated Strand in Practice: The Laurel Fork Bridge

# **EPOXY COATED STRANDS INSTALLATION**

# ASTM A882 Epoxy-Coated PC Strand Manufacturing & Testing

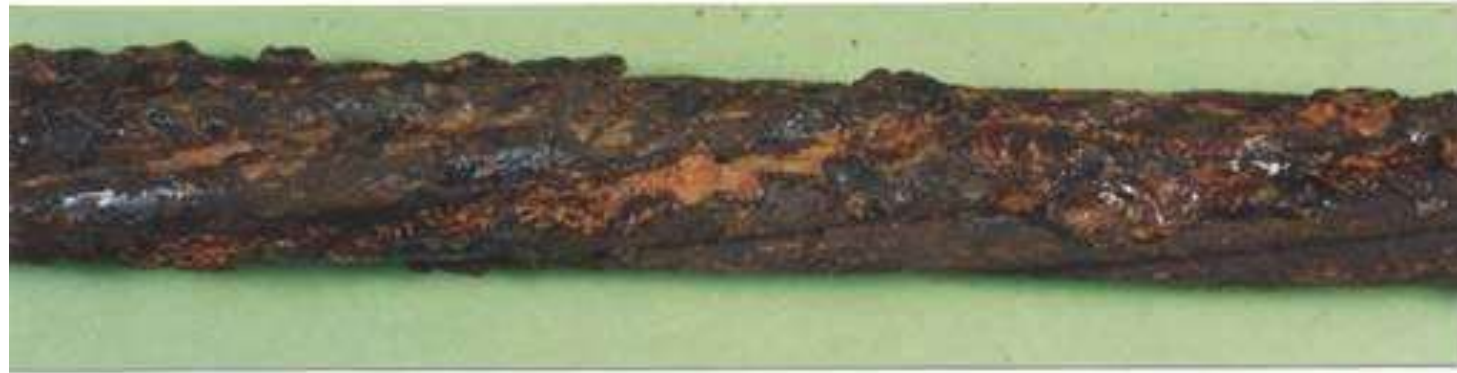
Bare strand

Corrosion

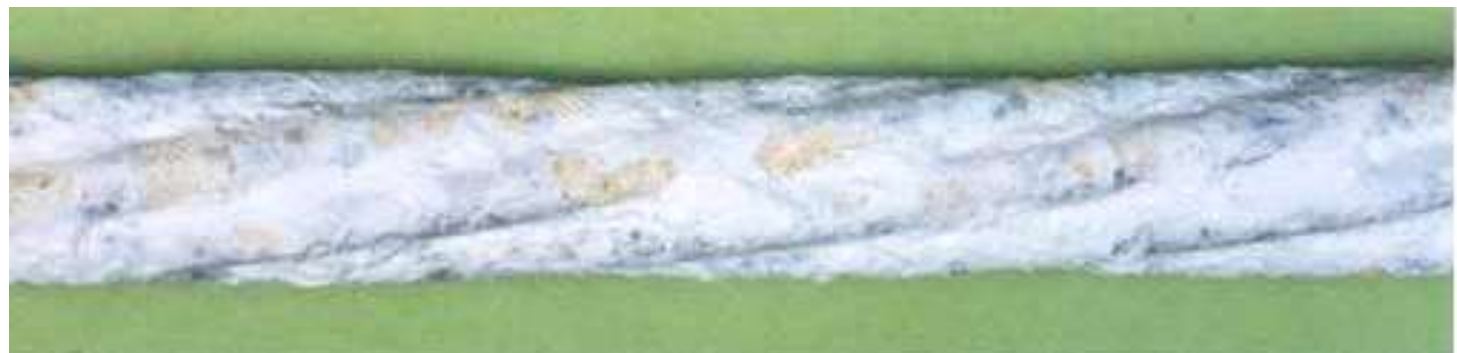
Galvanized strand

Corrosion (chalking)

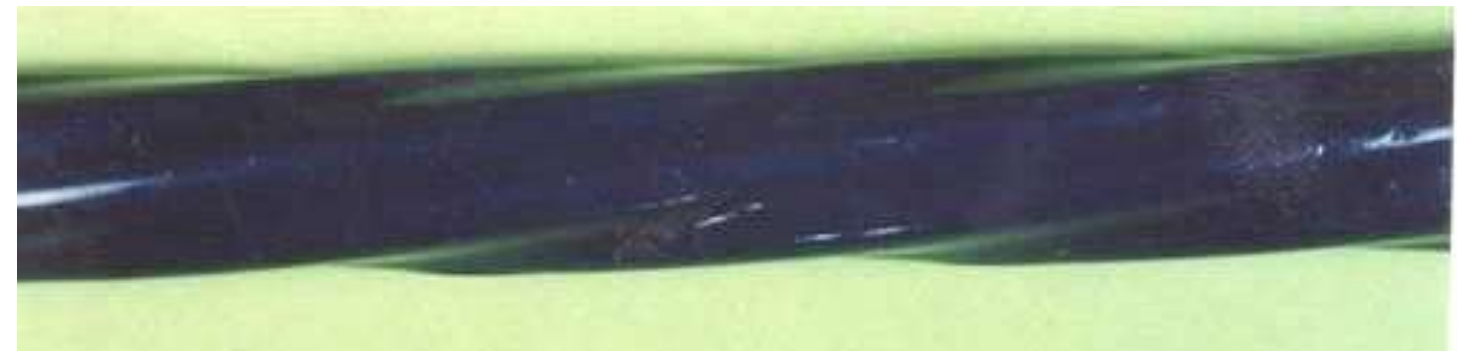
Epoxy-coated strand

No corrosion

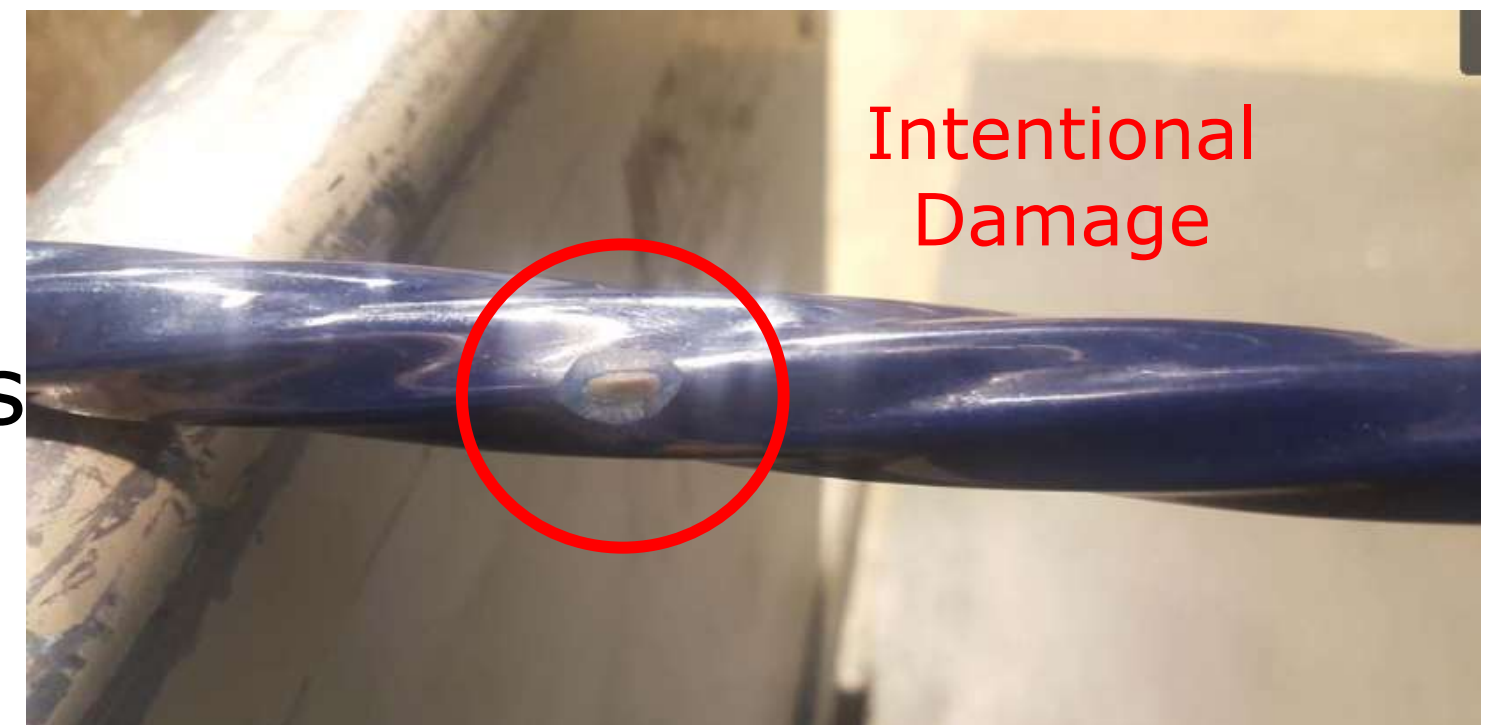
- Testing Conditions (ASTM A882)
  - Strand stressed 70% GUTS
  - **Intentional** Damage
- Test Results
  - **No loss** of tensile strength
  - **No corrosion** on wire except on the exposed wire surface.
    - **No corrosion migration** nor loss of epoxy adhesion

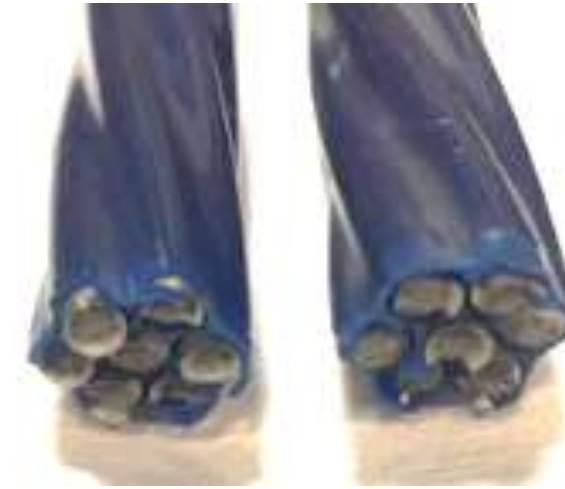
- Epoxy coating can elongate >50%.
- Elongation and adhesion confirmed by 32 x strand diameter mandrel bending test and tensile test
- Long-term elongation property confirmed by performing mandrel test and tensile test on strand taken from 800 mm ID wooden spools in warehouse after 10+ years storage.
  - No cracking or disbonding of epoxy coating in tensile test
  - No cracking or disbonding of epoxy coating in mandrel test

Example tensile test result after 10+ years storage

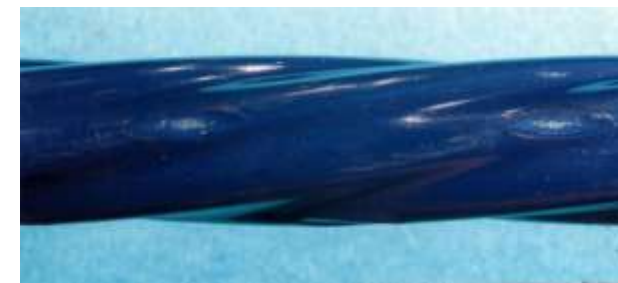
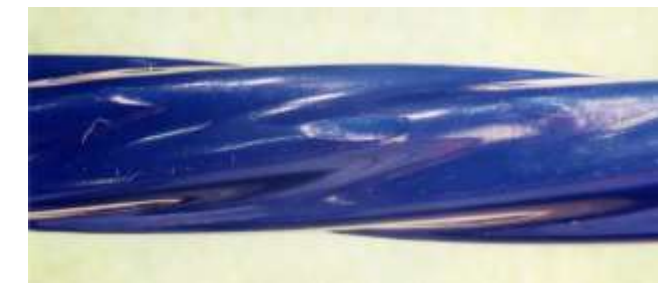
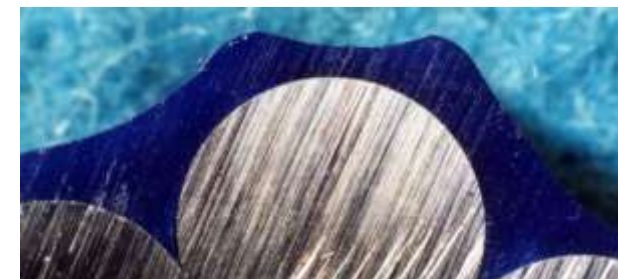
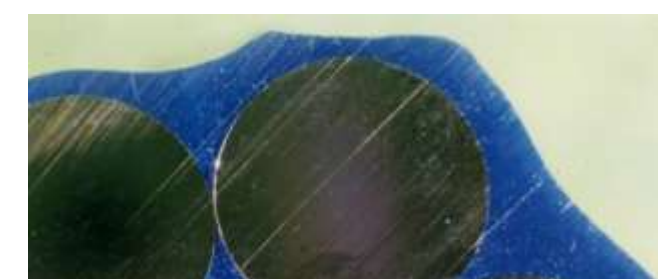
| Tendon Types | 19 x 0.6" Strand Tendons<br>Parallel Strands and Twisted Strands |

\*90% of nominal yield point

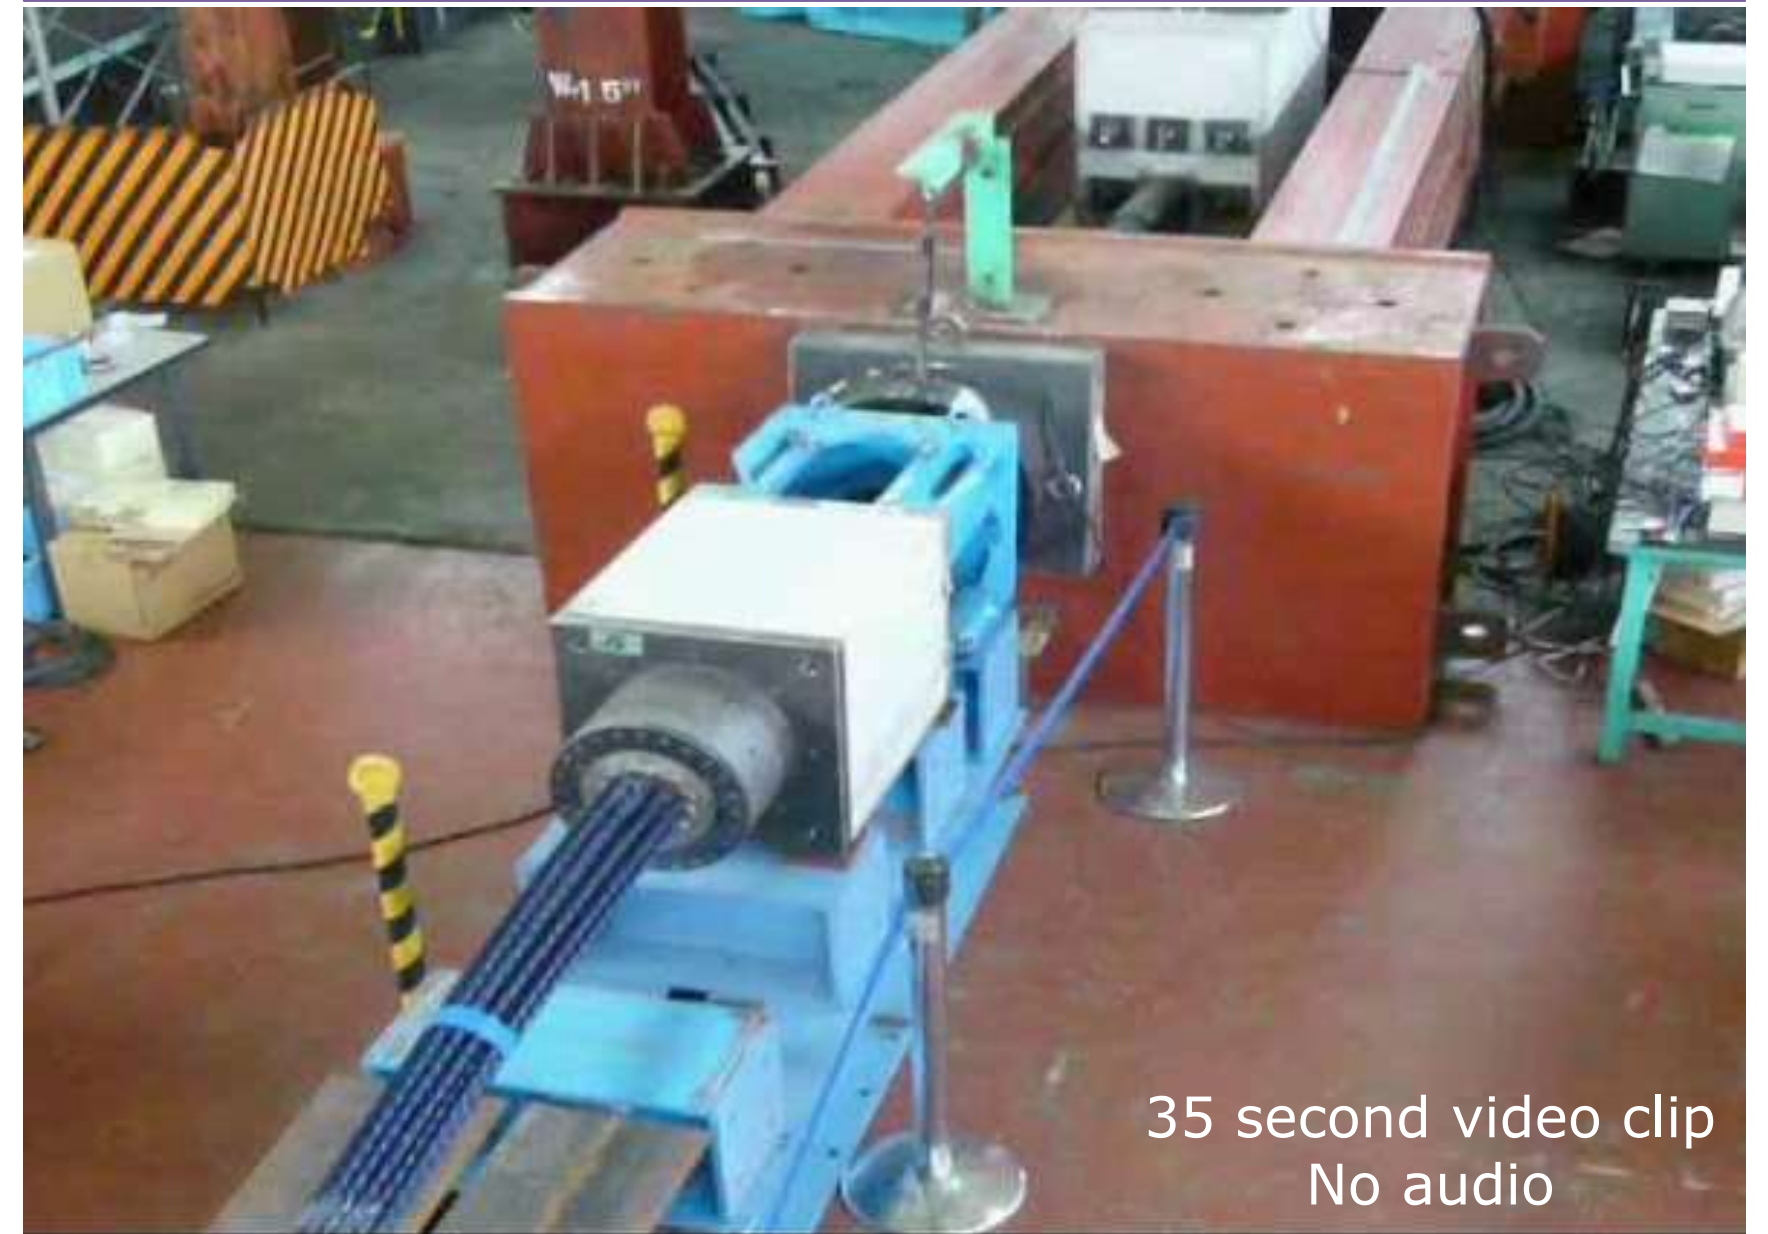
**Tested 3 Strand Types:** Bare strand, HDPE-coated strand, Epoxy-coated strand

- **13 wire breaks**  
at the contact point of each strands

- **4 wire breaks**  
at the contact point of each strands
- **Steel surface exposed**

- **No wire breaks**
- **Steel surface not exposed**

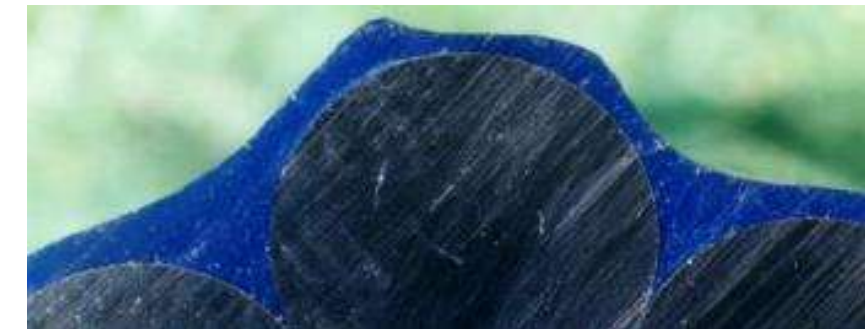
## Epoxy-coated strand

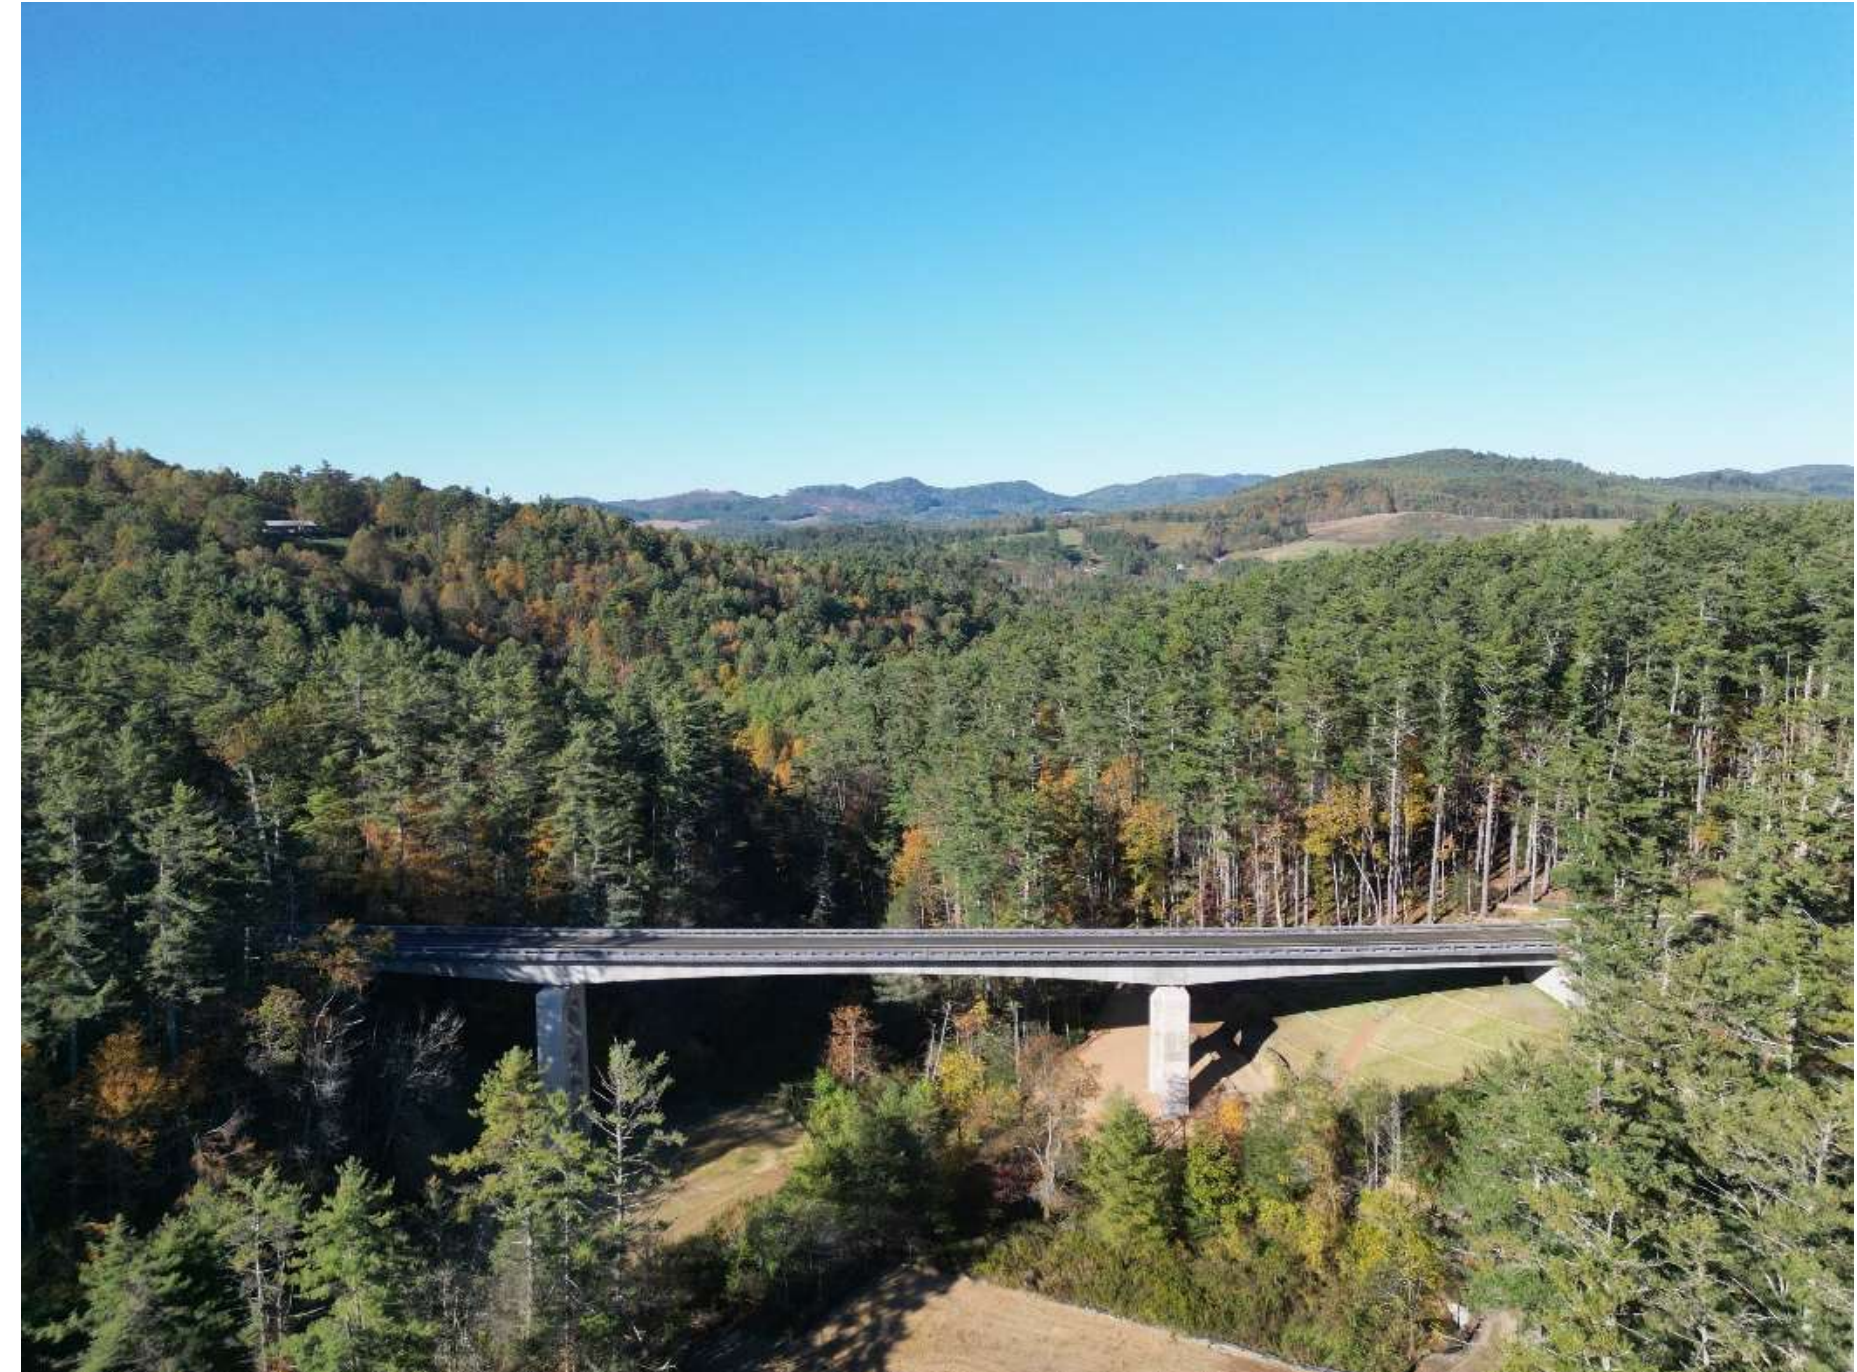
FHWA Demonstration Project for ECS continuity tendons

- Owner: National Park Service
- Prime Engineer: EFLHD
- Segmental Bridge Engineer: COWI
- Contractor: Structural Technologies/Vannoy JV
- ECS Supplier: Sumiden Wire Products

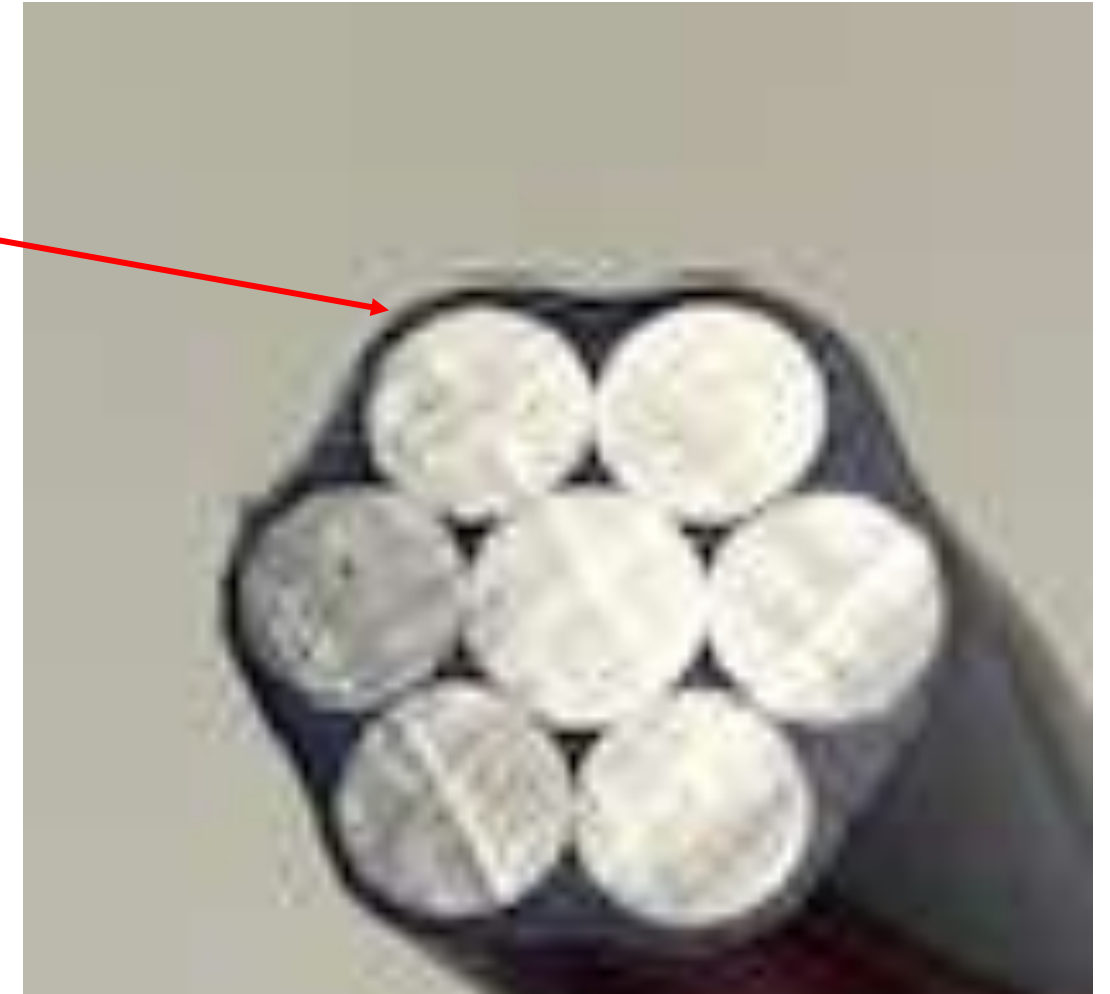
- Epoxy coating can be manufactured from 0.45 – 1.1mm thickness
- They selected wire with a 0.6-0.8mm epoxy thickness was selected for this project referenced that they knew it was going to be pushed.
- Following strand installation, field measurements showed epoxy coating residual thickness >0.45mm

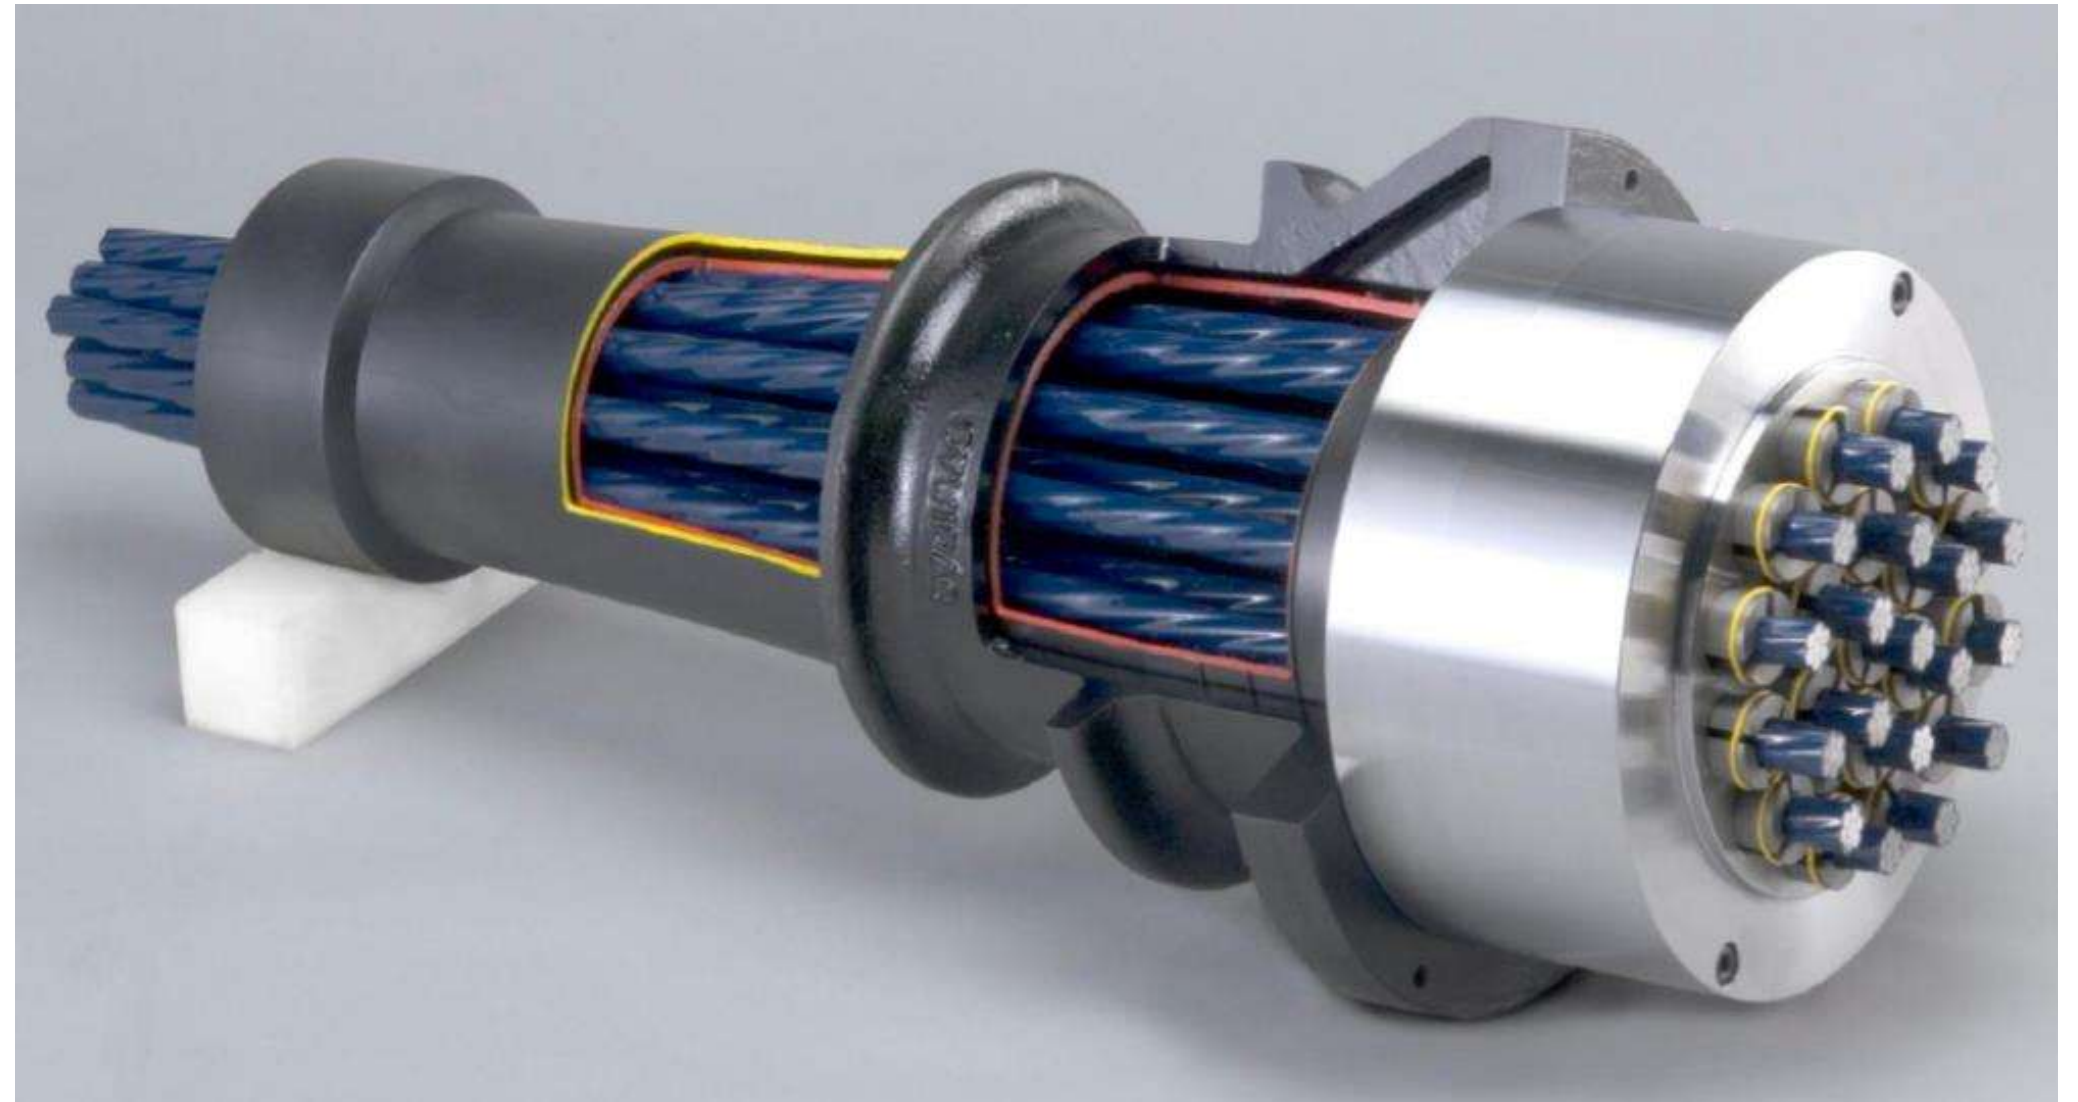
Standard wedge for bare strand

Bite into steel through epoxy coating  
without stripping

Inspection after removing epoxy coating

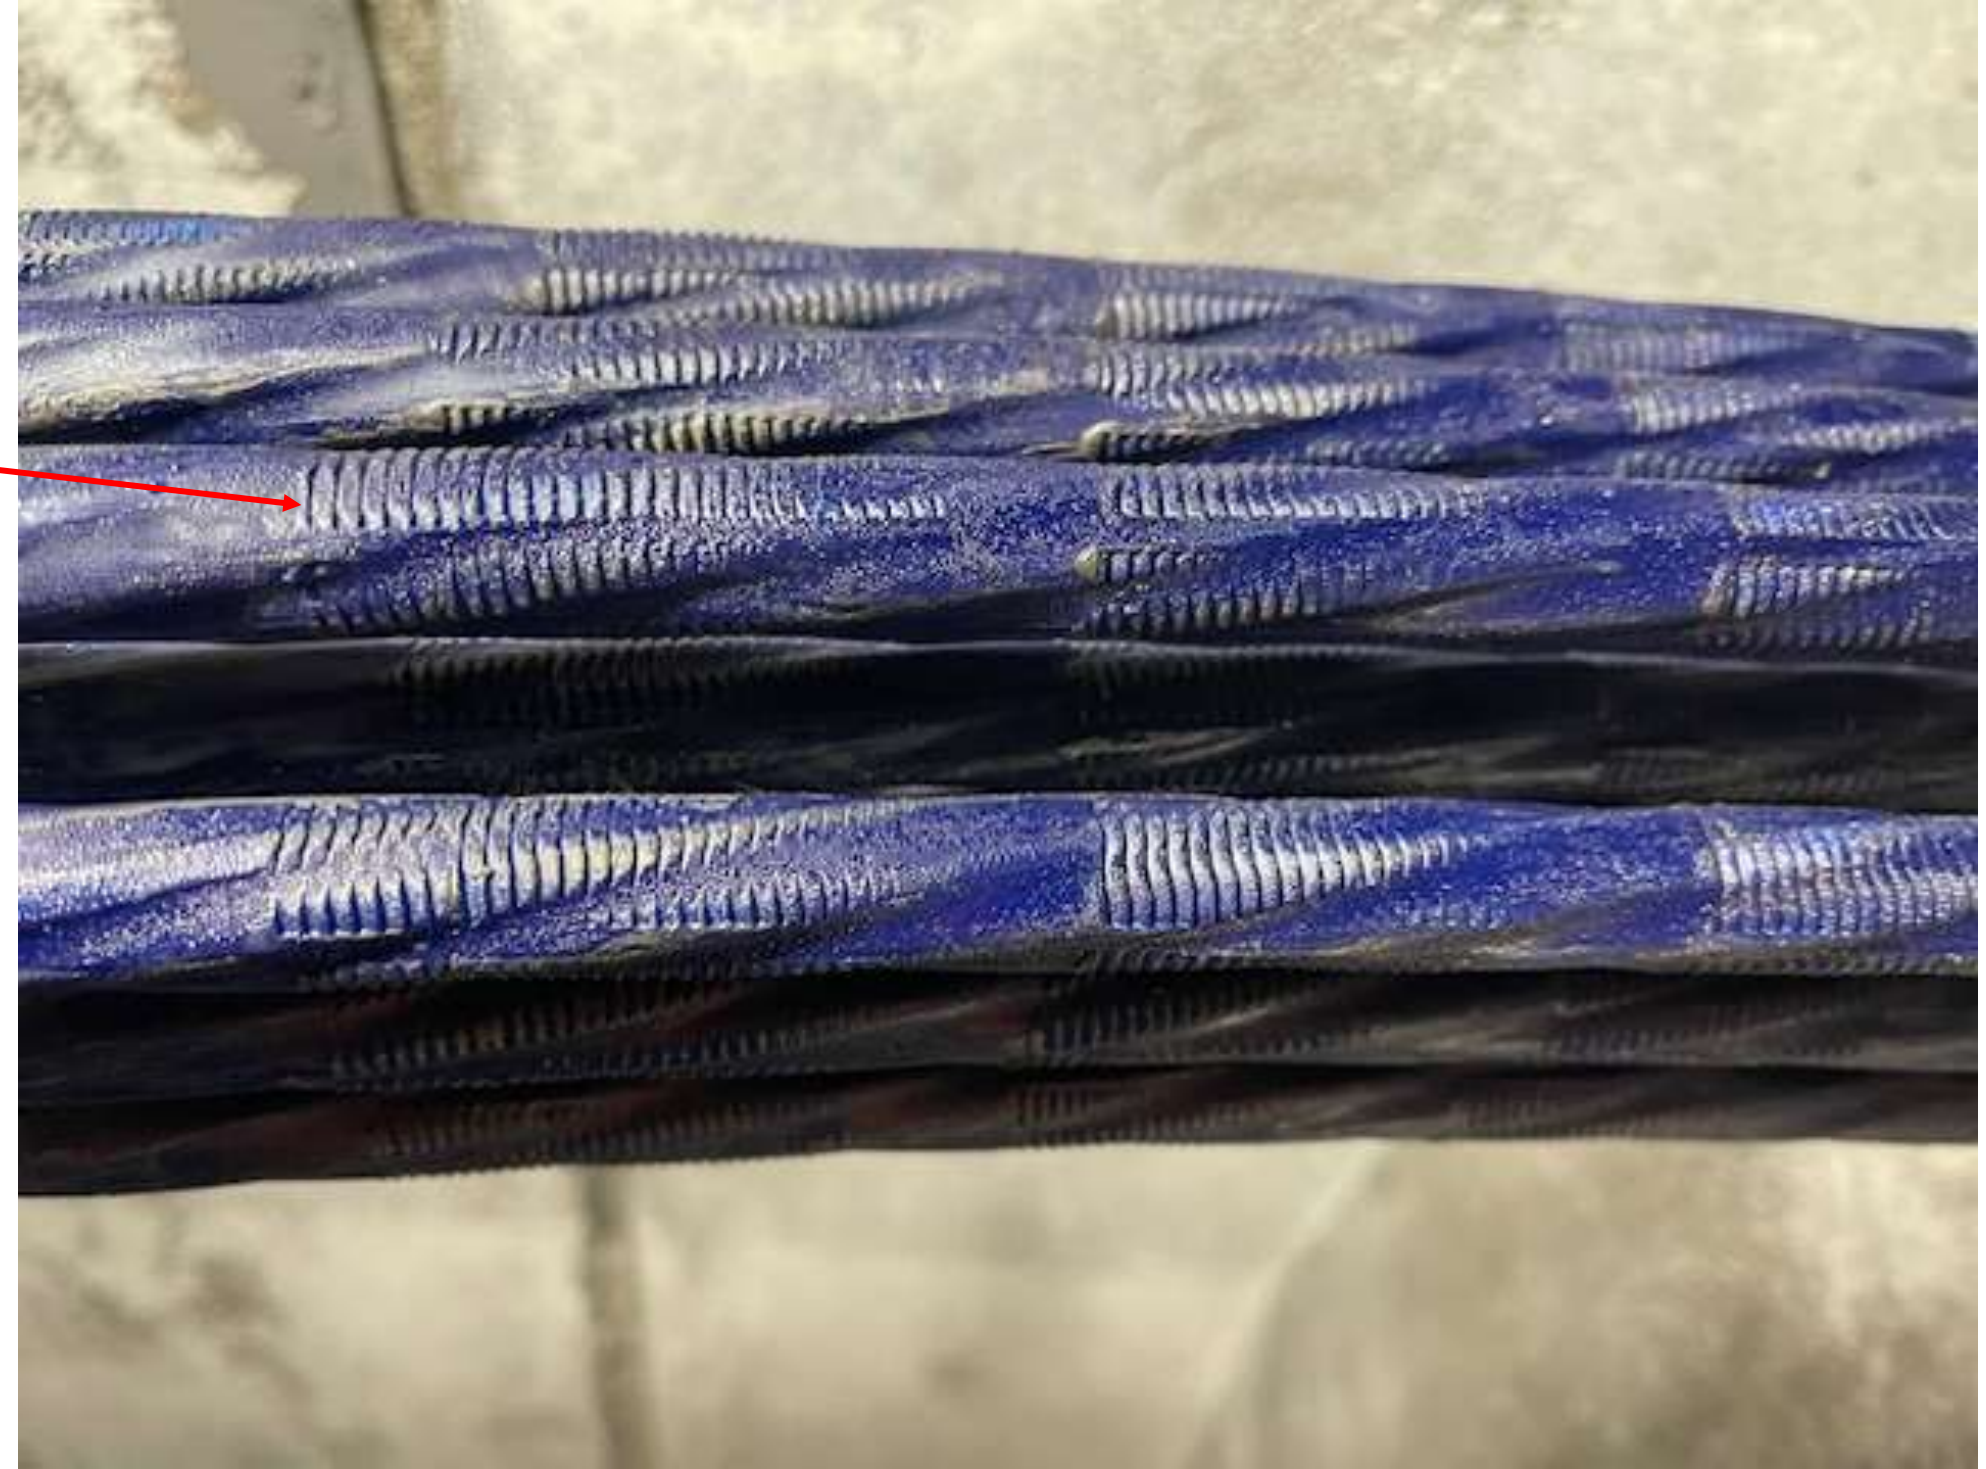
Anchor Wedge marks

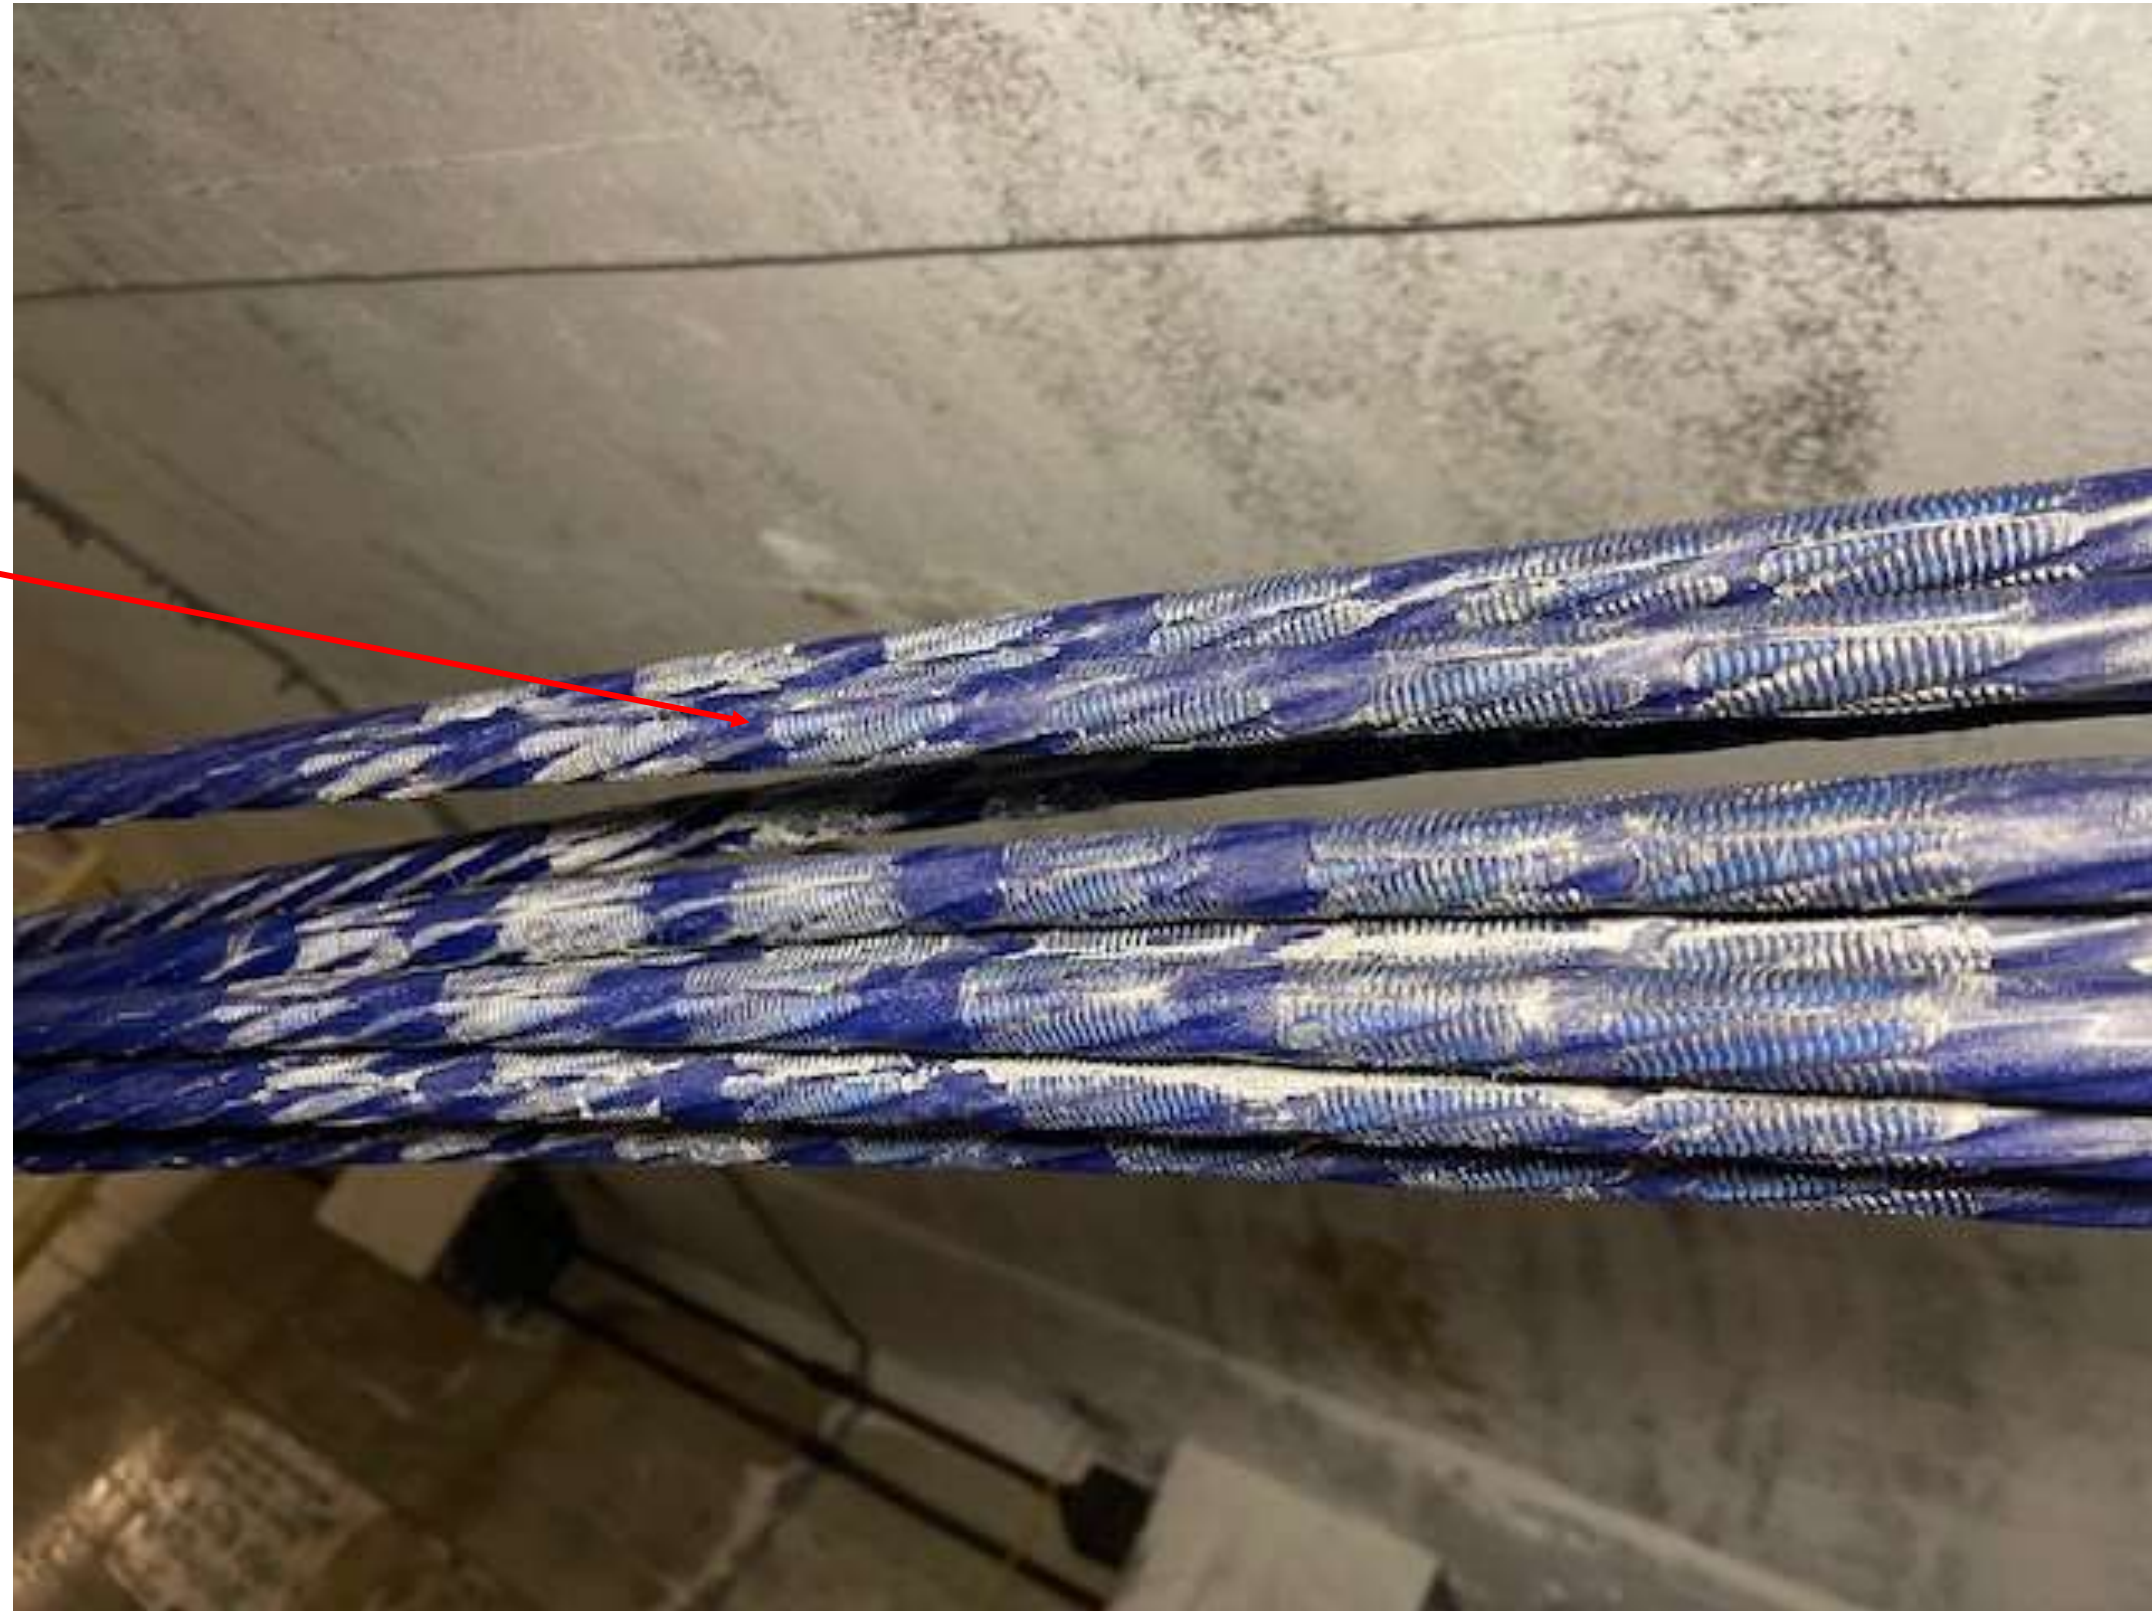
Pulling Head Wedge marks

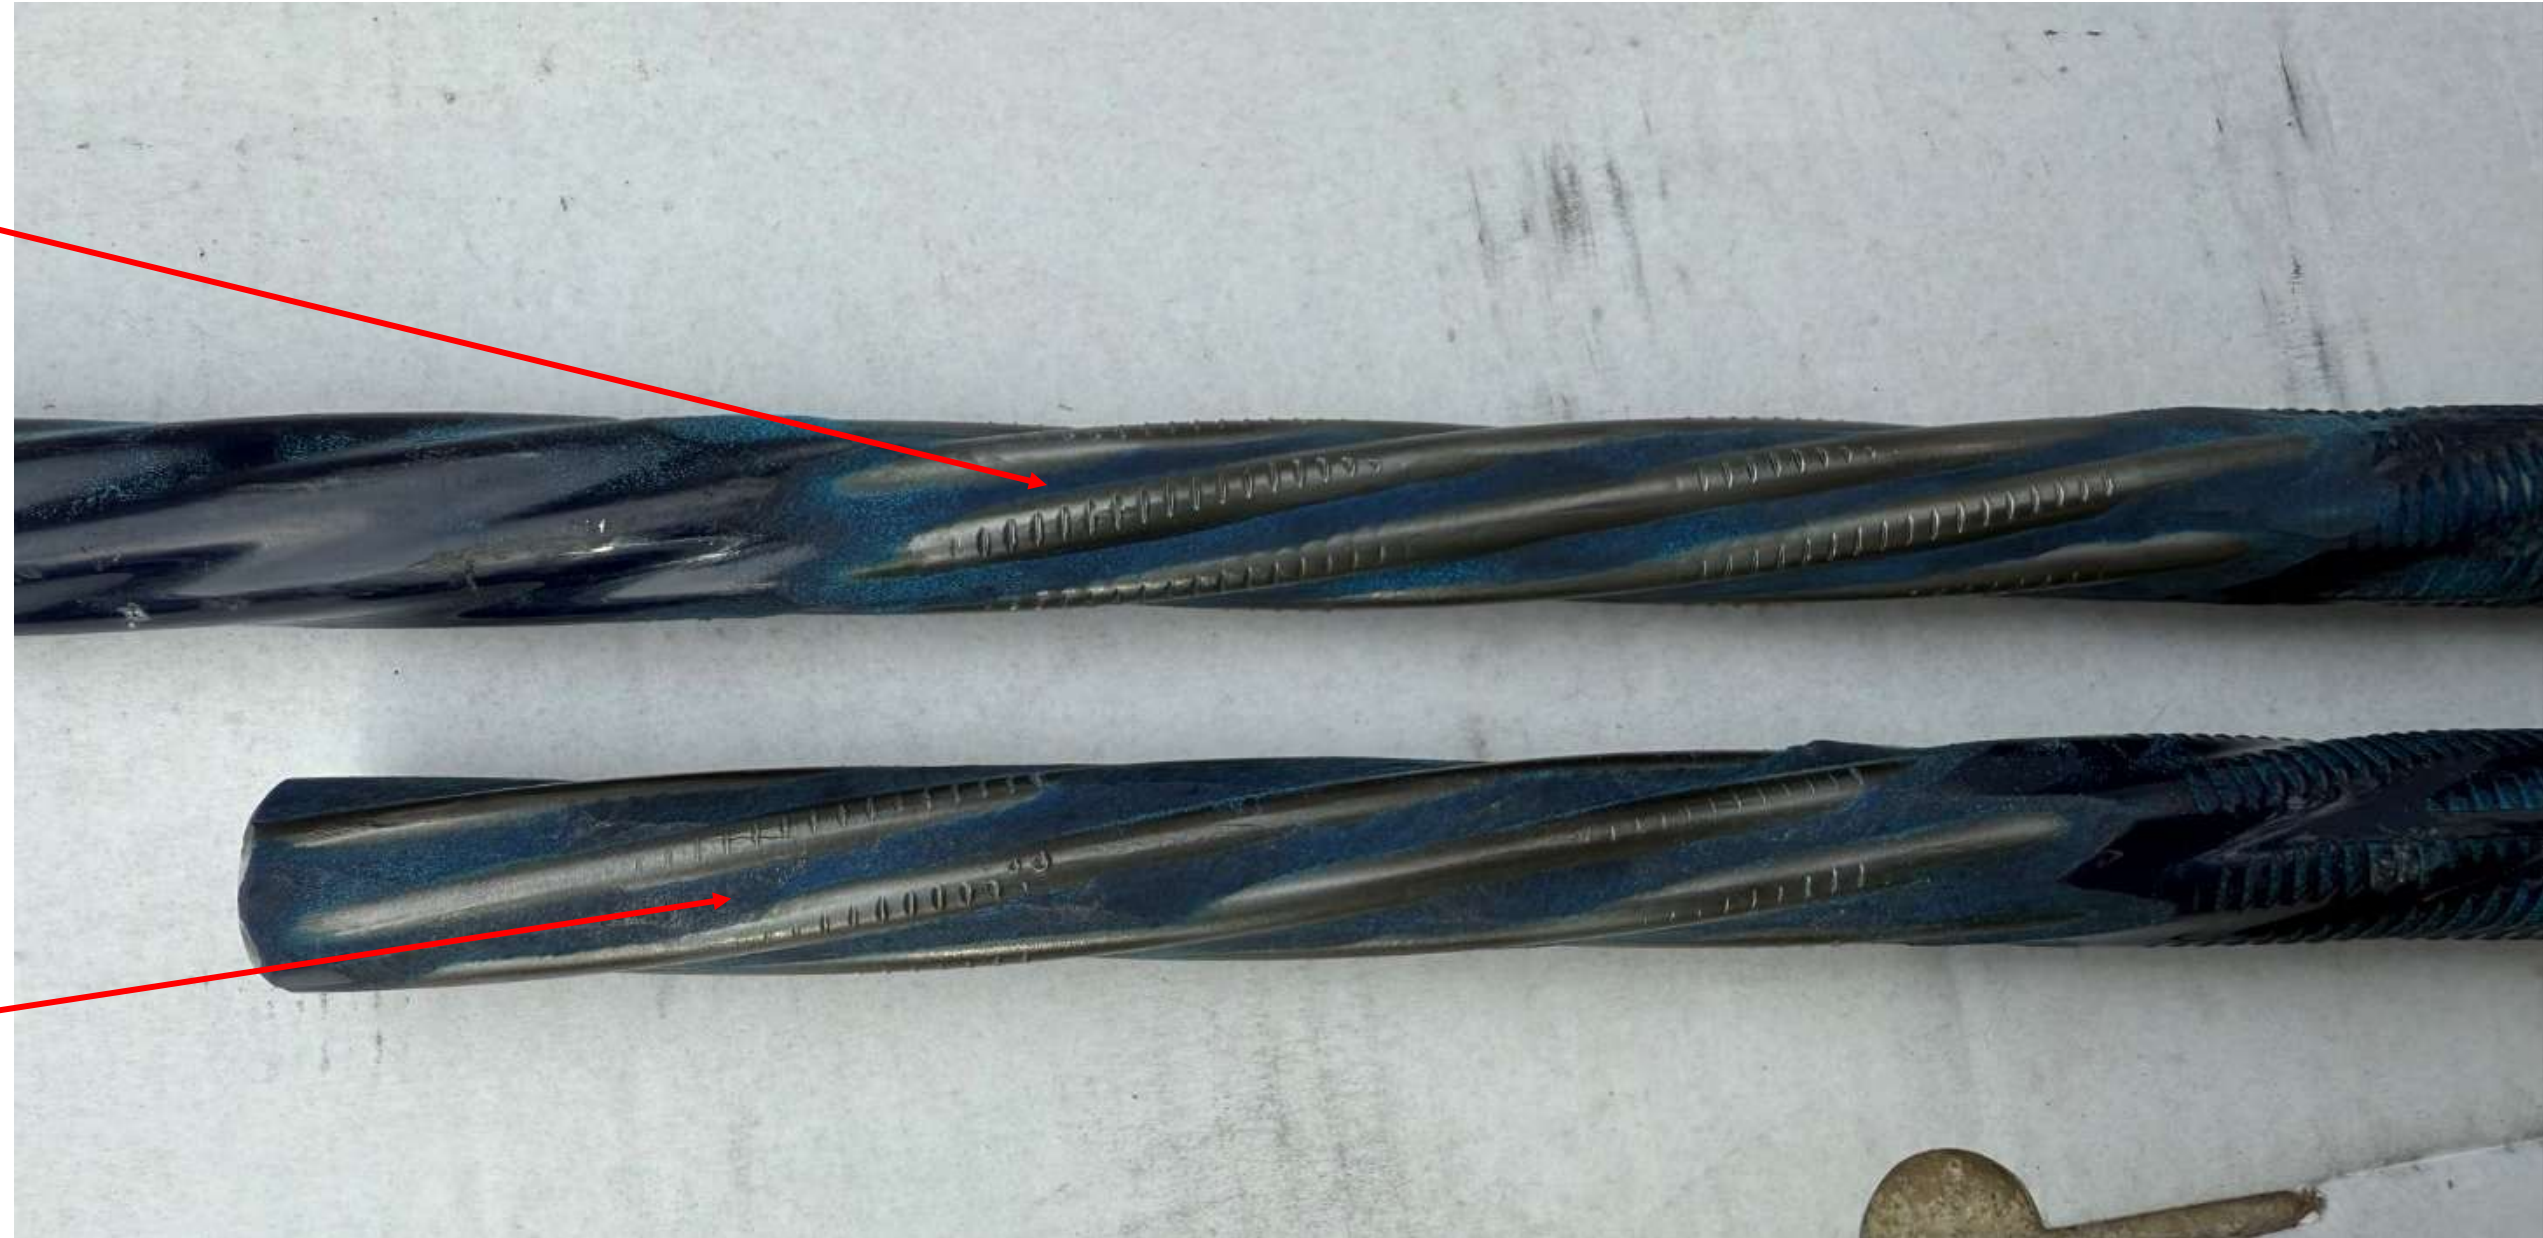
- After stressing, the epoxy from one strand tail was removed to examine the effectiveness of the wedge grip

Pulling Head Wedge marks  
fully engaged strand steel

Note: Pulling head wedges  
are longer than anchor  
wedges

Anchor Head Wedge marks  
also fully engaged strand  
steel
