# 2026 NCBC WEBINAR SERIES

## Unducted Epoxy-Coated Strand in Practice: The Laurel Fork Bridge

# **EPOXY COATED STRANDS INSTALLATION**

# ASTM A882 Epoxy-Coated PC Strand Manufacturing & Testing

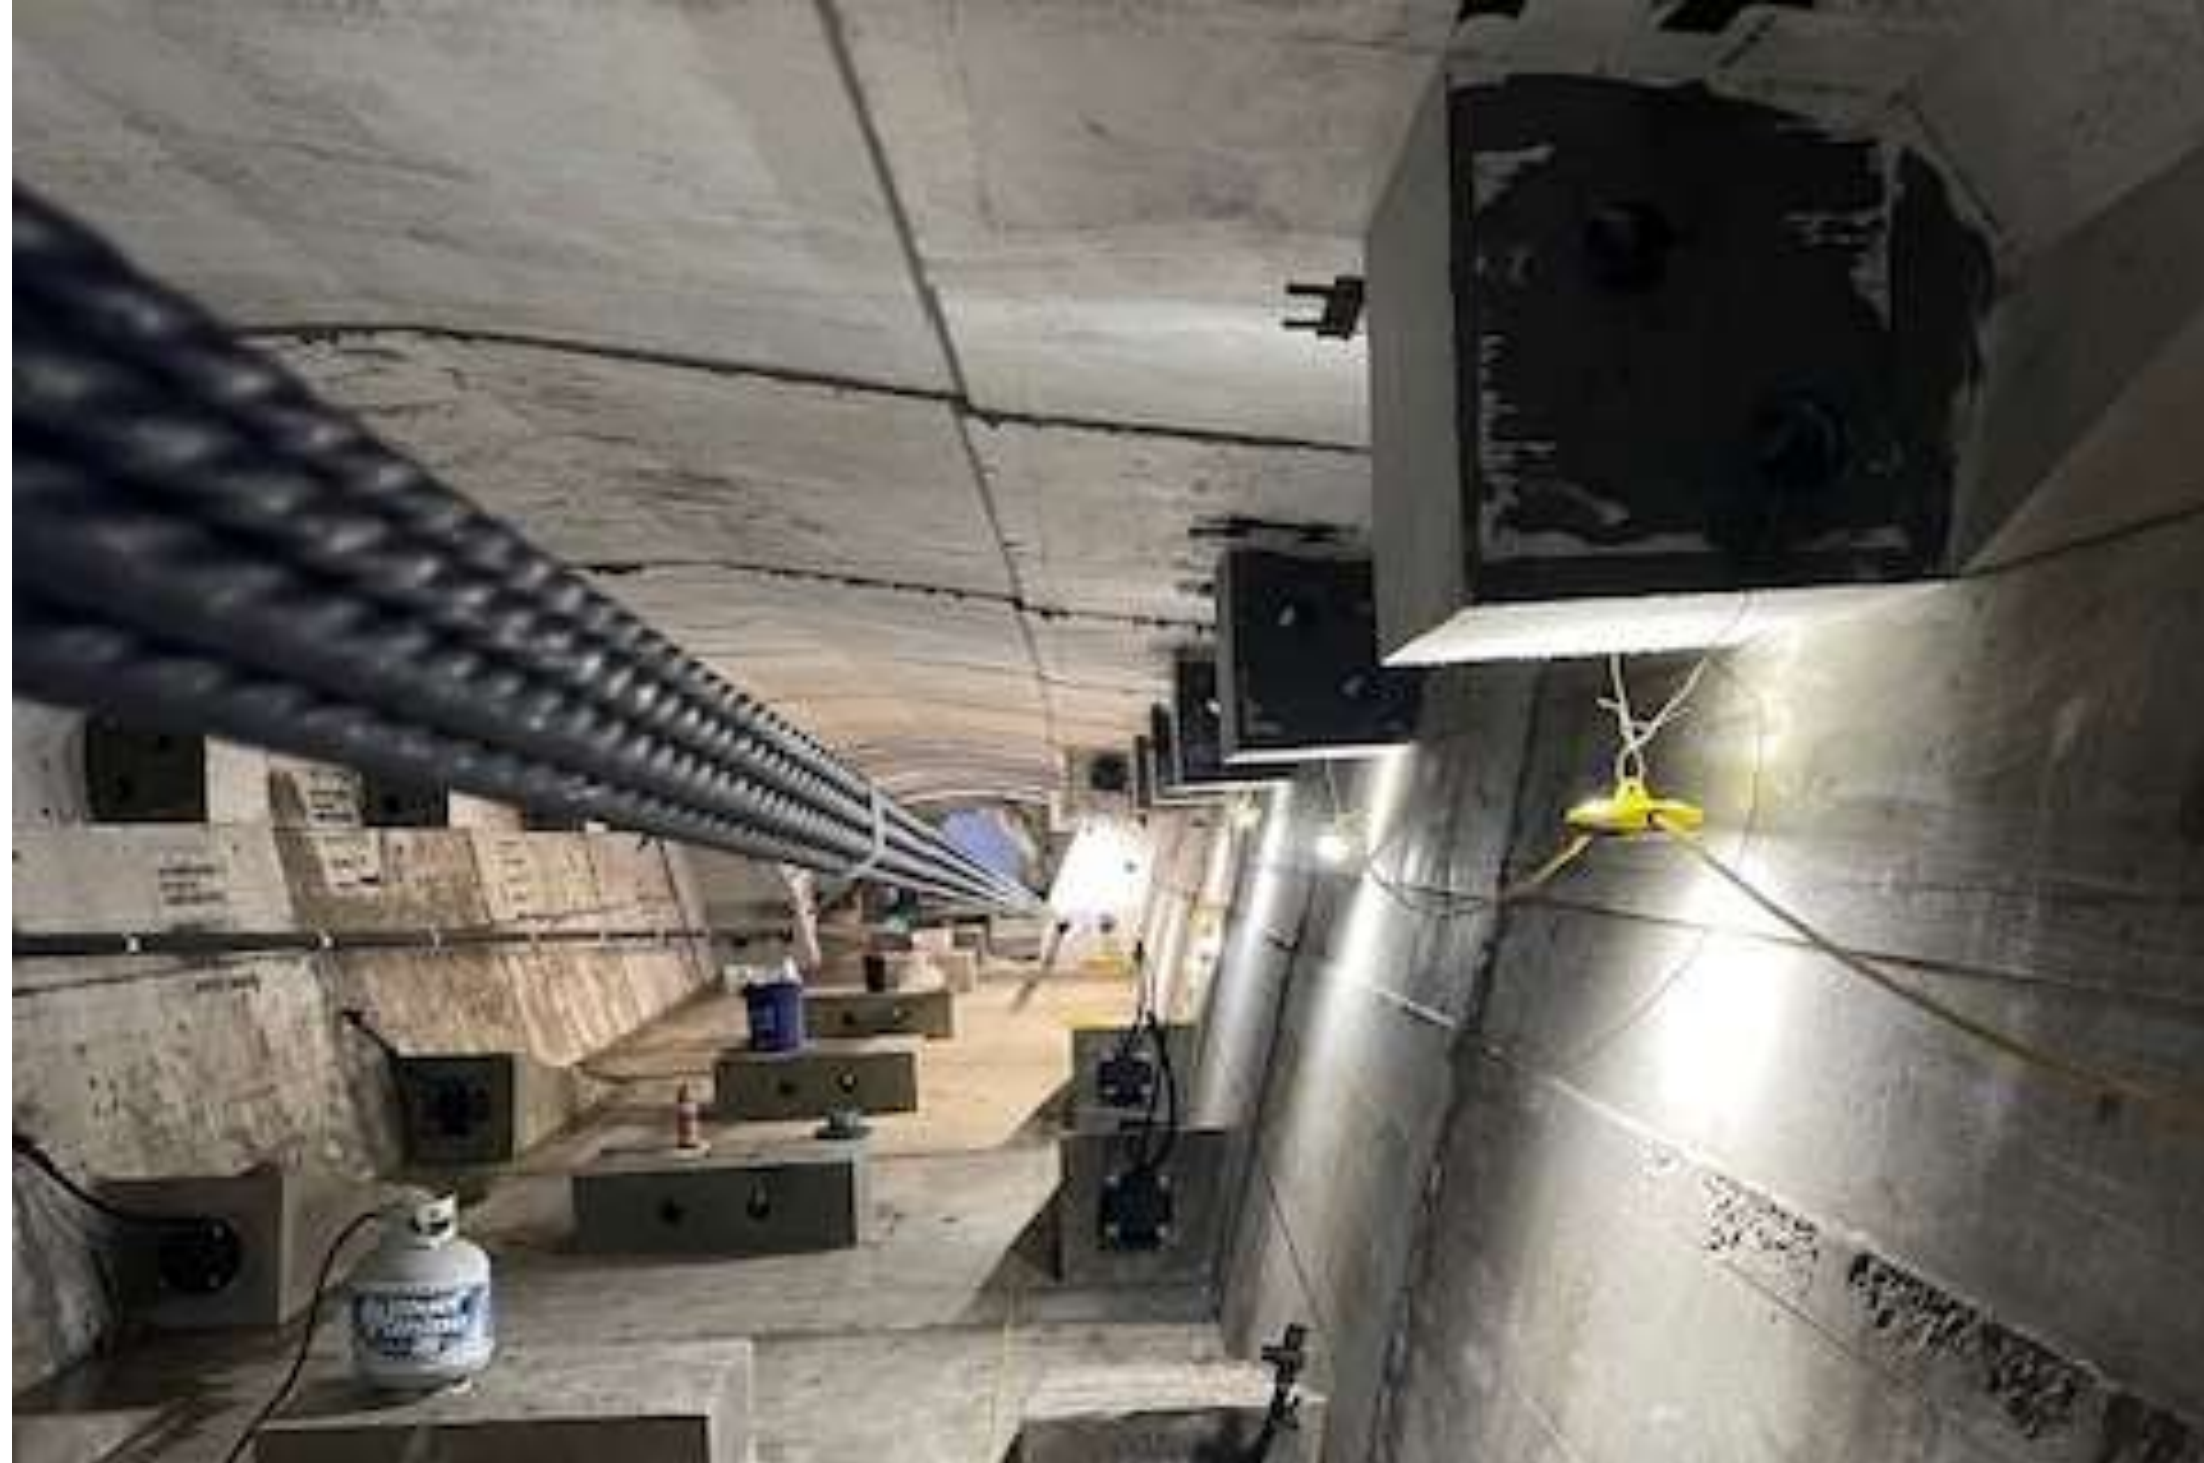
Fully stressed tendon with parallel strands.

- Left tendon shown had approx.  $\frac{1}{4}$  turn along its length, stressing not affected, no apparent impacts to the epoxy coating observed

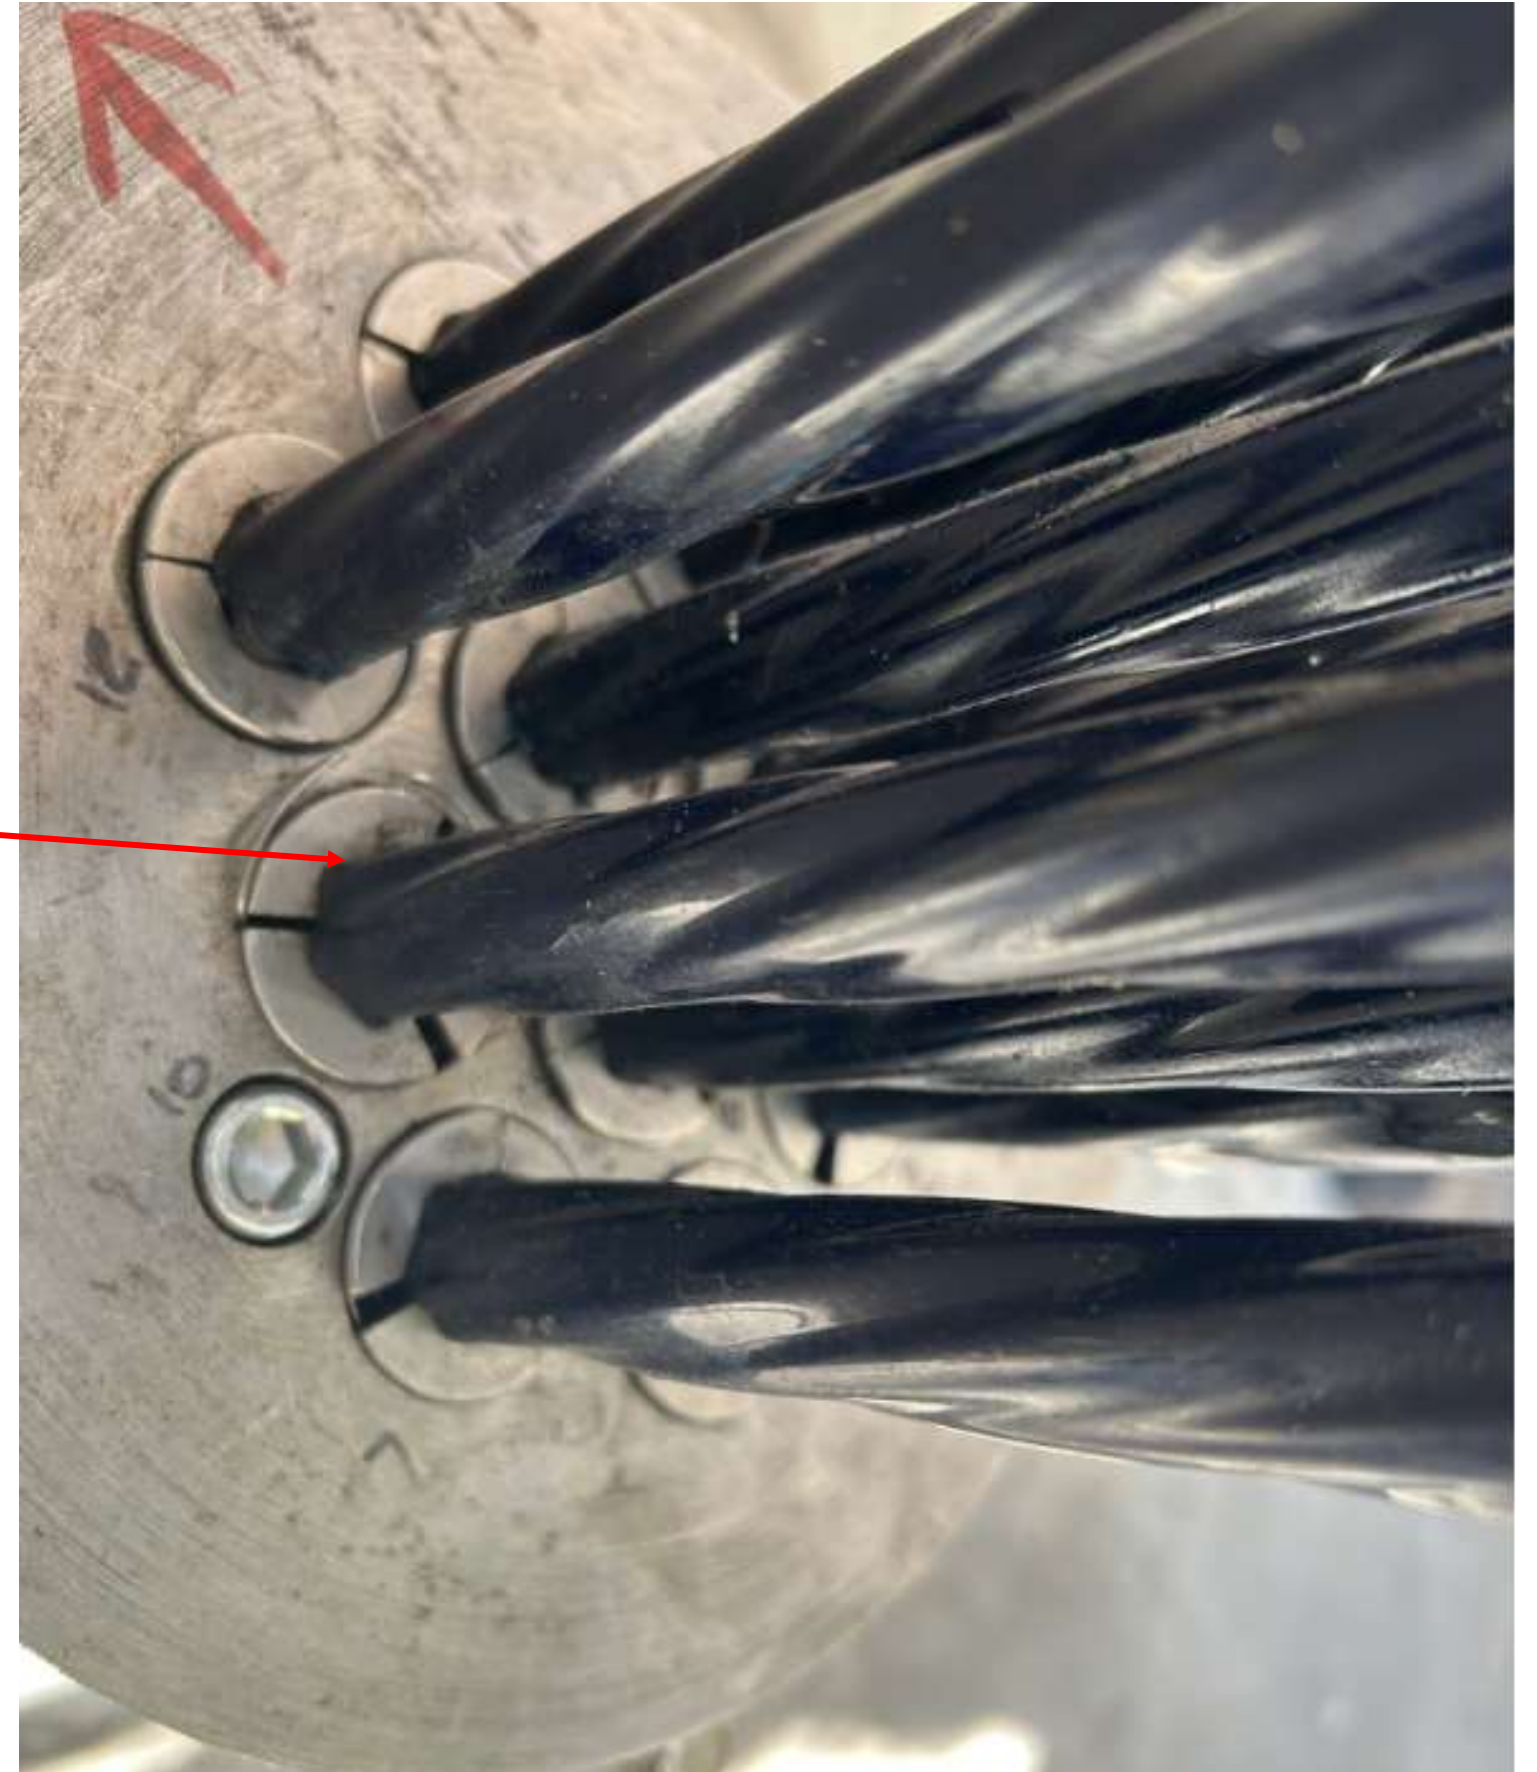
Dead end wedges fully seated.

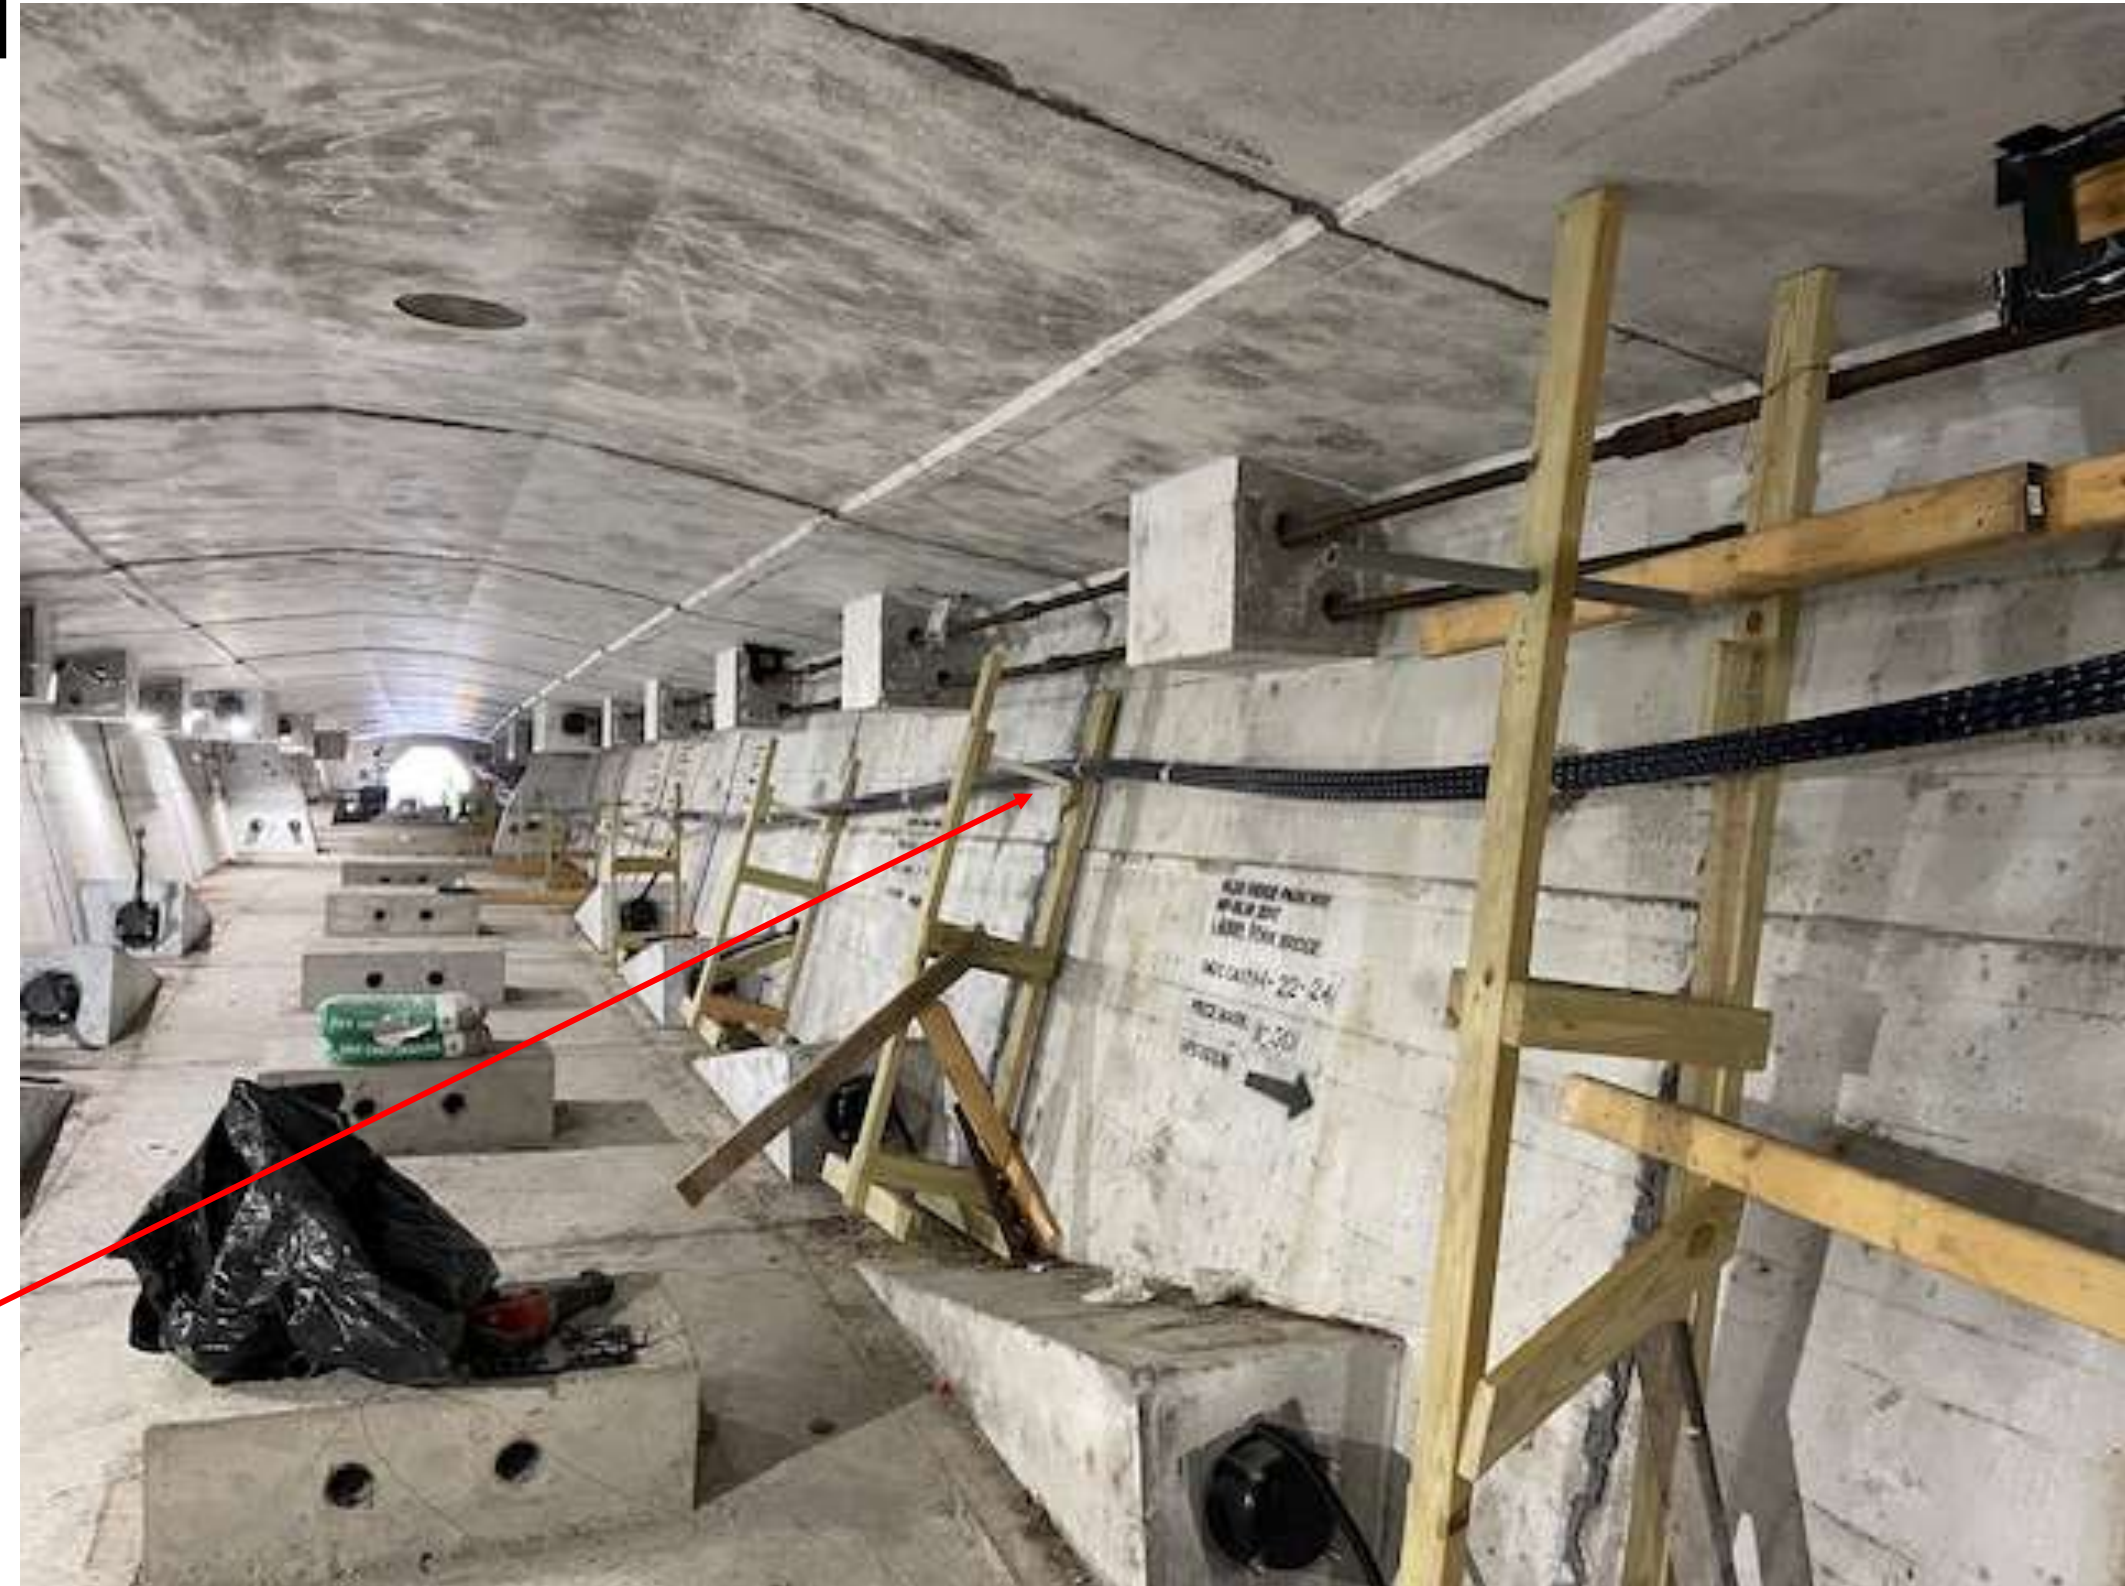
Contractor utilized a series of supports along the length of the tendon to minimize the sag between supports. This is necessary to minimize the relative difference in strand position relative to each to maintain equal elongation/force in all strands.

Note: PVC sleeves were used to minimize abrasion of the strand epoxy.

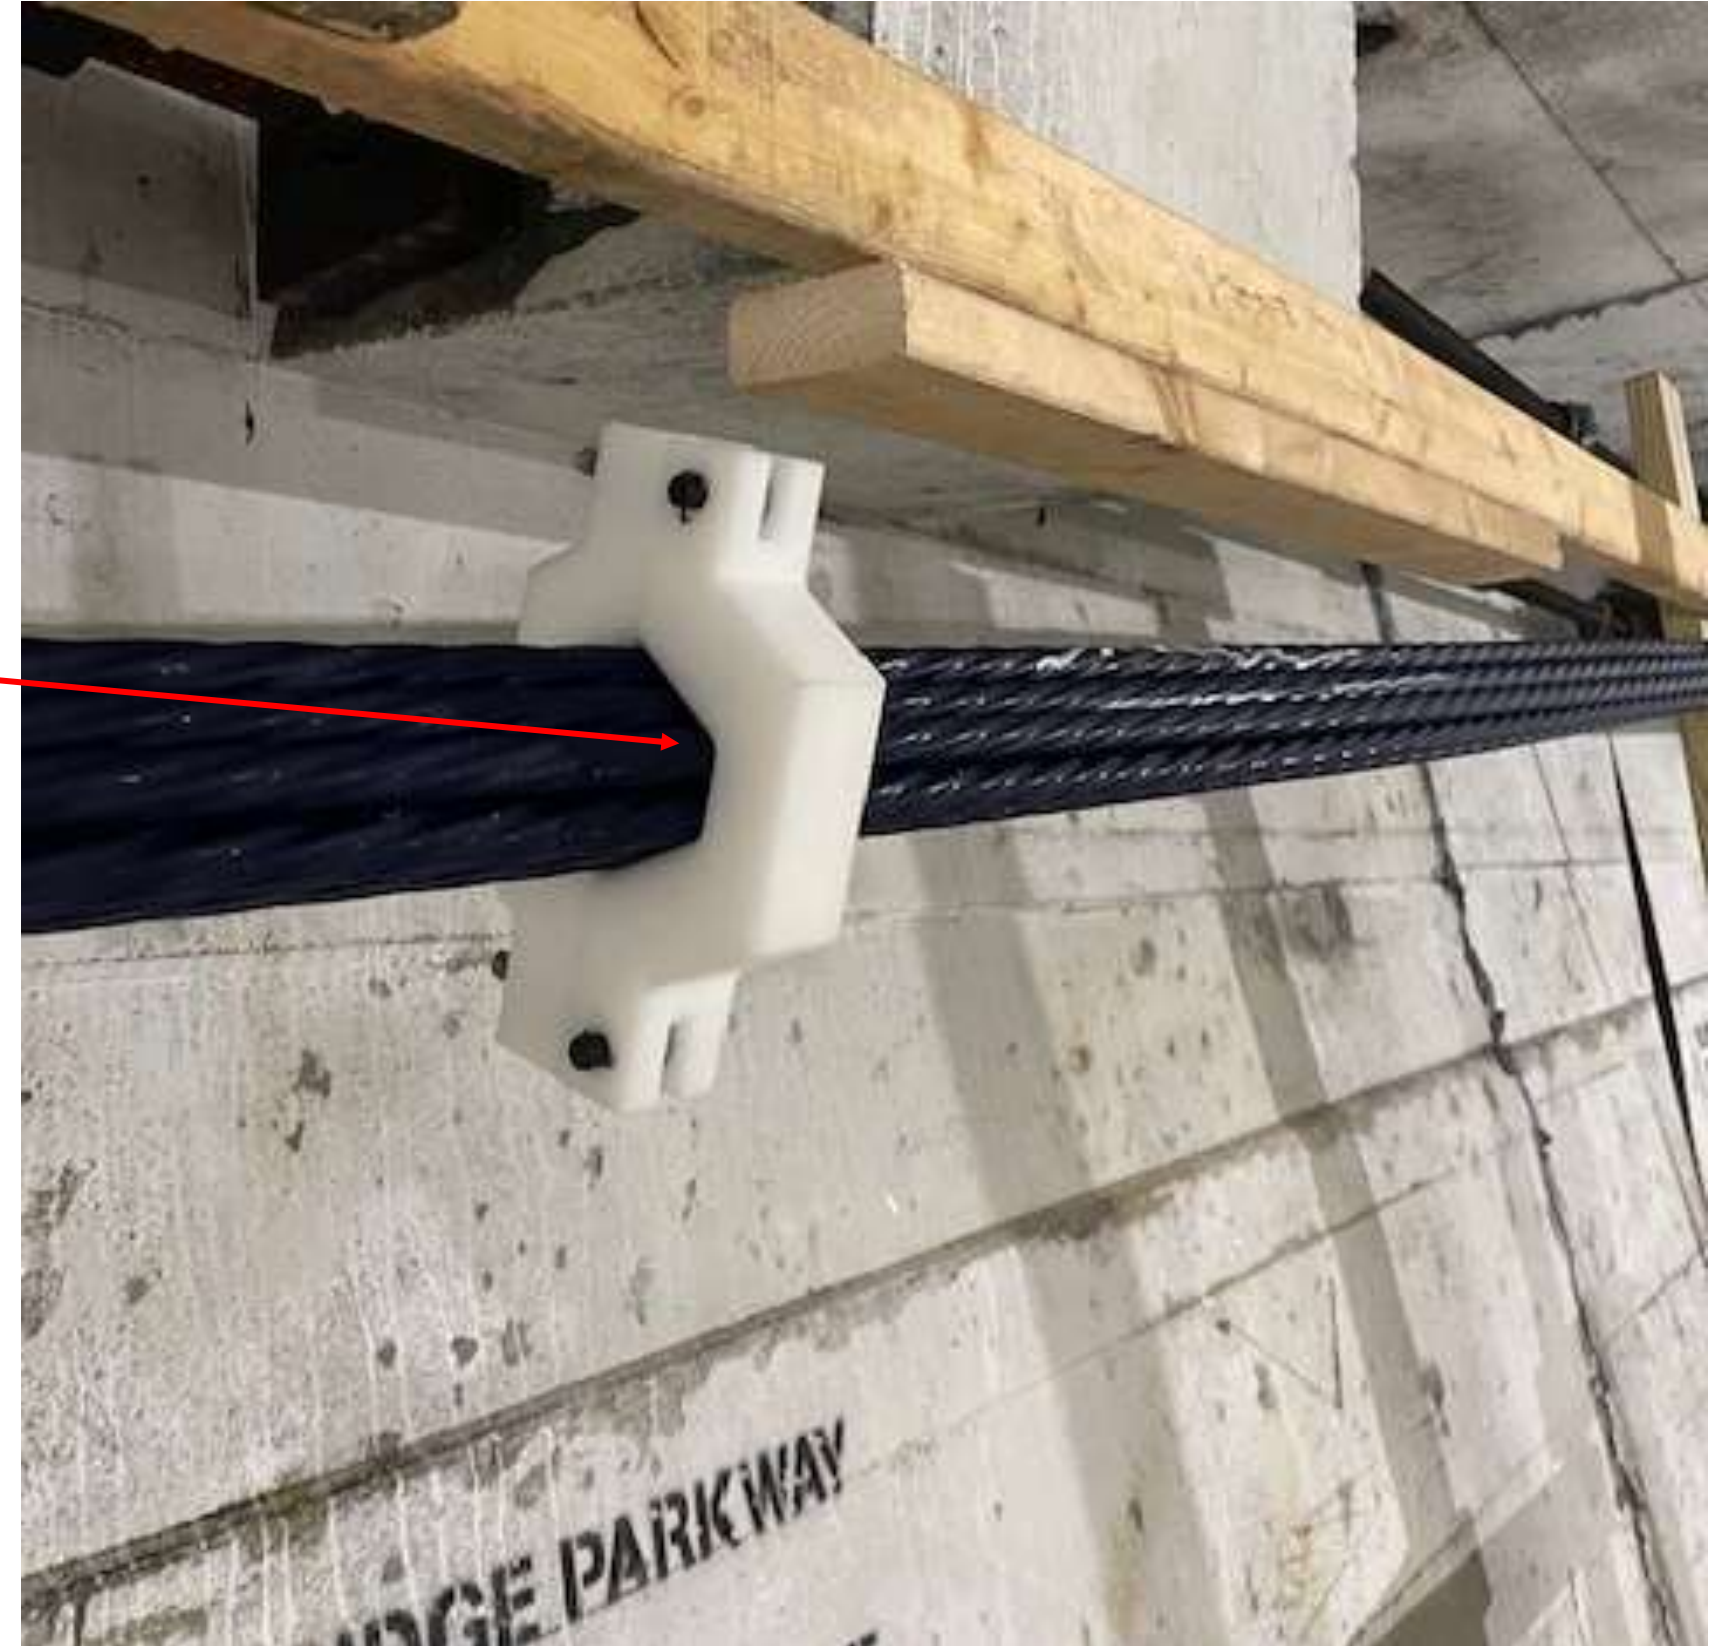
Strand compactors were utilized during strand installation to help maintain the strands parallel.

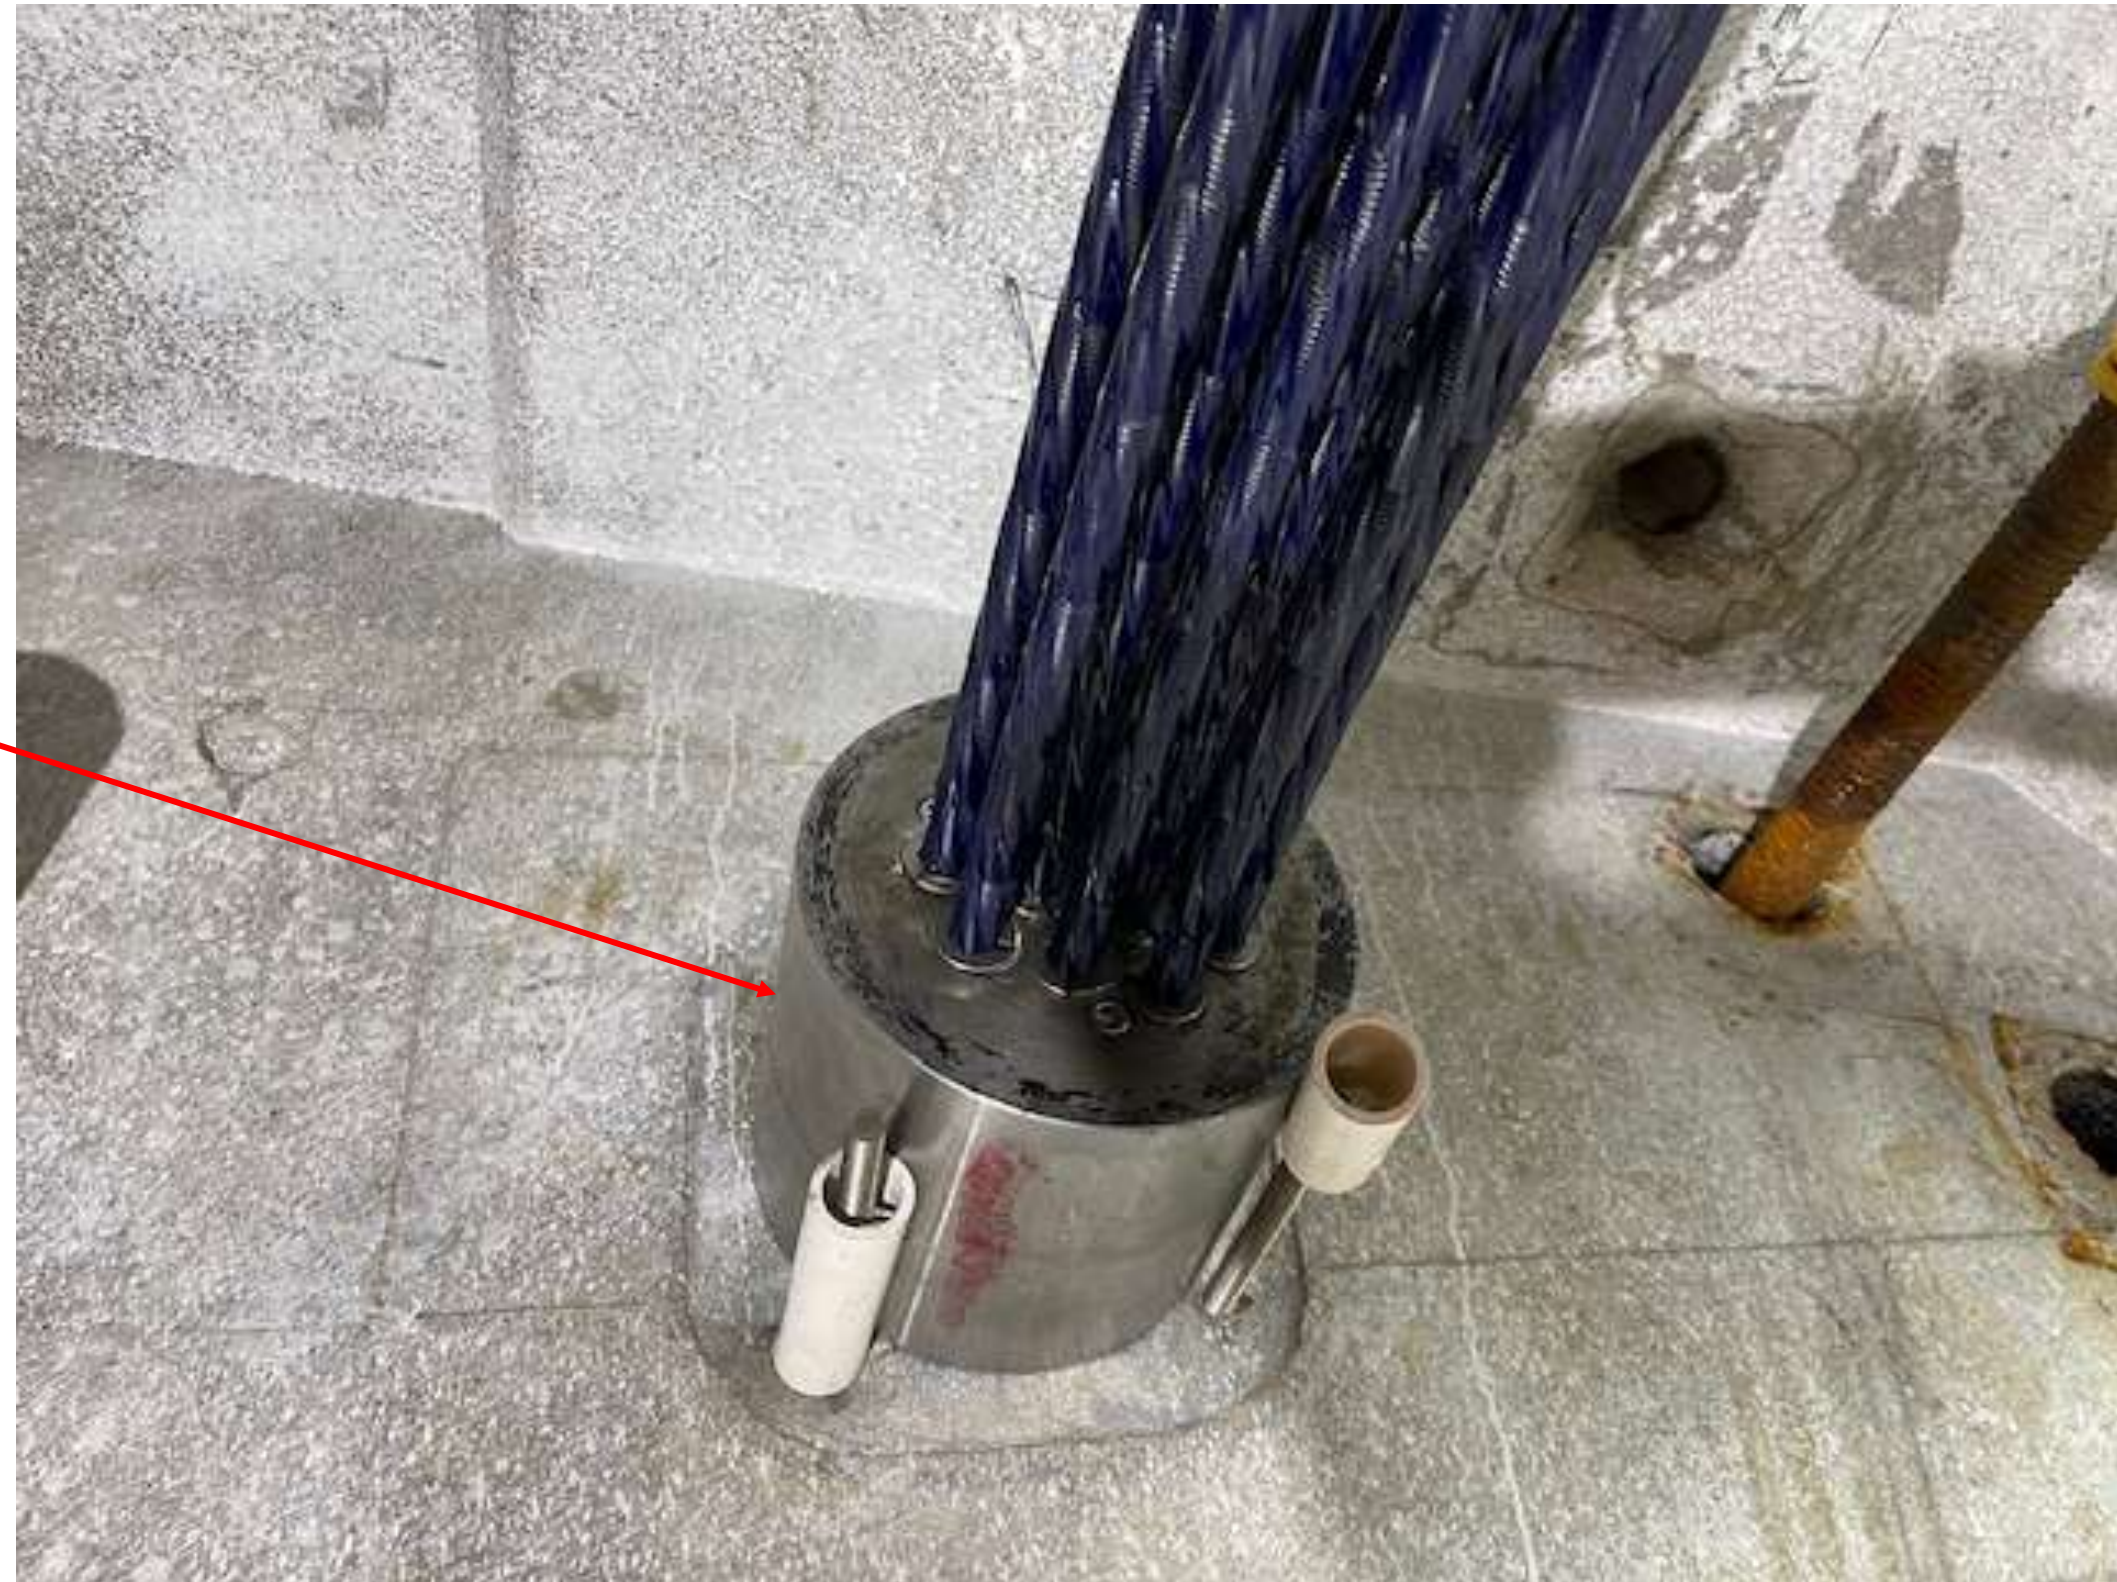
Contractor developed an elongated anchor head that allows use of standard bare strand anchor bearing plates

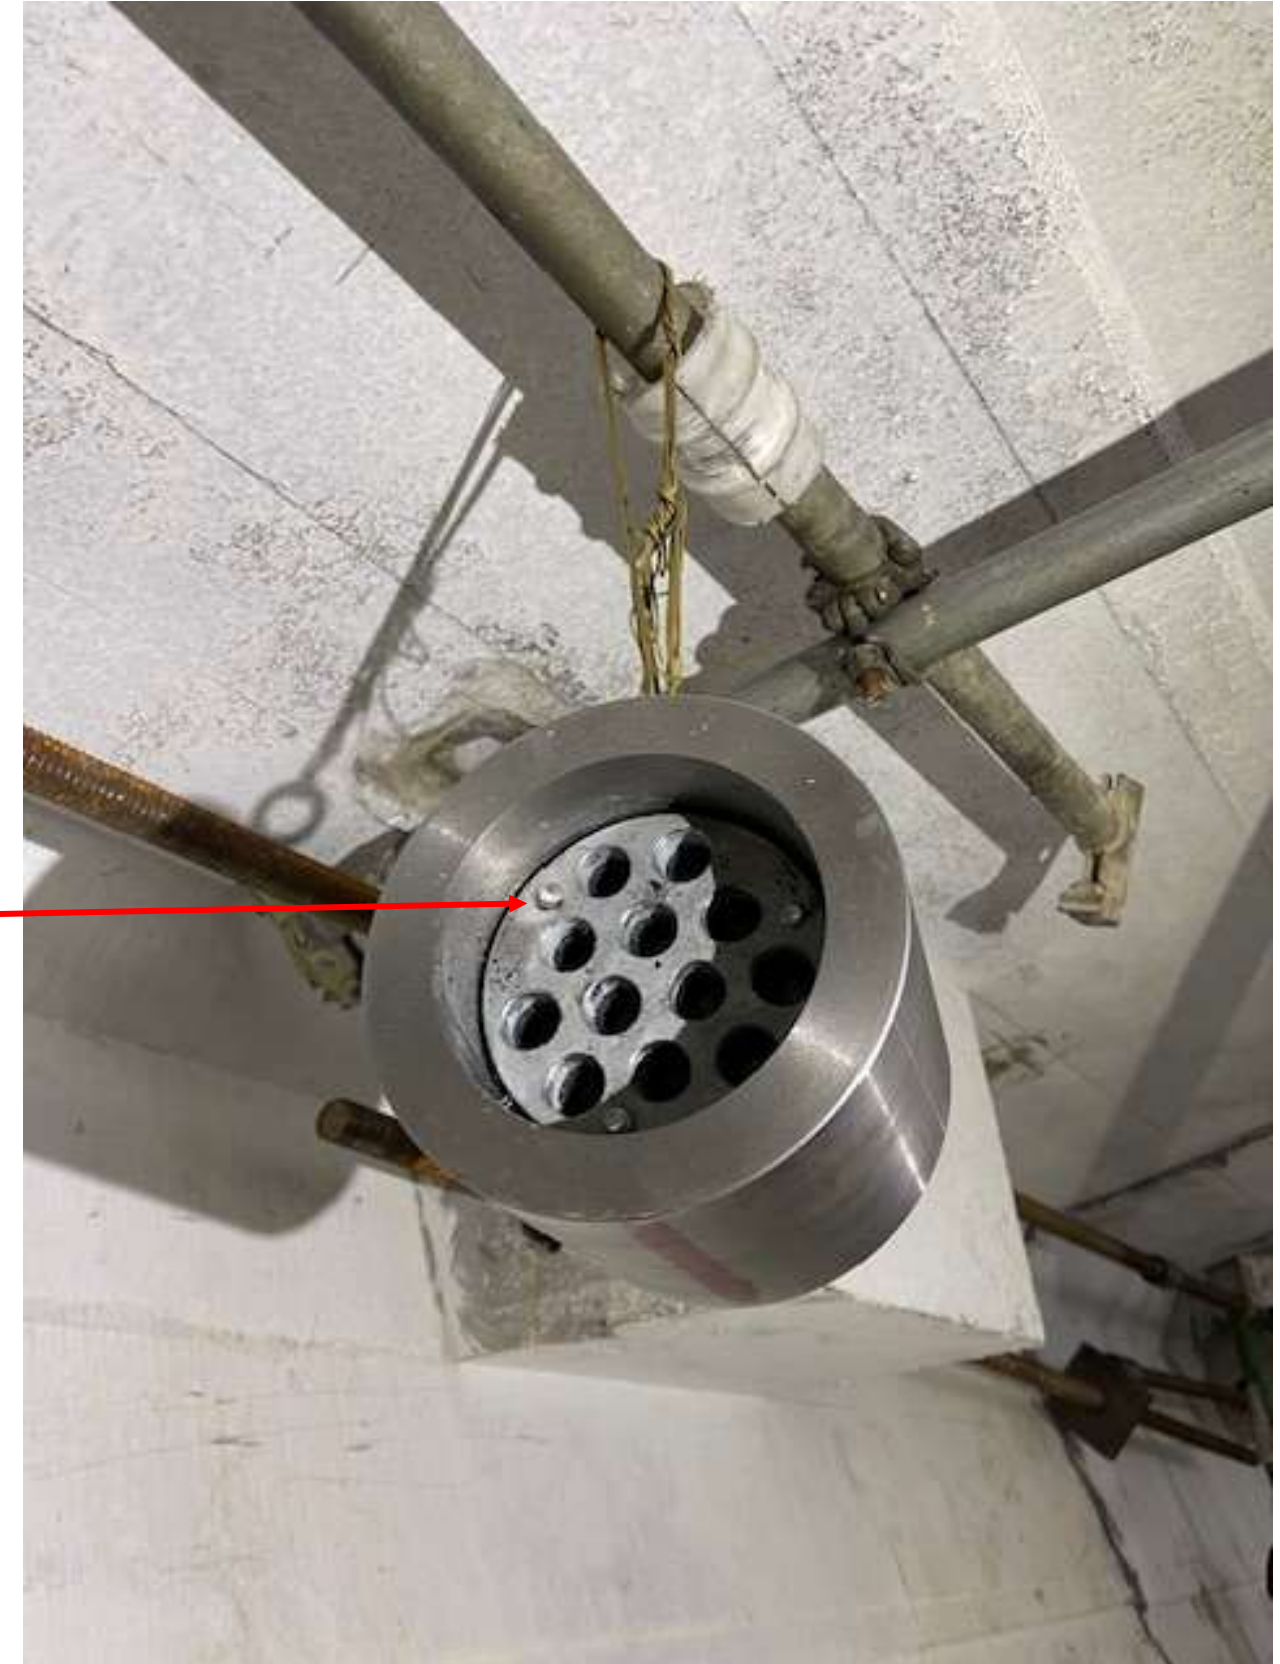
Interior of the anchor head contains a rubber diaphragm and plate that allows the three bolts to be tightened to compress the rubber diaphragm and seal the strands for grouting.

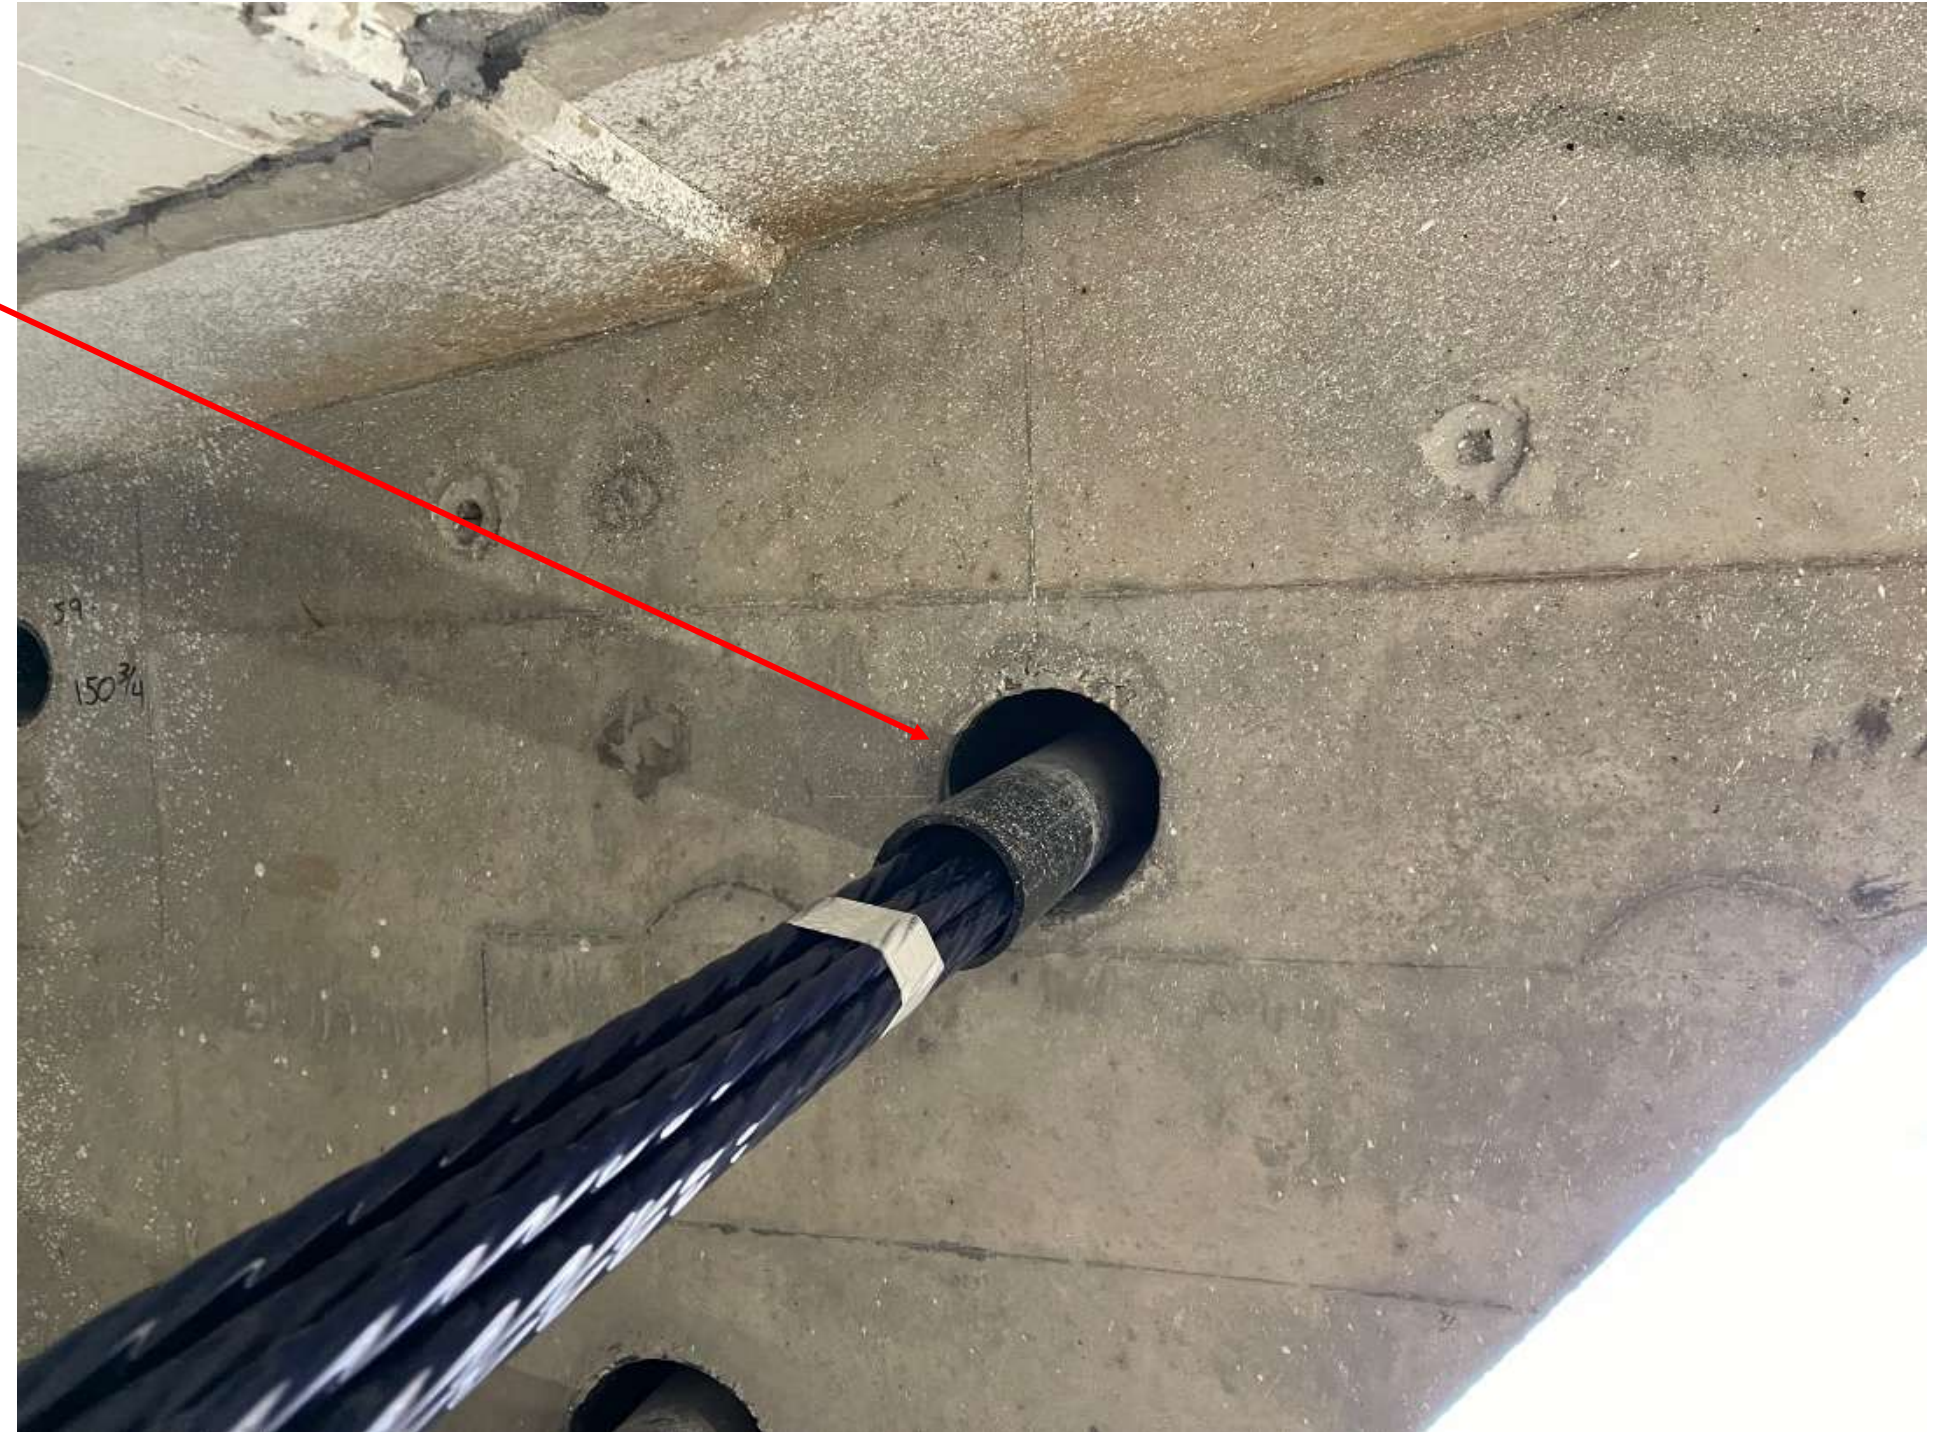
Note: Segments were detailed and precast for external post-tensioning ducts.

The PE duct served as a plastic sleeve for the epoxy coated strand and the diabolos accommodated the angle break and allowed the strand to bear 6+” to the interior of the diaphragm as intended
