# 2026 NCBC WEBINAR SERIES

## Unducted Epoxy-Coated Strand in Practice: The Laurel Fork Bridge

# **EPOXY COATED STRANDS INSTALLATION**

# ASTM A882 Epoxy-Coated PC Strand Manufacturing & Testing

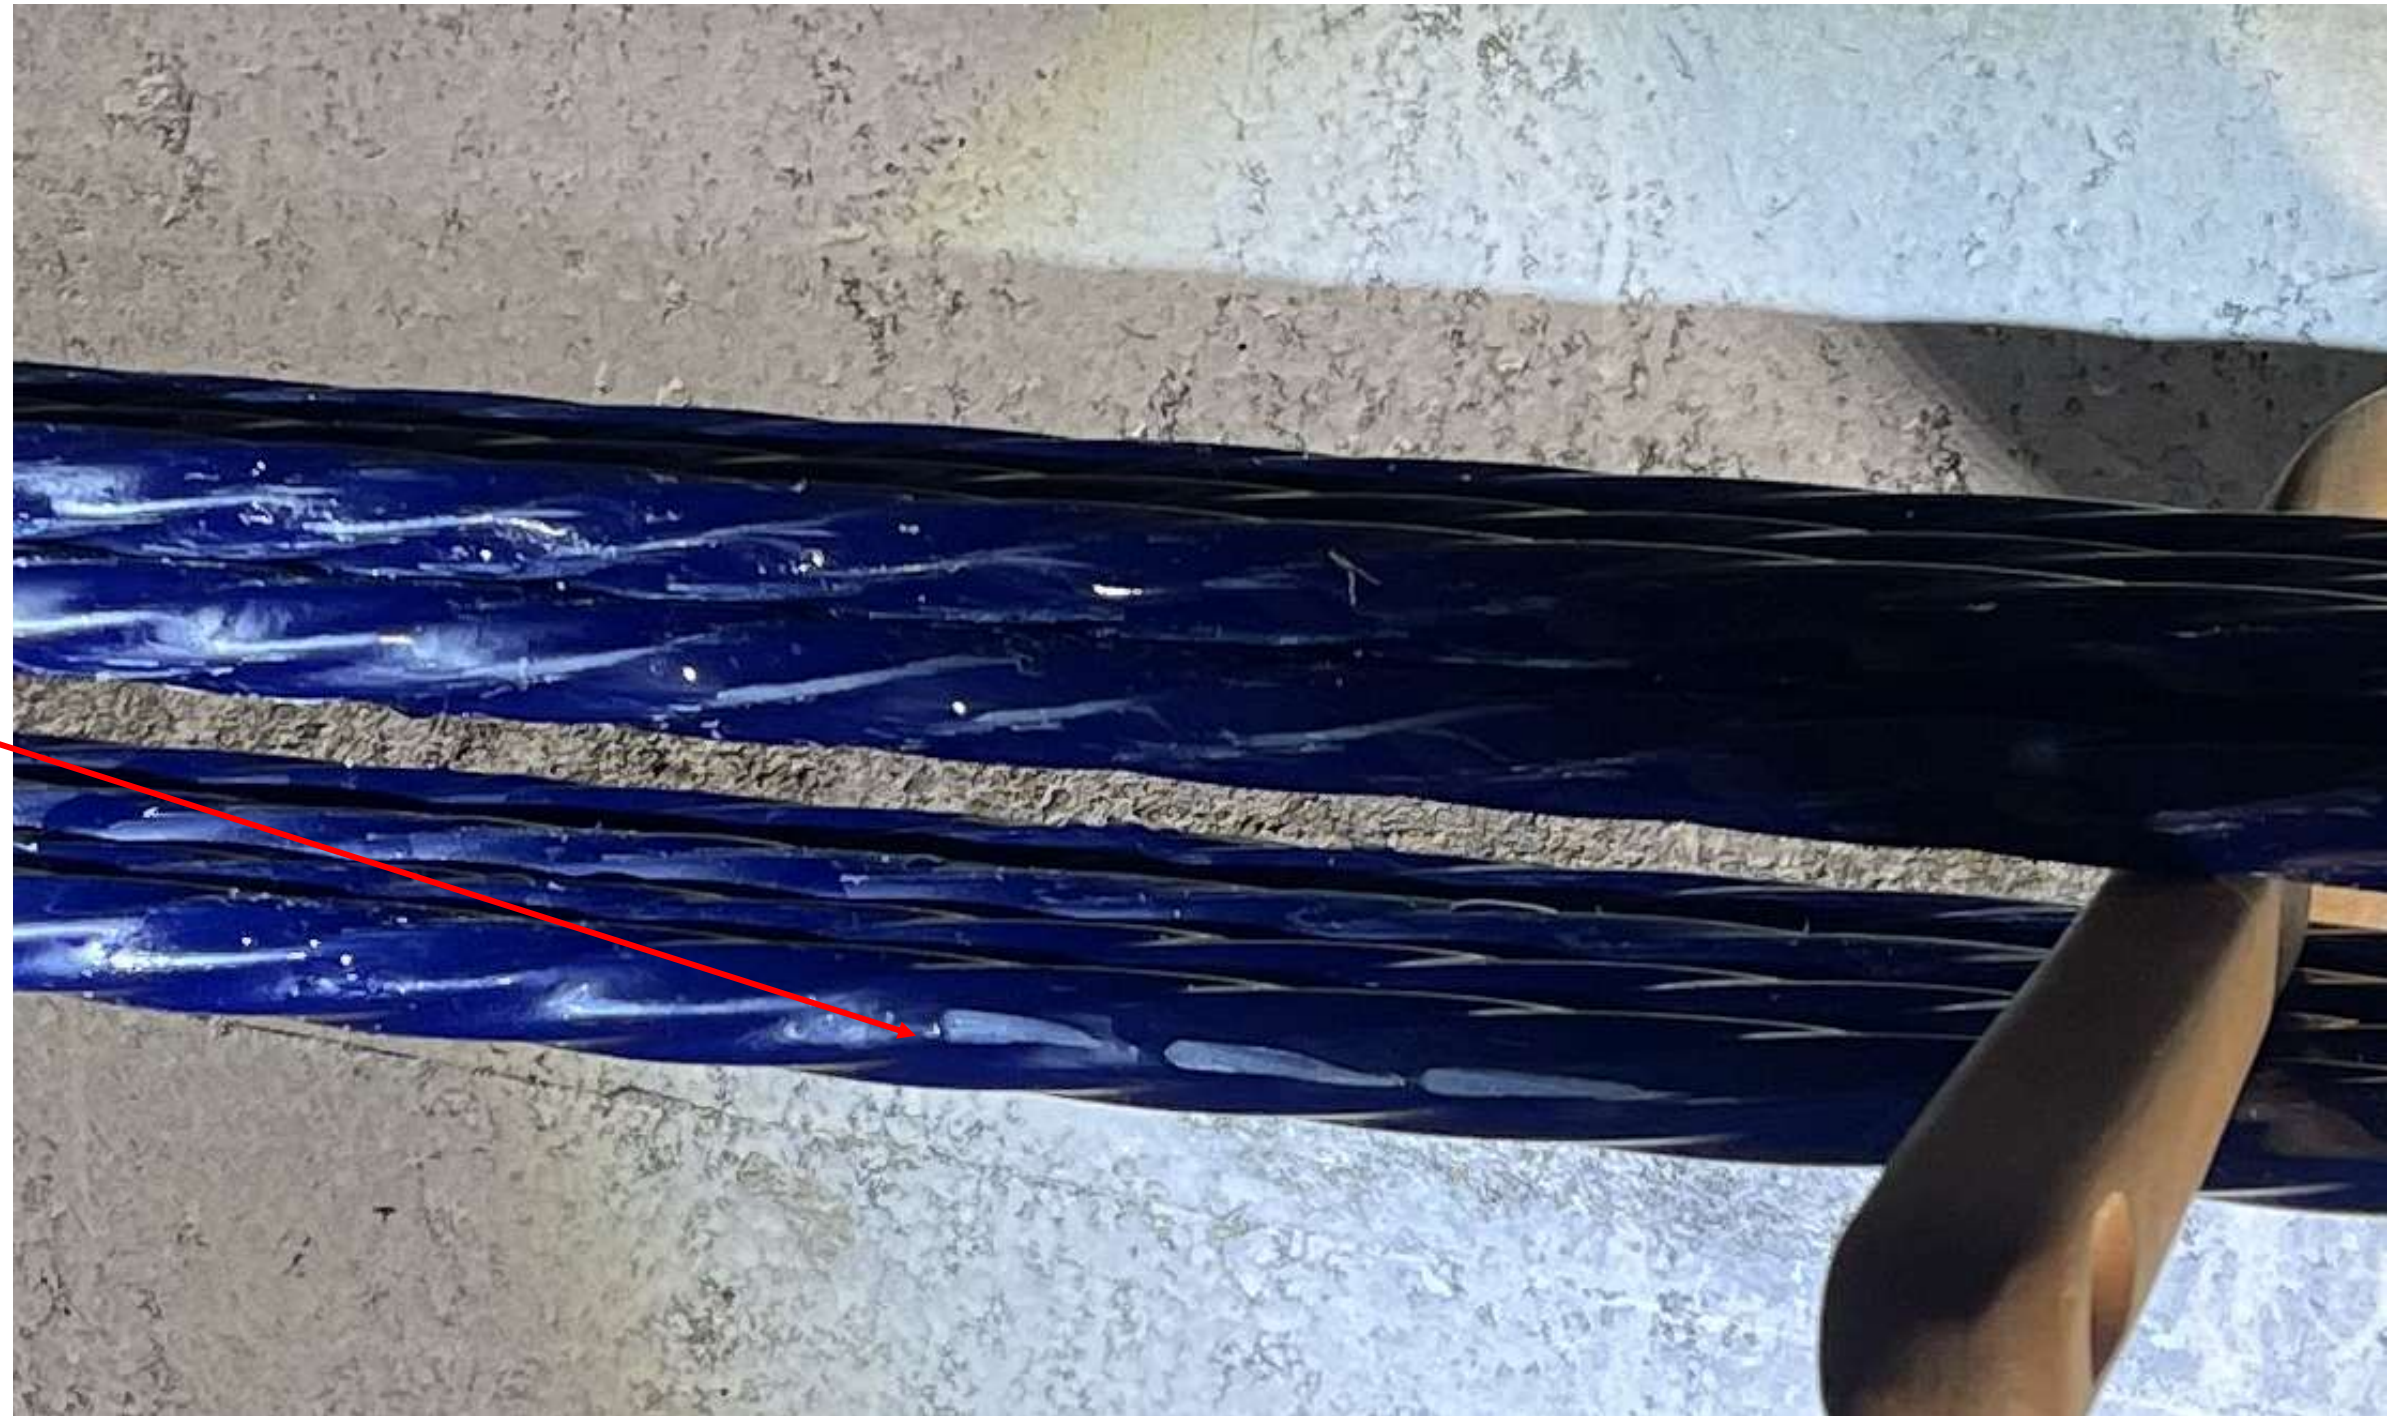
During strand installation, some abrasion was deep enough to require repair of the epoxy strand coating

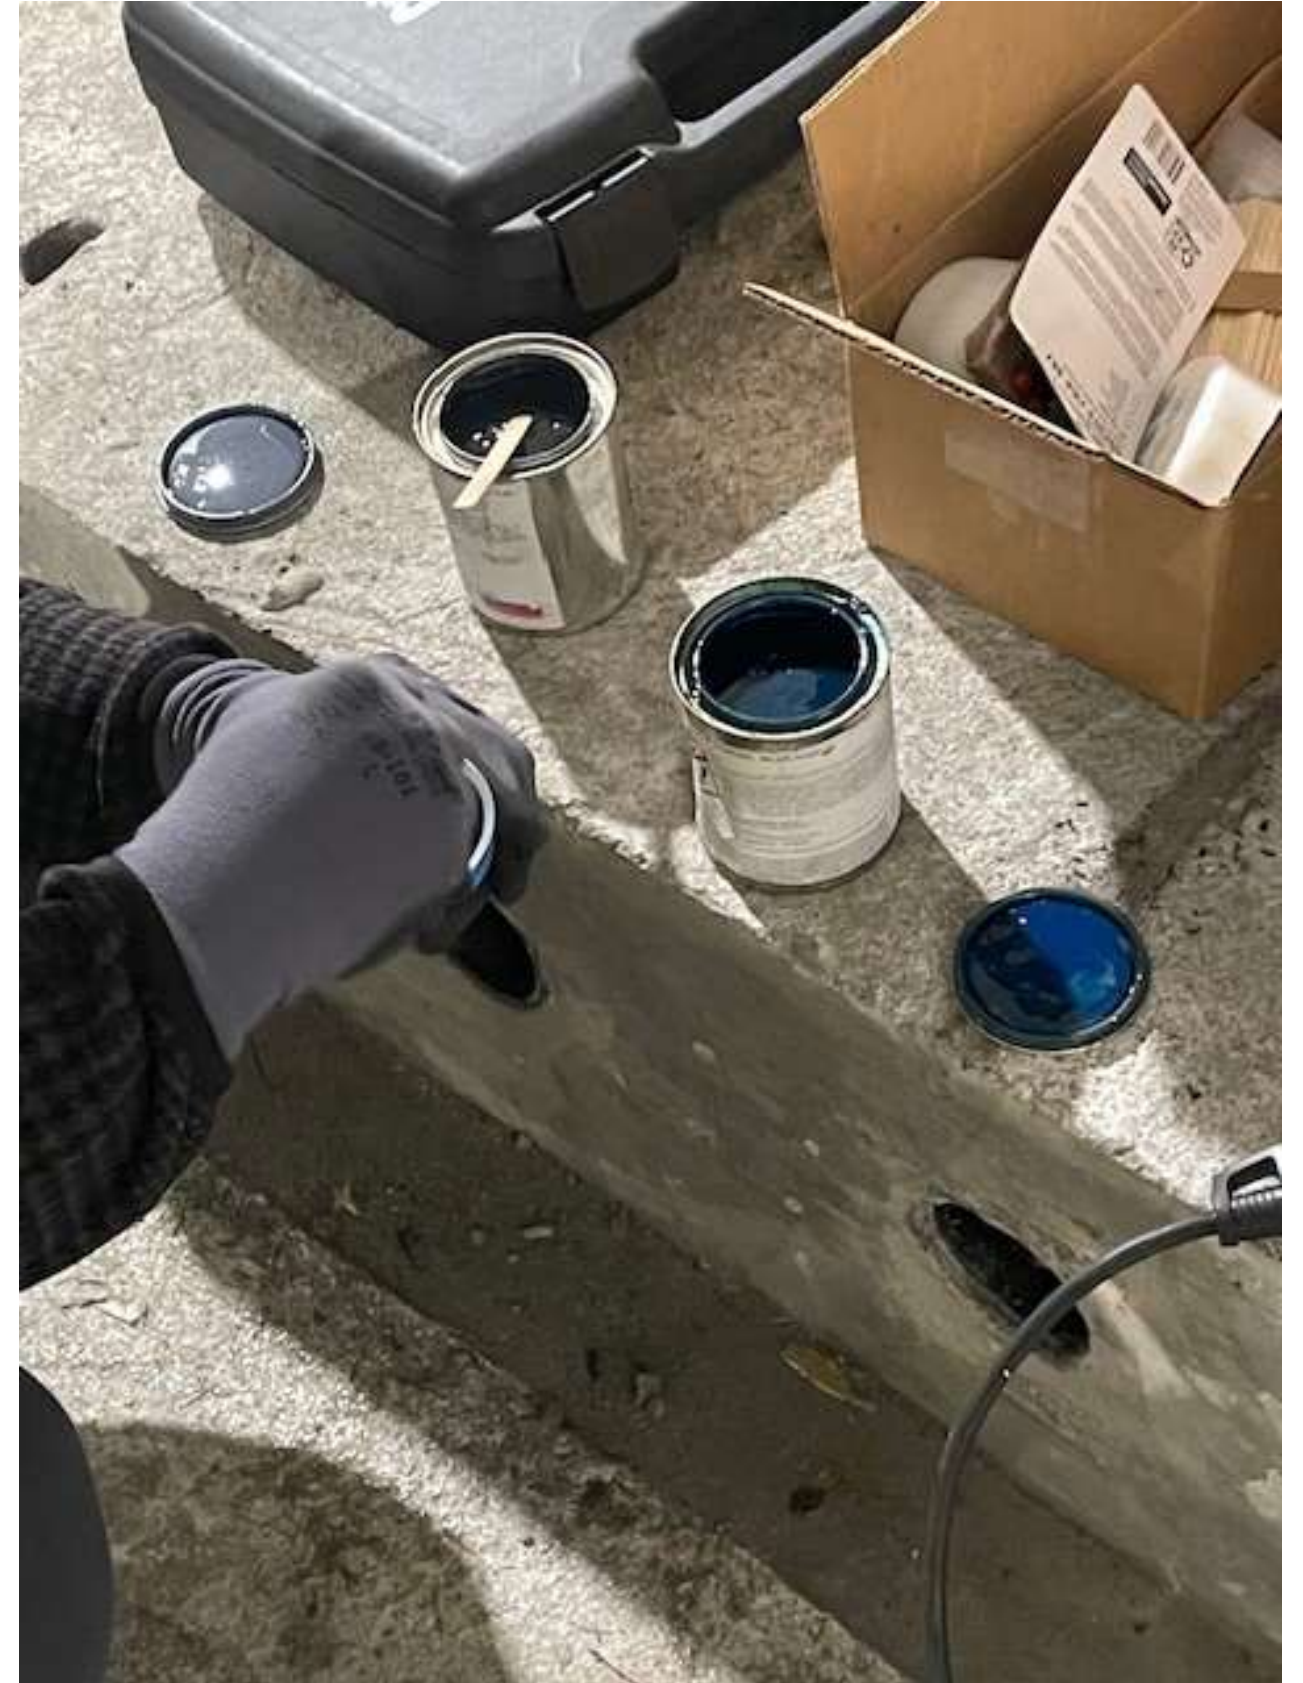
Epoxy coating repair materials are a two-part epoxy system that can easily be mixed on-site

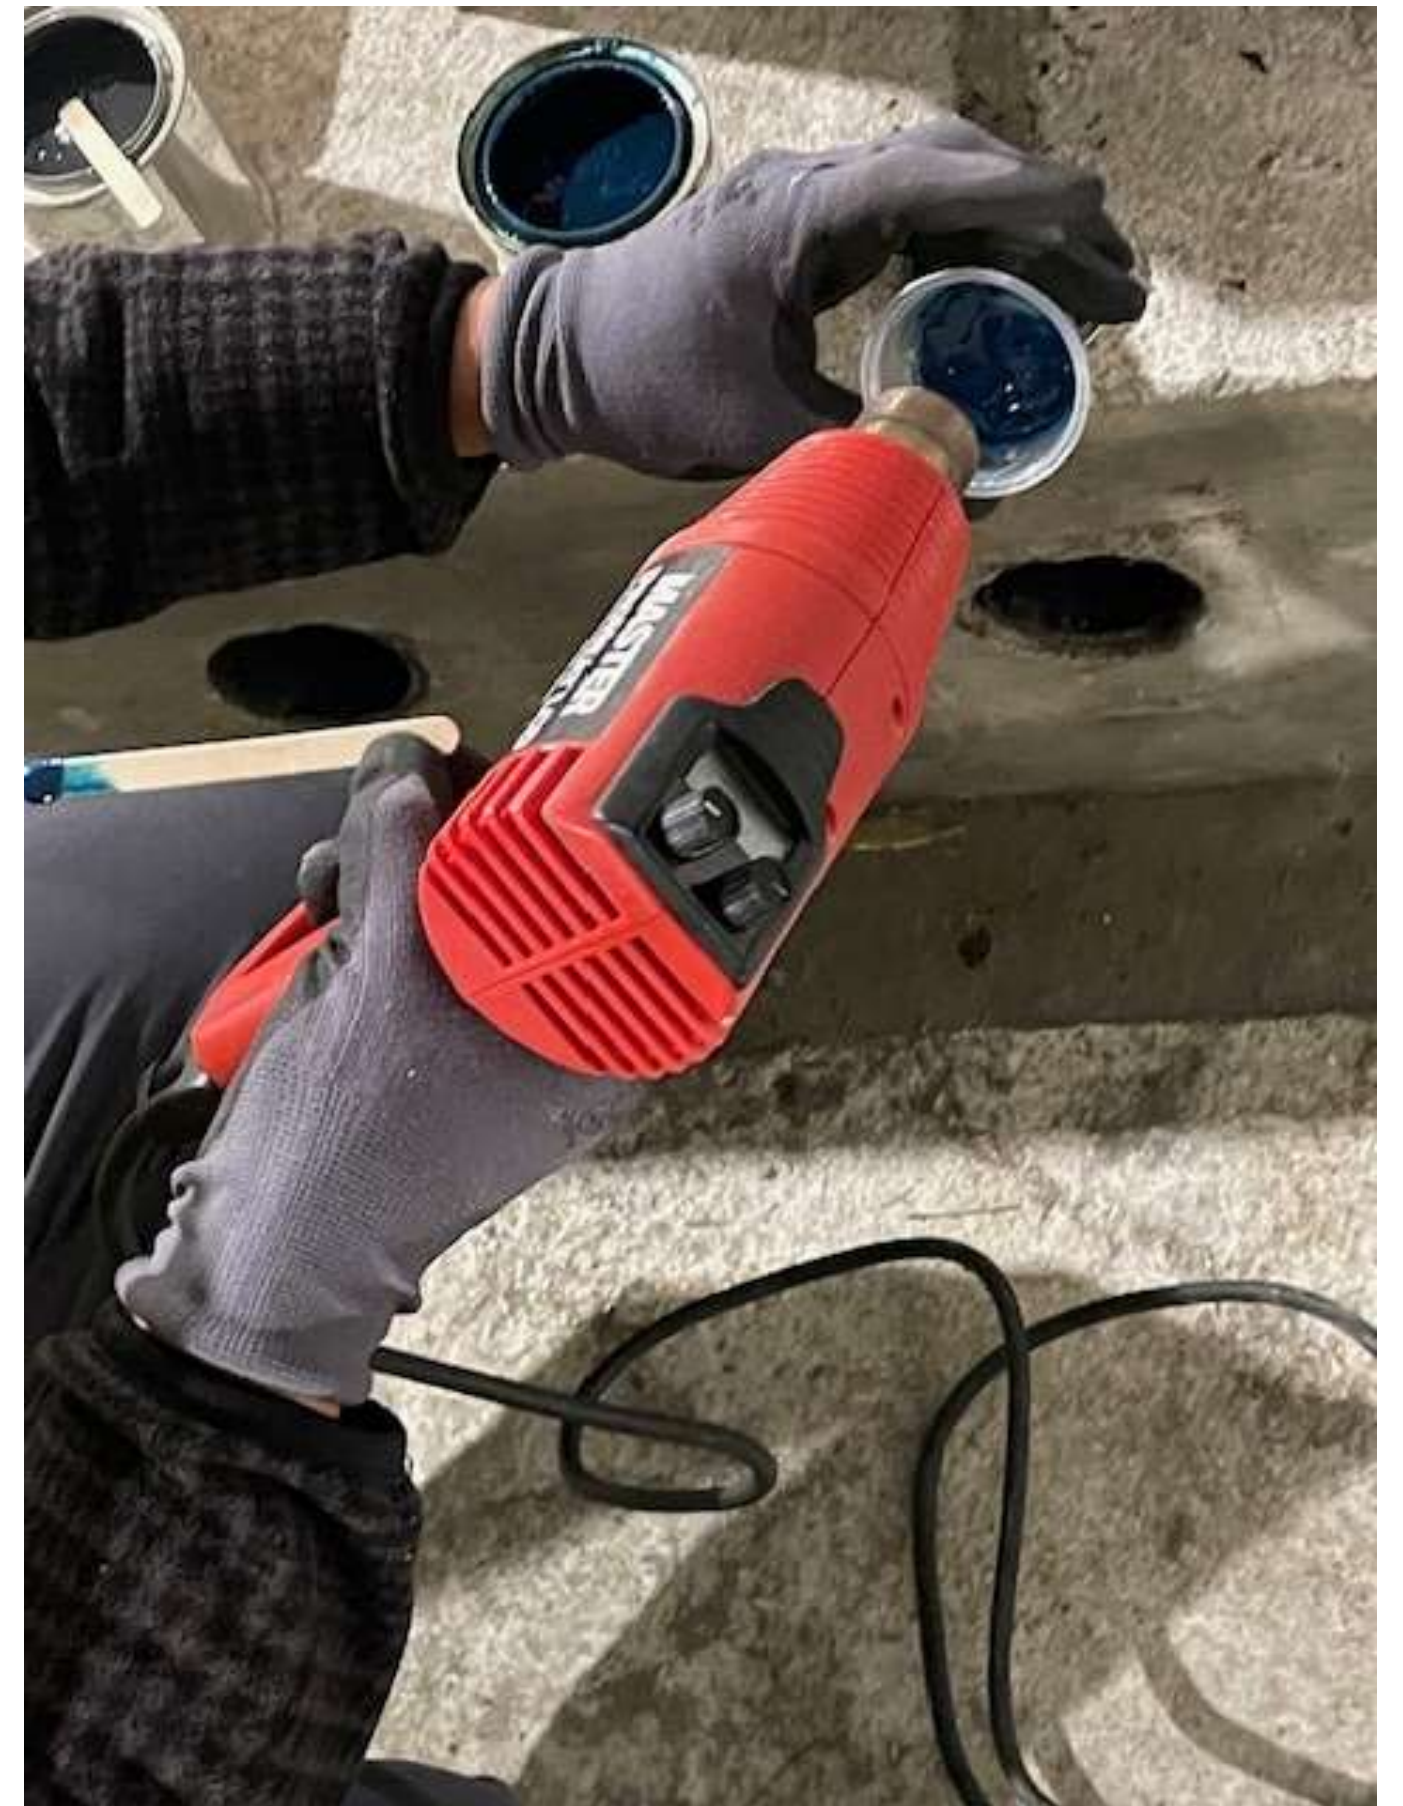
During cold weather, the portable handheld heater was used to assist with getting the epoxy reaction started

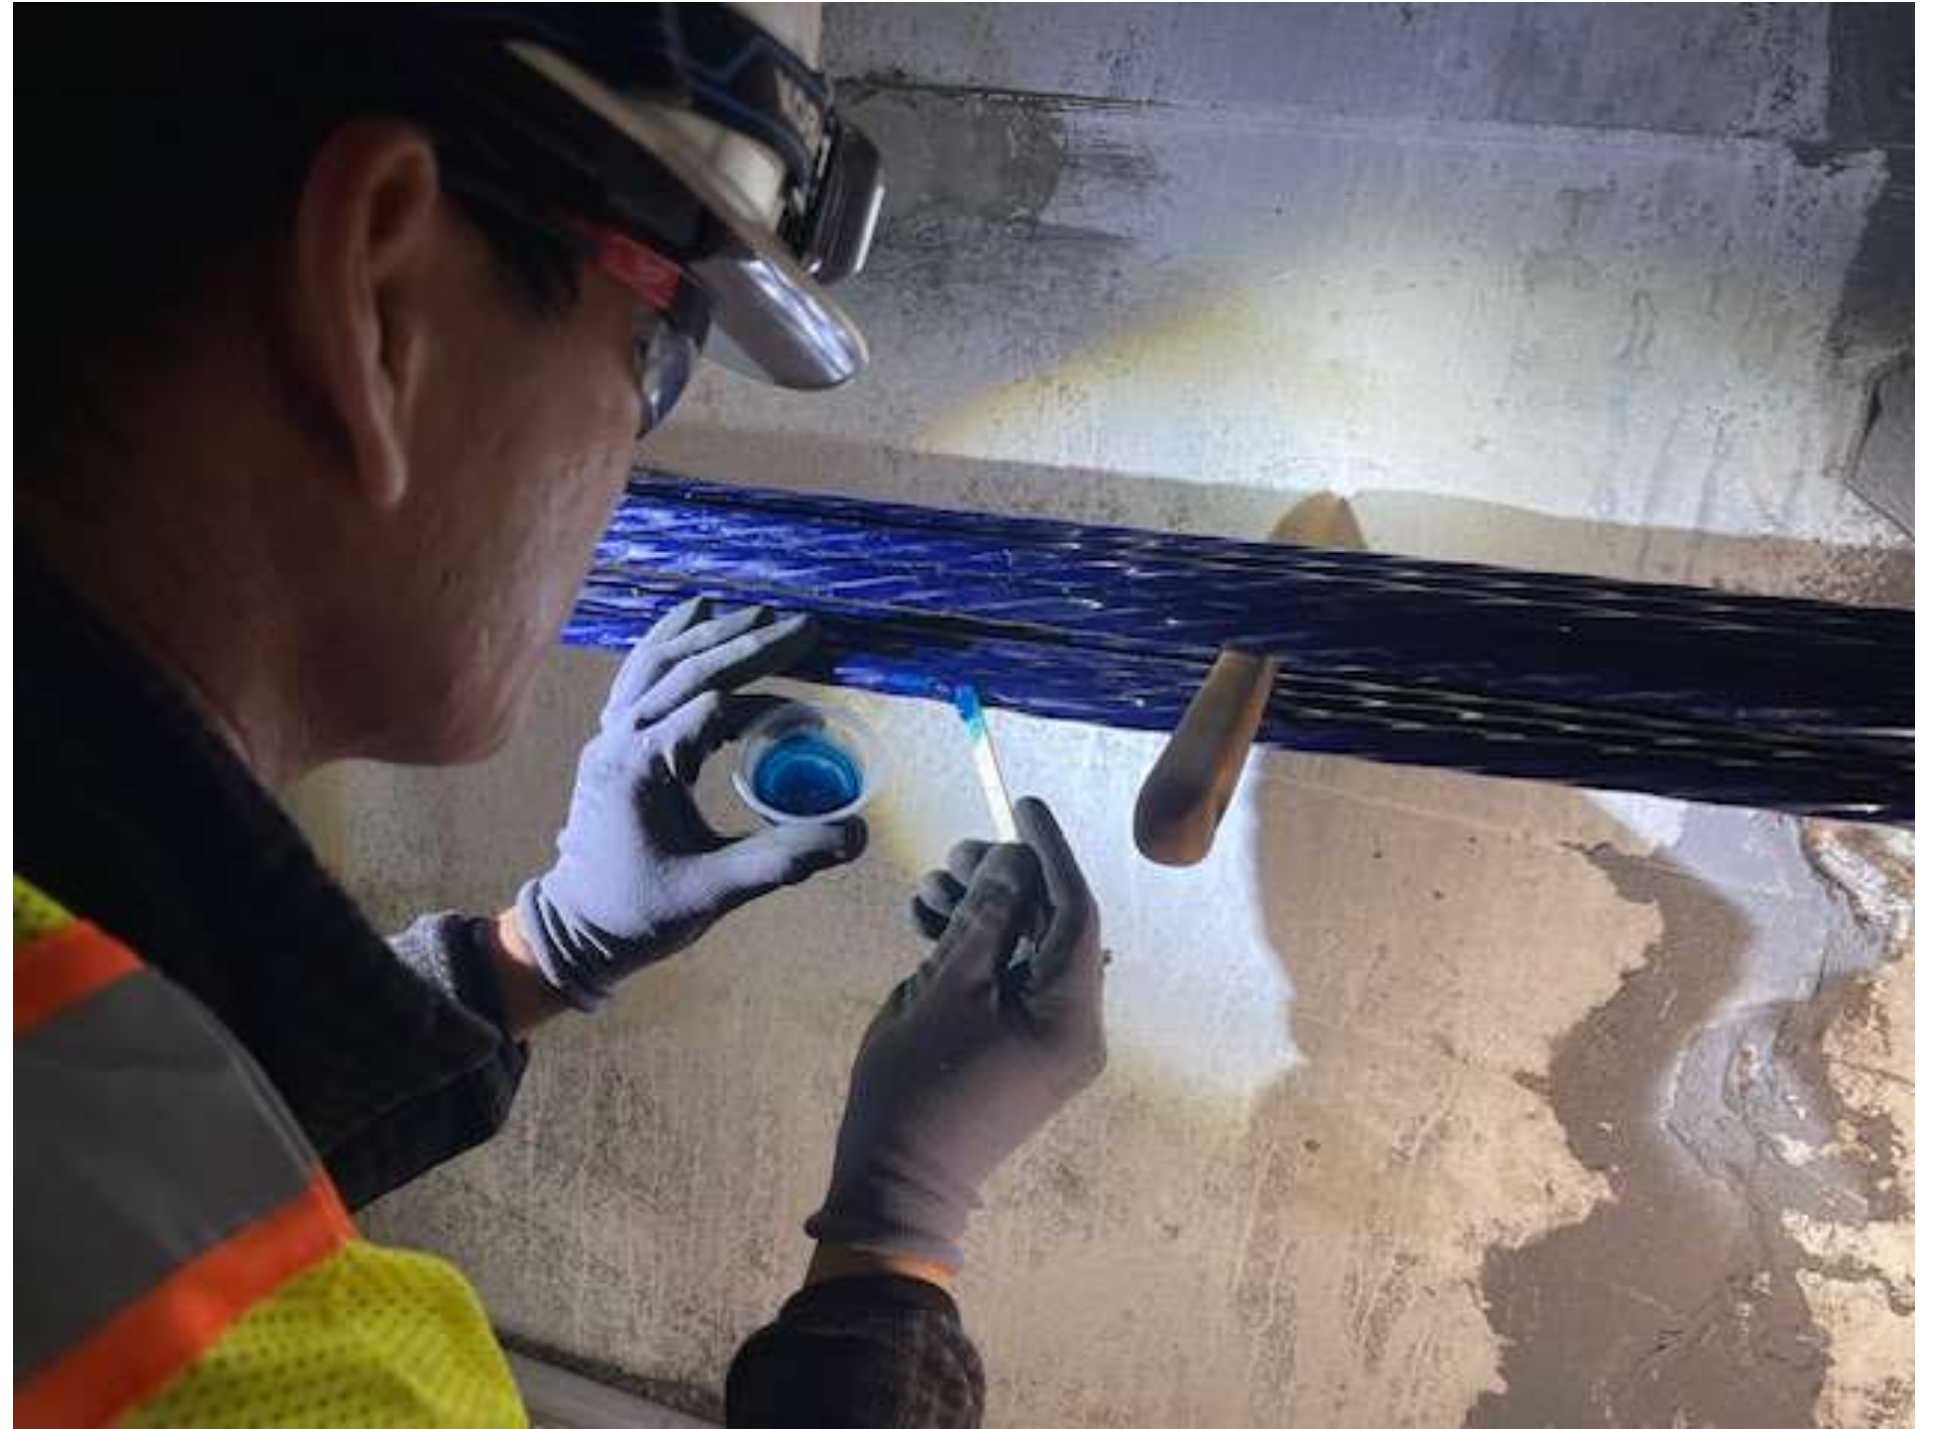
Epoxy repair coating was easily applied to the strand to be visibly thicker than the surrounding epoxy

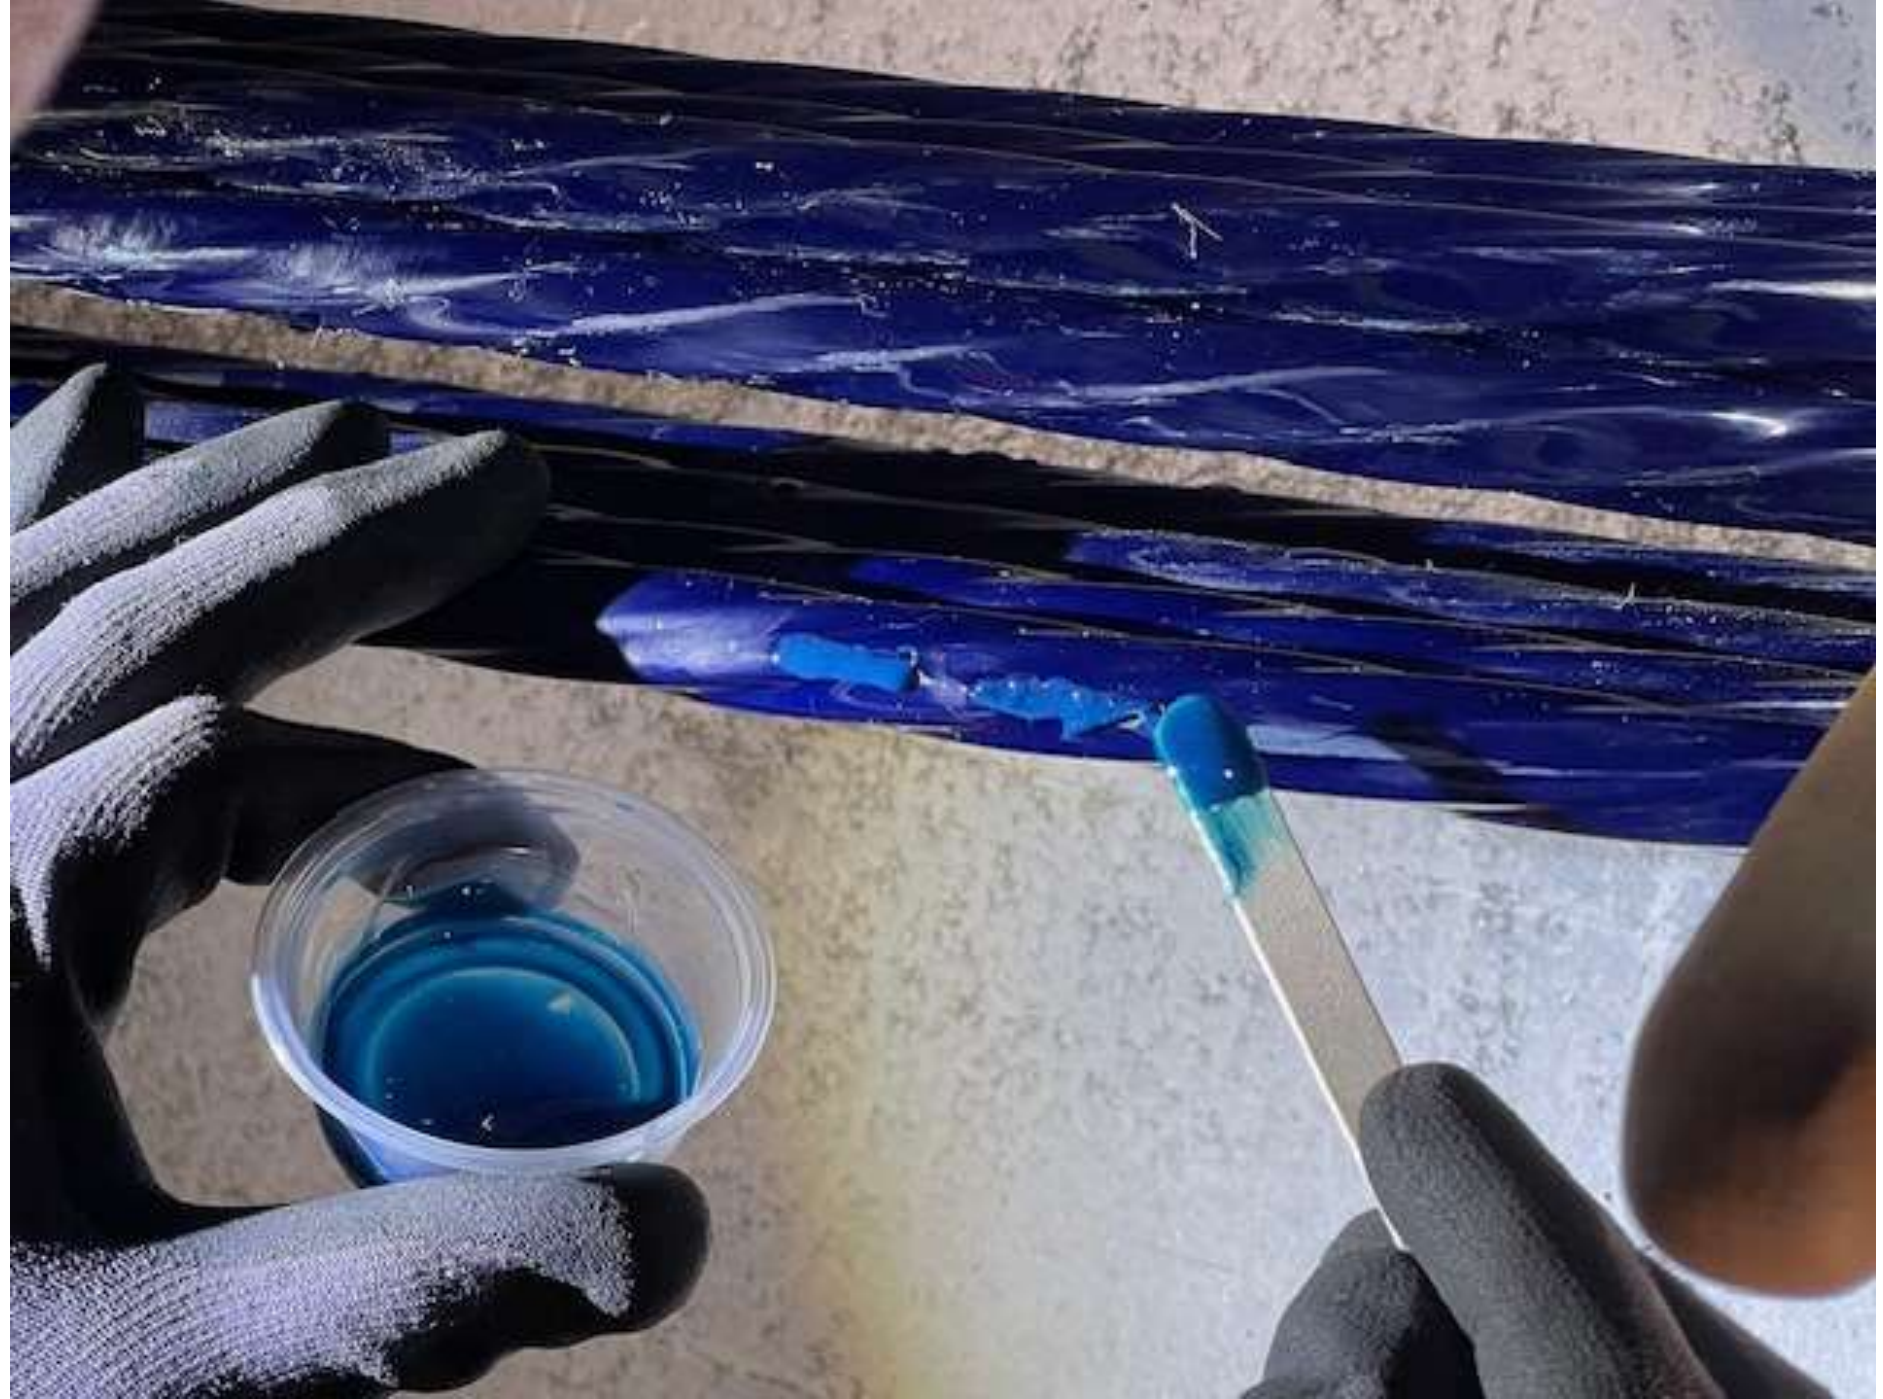
# Epoxy Coating Repair

The portable handheld heater was again used to cure the epoxy.

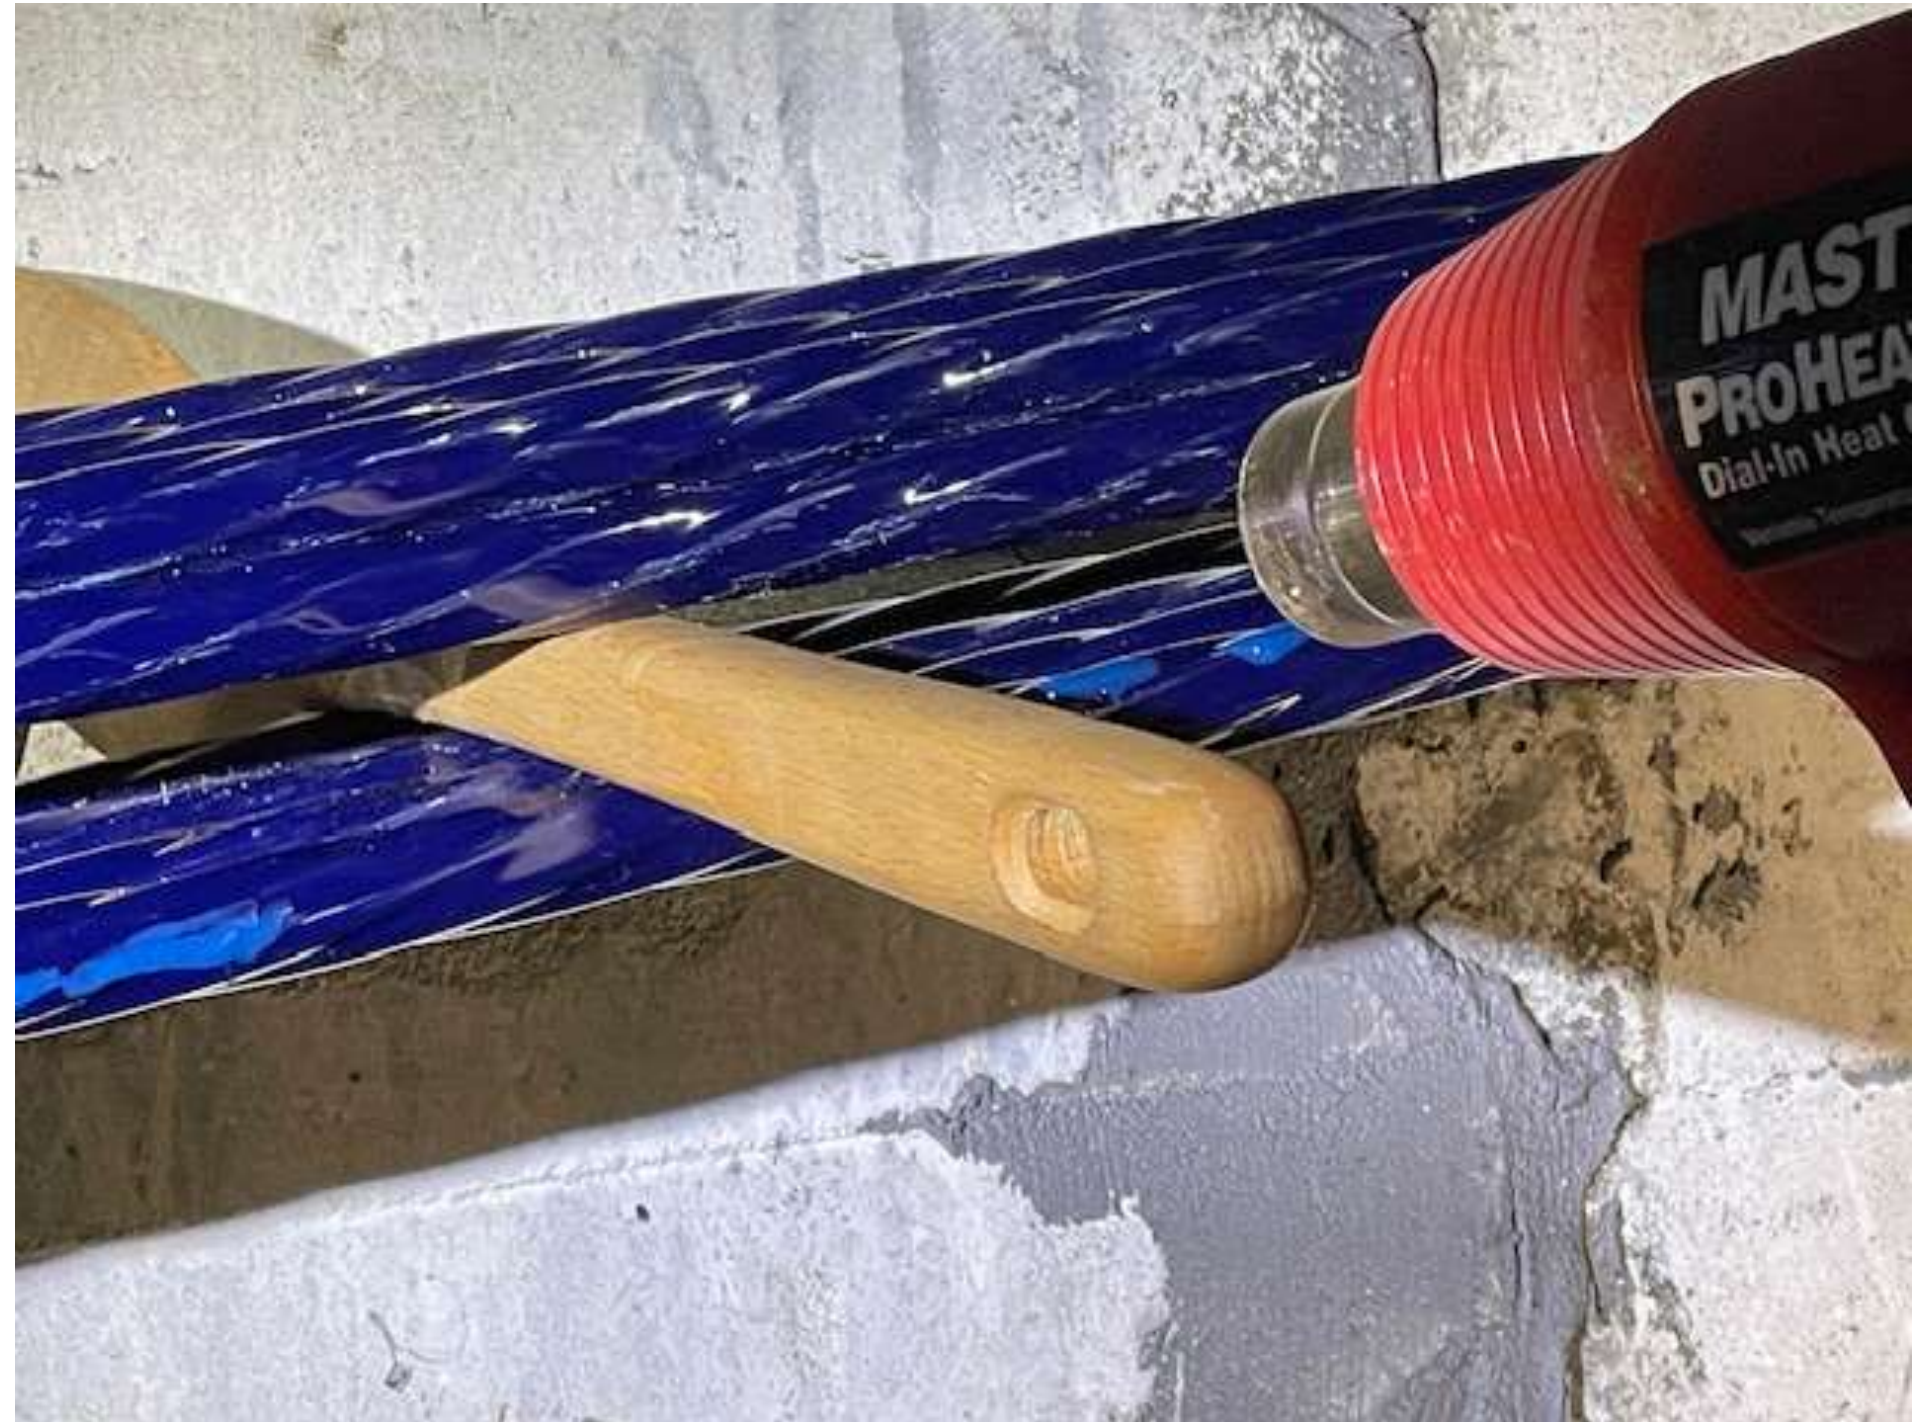
The total time for this observed repair was less than one hour and stressing was able to be performed upon completion.
