# MONTEREY'S DETERIORATING WHARVES:

## A CONCERN FOR PUBLIC SAFETY

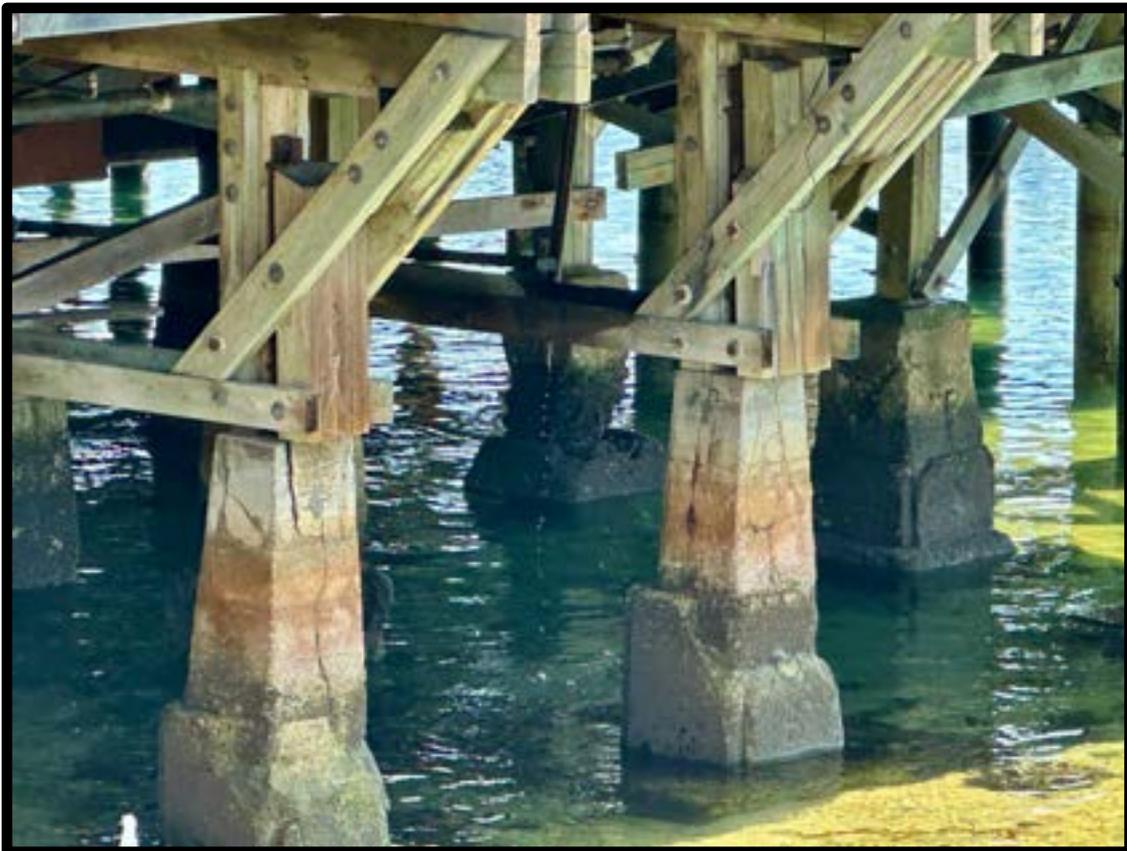
**Wharf 1 Substructure.** Pyramid piling showing vertical crack, allowing seawater intrusion to deteriorate interior rebar core support.

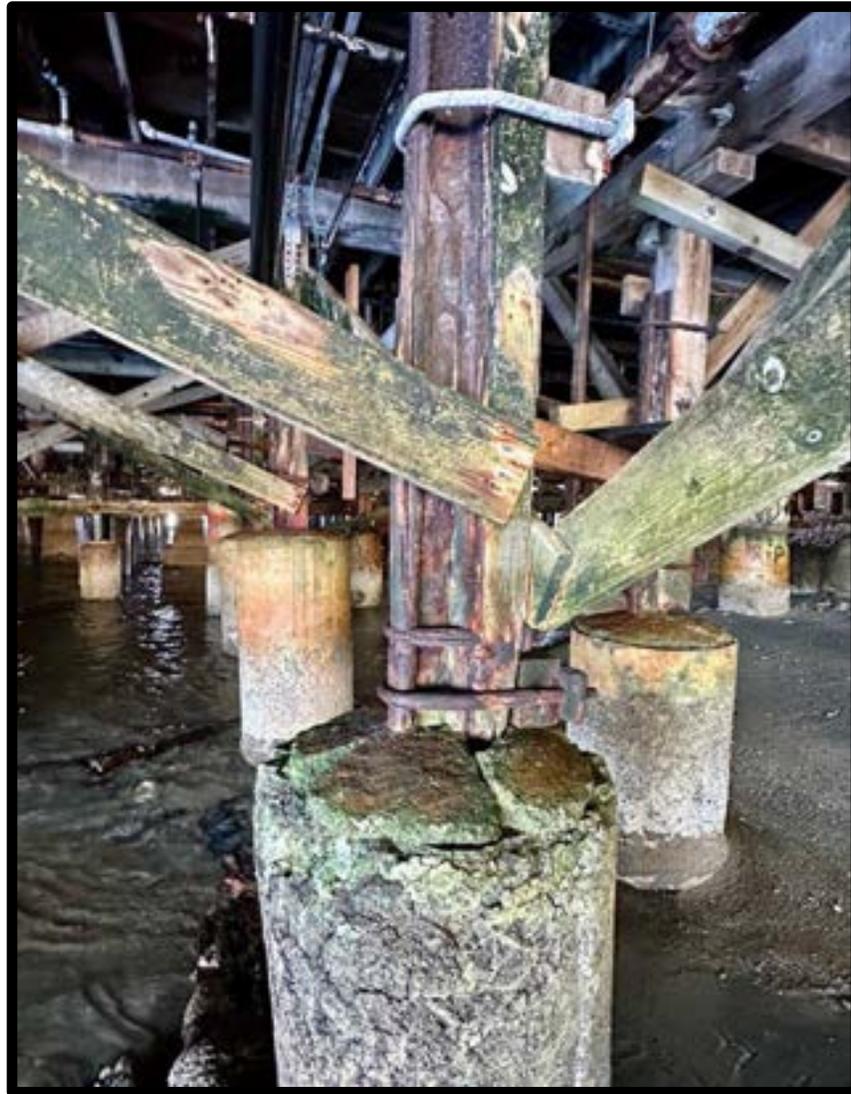
**Pile under Wharf 1.** Deteriorating railroad steel piling attached to timber pile with U-bolts. The concrete encasement has cracked at its crown allowing seawater intrusion resulting in the rebar to corrode and eventually failing.

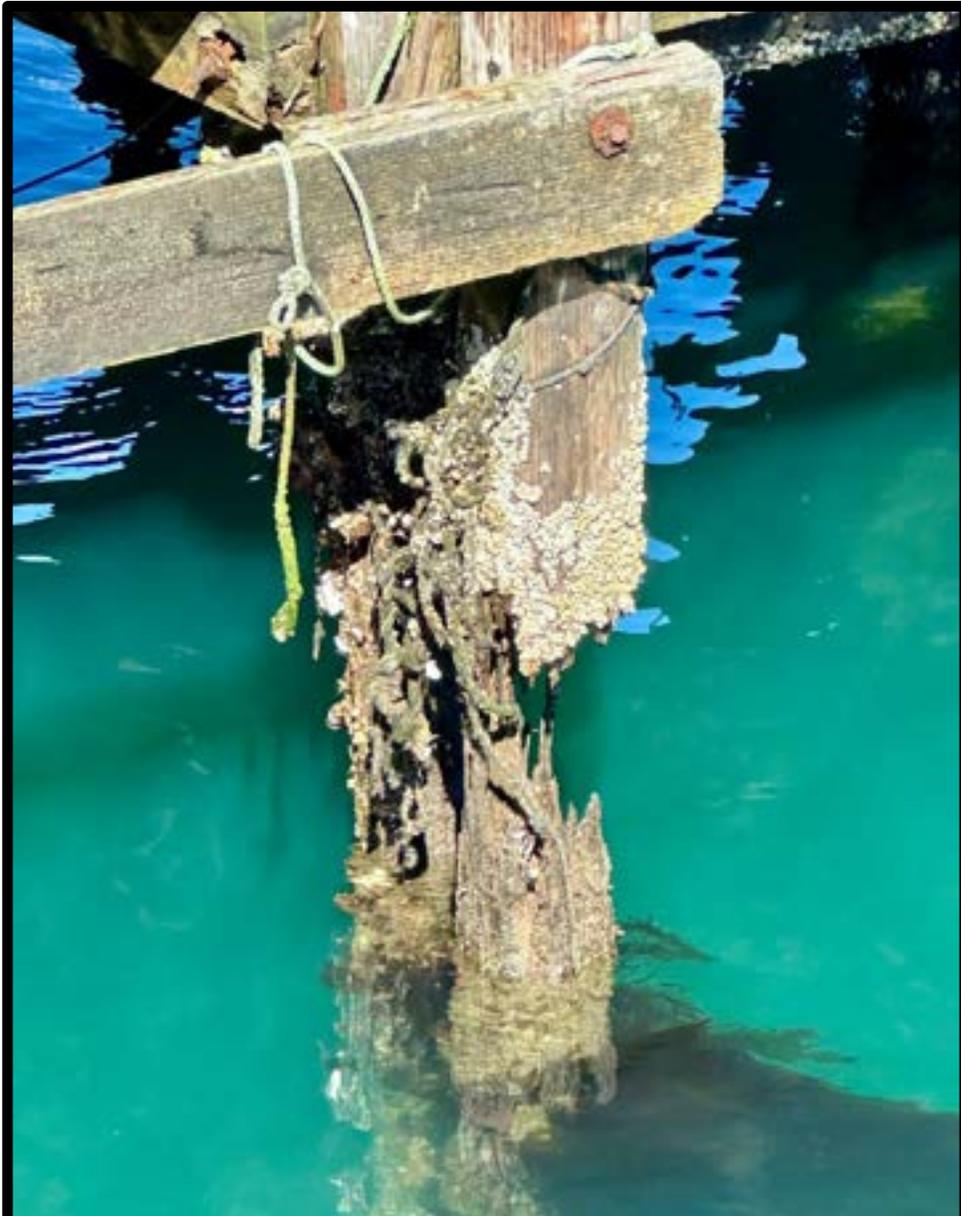
**Fender pile along Wharf 1.** Timber pile has lost most of its diameter at the water line.

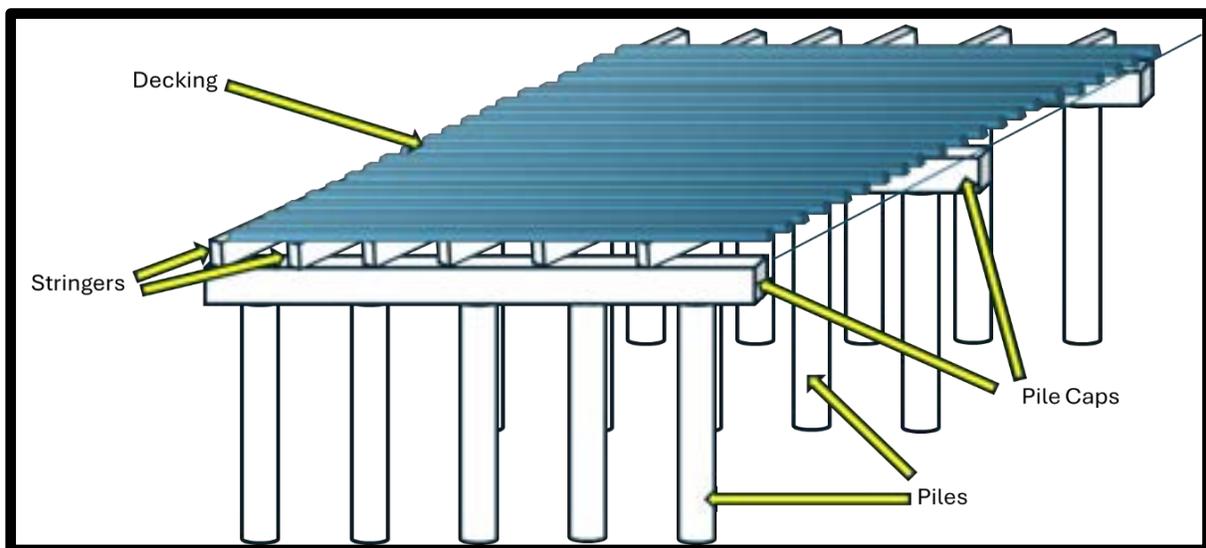
**The Underlying Structure of a Wharf**

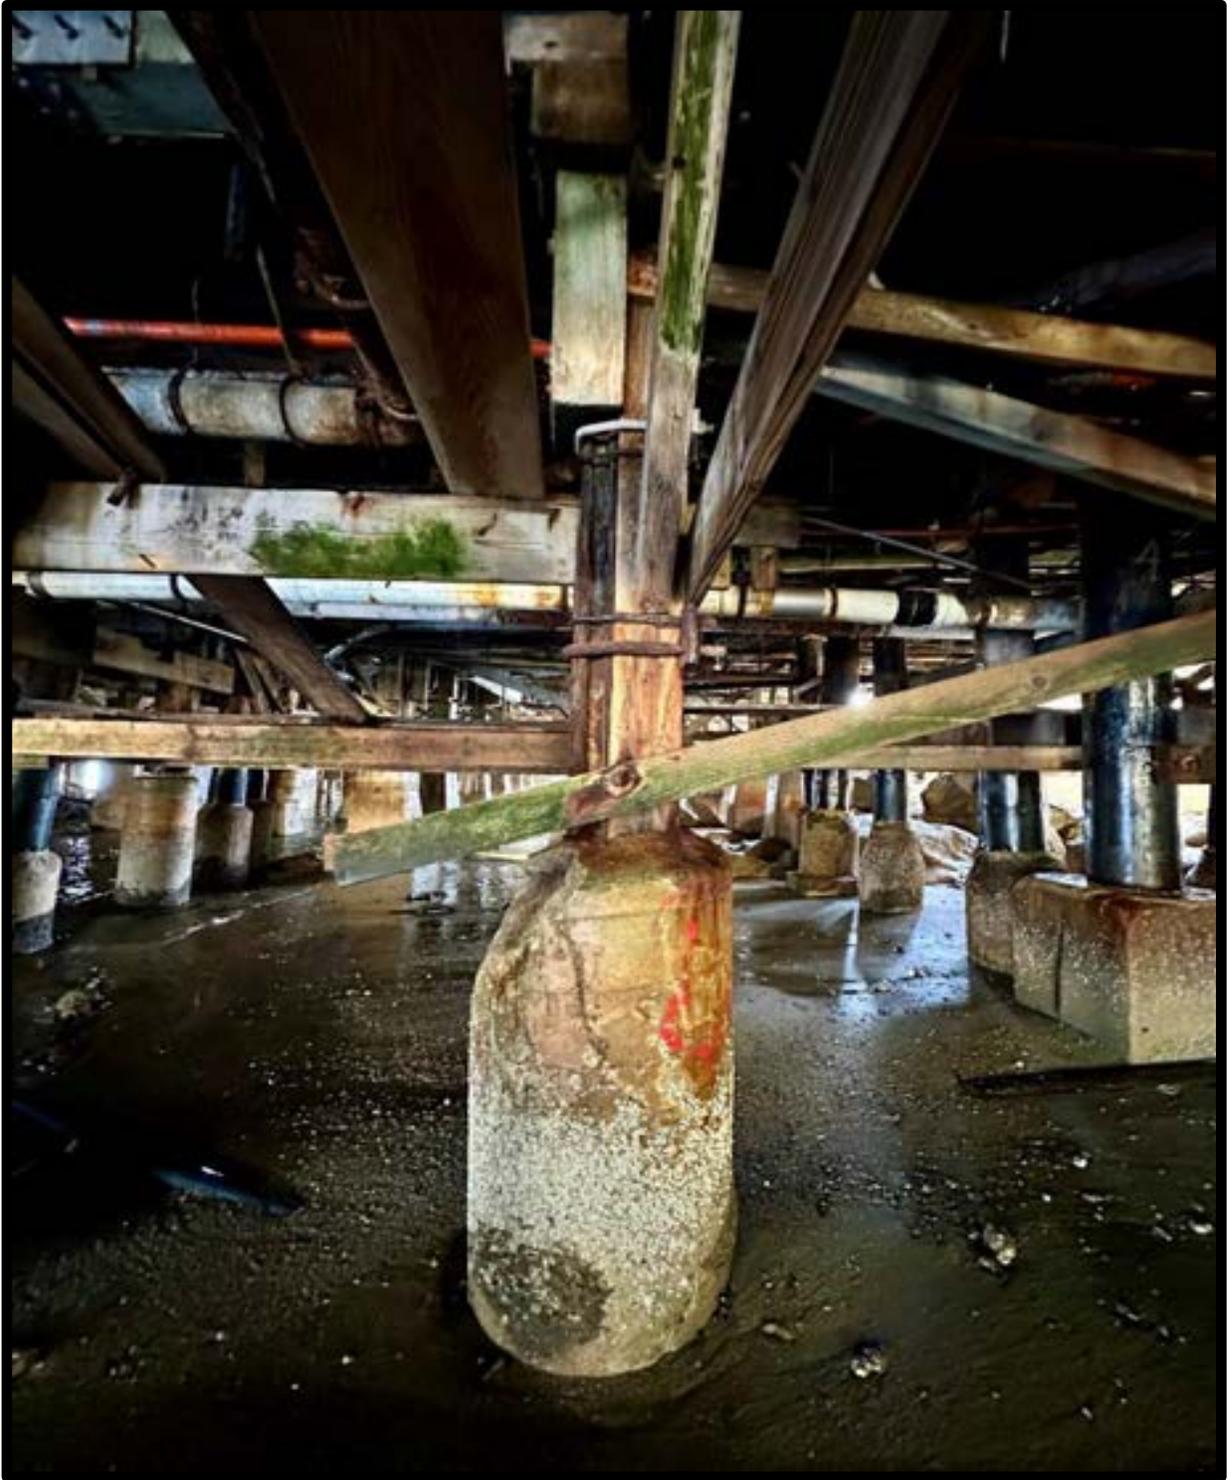
**Wharf 1 substructure.** Old railroad steel piling is highly deteriorated. Timber pile is attached by multiple corroded U-bolts, indicating original wood piling lacking structural integrity.

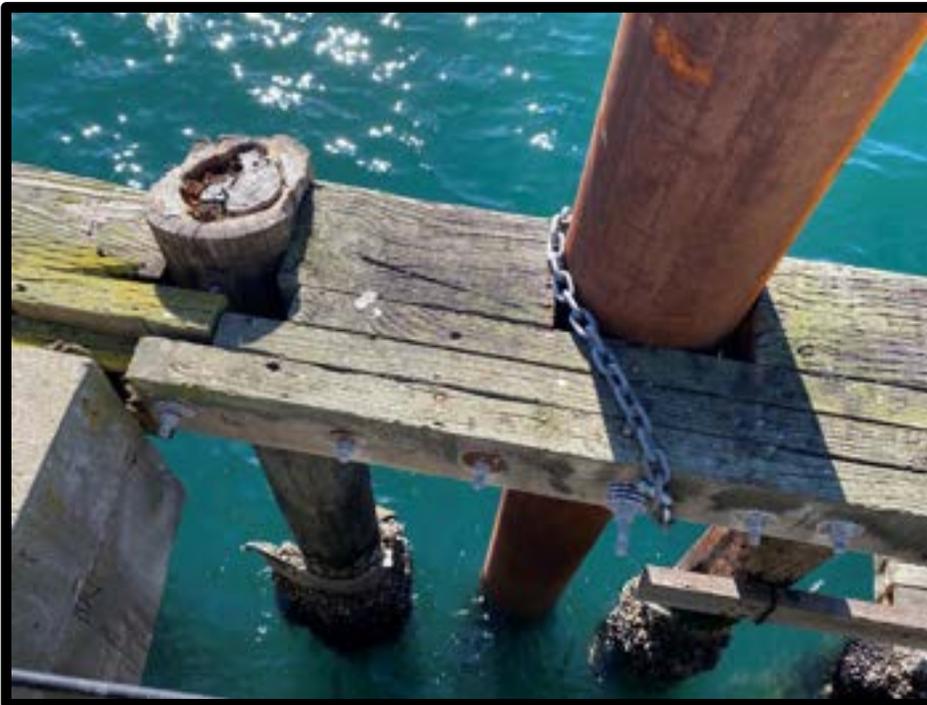
**Pile under Wharf 1.** Rotted core piling with galvanized through bolt supporting numerous wooden joists.

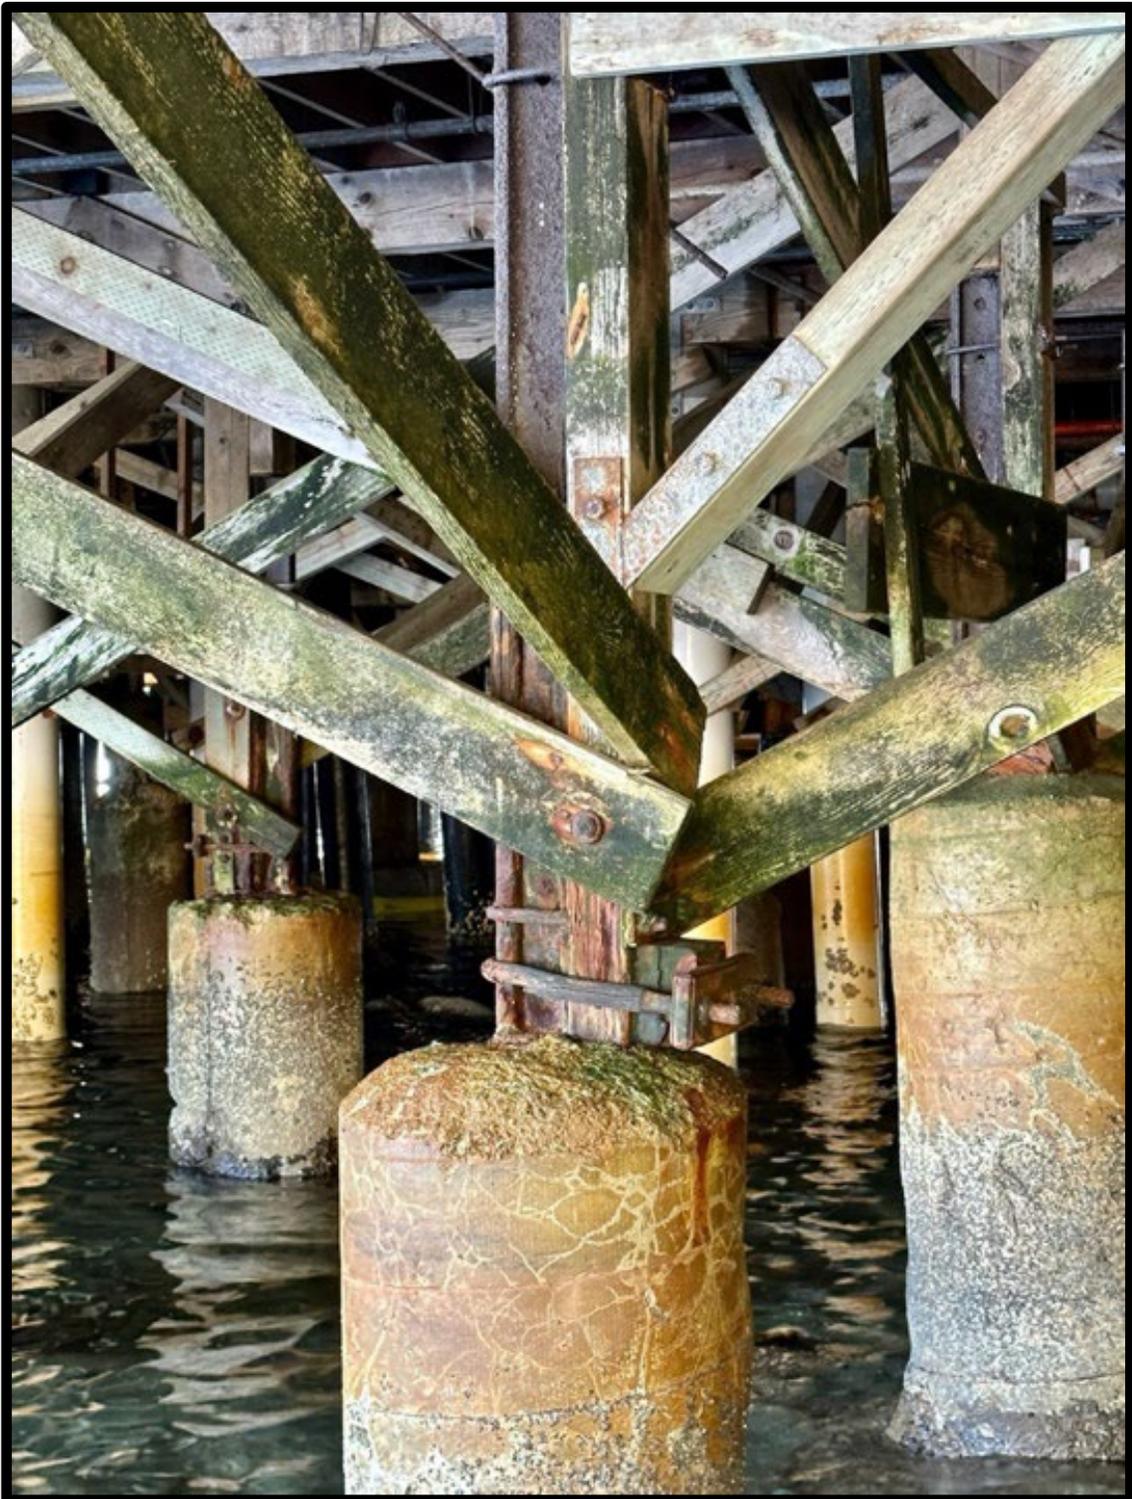
**Pile under Wharf 1.** Deteriorating railroad steel piling attached to timber pile with U-bolts.

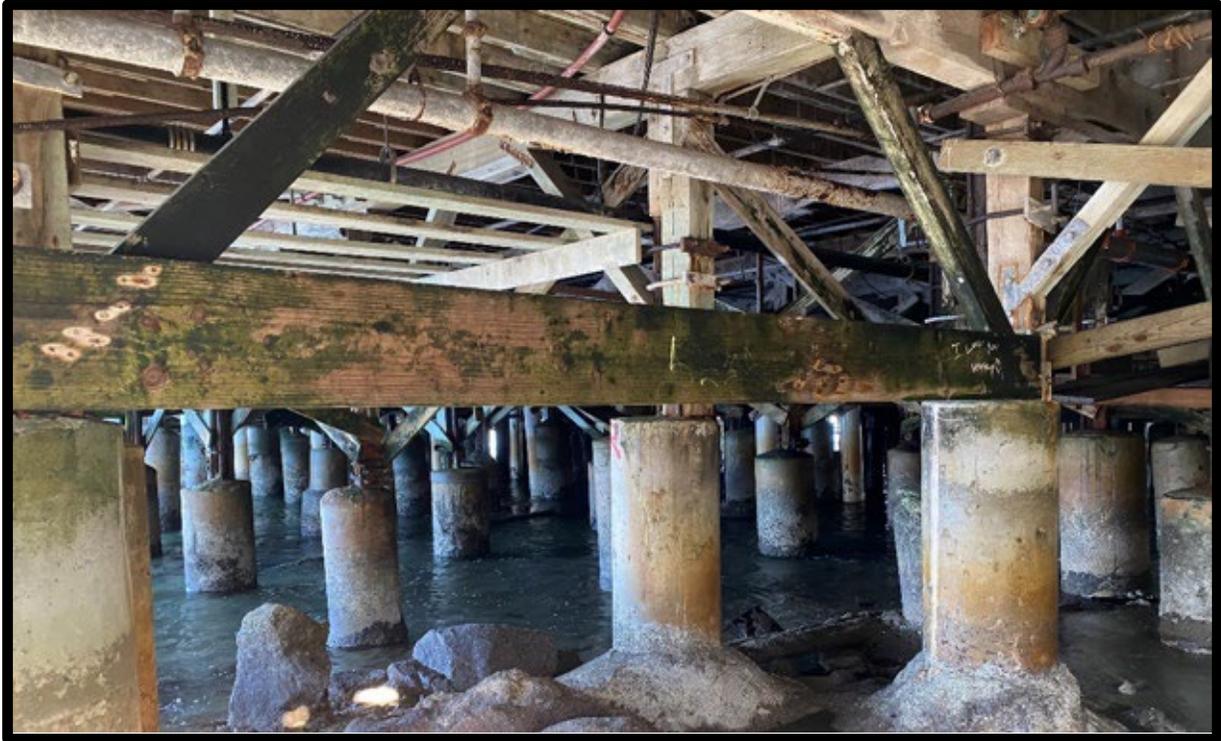
**Substructure of Monterey Wharf 1.** Deteriorating railroad steel piles supported by their concrete bases. Timber piles have been fastened to the steel with U-bolts. The substructure consists of varying materials, hardware and repair techniques.

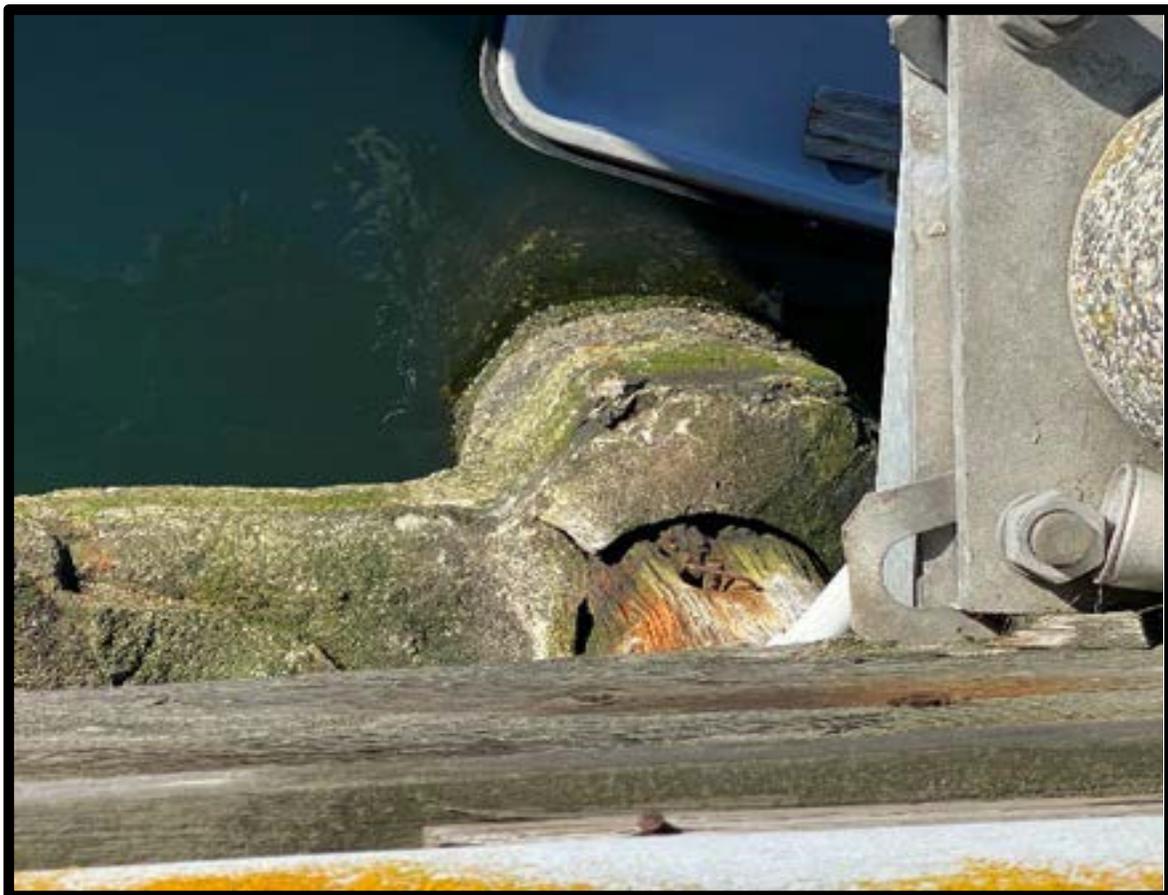
**Exposed Wharf 1 pile.** Concrete sleeve is not continuous above the high-water line, allowing seawater to contact the wood pile, which is suffering from serious deterioration.

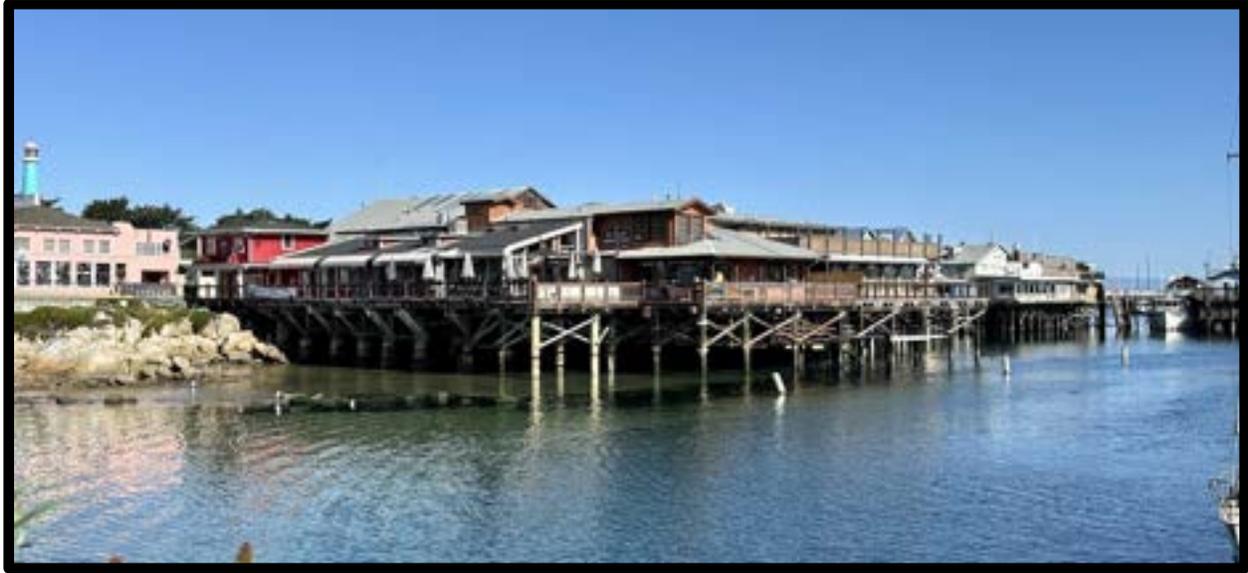
### **Monterey Wharf 1**

The Monterey wharves, still in “Poor” structural condition, require repairs that have yet to be addressed. Ultimately, the City of Monterey is responsible for maintenance, while leaseholders share the responsibility for repairs. Multiple inspections and reports have documented the necessary repairs at significant cost to the taxpayers. Discrepancies between evaluations by certified engineers for the leaseholders and the City have hindered progress. Additionally, a complex permitting process has further hindered the completion of those repairs. At the June 4, 2024, Monterey City Council meeting, staff reported that \$17 million is needed over the next five years to finish just the City’s identified portion of the work. However, the current funding projections are significantly less than this amount, further complicating repair efforts. While the City has taken steps to address maintenance challenges, substantial repairs are needed, and long-term solutions remain unidentified.
