TECHNICAL MEMORANDUM

Date: January 29, 2019
To: Mr. Alex Nattkemper and Ms. Ave' Brown, Contra Costa County Public Works Department
From: Mr. Bobby Carpenter and Mr. Michael J. Leacox, PG, C.E.G.
Subject: Danville Blvd. Underground Storage Tank Investigation

**Subject: Geophysical Investigation Results
Underground Storage Tank (UST) Investigation
1193 Danville Boulevard
Alamo, California**

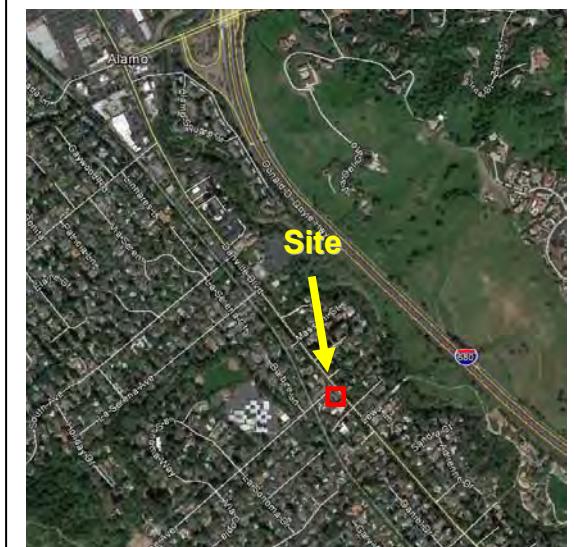
This letter presents the findings of Advanced Geological Services, Inc. (AGS) geophysical investigation to look for a suspected underground storage tank (UST) at the corner of Danville Boulevard and Hemme Avenue in Alamo, California (Figure 1).
