## Metallurgical Investigation - Steel Heat Exchanger Tube Failure

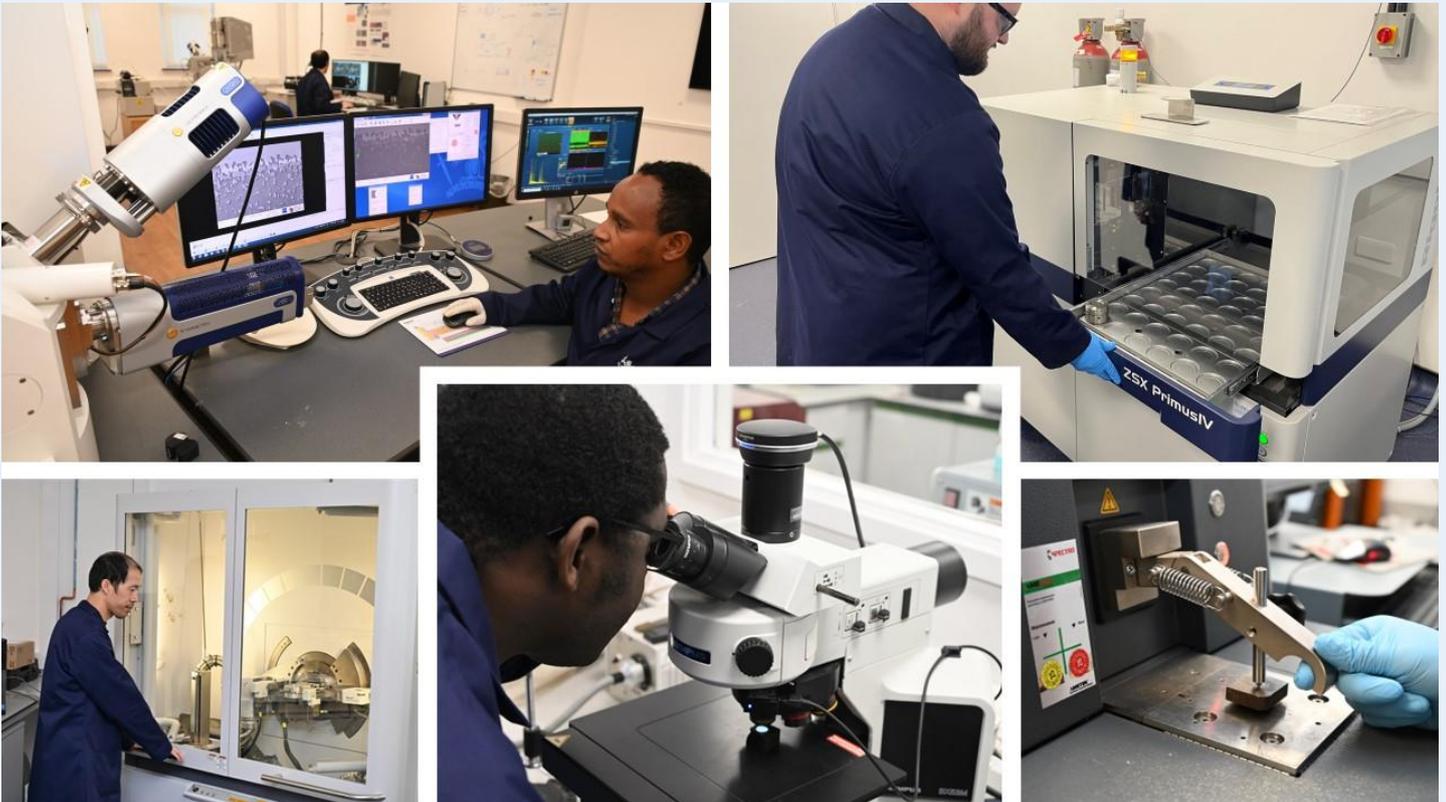
The initial visual inspection of the failed tube showed that it was heavily corroded.

- Analysis did not show any issues with the quality of the steel.
- The problem was found to be related to corrosion.
- The investigation found significant levels of chlorine containing corrosive salts.
- The corrosion attack of the metal by chlorine, and accelerated corrosion attack by the acidic deposits coming from the flue gas, were believed to be the main reasons for the failure of the tube.

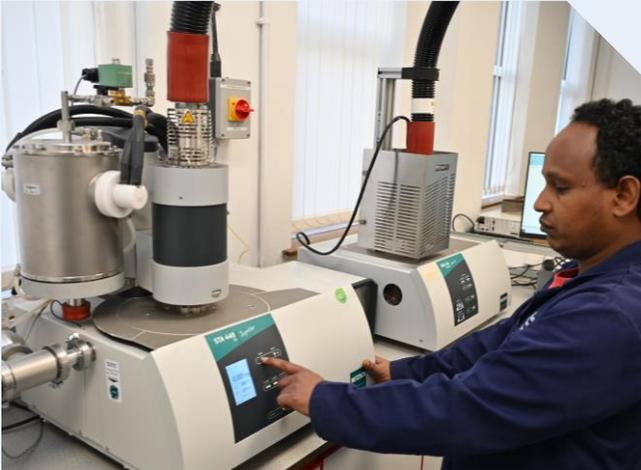
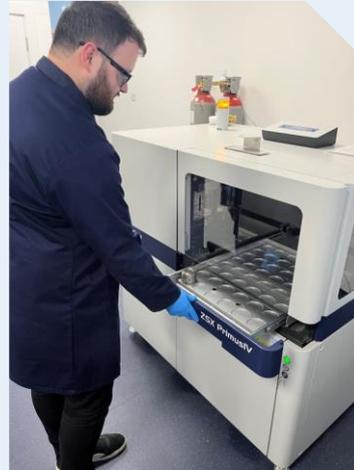
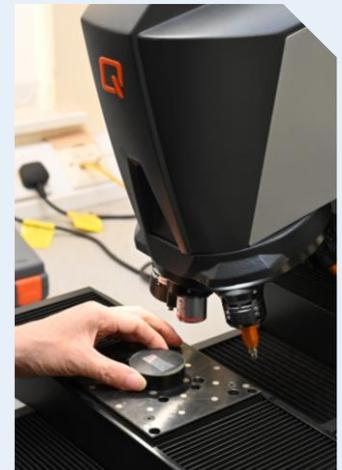
#### Part 1 - Characterisation of corrosion products/deposit

- **pH Measurement:** To determine acidity/alkalinity of corrosion products.
- **X-ray Fluorescence (XRF) Analysis:** For elemental composition of corrosion deposits.
- **X-ray diffraction (XRD) Analysis:** For phase identification in corrosion products.
- **Thermo-gravimetric Analysis with Quadrupole Mass Spectrometry TGA-QMS:** For thermal stability analysis and evolved gas identification.
