EXHIBIT 5

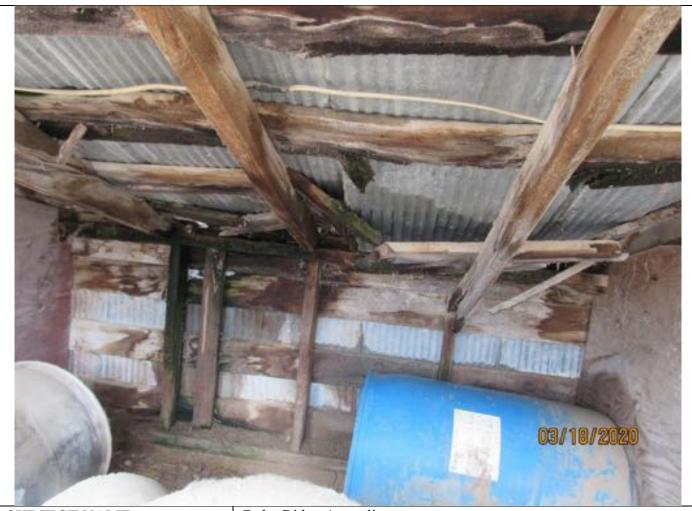
SUBJECT NAME:	Cedar Ridge Australians
LICENSE/REGISTRATION #:	AC0003CG
LICENSEE:	Marlisa McAlmond
NON-COMPLIANT ITEM:	2 CSR 30-9.030 (1) (A) 1. Housing facilities for dogs and cats must
	be designed and constructed so that they are structurally sound. They
	must be kept in good repair.
DESCRIPTION:	The roof of the shade structure had collapsed along the back portion
	of the facility in an enclosure housing three adult Australian
	Shepherds.
DATE:	03/18/2020
TIME:	10:00 am – 8:00 pm
PHOTOGRAPHER:	Joby Hoopes, Animal Health Officer

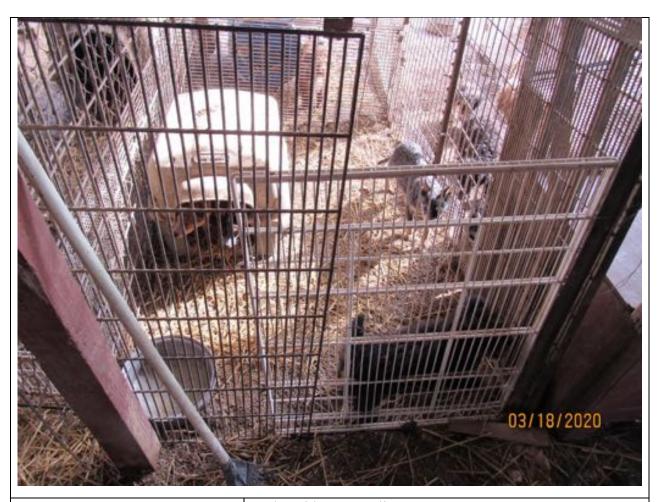
SUBJECT NAME:	Cedar Ridge Australians
LICENSE/REGISTRATION #:	AC0003CG
LICENSEE:	Marlisa McAlmond
NON-COMPLIANT ITEM:	2 CSR 30-9.030 (1) (D) 2. Outdoor facilities for animals
	must include one (1) or more shelter structures that are
	accessible to each animal in each outdoor facility, and that
	are large enough to allow each animal in the shelter structure
	to sit, stand and lie in a normal manner, and to turn about
	freely.
DESCRIPTION:	During today's inspection, there were two enclosures that
	did not provide enough dog houses or a dog house large
	enough to allow each animal in the enclosure to sit, stand,
	and lie in a normal manner, and to turn about freely.
DATE:	03/18/2020
TIME:	10:00 am – 8:00 pm
PHOTOGRAPHER:	Joby Hoopes, Animal Health Officer

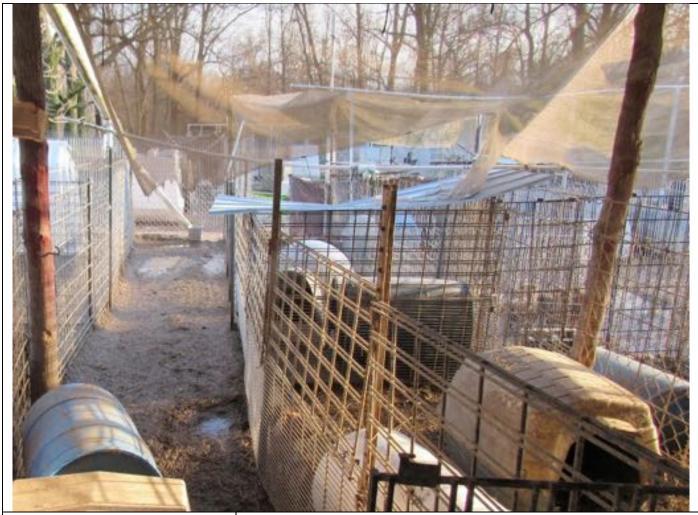
SUBJECT NAME:	Cedar Ridge Australians
LICENSE/REGISTRATION #:	AC0003CG
LICENSEE:	Marlisa McAlmond
NON-COMPLIANT ITEM:	2 CSR 30-9.030 (1) (D) 2. In addition to the shelter structures, one (1)
	or more separate outside areas of shade must be provided by means of
	trees, permanent awnings, or suspended shade cloth or heavy duty
	tarps in good repair and firmly secured to a frame, large enough to
	contain all the animals at once and protect them from the direct rays
	of the sun.
DESCRIPTION:	During today's inspection, tarps were provided for shade, however
	there were approximately 12 enclosures that had tarps that were not in
	good repair. Several were tore along the edges and others had been
	chewed on by the dogs.
DATE:	03/18/2020
TIME:	10:00 am – 8:00 pm
PHOTOGRAPHER:	Joby Hoopes, Animal Health Officer

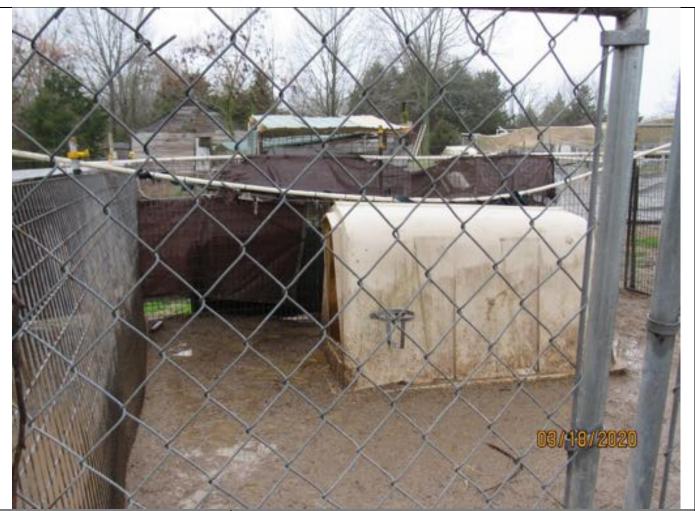
SUBJECT NAME:	Cedar Ridge Australians
LICENSE/REGISTRATION #:	AC0003CG
LICENSEE:	Marlisa McAlmond
NON-COMPLIANT ITEM:	2 CSR 30-9.030 (1) (D) 2. In addition to the shelter structures, one (1)
	or more separate outside areas of shade must be provided by means of
	trees, permanent awnings, or suspended shade cloth or heavy duty
	tarps in good repair and firmly secured to a frame, large enough to
	contain all the animals at once and protect them from the direct rays
	of the sun.
DESCRIPTION:	During today's inspection, tarps were provided for shade, however
	there were approximately 12 enclosures that had tarps that were not in
	good repair. Several were tore along the edges and others had been
	chewed on by the dogs.
DATE:	03/18/2020
TIME:	10:00 am – 8:00 pm
PHOTOGRAPHER:	Joby Hoopes, Animal Health Officer

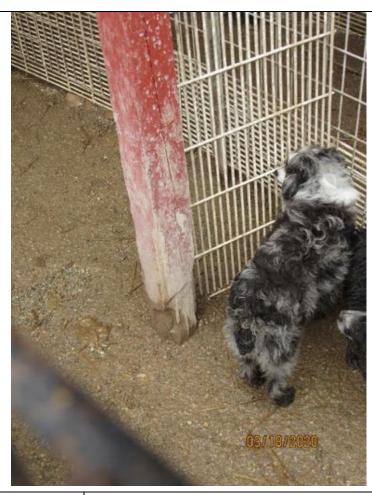
SUBJECT NAME:	Cedar Ridge Australians
LICENSE/REGISTRATION#:	AC0003CG
LICENSEE:	Marlisa McAlmond
NON-COMPLIANT ITEM:	2 CSR 30-9.030 (1) (D) 3. Building surfaces in contact with
	animals in outdoor housing facilities must be impervious to
	moisture. Shade structures were supported with wooden boards
	that the animals can come into contact with. These wooden boards
	were no longer impervious to moisture.
DESCRIPTION:	Shade structures were supported with wooden boards that the
	animals can come into contact with. These wooden boards were
	no longer impervious to moisture.
DATE:	03/18/2020
TIME:	10:00 am – 8:00 pm
PHOTOGRAPHER:	Joby Hoopes, Animal Health Officer

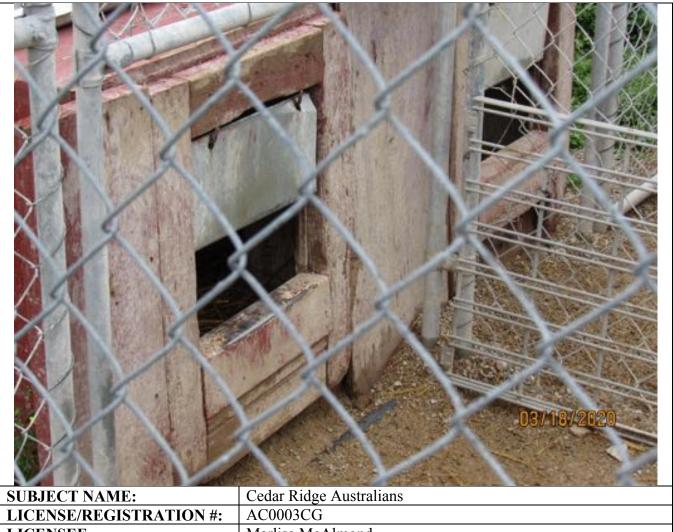
SUBJECT NAME:	Cedar Ridge Australians
LICENSE/REGISTRATION #:	AC0003CG
LICENSEE:	Marlisa McAlmond
NON-COMPLIANT ITEM:	2 CSR 30-9.030 (1) (D) 3. Building surfaces in contact with
	animals in outdoor housing facilities must be impervious to
	moisture.
DESCRIPTION:	There were several wooden dog houses that were no longer
	impervious to moisture.
DATE:	03/18/2020
TIME:	10:00 am – 8:00 pm
PHOTOGRAPHER:	Joby Hoopes, Animal Health Officer

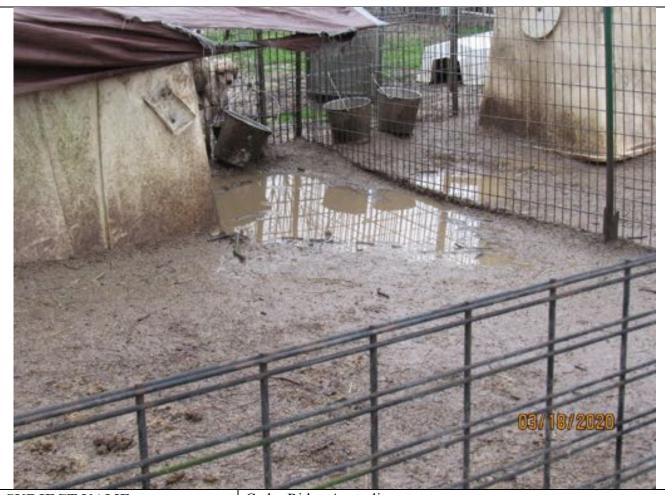
SUBJECT NAME:	Cedar Ridge Australians
LICENSE/REGISTRATION #:	AC0003CG
LICENSEE:	Marlisa McAlmond
NON-COMPLIANT ITEM:	2 CSR 30-9.030 (1) (D) 3. The floors of outdoor housing
	facilities may not be of bare dirt or sand; must have adequate
	drainage; and must be replaced if there are any prevalent odors,
	diseases, insects, pests, or vermin.
DESCRIPTION:	During today's inspection most of the enclosures did not have
	adequate drainage. The enclosures were previously comprised of
	gravel, however the gravel has been worn down and partially
	washed away, exposing large areas compacted dirt throughout
	the primary enclosure and causing standing water. Numerous
	animals were observed to have wet feet, legs, and bodies.
DATE:	03/18/2020
TIME:	10:00 am – 8:00 pm
PHOTOGRAPHER:	Joby Hoopes, Animal Health Officer

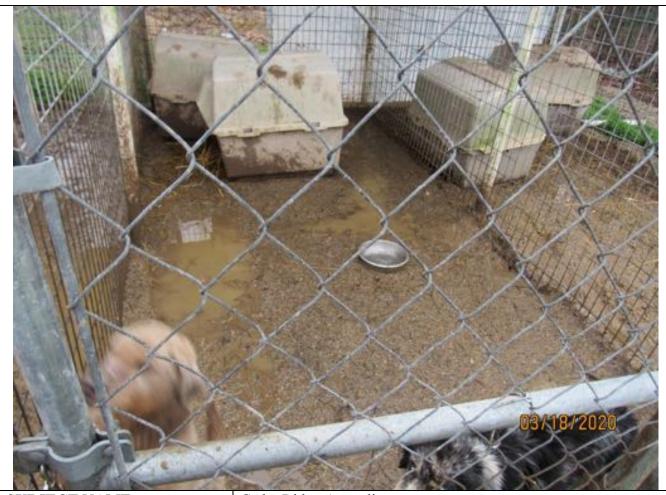
SUBJECT NAME:	Cedar Ridge Australians
LICENSE/REGISTRATION #:	AC0003CG
LICENSEE:	Marlisa McAlmond
NON-COMPLIANT ITEM:	2 CSR 30-9.030 (1) (D) 3. The floors of outdoor housing facilities
	may not be of bare dirt or sand; must have adequate drainage; and
	must be replaced if there are any prevalent odors, diseases,
	insects, pests, or vermin.
DESCRIPTION:	During today's inspection most of the enclosures did not have
	adequate drainage. The enclosures were previously comprised of gravel, however; the gravel has been worn down and partially washed away, exposing large areas compacted dirt throughout the primary enclosure and causing standing water. Numerous animals were observed to have wet feet, legs, and bodies.
DATE:	03/18/2020
TIME:	10:00 am – 8:00 pm
PHOTOGRAPHER:	Joby Hoopes, Animal Health Officer

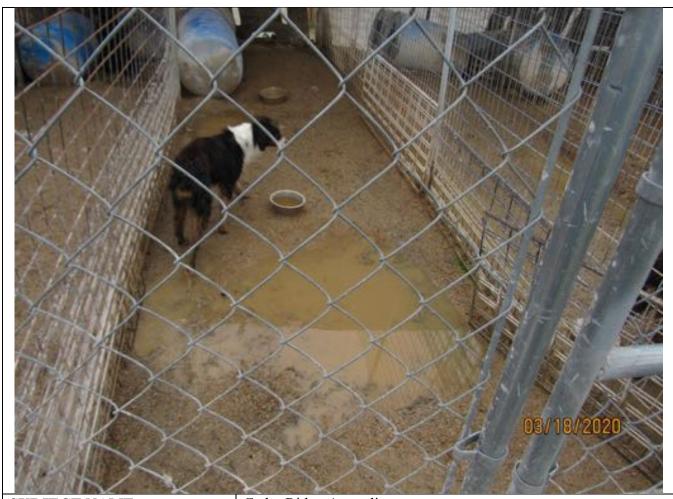
SUBJECT NAME:	Cedar Ridge Australians
LICENSE/REGISTRATION #:	AC0003CG
LICENSEE:	Marlisa McAlmond
NON-COMPLIANT ITEM:	2 CSR 30-9.030 (1) (D) 3. The floors of outdoor housing facilities
	may not be of bare dirt or sand; must have adequate drainage; and
	must be replaced if there are any prevalent odors, diseases,
	insects, pests, or vermin.
DESCRIPTION:	During today's inspection most of the enclosures did not have
	adequate drainage. The enclosures were previously comprised of gravel, however the gravel has been worn down and partially
	washed away, exposing large areas compacted dirt throughout the
	primary enclosure and causing standing water. Numerous animals
	were observed to have wet feet, legs, and bodies.
DATE:	03/18/2020
TIME:	10:00 am – 8:00 pm
PHOTOGRAPHER:	Joby Hoopes, Animal Health Officer

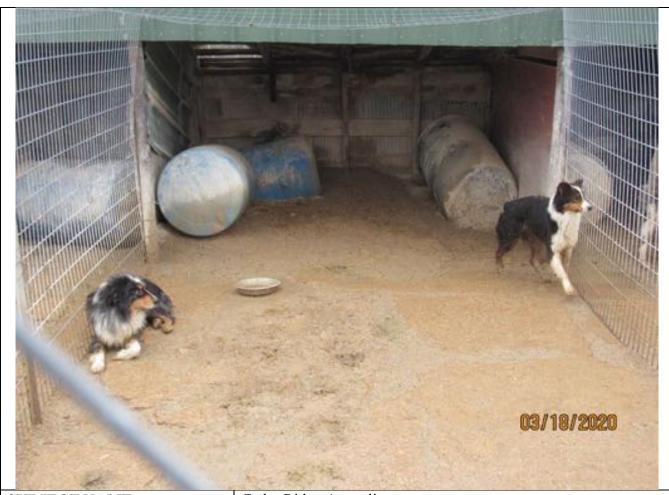
SUBJECT NAME:	Cedar Ridge Australians
LICENSE/REGISTRATION #:	AC0003CG
LICENSEE:	Marlisa McAlmond
NON-COMPLIANT ITEM:	2 CSR 30-9.030 (1) (D) 3. All surfaces must be maintained on a
	regular basis. Surfaces of outdoor housing facilities, including
	houses, dens, and the like, that cannot be readily cleaned and
	sanitized, must be replaced when worn or soiled.
DESCRIPTION:	A majority of the dog houses throughout the facility need to be
	cleaned inside and out. The outside of the dog houses are caked in
	mud and several of them have gravel inside of them.
DATE:	03/18/2020
TIME:	10:00 am – 8:00 pm
PHOTOGRAPHER:	Joby Hoopes, Animal Health Officer

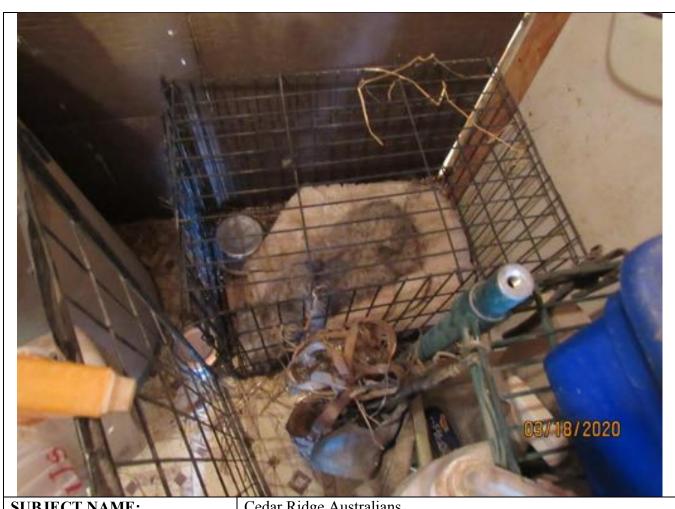
SUBJECT NAME:	Cedar Ridge Australians
LICENSE/REGISTRATION #:	AC0003CG
LICENSEE:	Marlisa McAlmond
NON-COMPLIANT ITEM:	2 CSR 30-9.030 (2)(B)4. Exercise for dogs. Except as prescribed
	by rule, commercial breeders with more than ten (10) intact
	females must provide covered dogs with constant and unfettered
	access to an attached outdoor run.
DESCRIPTION:	There was an adult Australian Shepherd cross, Snappy being
	housed in the whelping building that did not have constant and
	unfettered access.
DATE:	03/18/2020
TIME:	10:00 am – 8:00 pm
PHOTOGRAPHER:	Joby Hoopes, Animal Health Officer

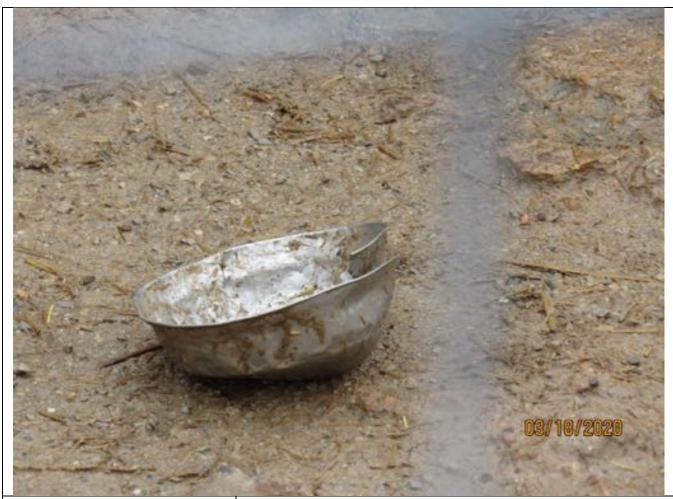
SUBJECT NAME:	Cedar Ridge Australians
LICENSE/REGISTRATION #:	AC0003CG
LICENSEE:	Marlisa McAlmond
NON-COMPLIANT ITEM:	2 CSR 30-9.030 (2) (C) 2. Feeding pans must either be made of a
	durable material that can be easily cleaned and sanitized or
	disposable.
DESCRIPTION:	There were feeding pans in enclosures today that were chewed,
	causing sharp points. These feeding pans were no longer able to
	be easily cleaned or sanitized.
DATE:	03/18/2020
TIME:	10:00 am – 8:00 pm
PHOTOGRAPHER:	Joby Hoopes, Animal Health Officer

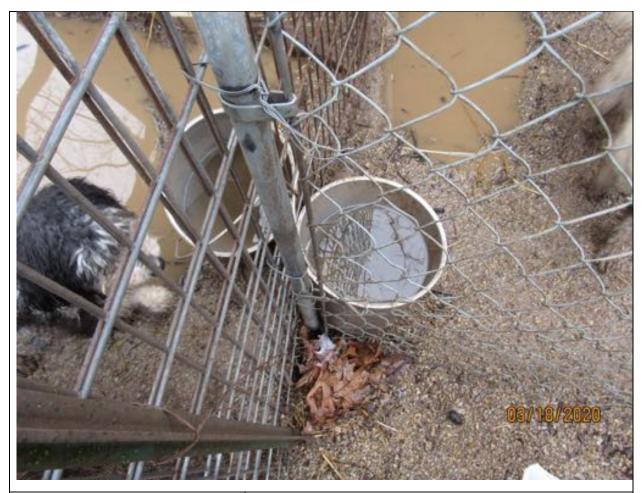
SUBJECT NAME:	Cedar Ridge Australians
LICENSE/REGISTRATION #:	AC0003CG
LICENSEE:	Marlisa McAlmond
NON-COMPLIANT ITEM:	Each licensee subject to the provisions of section
	273.345, RSMo, shall provide continuous access to
	potable water that is not frozen and is generally free of
	debris, feces, algae, and other contaminants.
DESCRIPTION:	During today's inspection, at least eight primary
	enclosures were observed to have empty water bowls. In
	addition, a majority of the water receptacles were
	observed to have dirty water or a build-up of debris in the
	water.
DATE:	03/18/2020
TIME:	10:00 am – 8:00 pm
PHOTOGRAPHER:	Joby Hoopes, Animal Health Officer

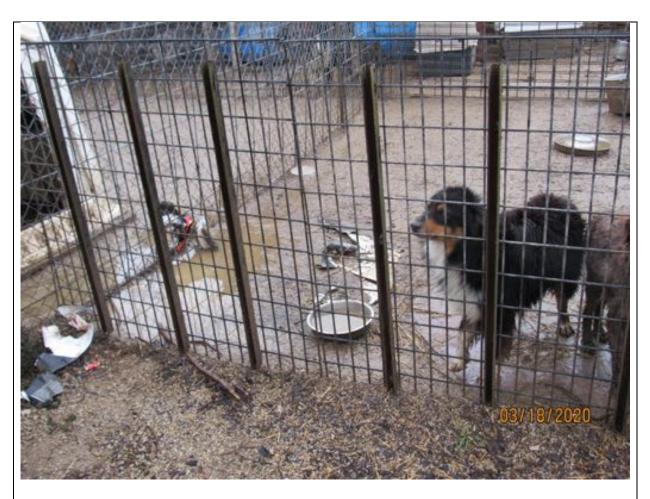
SUBJECT NAME:	Cedar Ridge Australians
LICENSE/REGISTRATION #:	AC0003CG
LICENSEE:	Marlisa McAlmond
NON-COMPLIANT ITEM:	2 CSR 30-9.030 (2) (E) 3. Premises must be kept free of accumulations of trash, junk, waste products, and discarded matter. Weeds, grasses, and bushes must be controlled so as to facilitate cleaning of the premises and pest control and to protect the health and well-being of the animals.
DESCRIPTION:	There was an enclosure housing two Australian Poodle crosses that had torn up pieces of a dog food bag in the enclosure.
DATE:	03/18/2020
TIME:	10:00 am – 8:00 pm
PHOTOGRAPHER:	Joby Hoopes, Animal Health Officer

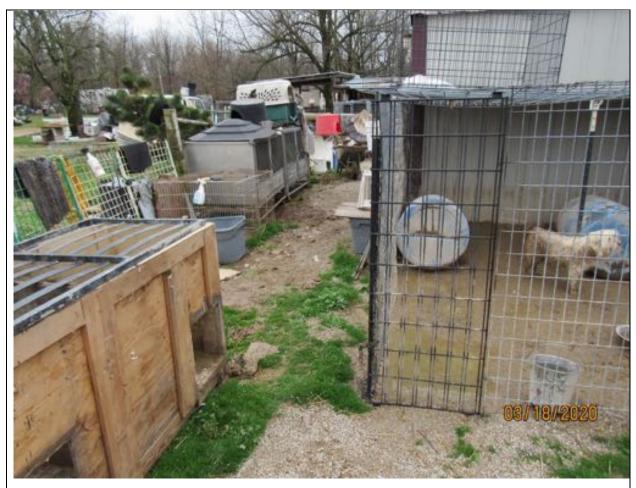
SUBJECT NAME:	Cedar Ridge Australians
LICENSE/REGISTRATION #:	AC0003CG
LICENSEE:	Marlisa McAlmond
NON-COMPLIANT ITEM:	2 CSR 30-9.030 (2) (E) 3. Premises must be kept free of accumulations of trash, junk, waste products, and discarded matter. Weeds, grasses, and bushes must be controlled so as to facilitate cleaning of the premises and pest control and to protect the health and well-being of the animals.
DESCRIPTION:	The whelping building and the area behind the elevated whelping boxes had an accumulation of trash, junk, waste products, and discarded matter.
DATE:	03/18/2020
TIME:	10:00 am – 8:00 pm
PHOTOGRAPHER:	Joby Hoopes, Animal Health Officer

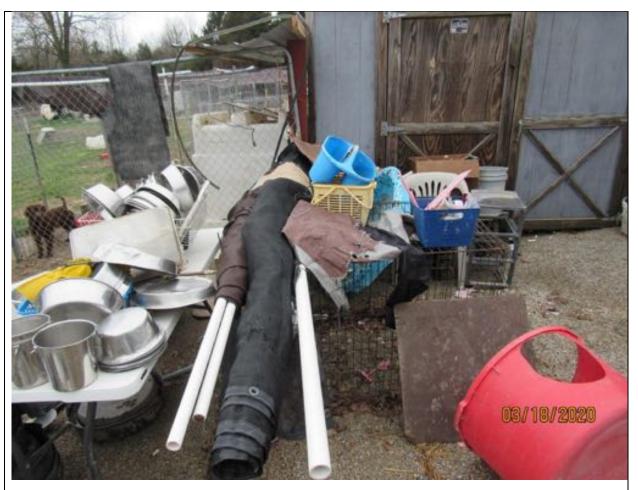
SUBJECT NAME:	Cedar Ridge Australians
LICENSE/REGISTRATION #:	AC0003CG
LICENSEE:	Marlisa McAlmond
NON-COMPLIANT ITEM:	2 CSR 30-9.030 (2) (E) 3. Premises must be kept free of accumulations of trash, junk, waste products, and discarded matter. Weeds, grasses, and bushes must be
	controlled so as to facilitate cleaning of the premises and pest control and to protect the health and well-being of the animals.
DESCRIPTION:	The whelping building and the area behind the elevated whelping boxes had an accumulation of trash, junk, waste products, and discarded matter.
DATE:	03/18/2020
TIME:	10:00 am – 8:00 pm
PHOTOGRAPHER:	Joby Hoopes, Animal Health Officer

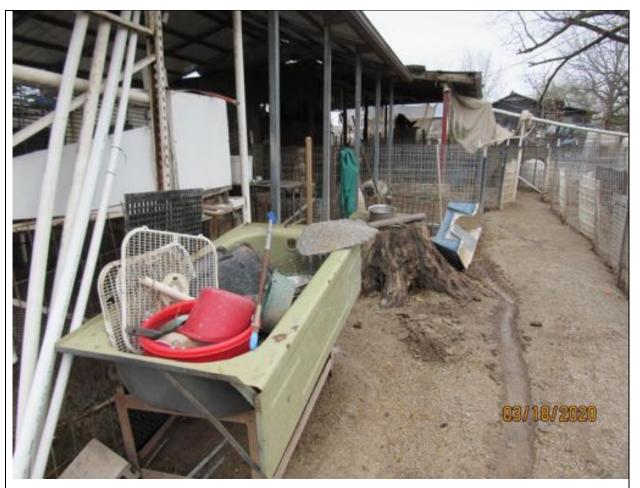
SUBJECT NAME:	Cedar Ridge Australians
LICENSE/REGISTRATION #:	AC0003CG
LICENSEE:	Marlisa McAlmond
NON-COMPLIANT ITEM:	2 CSR 30-9.030 (2) (E) 3. Premises must be kept free of
	accumulations of trash, junk, waste products, and
	discarded matter. Weeds, grasses, and bushes must be
	controlled so as to facilitate cleaning of the premises and
	pest control and to protect the health and well-being of
	the animals.
DESCRIPTION:	The whelping building and the area behind the elevated
	whelping boxes had an accumulation of trash, junk, waste
	products, and discarded matter.
DATE:	03/18/2020
TIME:	10:00 am – 8:00 pm
PHOTOGRAPHER:	Joby Hoopes, Animal Health Officer
