Fish Creek Estuary

Natural and Human History (1926 to 2019 Imagery)

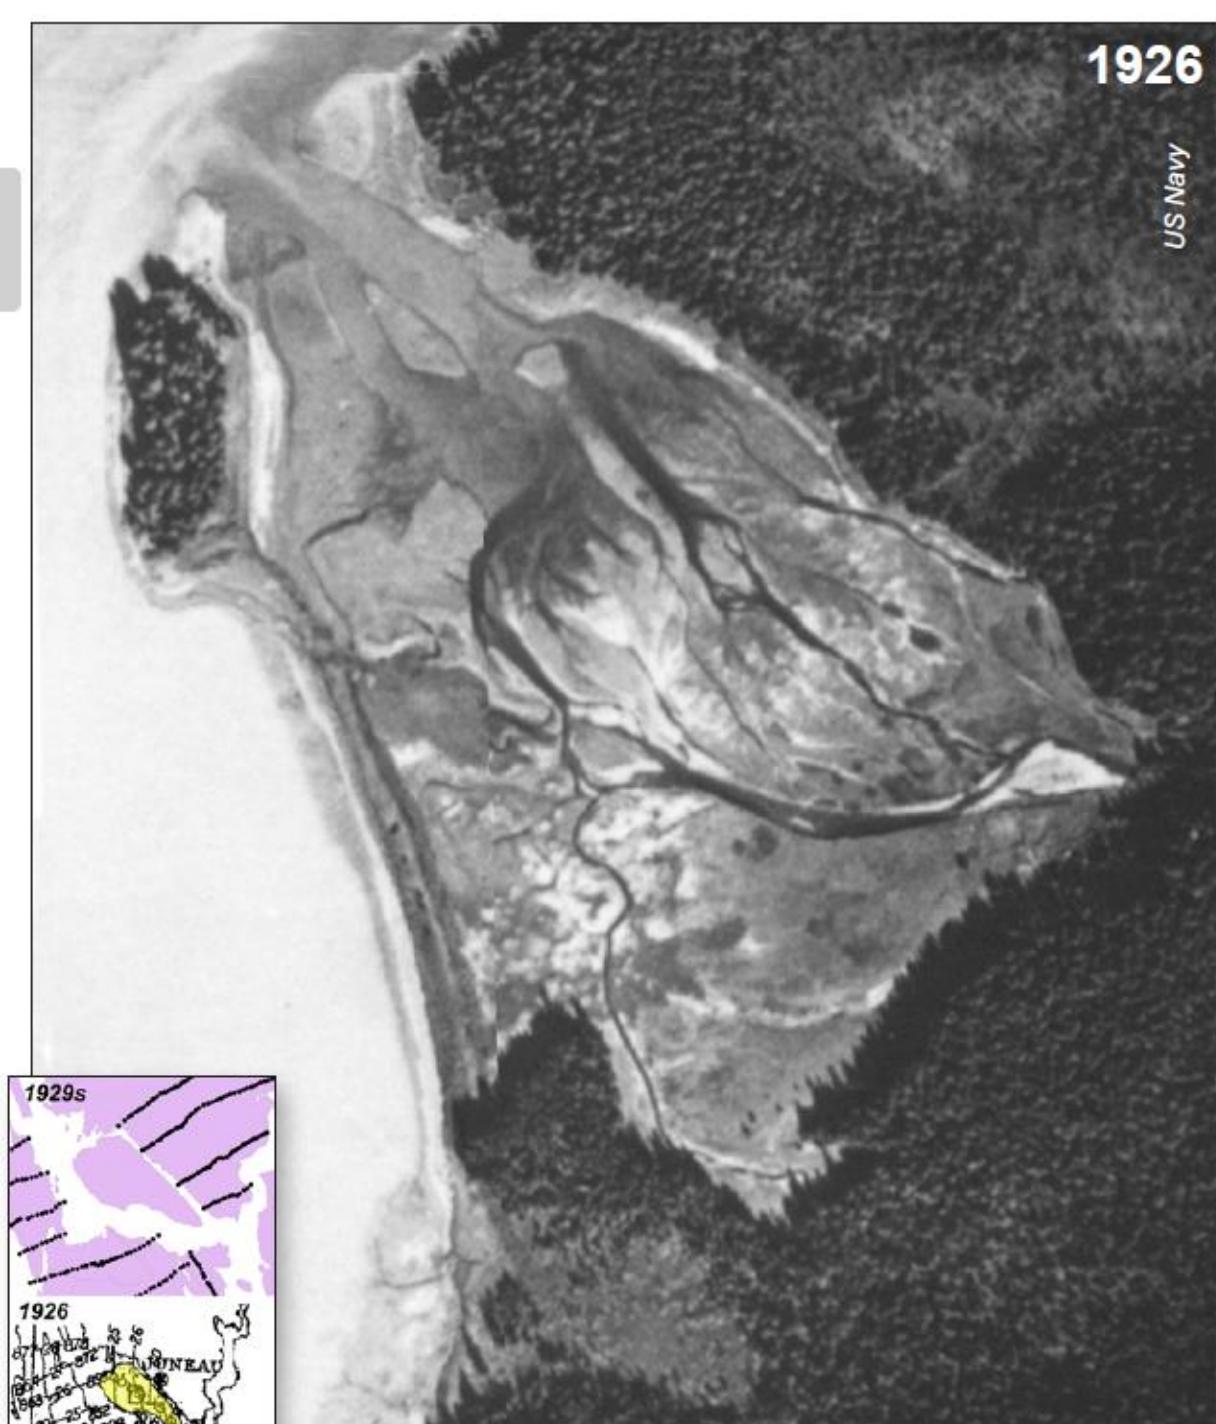
1926:

- Estuary is intact, including stream delta
- Delta with multiple active and abandoned channels
- Hydrologic and habitat complexity high

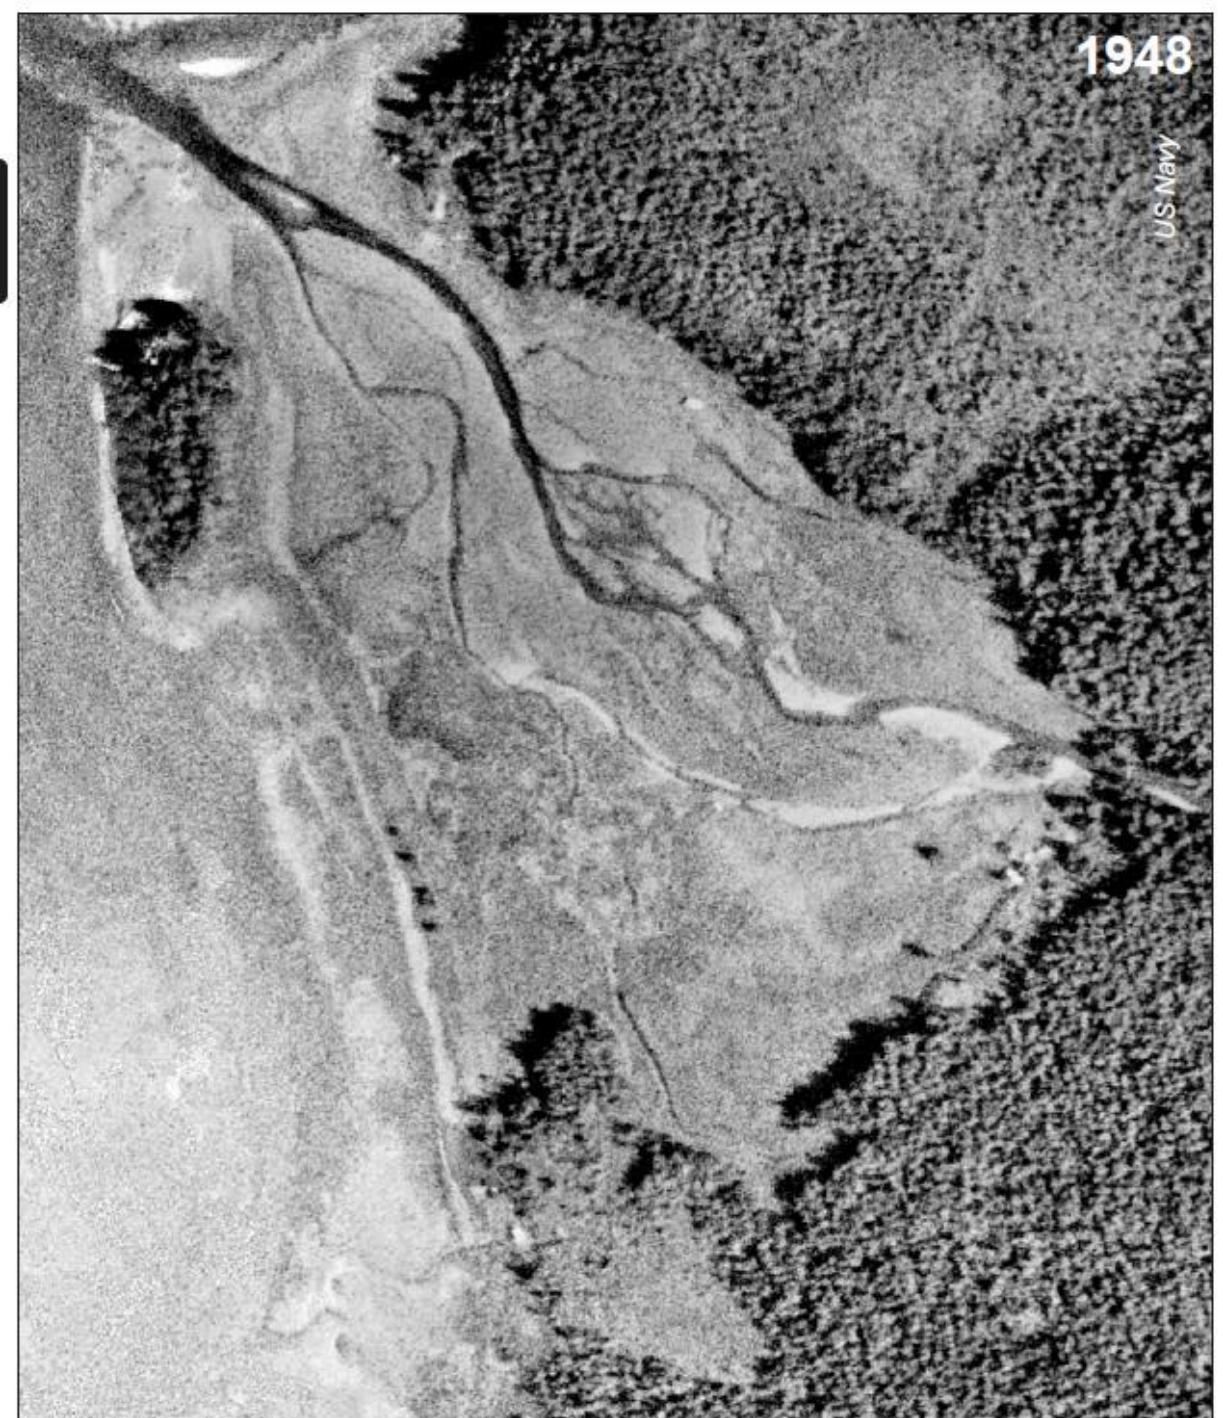
1948:

- Estuary is intact, including stream delta
- Delta with multiple active and abandoned channels
- Hydrologic and habitat complexity high

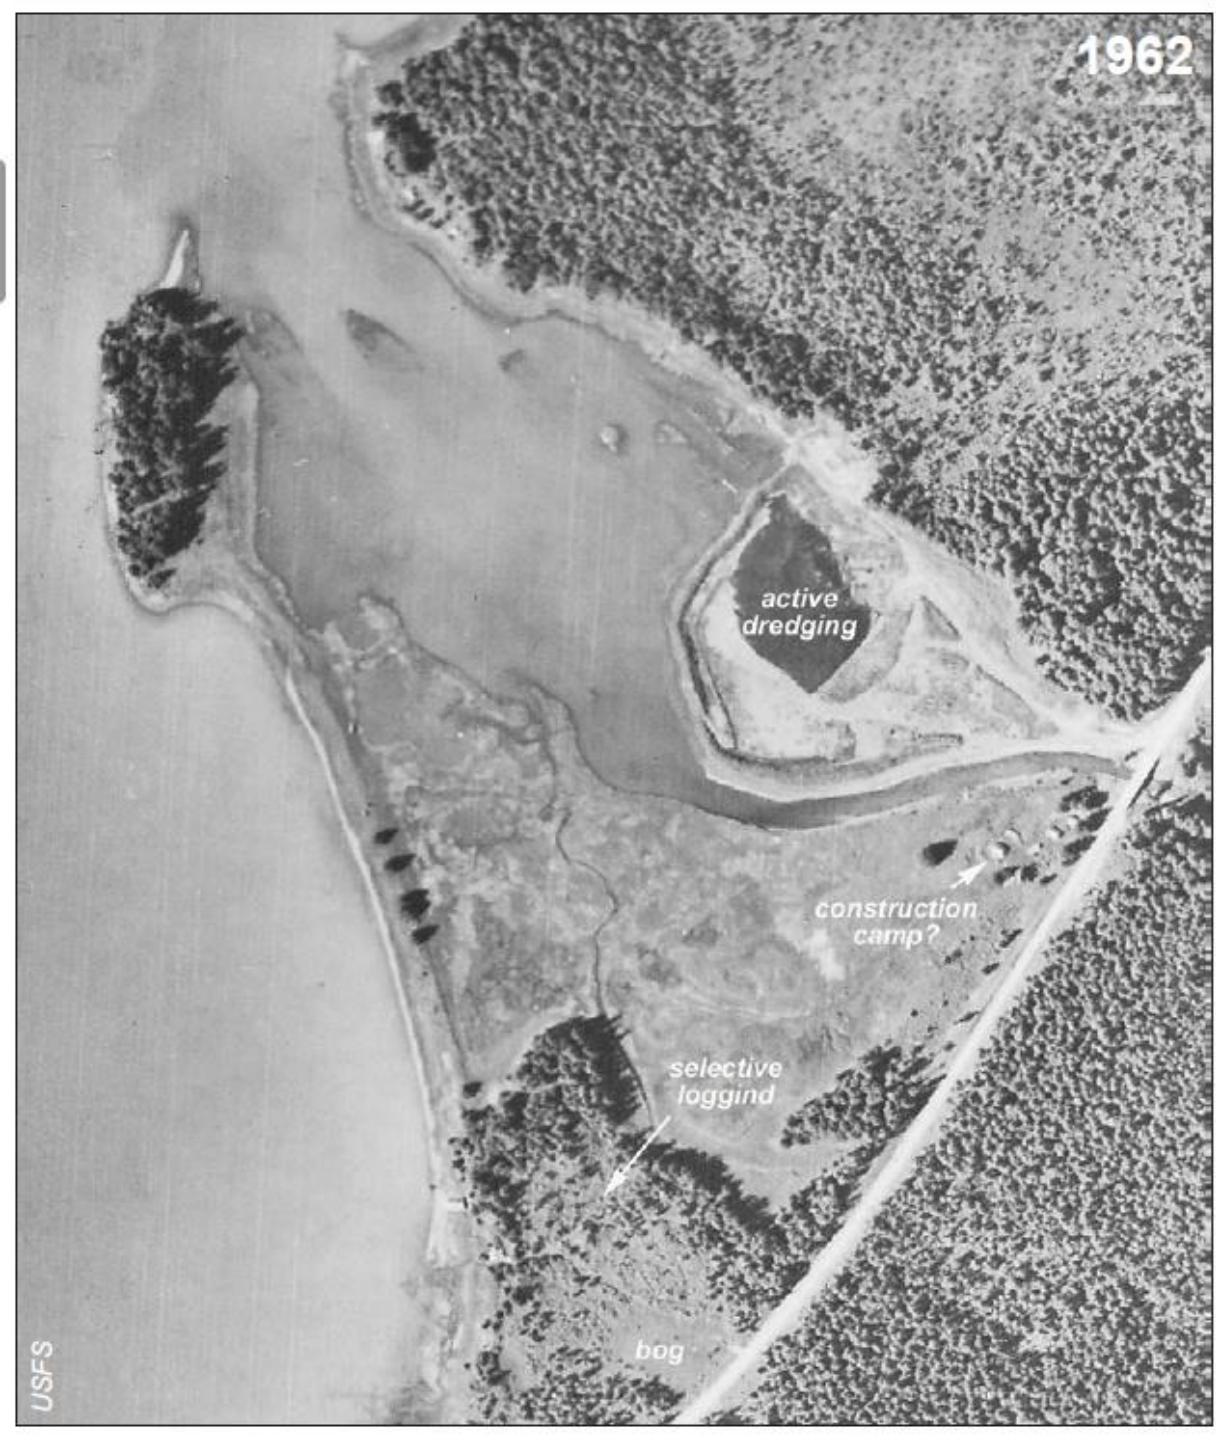
1962:

Aerial photograph of a coastal area in 1962. The image shows a mix of natural forested land and human-made features. In the upper center, a dark, irregular area is labeled 'active dredging'. In the lower center, a small, dark cluster of buildings is labeled 'construction camp?'. In the lower left, a dark area is labeled 'selective logging'. In the bottom left corner, the word 'bog' is written. The year '1962' is printed in the top right corner of the image.

- N. Douglas Highway has been constructed
- 13 acres of estuary/meadow lost to gravel mining activities (NE Pond)
- NE dredge pond forming
- Construction camp

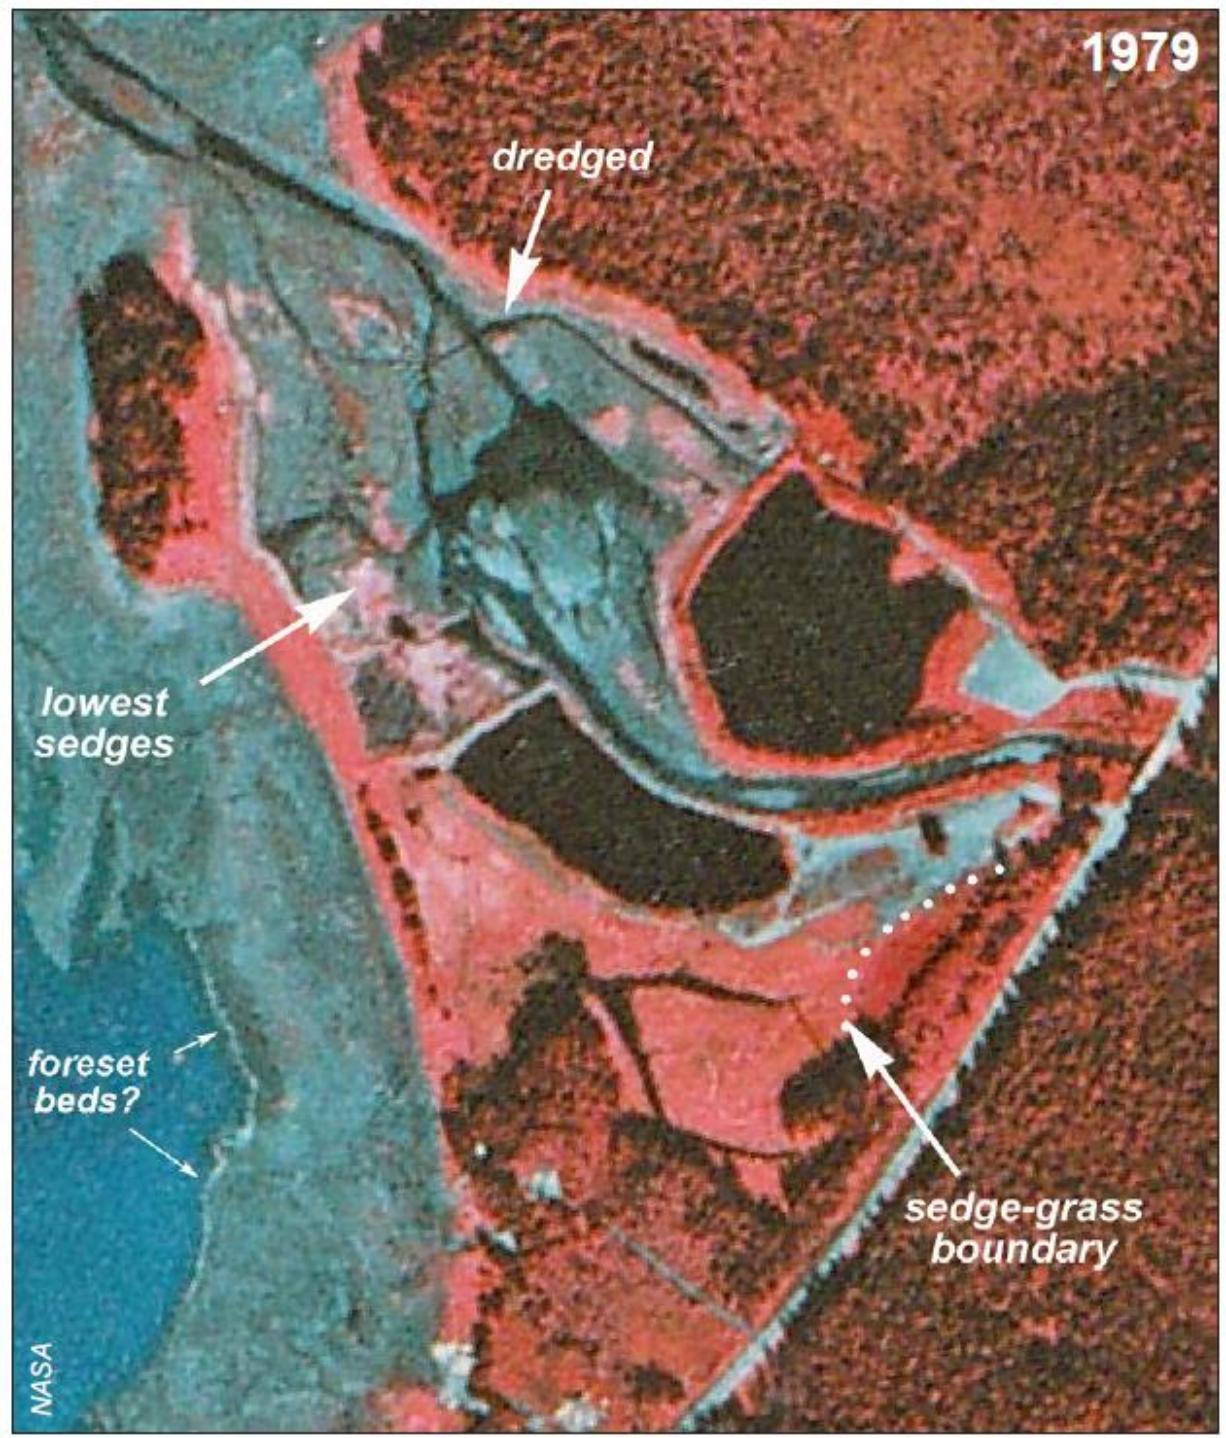
1979:

- NE and SW dredge ponds are present
- Dikes confine 1,300 feet of stream
- 9 acres of estuary/meadow lost to gravel mining activities (SW Pond)
- Dredging has occurred in the lower estuary

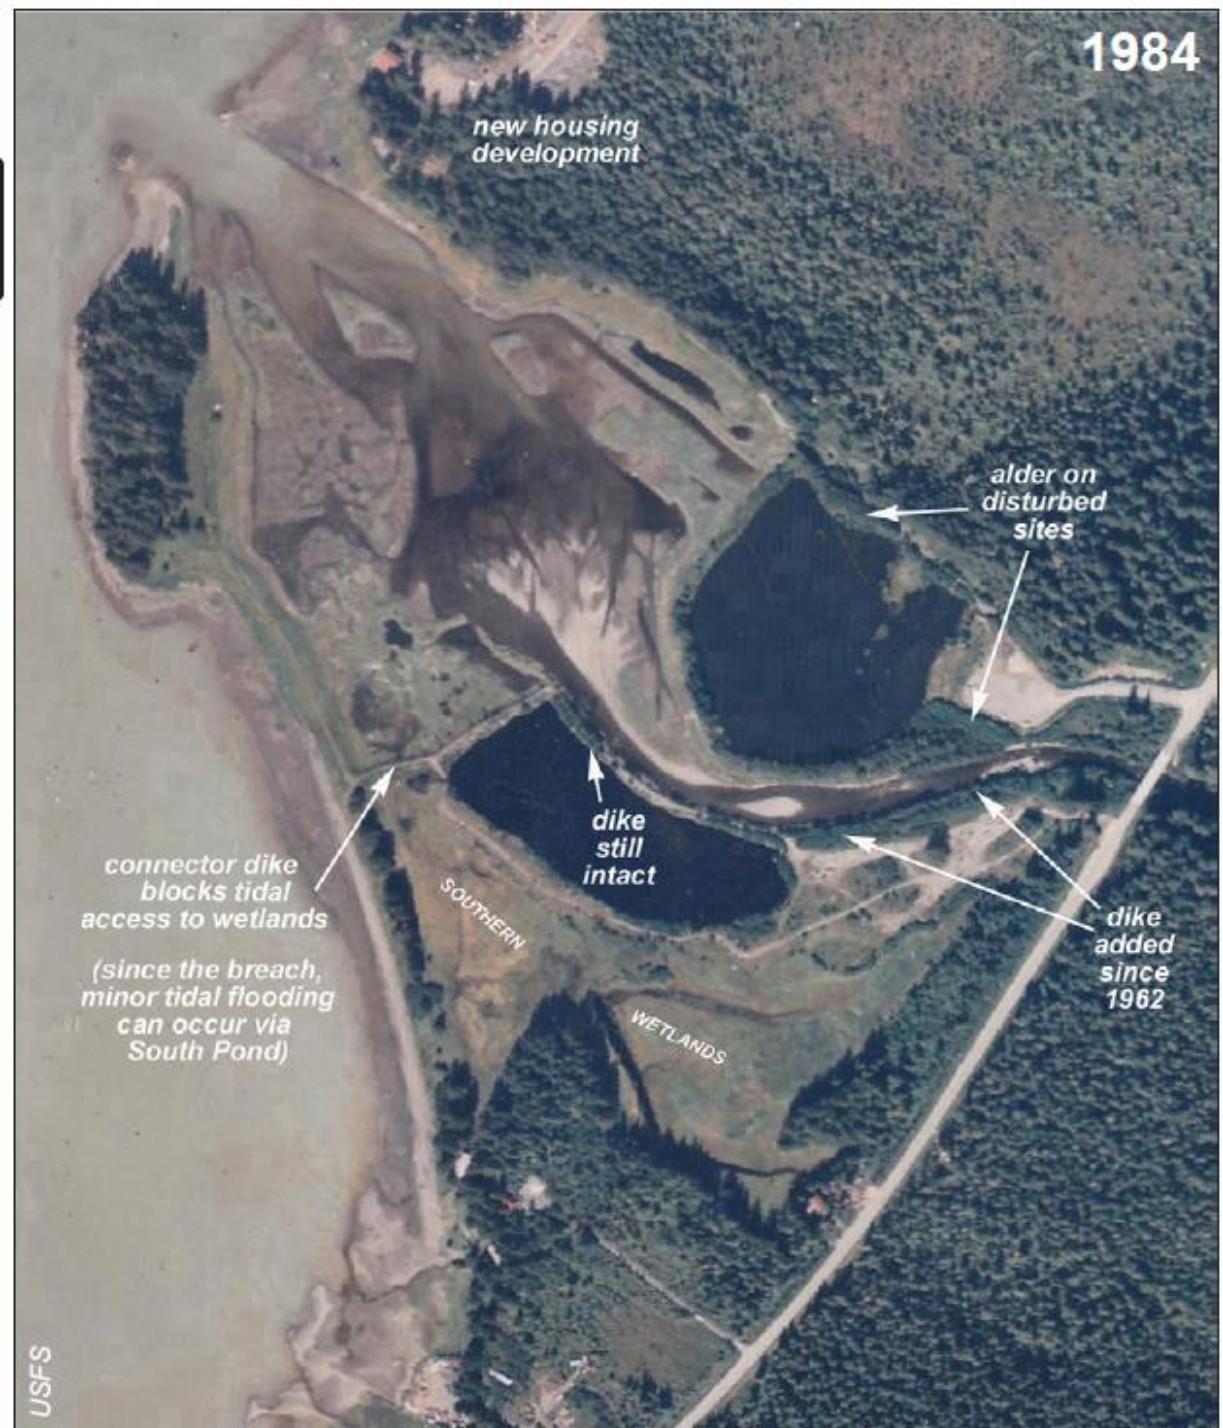
1984:

- SW Pond dike intact
- New housing development in Bayview Subdivision

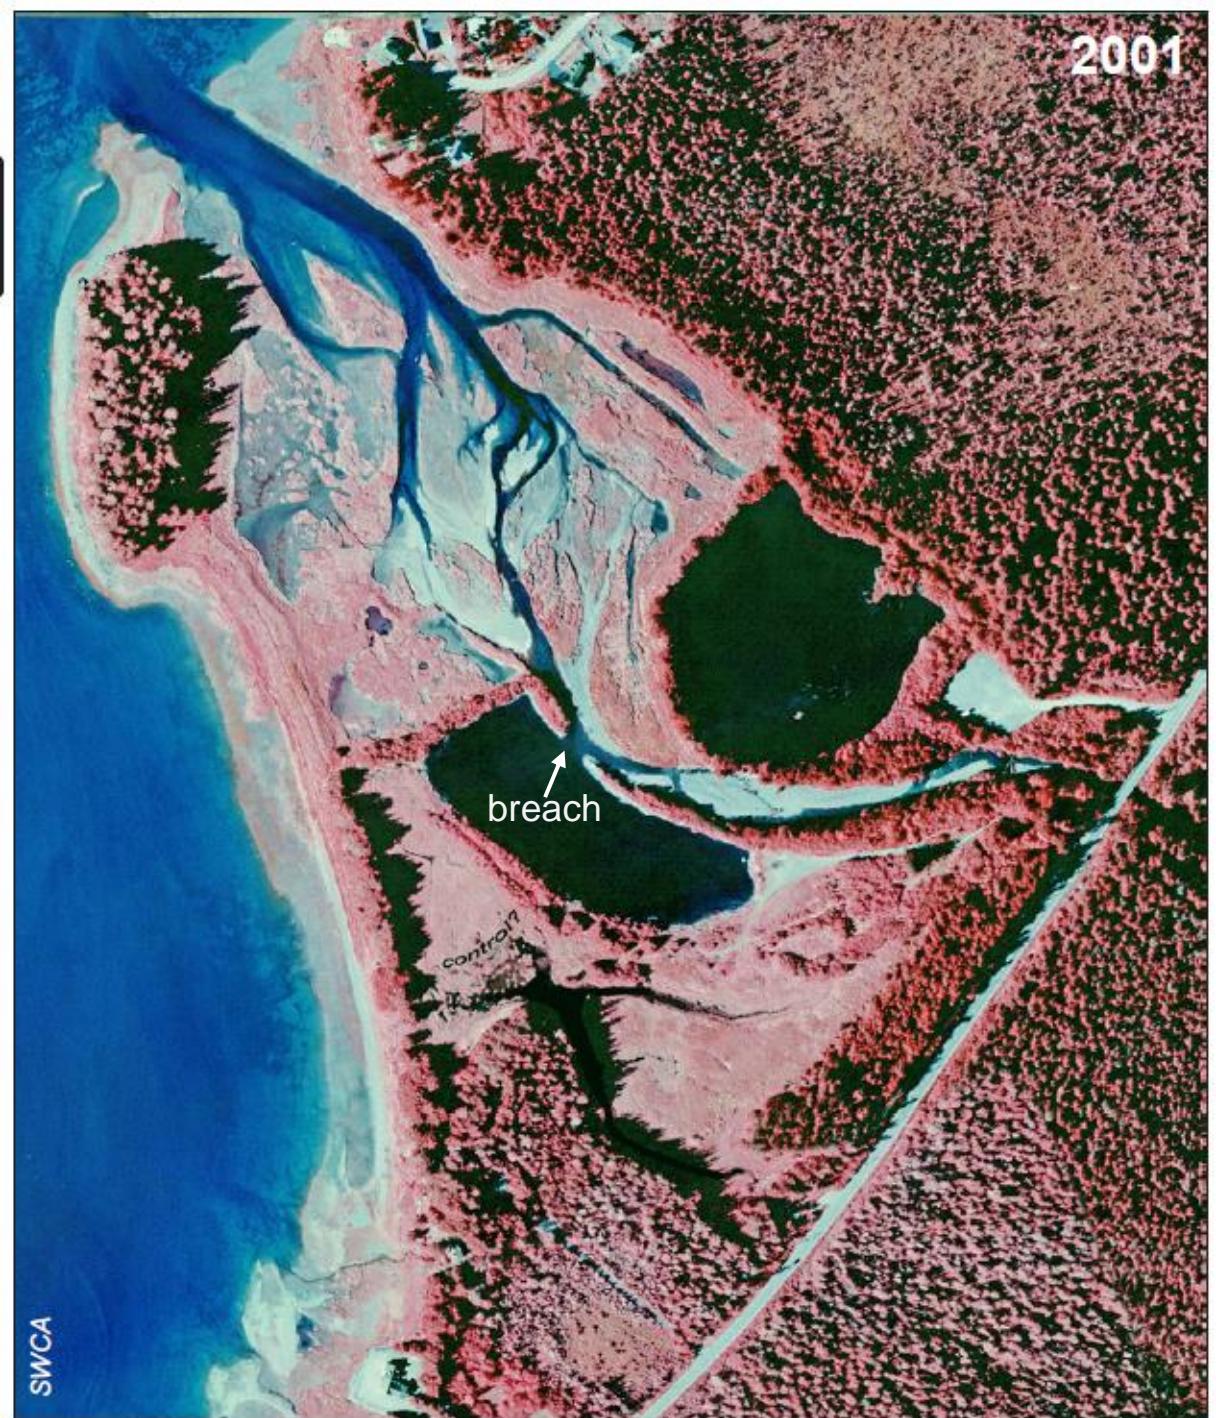
2001:

- SW Pond dike is breached
- New houses built in subdivision

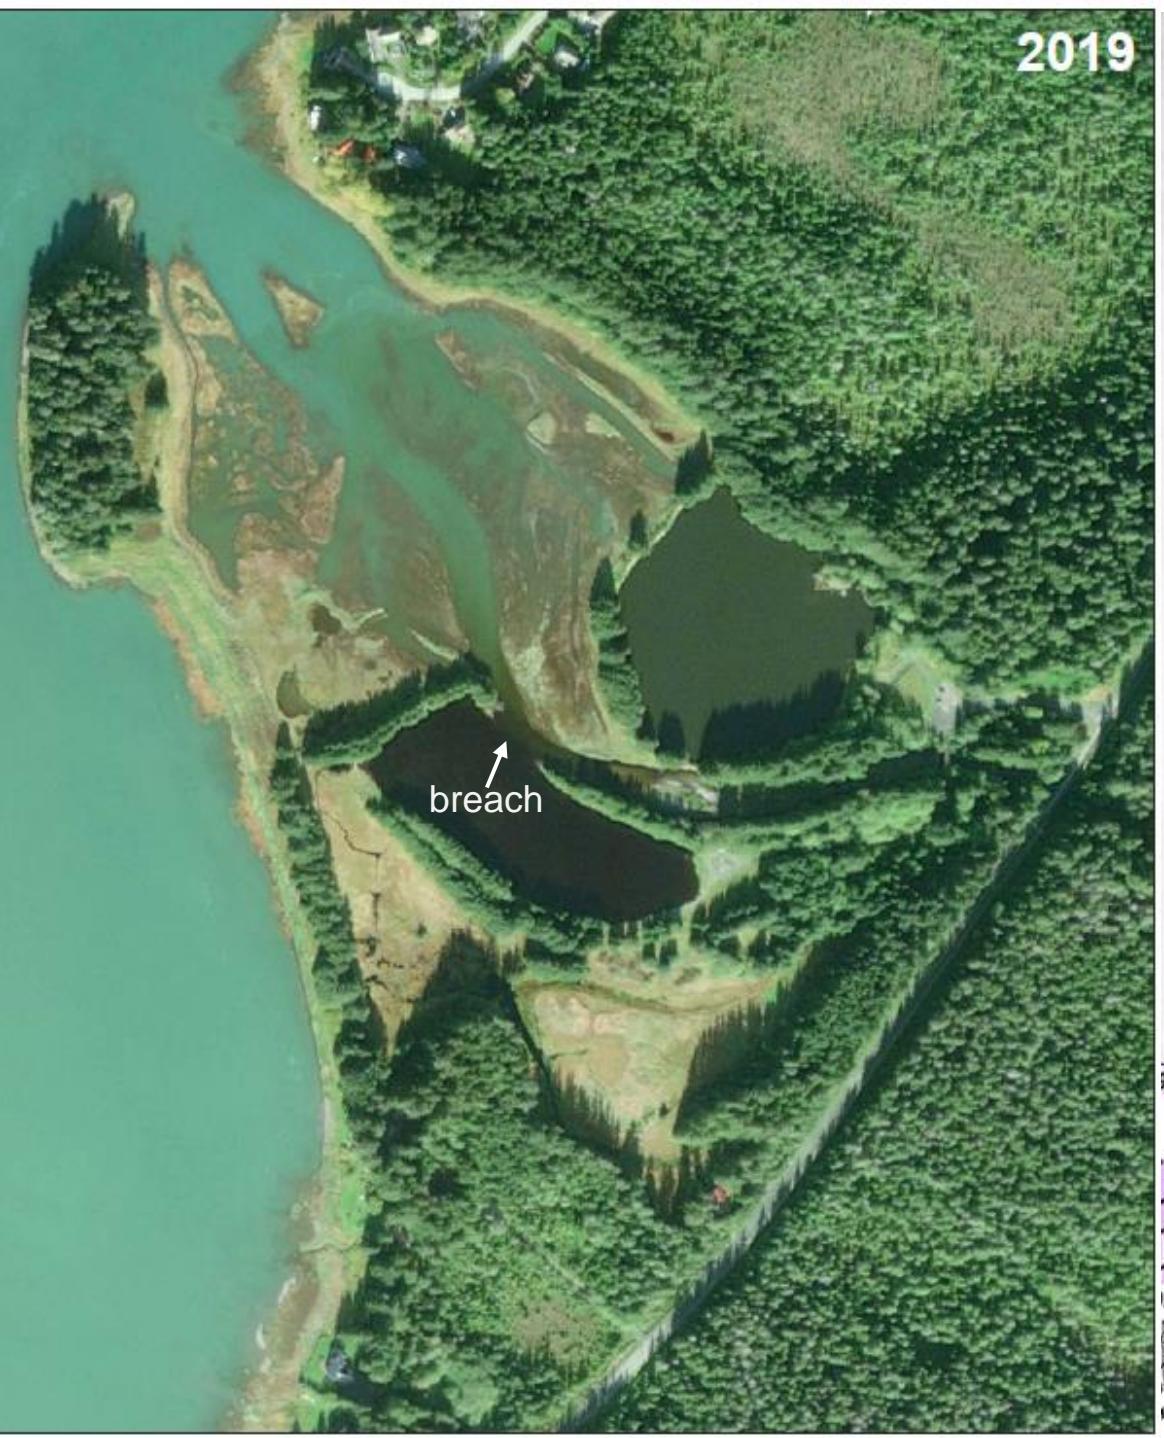
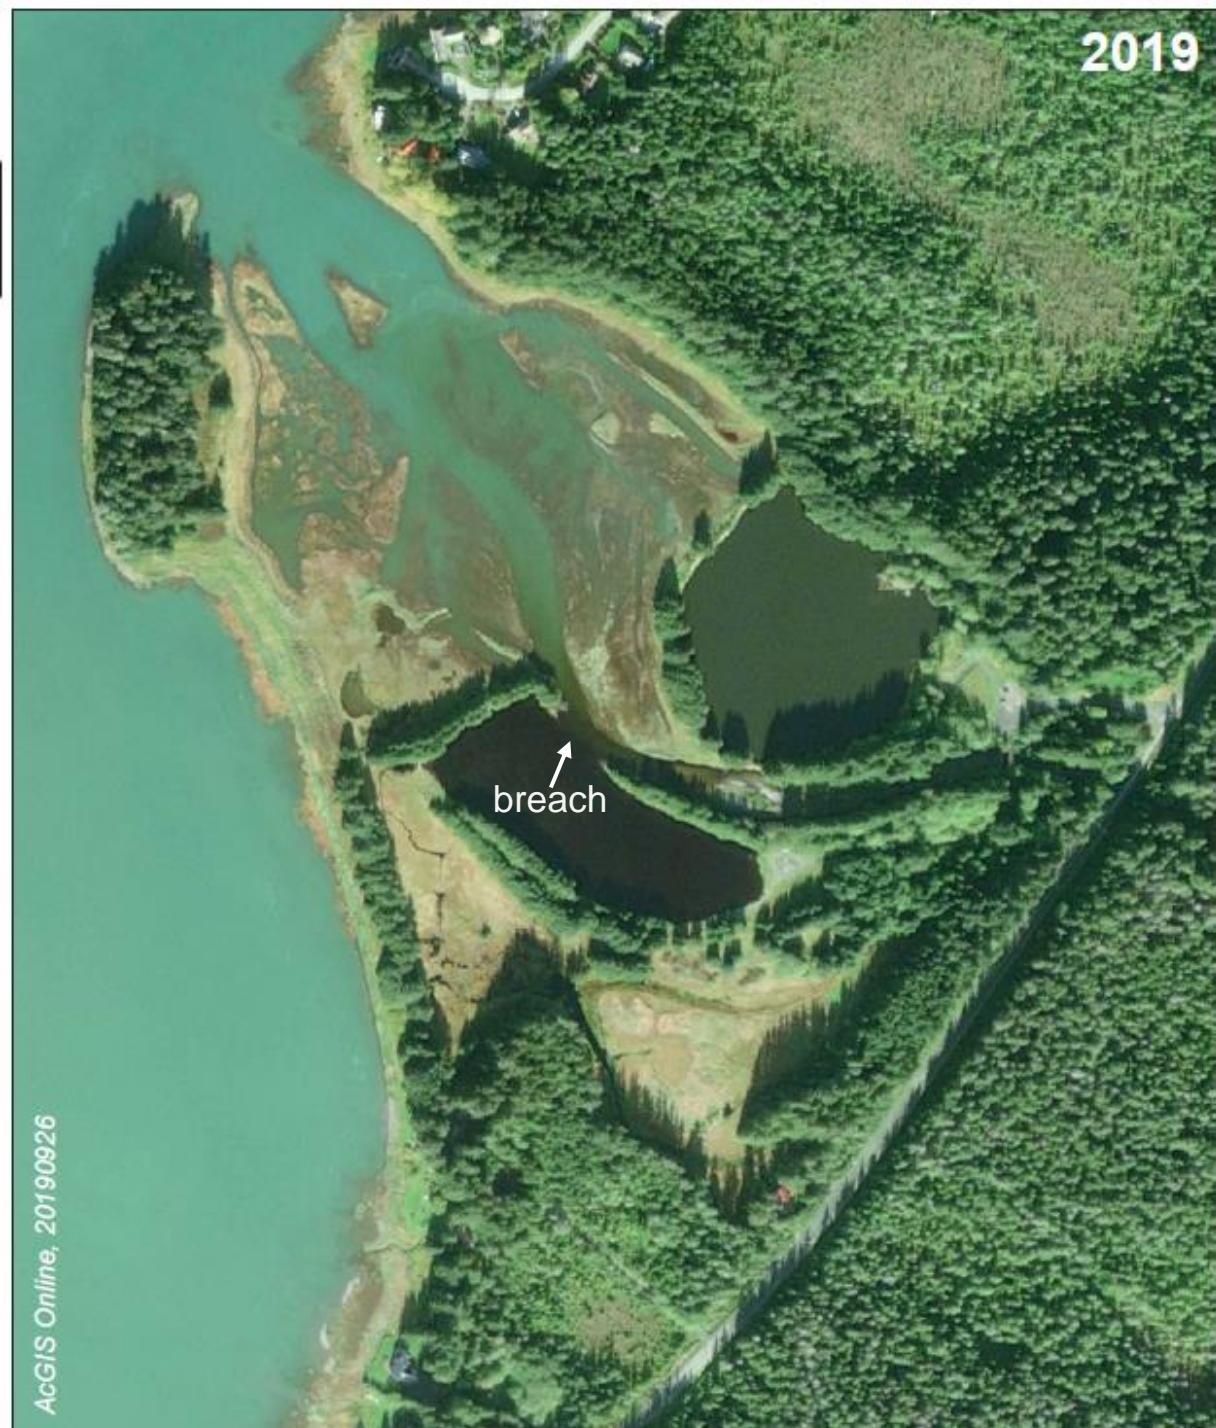
2019

- Two manmade ponds and a dike-confined stream channel have replaced a large portion of this hydrologically dynamic and habitat diverse estuary.
- These impacts have had consequences for fish, wildlife, and recreation opportunities.
 - Breach doubles in size since 2001
 - More new houses in subdivision
