September 2, 2023  
Baldwin-Buss House Update

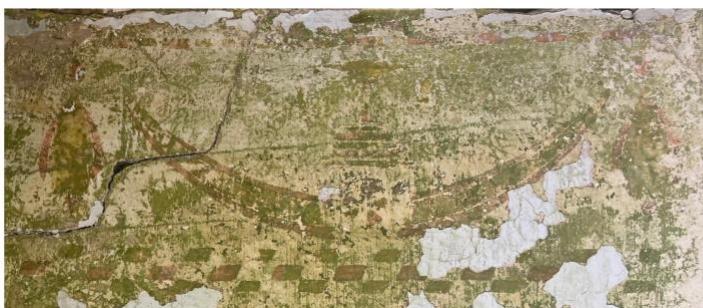
A frieze containing a swag flanked by tassels with a center bell and pin-wheel was revealed at the Baldwin-Buss House recently. Shades of green and red dominate the design.

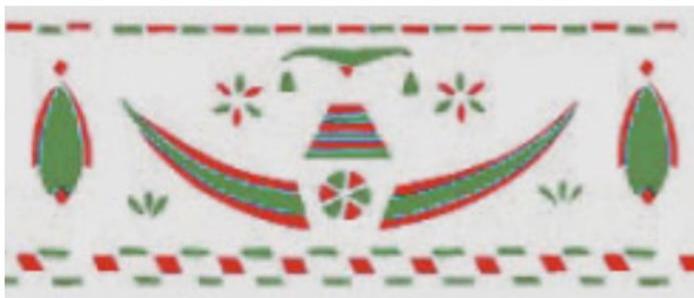
A similar swag (left) was documented at the Sage House in South Sandisfield, Massachusetts.

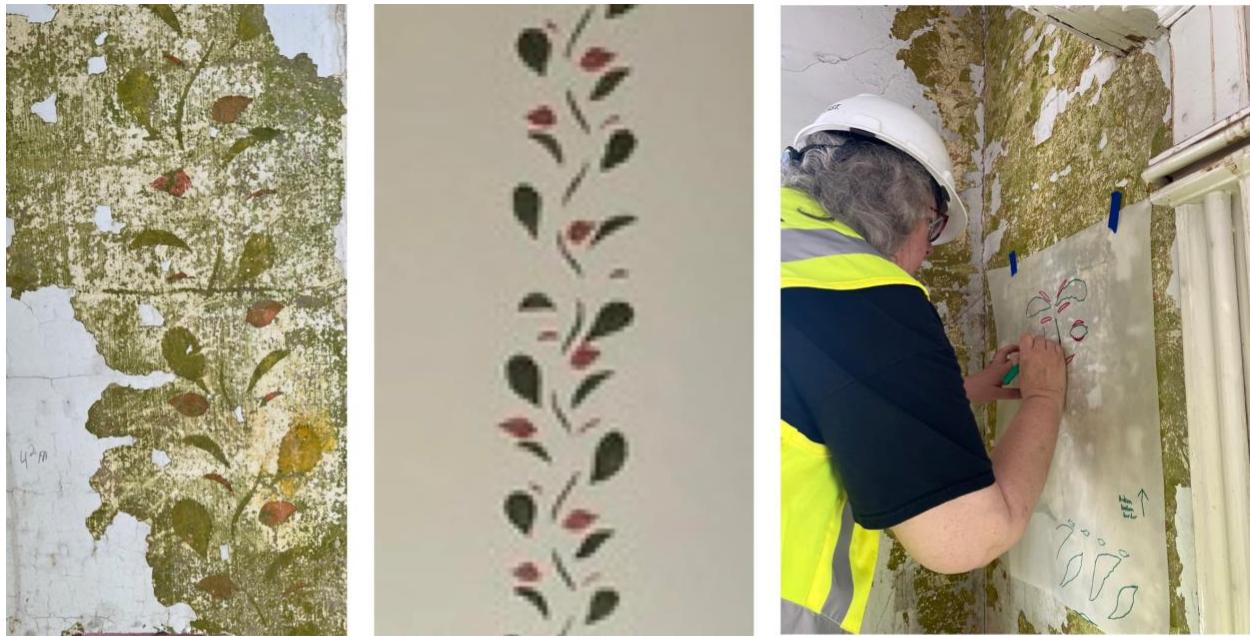
**L to R: Stenciled vertical vine pattern discovered at the Baldwin-Buss House, recreated and documented vine pattern found in a home in Aurora, Christie Borkan using tracing paper to document the design found at the Baldwin-Buss House.**

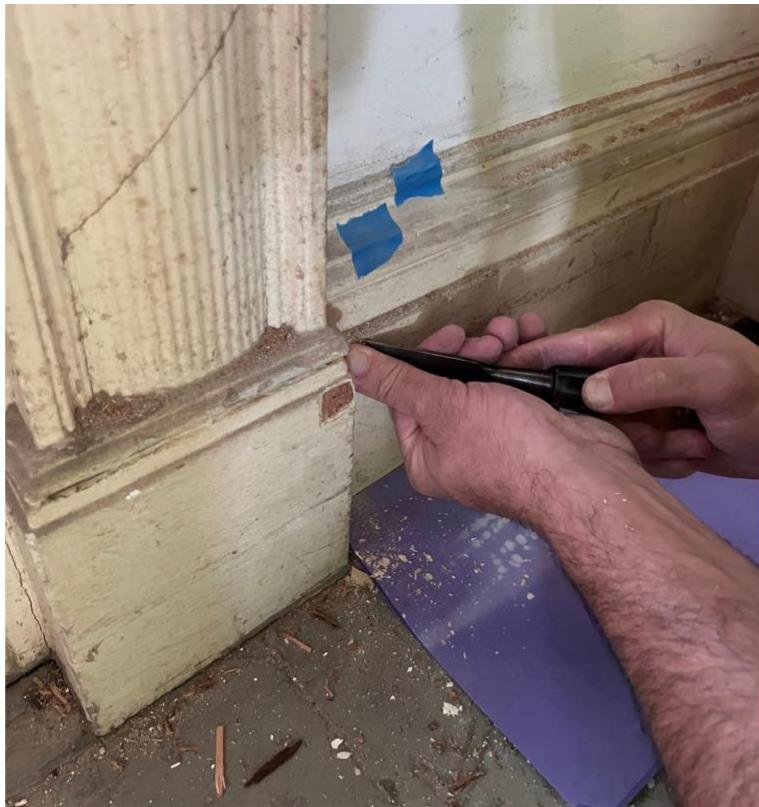
**Using an X-acto knife, samples were taken from select areas of the woodwork and plaster in the main block of the house. The samples were cataloged and sent out for laboratory analysis.**

Along with the documentation of the stenciling, BBHF, under the guidance of Frank Welsh of Welsh Color and Conservation, collected samples of paint and plaster in the main block of the Baldwin-Buss House. These samples will undergo laboratory analysis to identify the original colors and composition, finishes, and any additional decorative painting that may have been used. Recording this type of adds to the cultural significance of the building and contributes to its historical legacy. In the future, the information could be used to reinstate the original color palette and decorative finishes. More information can be obtained about historic paint analysis by clicking [here](#). Results will be shared with you once the final report is received.
