BEFORE

DURING

AFTER

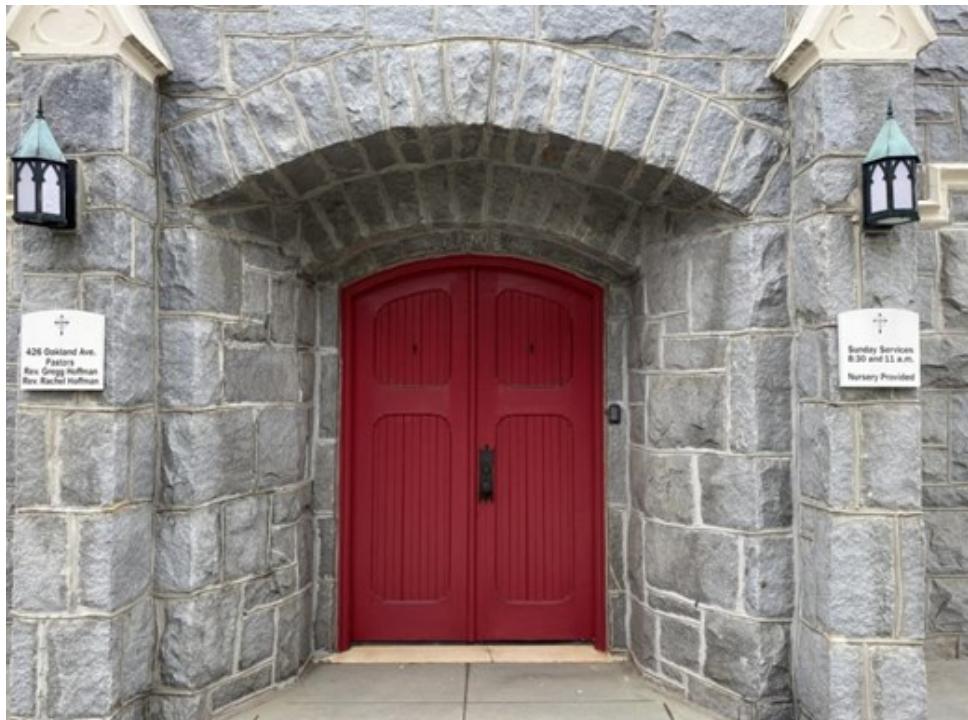
These doors are, we believe, the original set, making them nearly 100 years old! They have served us well, but the hardware mechanisms were beginning to fail and the wear of a century of use and weather was visible.

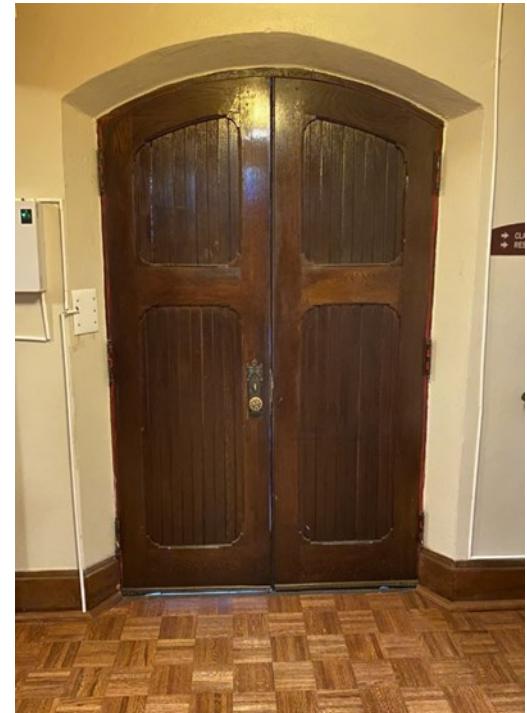
From the inside, you can see the outside! As the wood aged, it began to shrink, and crevices appeared between the bead boards. Light also shone between and under the doors.

While it was a bit comical to see through wooden doors, this wasn't great for keeping the weather out! Additionally, these doors swung inward, which was a safety hazard.

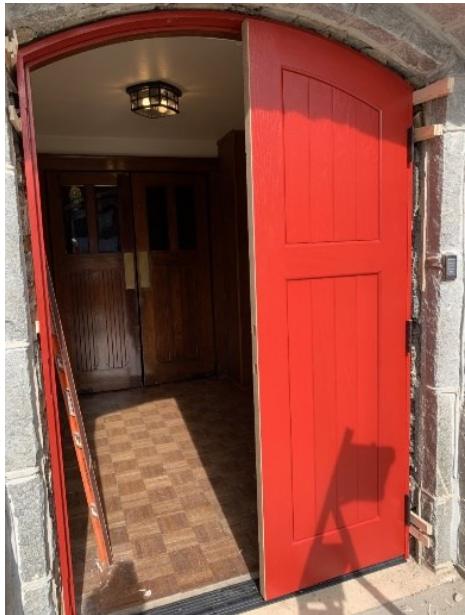
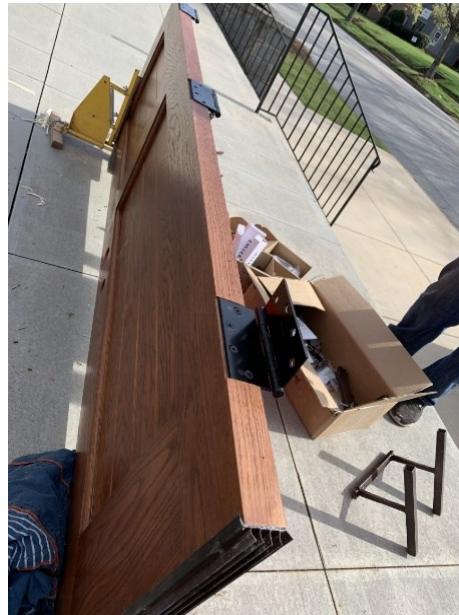
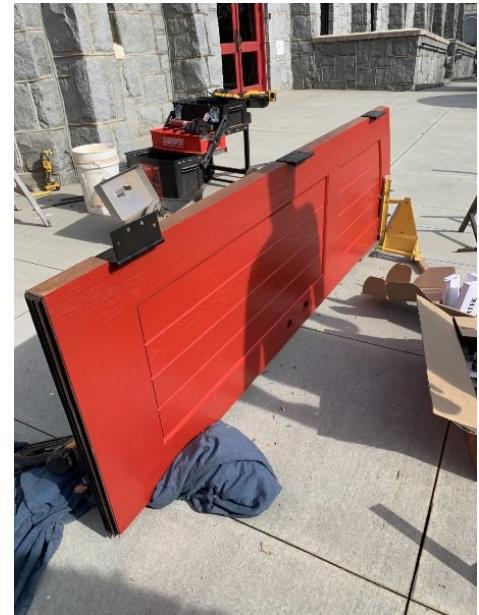
The old doors were removed and the new doors were fitted to the archway - the fitting took hours!

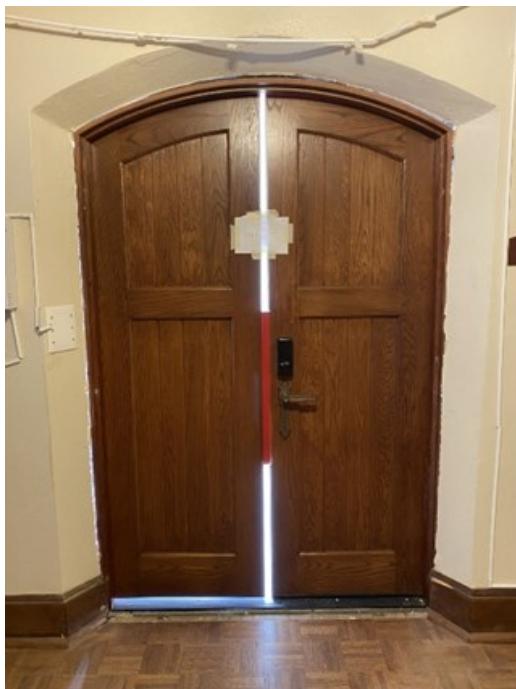
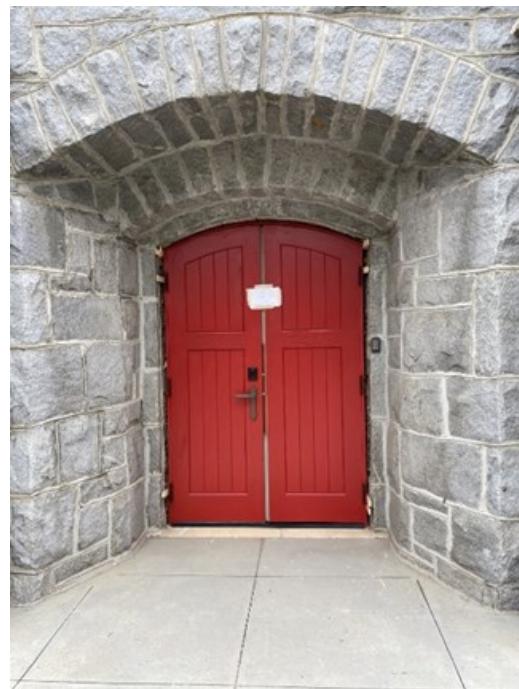
For a short time, there was even MORE sunlight visible through the doors!

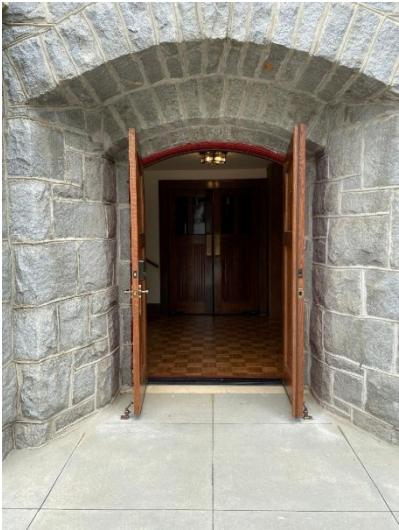
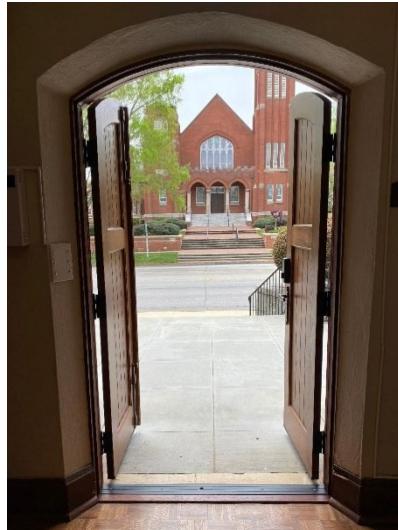
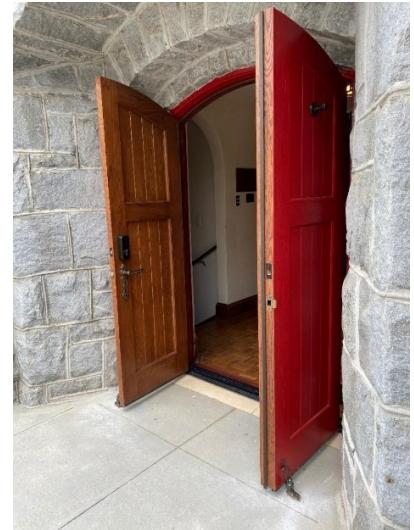
The doors now swing safely outward and hook onto hinges to stay open when needed.

These doors are 2 inch white oak, which should stand sturdy for at least 75 years! The detail work is carved on the surface, so panels won't shrink apart in years to come. The non-handle door uses sliding surface locks on top and bottom, which are much more durable than in-door floor and ceiling locks.

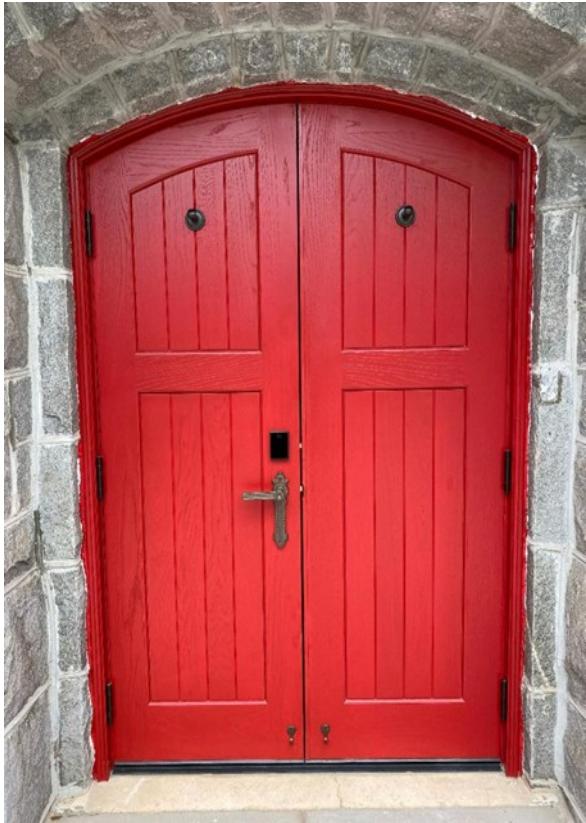
The hardware, while not an exact match to the former doors, echoes the previous style, and will only become more beautiful with wear. The lever handles themselves, inside and outside, should be much more accessible.
