# Field Validation of GIS Mapped Hardened Shoreline Structures in the Peconic Estuary

Kaitlin Morris, Stephen Havens, Joe Costanzo and Matthew Selafani  
Cornell Cooperative Extension of Suffolk County

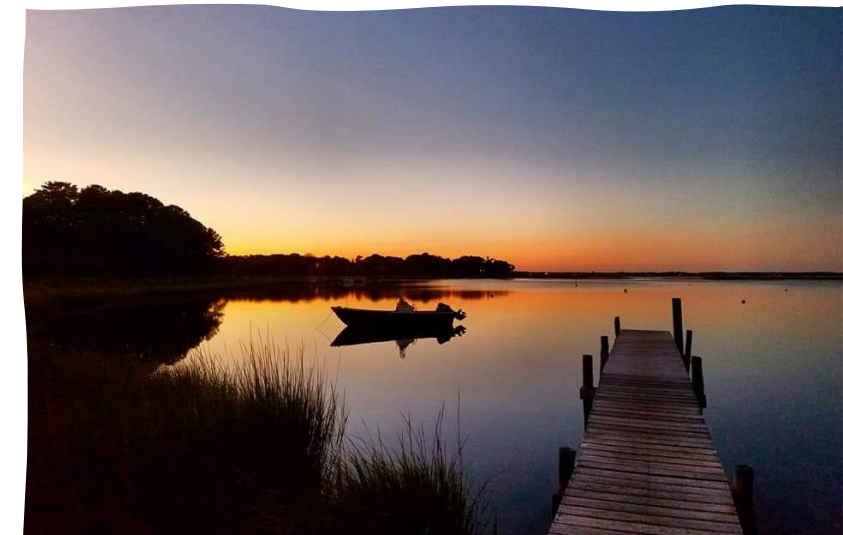
- In 2019, PEP completed a GIS-based inventory to document the extent of hardened shoreline coverage along the Peconic Estuary
- Goals of this inventory were to:
  - Assess the number of bulkheads, revetments, piers, groins, jetties, and docks using 2016 Orthoimagery from the NYS GIS Clearinghouse
  - Create a tool for local governments to inform decision-making regarding land preservation
  - Form the basis of the PEP Shoreline Hardening Strategy and future projects
