# Shear Frustration

Seizing a unique opportunity to work around broken timing chain guide bolts

## AFTERMARKET CASE STUDY

## ENGINE TIMING CHAIN GUIDE BOLT

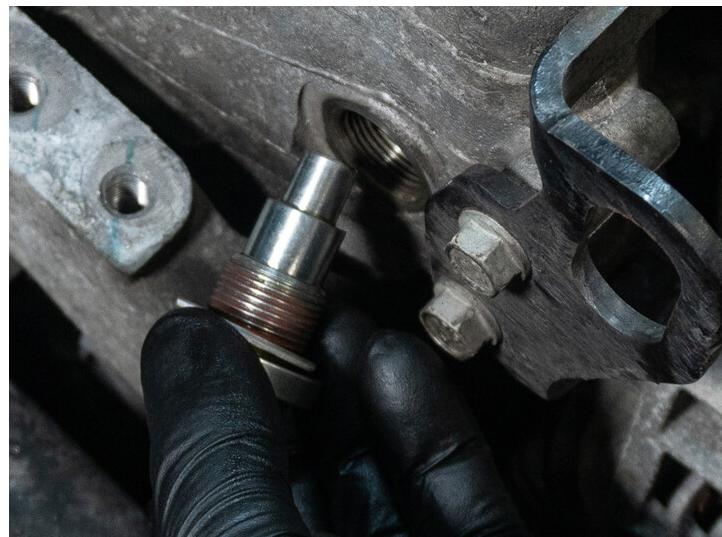
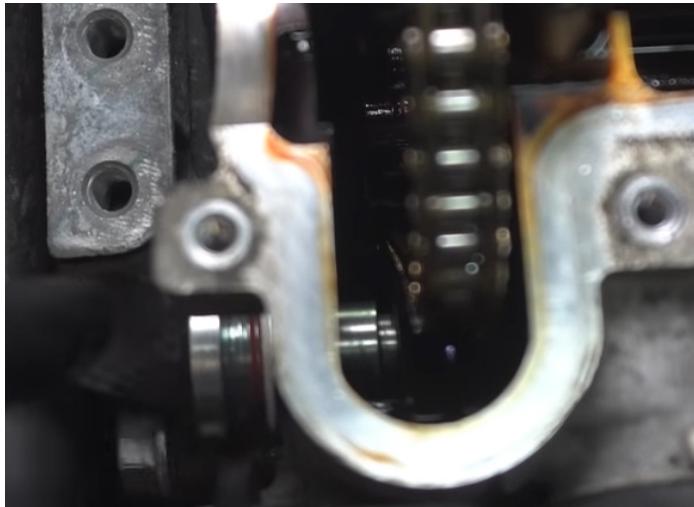
While this kind of damage might spell catastrophe on some engines, GM may have unintentionally left room for a clever last-chance repair. That failure-prone bolt securing the timing chain guide to the inner section of the cylinder head is installed through an opening in the outer wall of the cylinder head. This access opening is normally sealed with a threaded plug to keep moisture

and other contaminants out of the engine, but because it is concentrically aligned with the bolt hole, it also provides a secondary mounting point for a new guide bolt.

Our redesigned timing chain guide bolt is essentially two parts in one, functioning as both mounting bolt and debris plug. It mounts through the existing outer access hole in the cylinder head where the plug would normally be and features a reinforced stud that reaches where the original bolt sheared off, securing the timing chain guide to the head.

"Since the original components are accessibly mounted at the upper front part of the engine, swapping out the broken bolt for the replacement typically takes just a few minutes," says Kovacs. "Simply remove the original plug, use a magnetic tool to remove the loose broken bolt, then install the new bolt and torque it to specs. It's that easy."

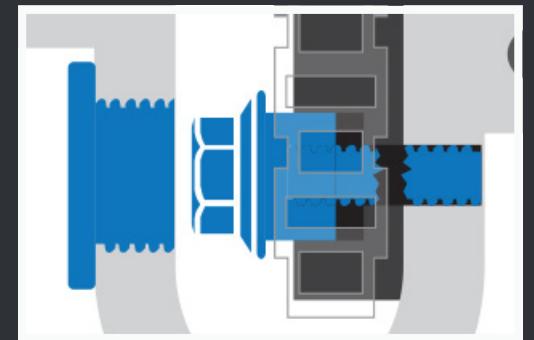
### OE Problem:

The OE design requires labor-intensive drilling and tapping to remove the original bolt.

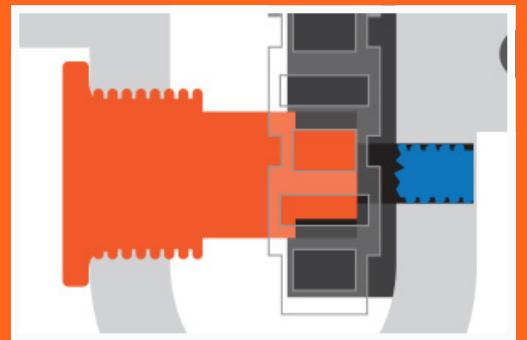
Reduces labor time by eliminating the need to remove the cylinder head during installation, saving time and money.
