## West Valley Feeder No. 1 Shutdown

*Doing What it Takes to Ensure Reliability of our Infrastructure*

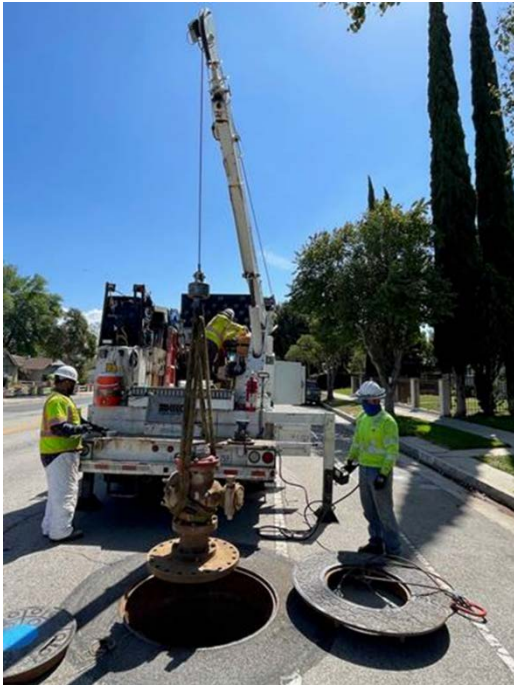
Carlos Marquez, Adam Guzman, and James Espinosa (C&D) removing a pipeline flange

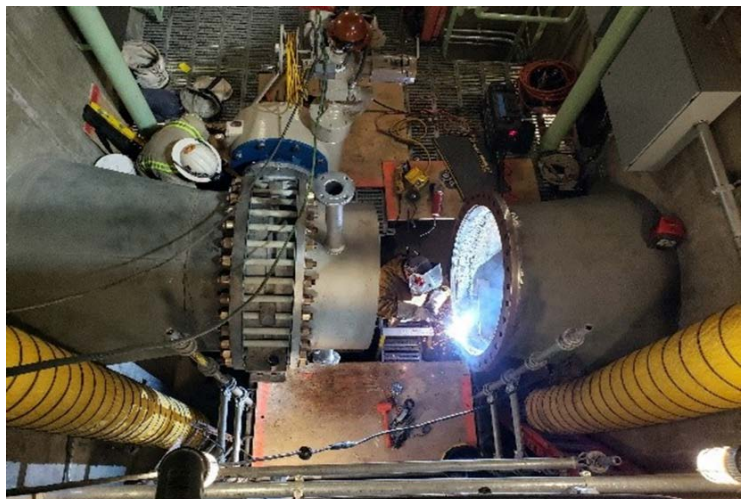
Luis Cortez welding a 42-inch flange

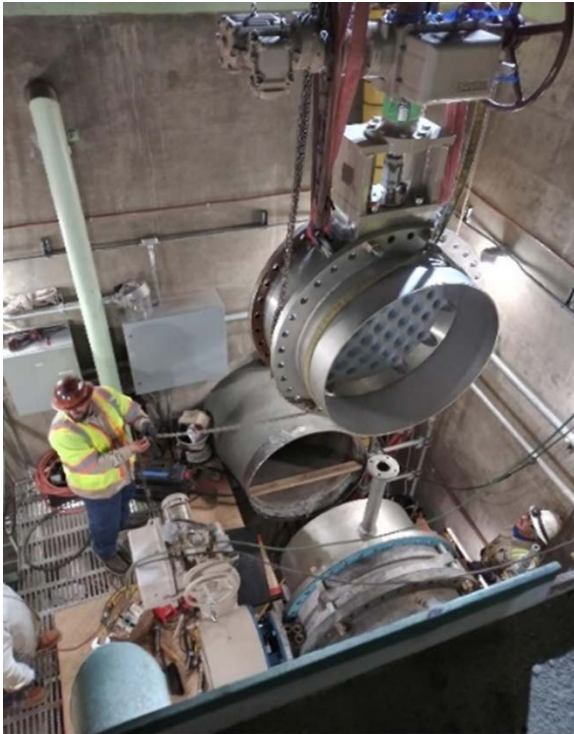
Paul Gonzalez installing the multi-orifice valve

orifice valve regulates flow to support flexible operations including an interconnection with LADWP. During this outage, C&D also repaired or replaced other valves on the pipeline that were of similar vintage.

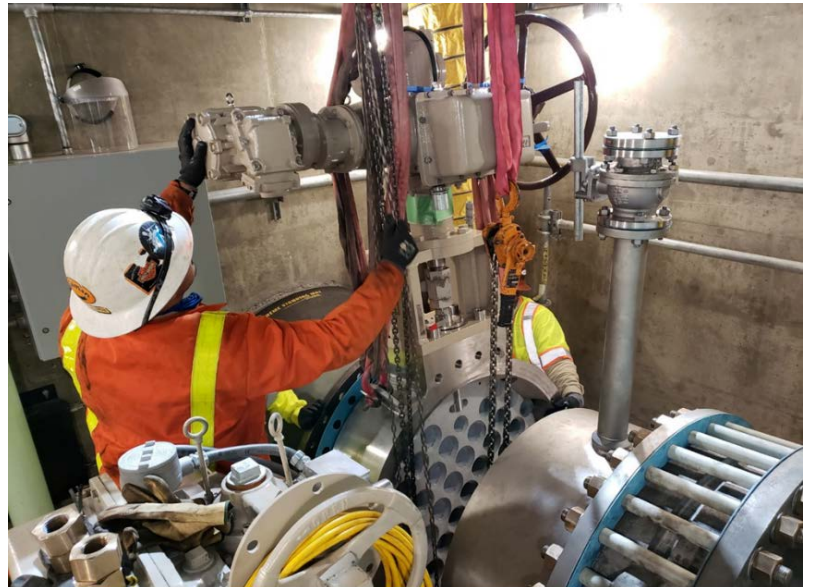
Mario Salgado (CSU) guiding in the multi-orifice valve

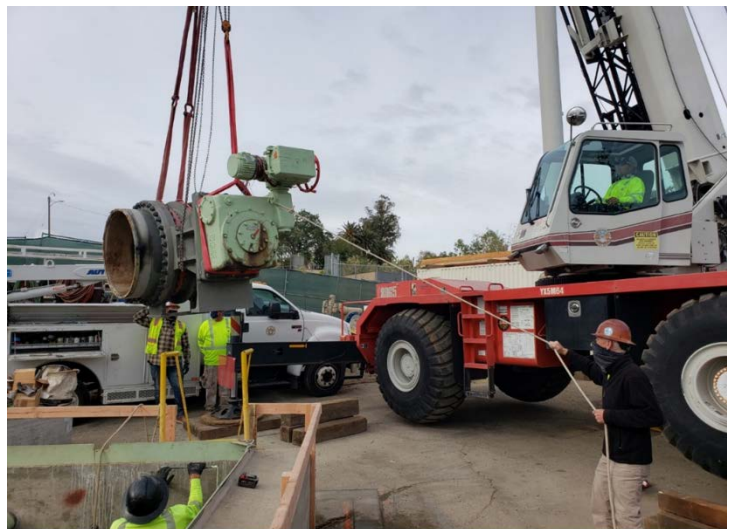
Dan Conover (CSU) mans the tag line while, Crane Operator David Jenkins (CSU) pulls out the old butterfly valve

The West Valley Feeder No. 1 was constructed using pre-stressed concrete cylinder pipe (PCCP) that was a popular pipeline material in that era but requires attention as it ages. PCCP pipelines are monitored through periodic inspections under Metropolitan’s PCCP Rehabilitation Program. Combining the pipeline inspection with replacement of the 57-year old butterfly

valve (located on Rinaldi Street in Chatsworth) allowed maintenance and repairs within a single shutdown window, minimizing impacts to member agencies. C&D staff isolated, dewatered, and prepared the pipeline for Engineering staff to inspect and perform an electromagnetic scan of the 8-mile-long PCCP.
