## *Eagle Rheostat: Baking in the Heat*

Working on vintage 1930's equipment presents challenges that require creativity and innovation. Recently Engineer **Luigi Delgado** from WSO's Hydroelectric Team and Engineering Tech **Ryan Leitner** from ESG's Corrosion Control Team had to come up with creative ways to replace a failed rheostat for the Eagle Mountain pumping plant after a vendor was not able to repair the device. A rheostat is a large variable resistor which is analogous to the volume control on an old radio. The device is integral to the efficiency and operation of the pumps and the pumps will not run without it. Components within the rheostat can generate temperatures as high as 1,400 °F and require an insulating compound that can withstand this heat and maintain electrical insulation to prevent shorting of the conductive wires.

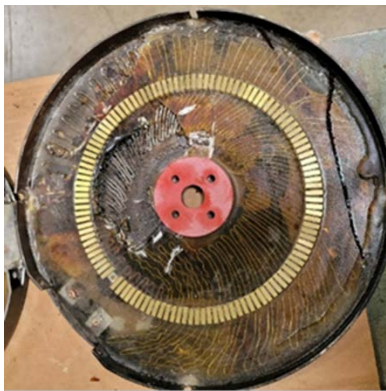
Failed Rheostat

Ultimately a ceramic-based insulating cement was used as the base material and a specially formulated high temperature epoxy was used as filler to control cracking due to thermal expansion. Luigi worked closely with the ceramic and epoxy manufacturers to repair the rheostat. The rebuilt rheostat was then installed on Eagle Pump Unit No. 1 and the unit was successfully returned to service in early June. This repair allowed Eagle Mountain pumping plant to maintain a spare pump to support Metropolitan's 8-pump flow operation. Considering the extraordinary drought conditions, we face this year, Luigi's innovative work, along with the rest of team's efforts, truly helps to ensure Metropolitan's reliable deliveries during this critical year.

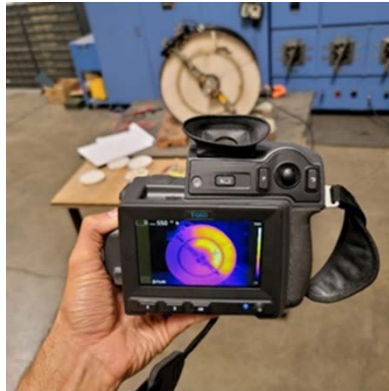
Thermal Testing New Material
