## Inland Feeder Shutdown

### *Partnering and Problem Solving to Ensure Reliable Operations*

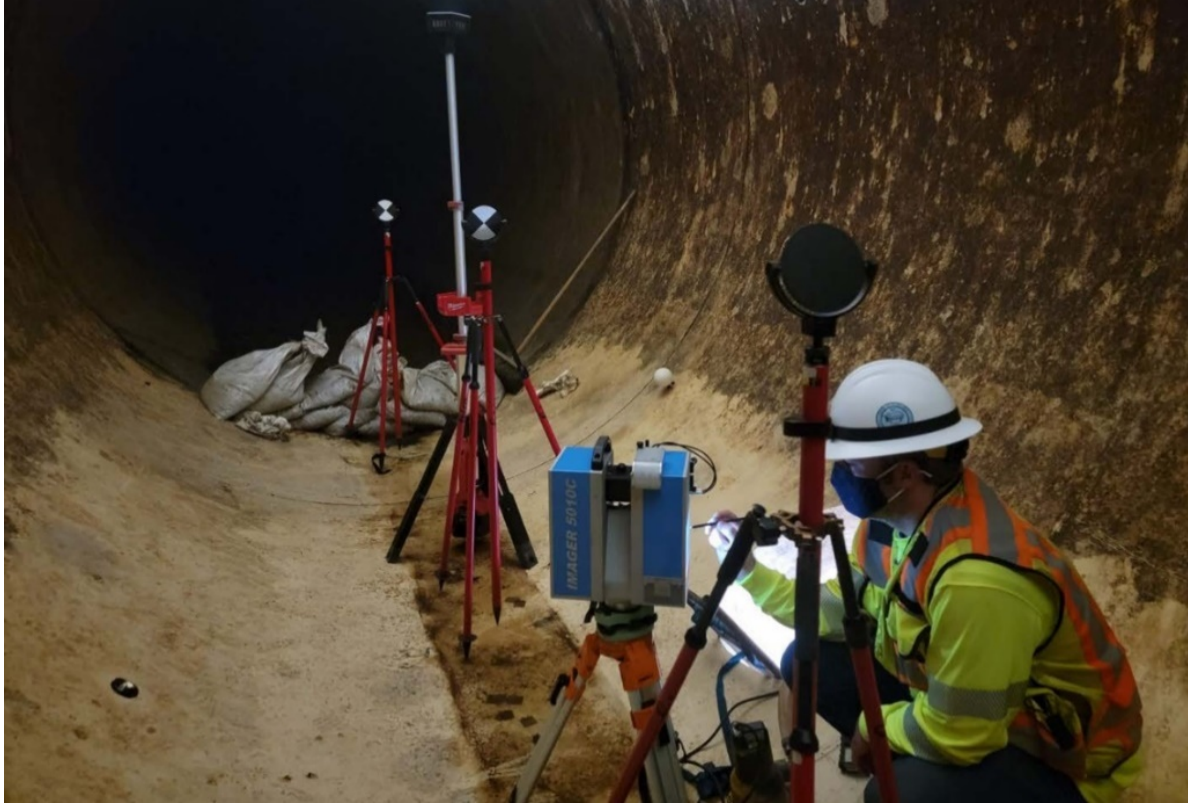
ESG's Matt Corcoran (Field Survey) preparing the 3D laser scanner to scan the Inland Feeder

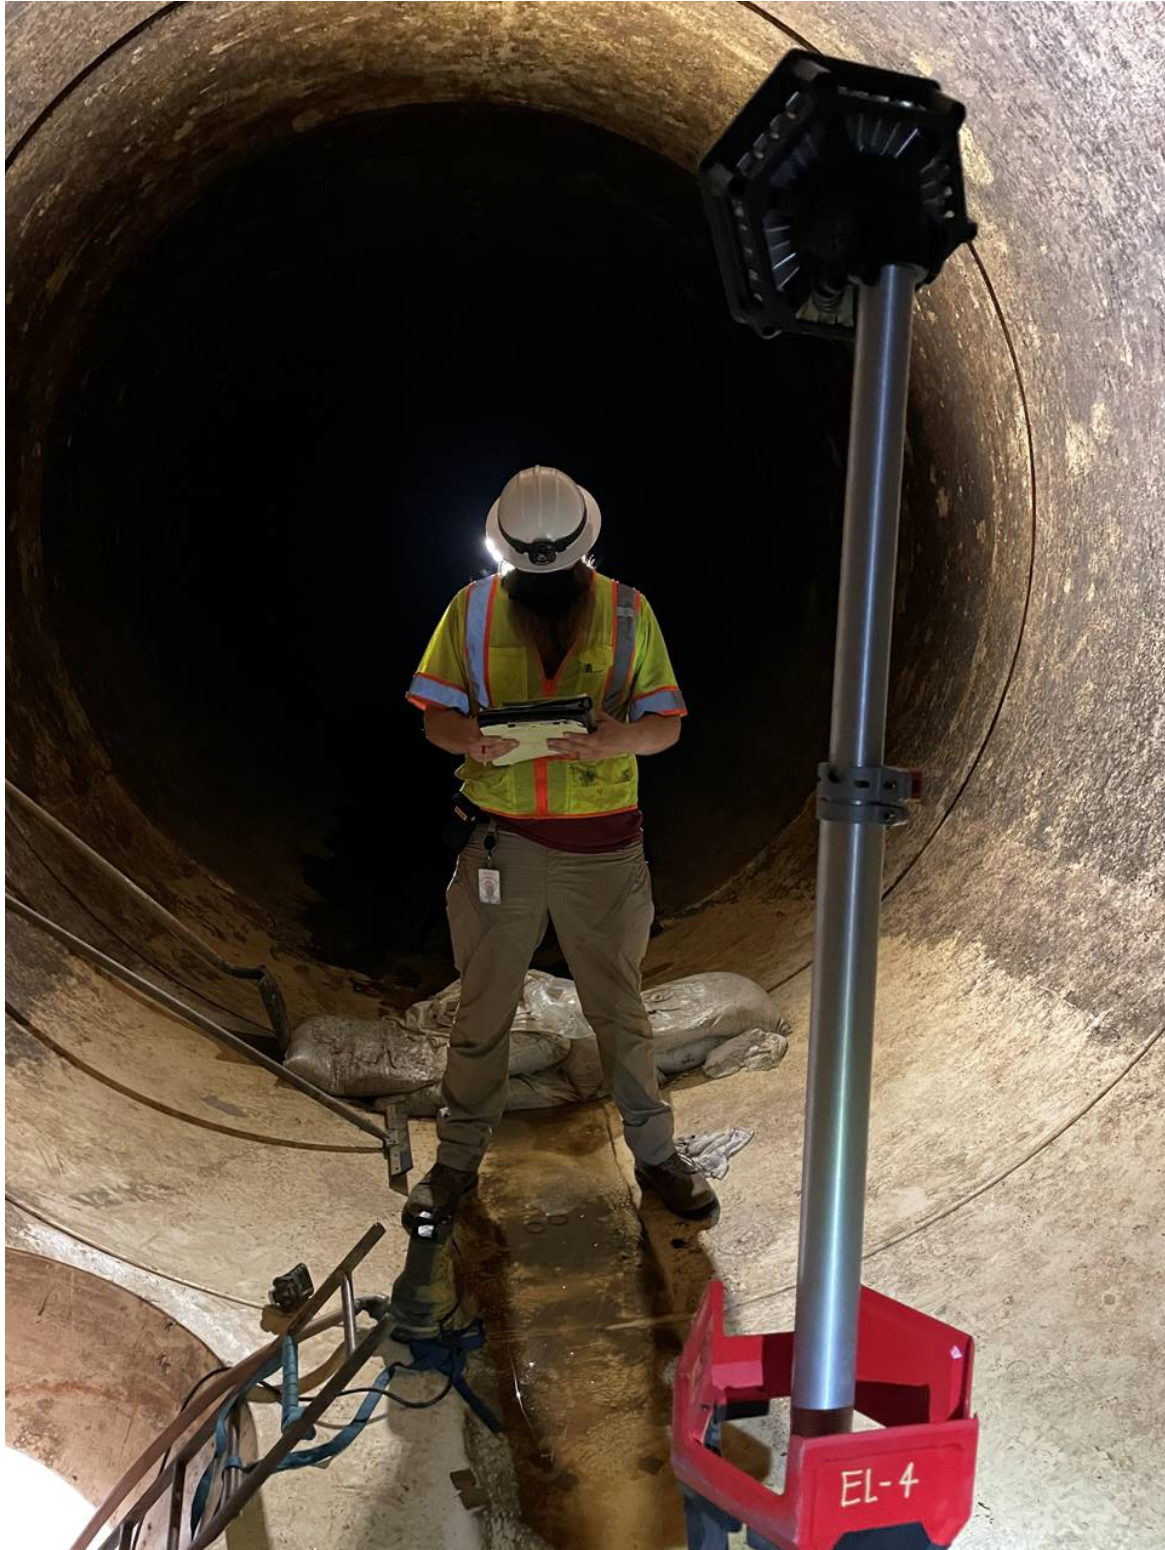
WSO's Scott Radel (Maintenance Engineering) records handheld laser measurements

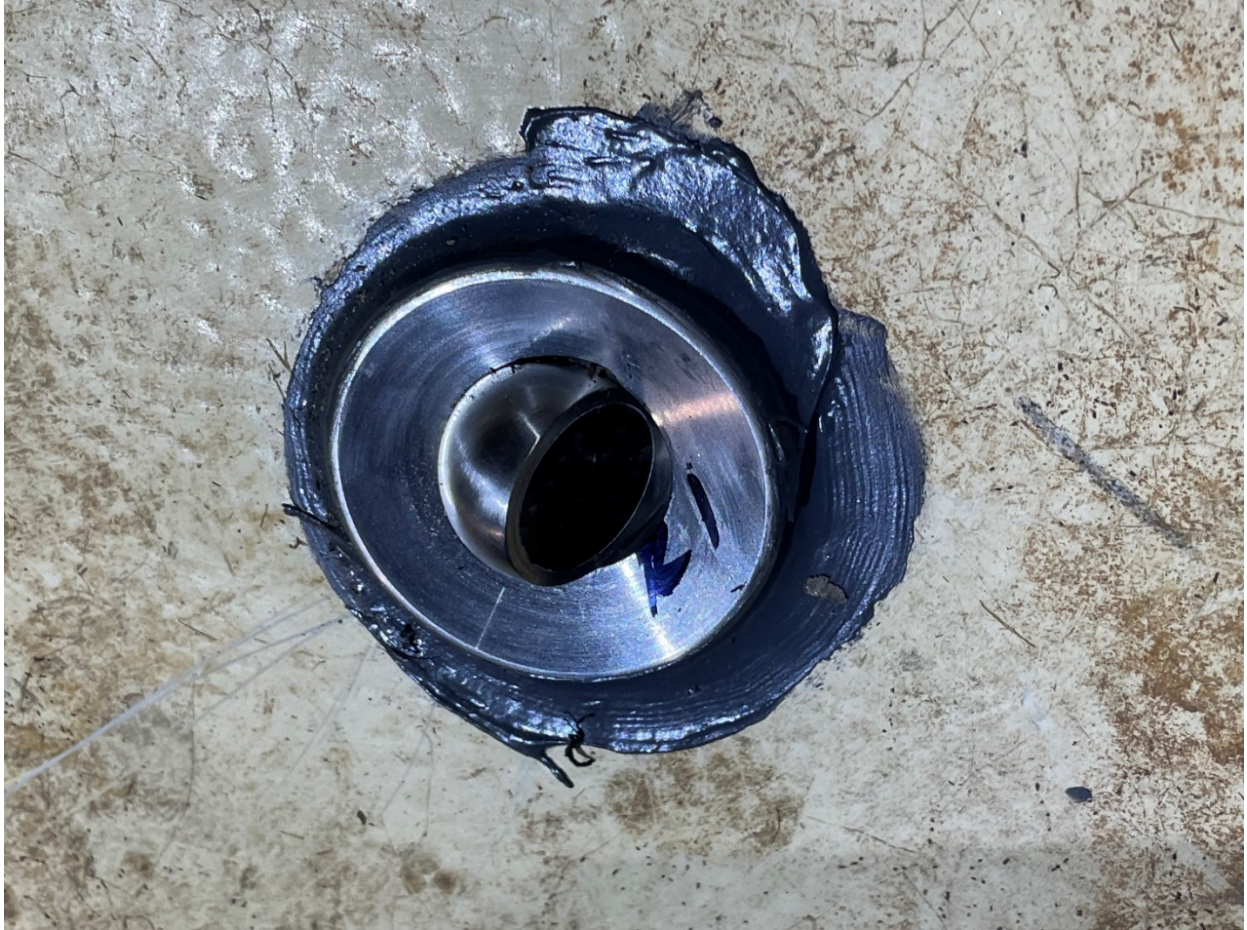
Close-up photo of a newly installed transducer used to determine the flow rate
