CAUTION

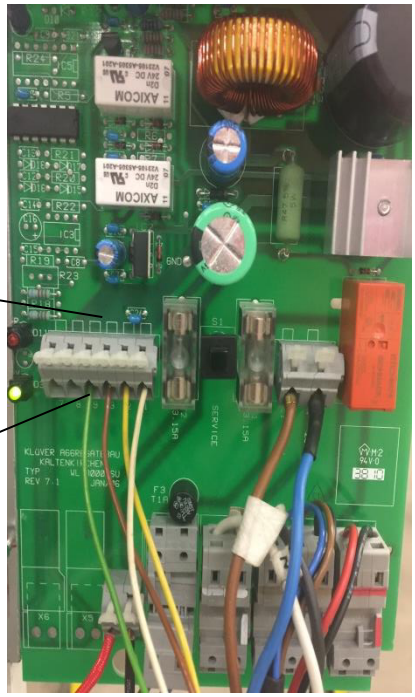
Always 24VDC with system on, if not replace K2

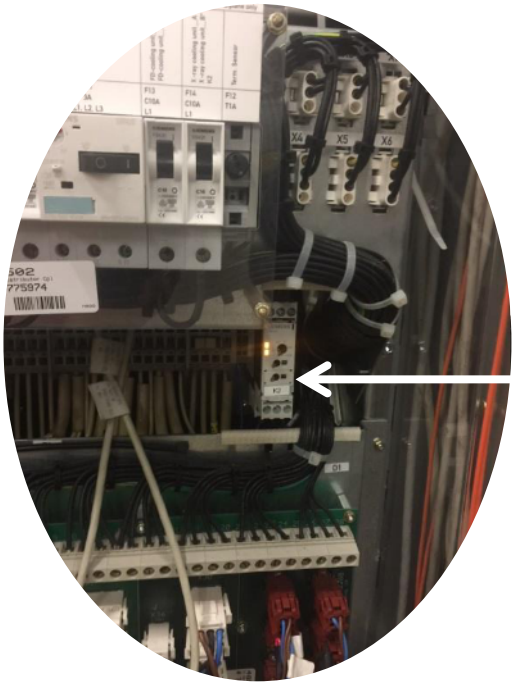
K2 Relay, Located in system cabinet

If you are replacing this Kluver tube chiller due to the following reason;
Tube Oil pump is not turning (No 24VDC at Kluver tube chiller pins 1-2)
The K2 relay in the system cabinet is known to fail in a way that will chatter 230VAC and damage the Kluver circuit board.
If this happens the K2 relay must be replaced. It is located in the system cabinet.

This relay failure is usually intermittent and may be very difficult to catch in the failed state.
