Flexware Sleeve Seal

Case Study

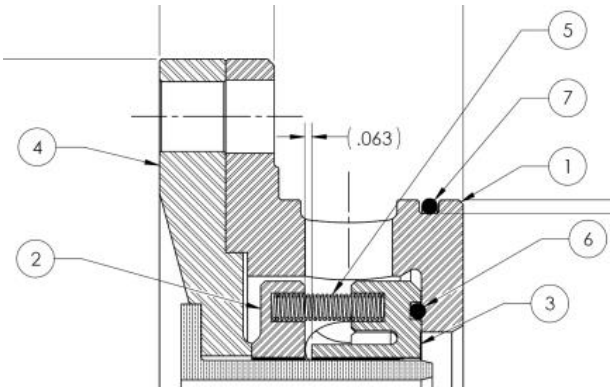
Figure 2. Flexware® cartridge sleeve seal: 1) inner hsg, 2) outer seal ring, 3) inner seal ring, 4) outer hsg, 5) springs, 6 & 7) O-rings.

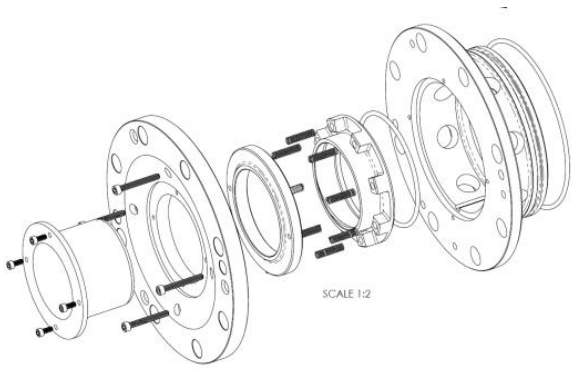
Figure 3. Expanded view of Flexware® cartridge sleeve seal.

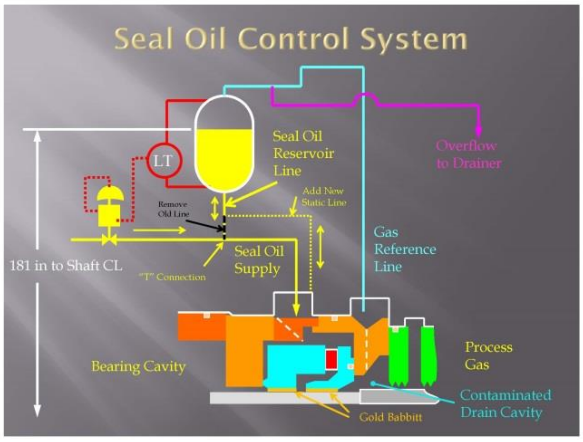
If the clearance increases on the breakdown bushing (outer seal ring) the seal oil supply to the seal will increase accordingly. This in turn increases the pressure drop from the seal oil differential control point ("T" connection, Figure 4) to the seal cavity and reduces the pressure drop across the inner seal ring. A side effect is gas migration into the seal cavity and the seal "blowing gas".

Figure 4. Seal oil control system. Add a new static line (yellow dotted line) to the overhead tank to improve controllability.

The overhead tank is located 181" above the shaft centerline and the oil control valve is set to control this level providing a 5 psi seal oil pressure above the compressor discharge end contaminated drain line. One problem with this is that there is a pressure drop from the "T" connection (Figure 4) to the seal cavity and this pressure drop is a function of the seal oil flow rate. This pressure drop reduces the 5 psid across the gas side seal ring and can result in gas crossing over into the seal cavity if this psid is reduced too much.

In order to prevent gas from entering the seal oil, the "T" connection should be moved as close as possible to the seal oil cavity itself. Ideally, an additional line is drilled into the compressor seal housing to provide a static connection to the overhead tank. Alternately, the "T" connection can be moved closer to the compressor, just outside the seal housing.

In addition to moving the "T" connection closer to the seal cavity, consider reducing the cooling oil flow through the seal. The reduced flow rate will reduce the pressure drop to the seal and thus improve the differential pressure across the gas side seal. This is possible with the gold Babbitt as it can withstand much higher temperatures than the tin or lead based Babbitt.
