NO. LTC # **596-2017** **LETTER TO COMMISSION**

SUBJECT: Removal of Two Australian Pines on Pine Tree Drive

SUBJECT: Hurricane Irma Tree Assessment and Next Steps

Pine Tree Drive Tree Risk Assessment
Tree Risk Assessment Report

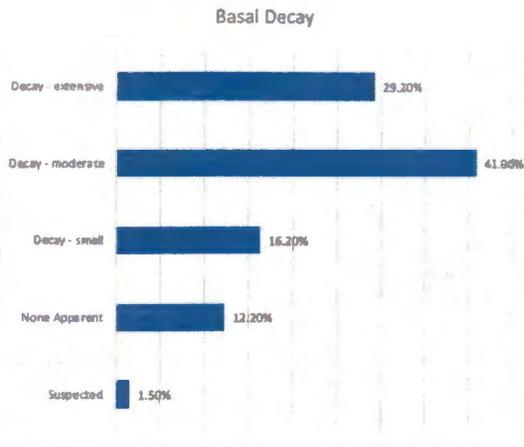
Figure 5

Basal decay and the somewhat related gall decay provide an indication of the structural condition of the tree. The condition of the base of the trunk and the condition of the galls coincides (Figures 5 and 6). Basal decay is difficult to measure because a small opening at the base of the trunk may be the only indication that a large decayed area exists. A probe is still the best tool for locating basal decay. Because so many of the Australian pine trees on Pine Tree Drive have galls (97 percent of the trees), monitoring decay on the galls is useful. We have observed that often gall decay is a precursor of trunk decay. Figures 7 and 8 show how basal decay colonizes the lower trunk and Figure 8 shows why diagnosing basal decay is so difficult.

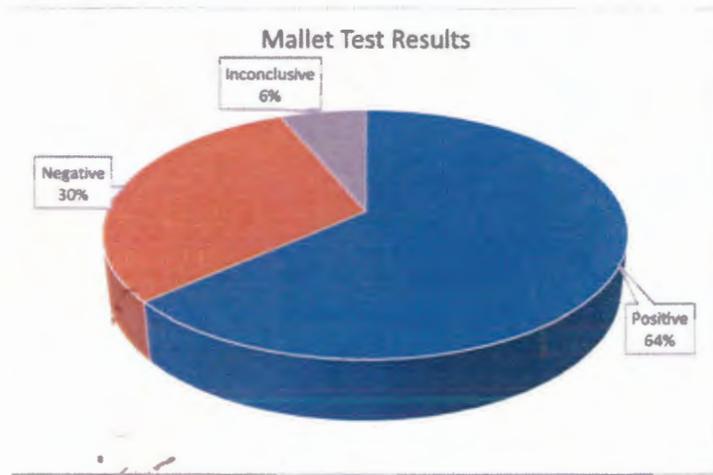
Figure 9

The simple rubber mallet test is still a useful tool in locating decay on the trunk. Sixty four percent of the trees had a positive mallet test result on some portion of the trunk (Figure 9). Sometimes the decay or hollow area was in one section and one side of the trunk and other times the mallet test showed that there was a column of decay extending from low in the trunk upward. A column of decay is usually of greater concern than a localized hollow area or area of decay on the trunk because it indicates a lack of vertical compartmentalization.

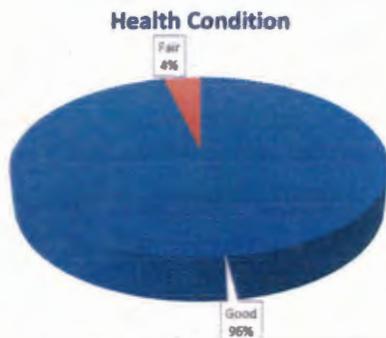
Figure 10

The health condition (Figure 10) of a very high percentage, 96 percent, of the Australian pine trees is good with only four percent evaluated as fair. Structural condition, however, is not so good because of the widespread decay found on the trunks, basal areas and galls. Only eight percent of the trees are in good structural condition while 45 percent are fair and 47 percent are poor (Figure 11). Breaking down the data between the north section and south section (Figure 12), more trees are in poor structural condition on the south section.

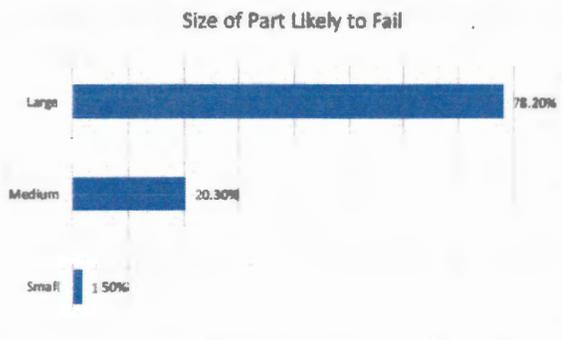
Figure 13

Because of the location of most of the decay in the trunk or basal area, the part of the tree most likely to fail is the entire trunk or a large branch. Seventy-eight percent of the tree parts likely to fail are large (Figure 13).

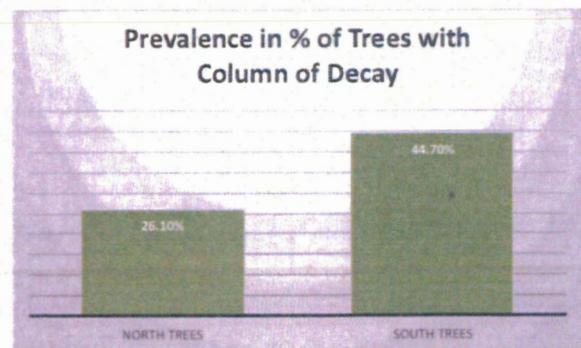
Figure 14

Breaking down the decayed trees into those that have a column of decay and further breaking the data down into trees in the north section (with the wide median) and trees in the south section (with the narrow median), 26.1 percent of the north trees have a column of decay while 44.7 percent of the trees south of 41st Street had a column of decay (Figure 14).

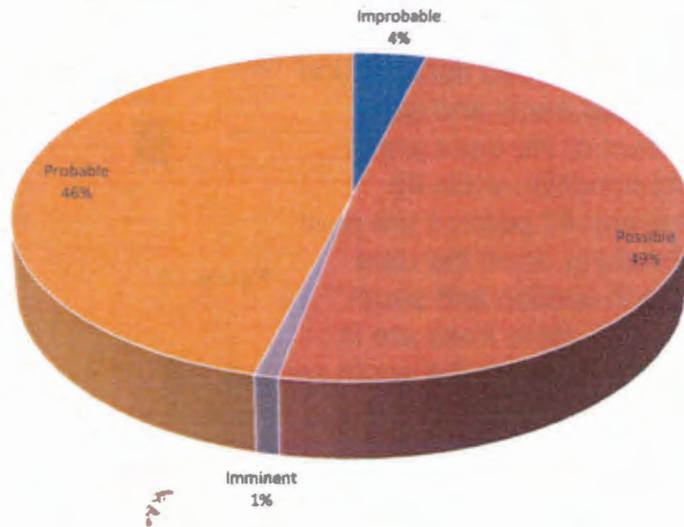
The likelihood of failure of the tree or part of the tree is another measurement of risk. Figure 15 shows that Probable Risk of Failure and Possible Risk of Failure are nearly the same. However when looking at the Failure Probability based upon the north section and the south section (Figure 16), the south section has 52.6 percent "Probable" compared to 37.8 percent "Probable" in the north section. Again our data is showing increased risk in the south section.

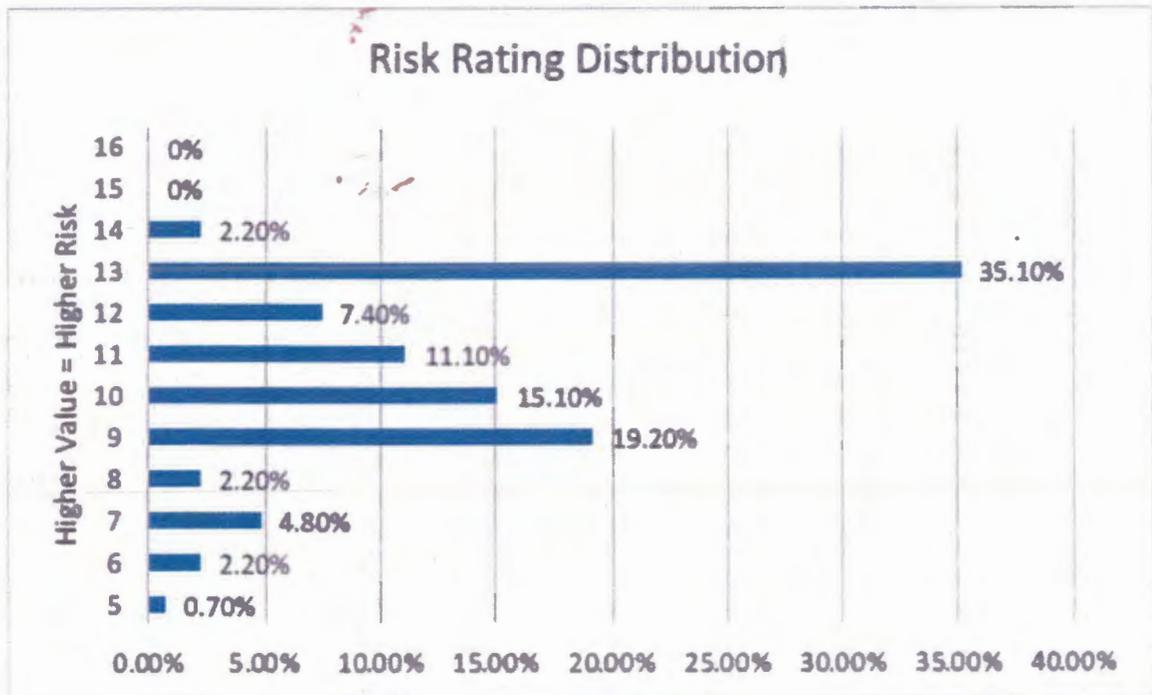
Trees were rated in each category and the sum of the five categories represents the Risk Score. The higher score means a higher risk for that category. The highest risk tree could attain a hazard rating of 16. The lowest risk tree could have a hazard rating of 5. The risk ratings for all the trees are shown in Figure 19 on page 21 of this report.

The distribution of the risk scores in Figure 19 shows that the relatively high rating of 13 included the largest number of trees of any single rating. These scores alone do not always warrant removal or other maintenance treatment. But the ranking is another way of viewing the cumulative scores of several individual defects.
