# BARTLESVILLE FIRE DEPARTMENT

## FIRE INVESTIGATION REPORT

### WITH ORIGIN AND CAUSE REPORT

| <b>Incident Number:</b> | 2026-1451 (NERIS/CAD: 2026-000001451) |

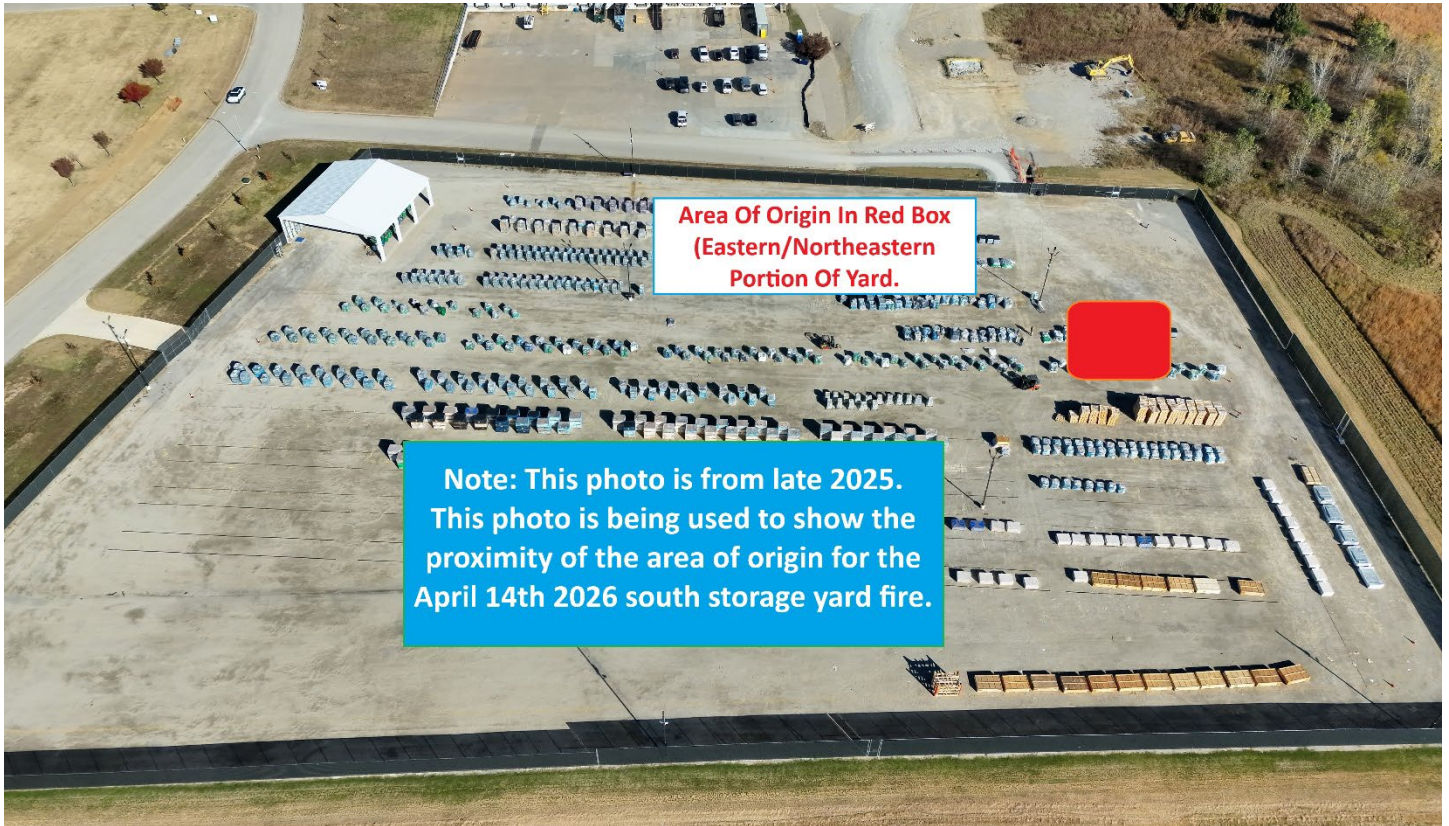
**Note:** Aerial photograph taken November 2025. Included to illustrate the proximity of the south storage yard to surrounding structures relative to the April 14, 2026 area of origin.
