June 13, 2022

William C. Wallick
Pelican Isle Master Association
435 Dockside Drive
Unit #203
Naples, Florida 34110

RE: Seawall Assessment Report

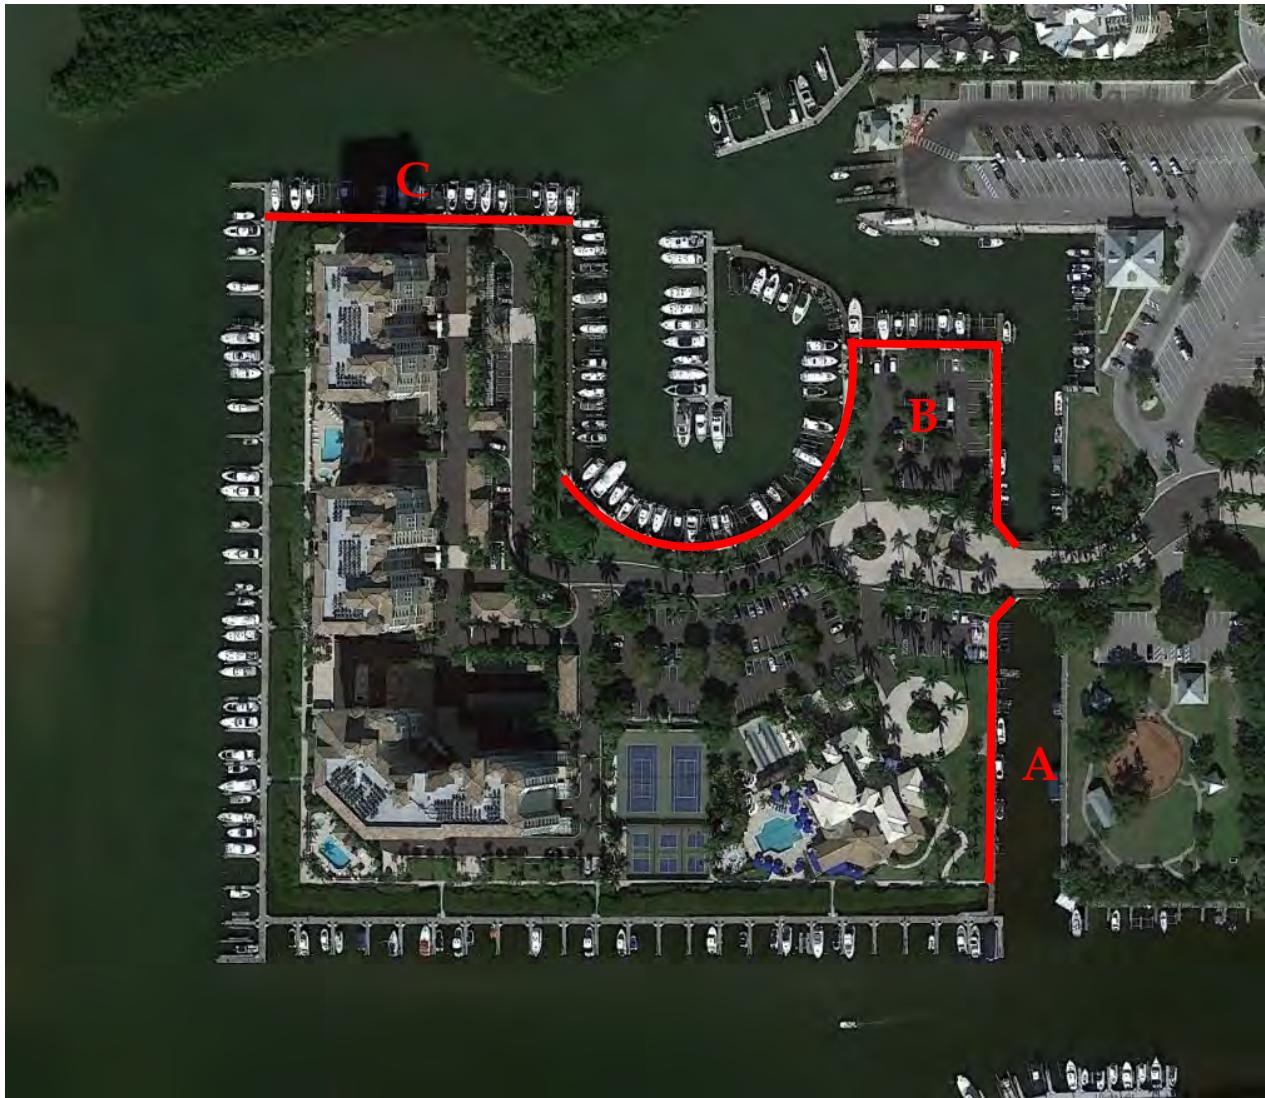
Figure 2: Site Aerial

For clarity in this report, the seawall is divided into three sections. They are depicted in figure 2 and will be referred to as sections A, B, and C. On the South and West sides of the island, the seawall functions as an upland retaining wall. These areas were not assessed.
