Re: Westhampton Landings Co-op  
3001-3050 Mitchell Road  
Westhampton Beach, NY 11978

RE: Roof Assessment

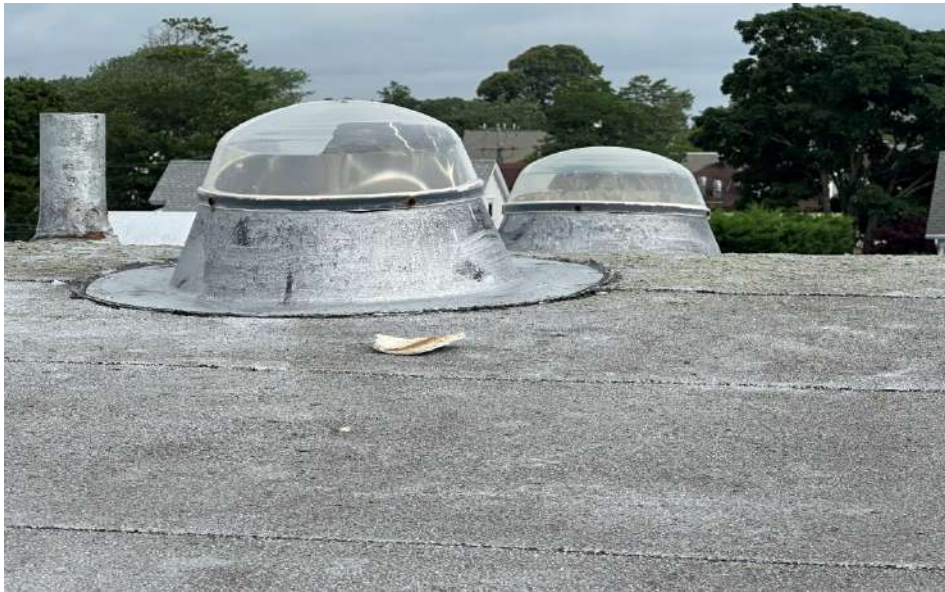
Some of the solar tube skylights did not appear to have flashing at the base ring some with exposed fasteners. A new base flashing should be applied where missing. Also, some of the edge metal where the flat roof transitions to the steeply sloped shingle roof has unsealed and loose fasteners as well as some openings in the corners. These openings could allow water penetration under the membrane and should be repaired to ensure a tight seal. It should be anticipated that approximately ten (10) percent of the underlying roof sheathing plywood roof deck will be rotted. Rotted roof decking can sag and no longer adequately support the membrane. Some depressions were observed suggesting that some of the decking is rotted.

P-6 Solar Tube Skylight

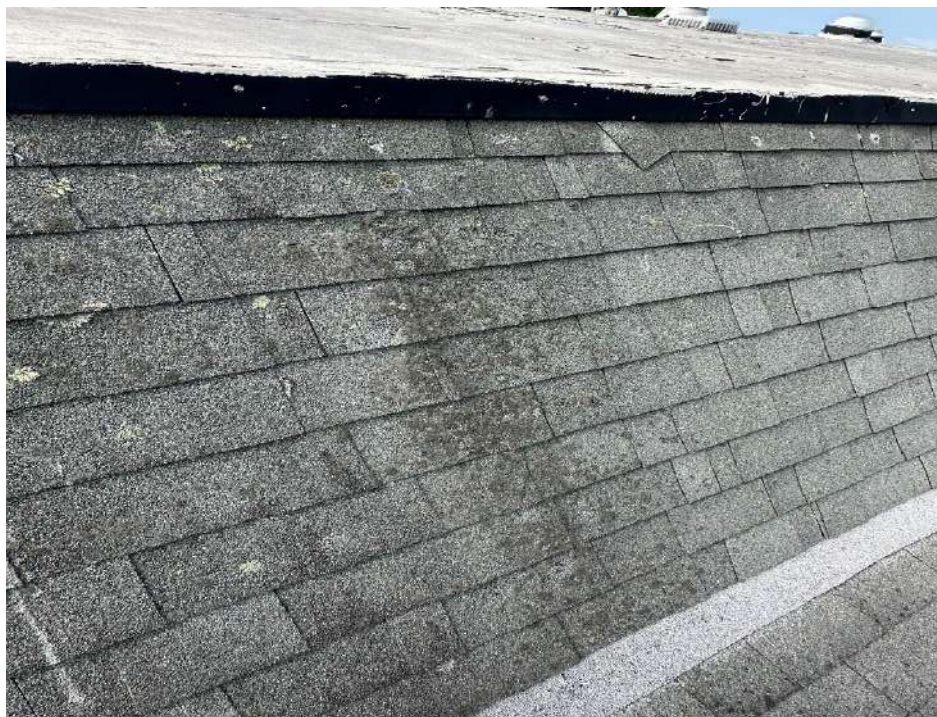
P-44 Delaminating Shingle

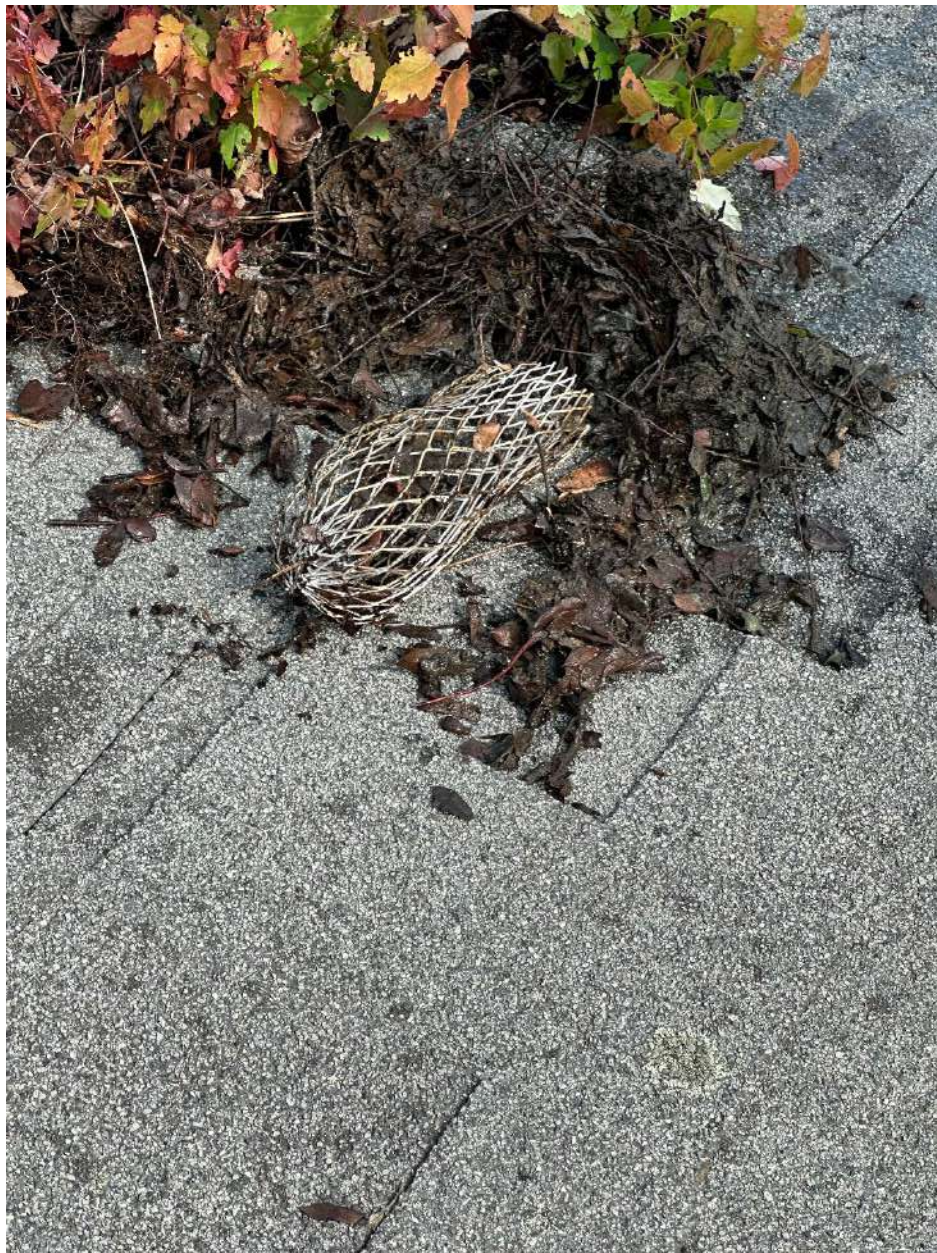
P-48 Strainer in Gutter at Leader Opening

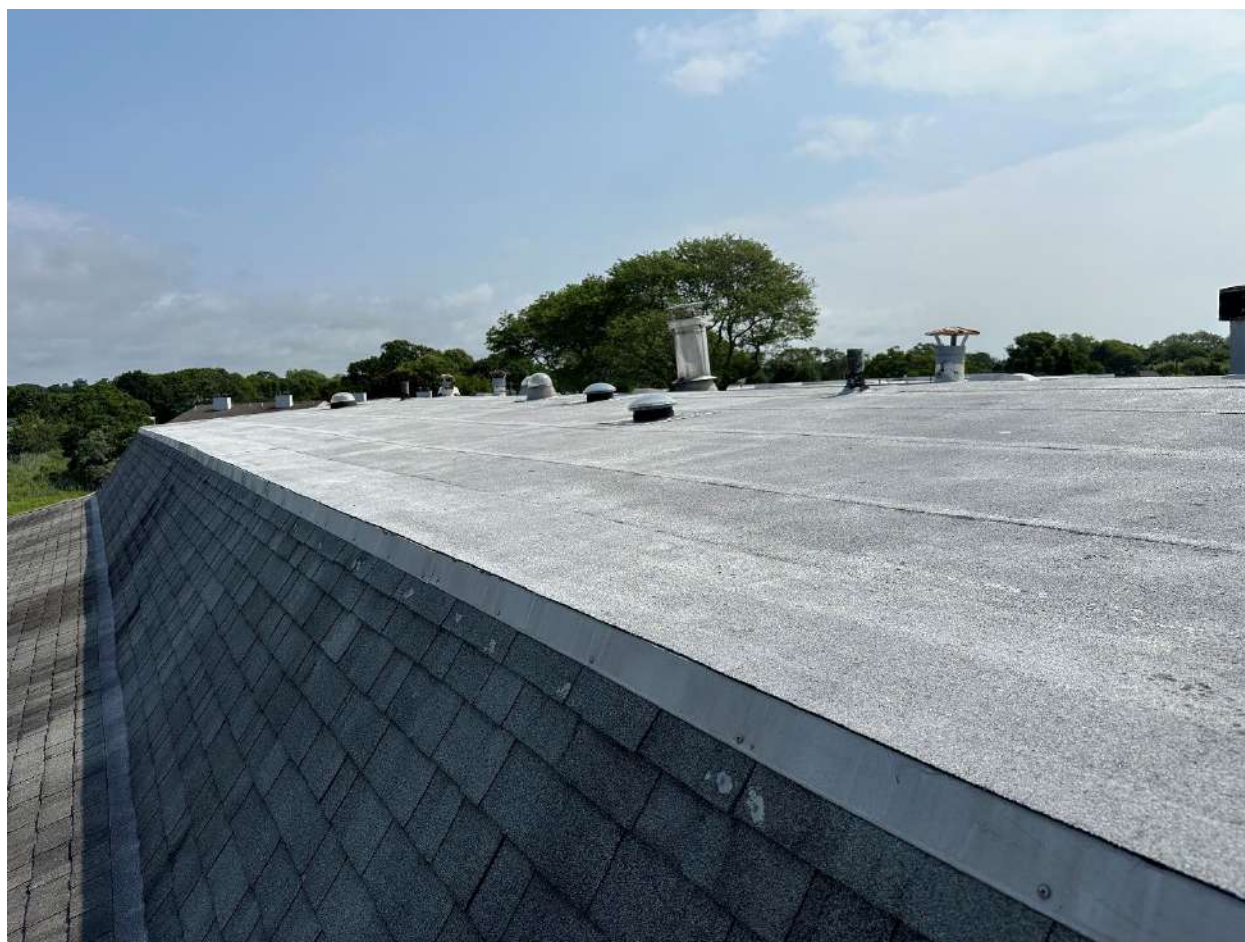
P-67 Overall of Roof

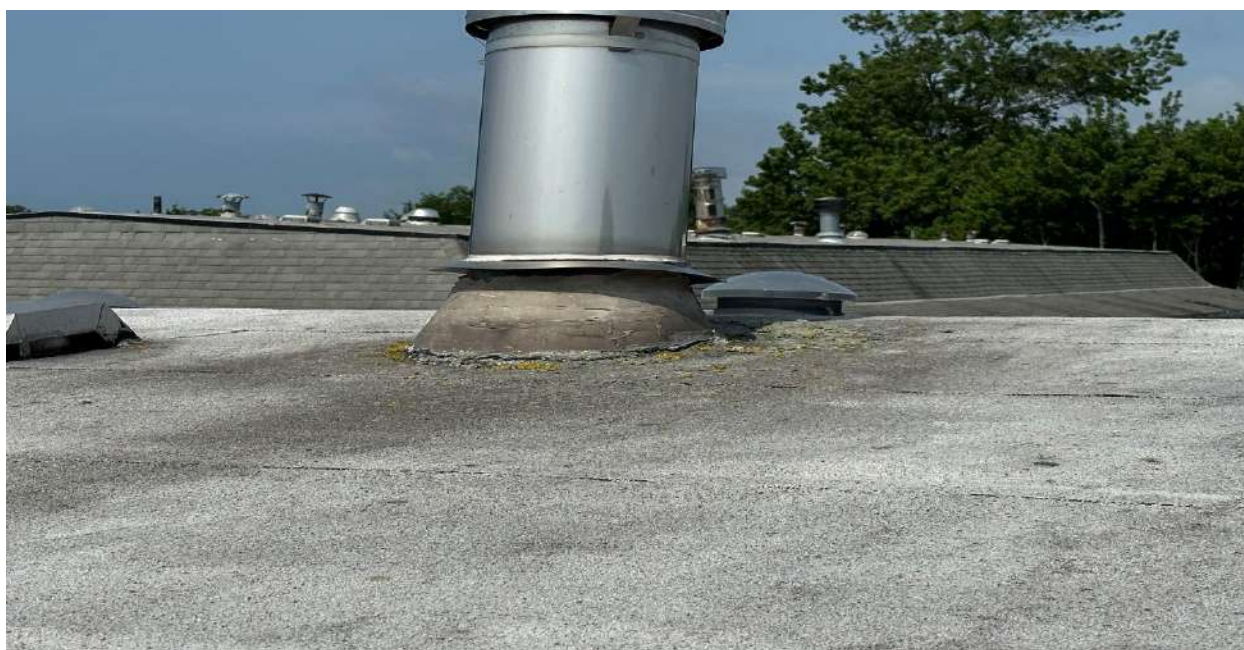
P-70 Chimney Penetration

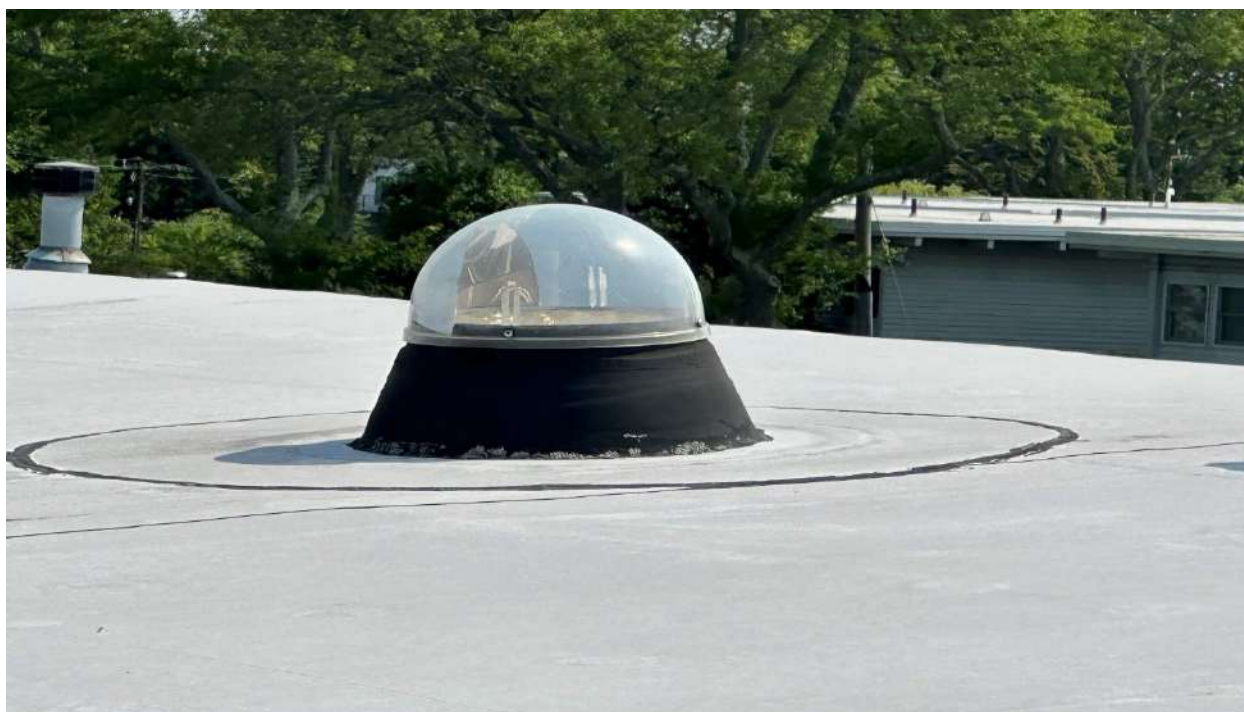
P-56 Solar Tube Skylight With TPO Flashing

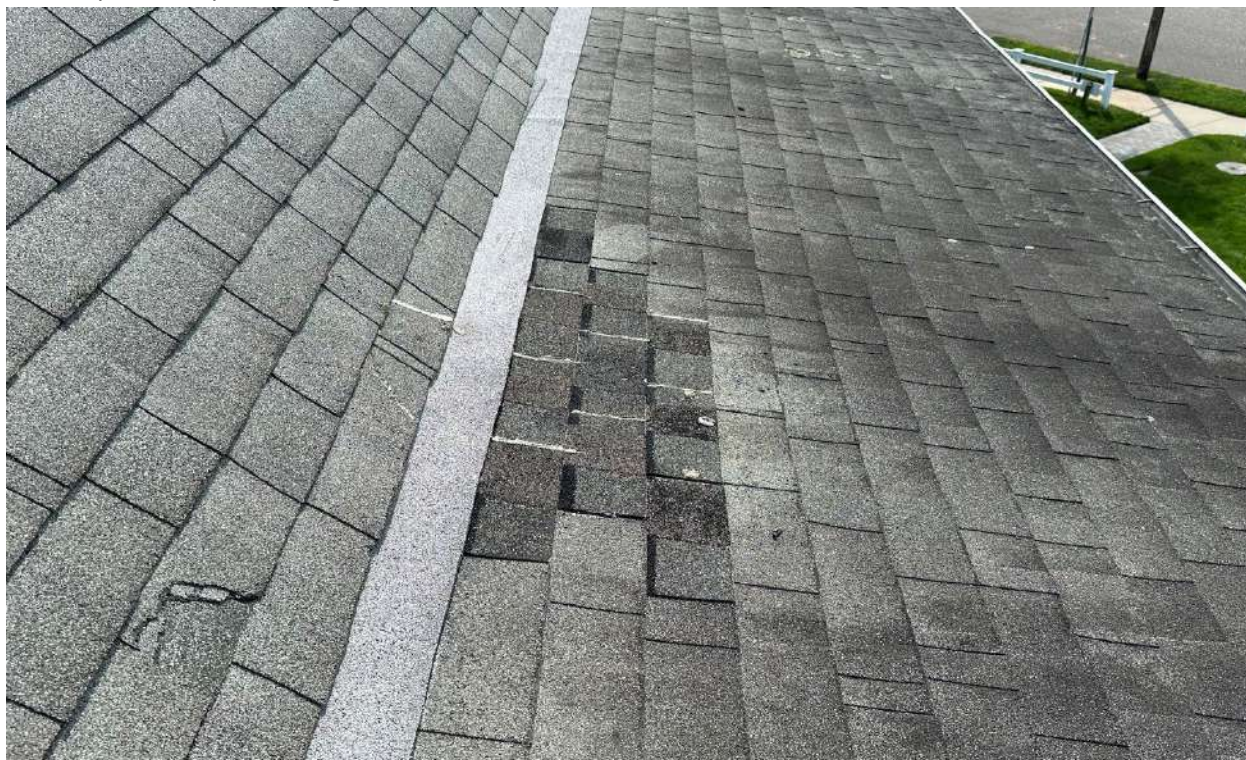
P-59 Replaced Asphalt Shingle

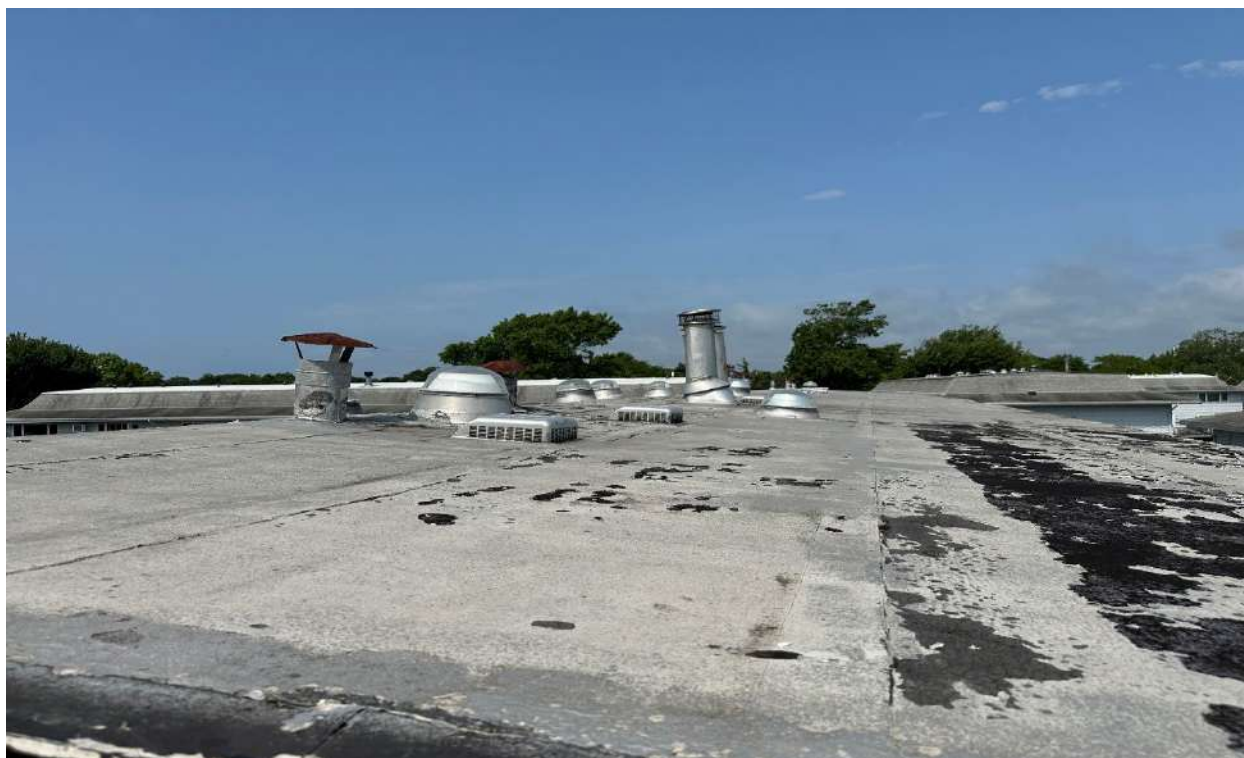
P-84 Overall Of Roof

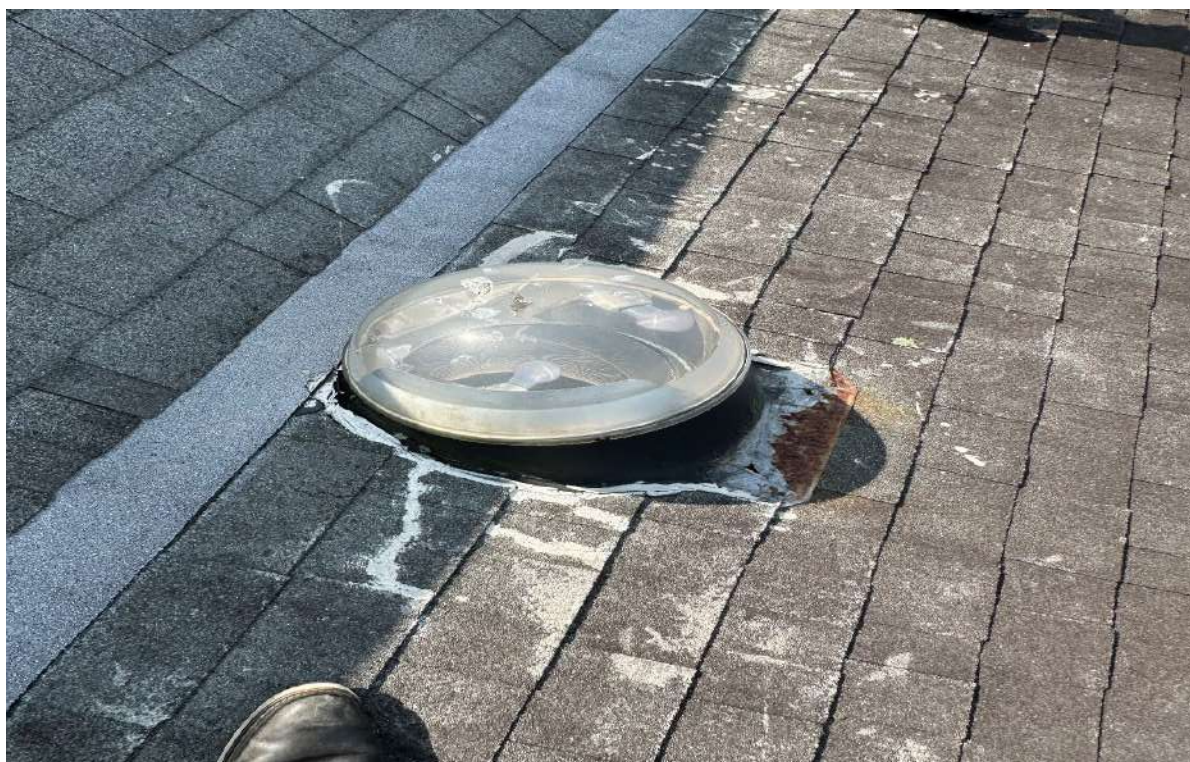
P-86 Sealant Added At Solar Tube Flashing
