Year: 1949

Make: Ford

Model: Custom Woody

V.I.N # 8BA-3405DB

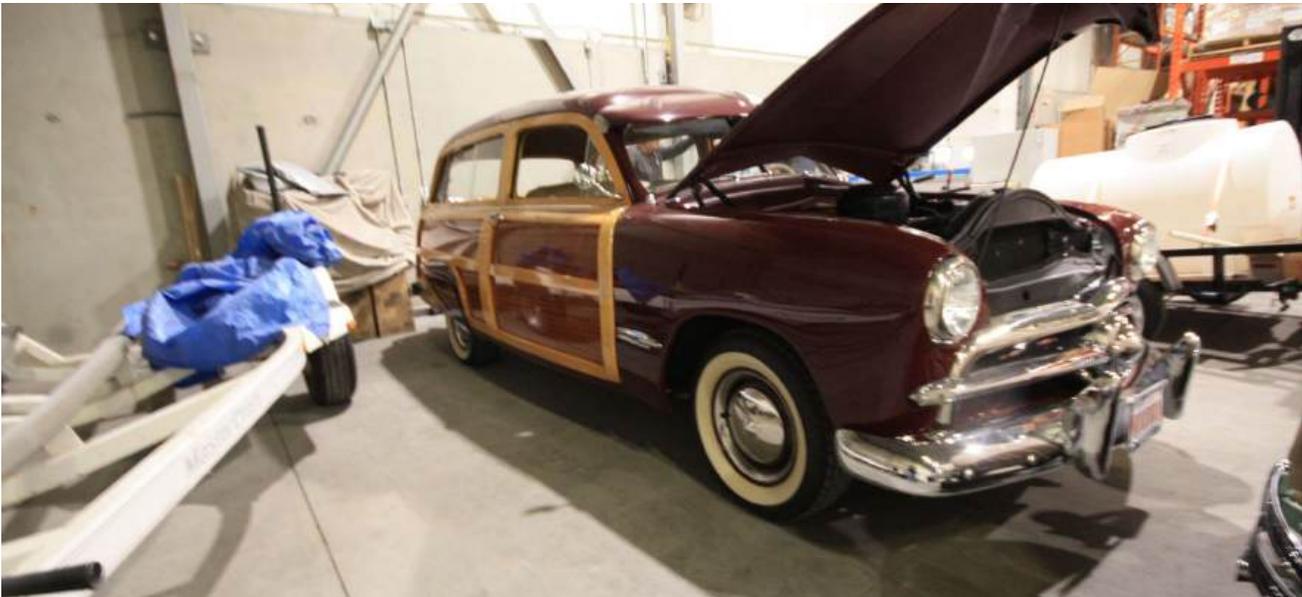
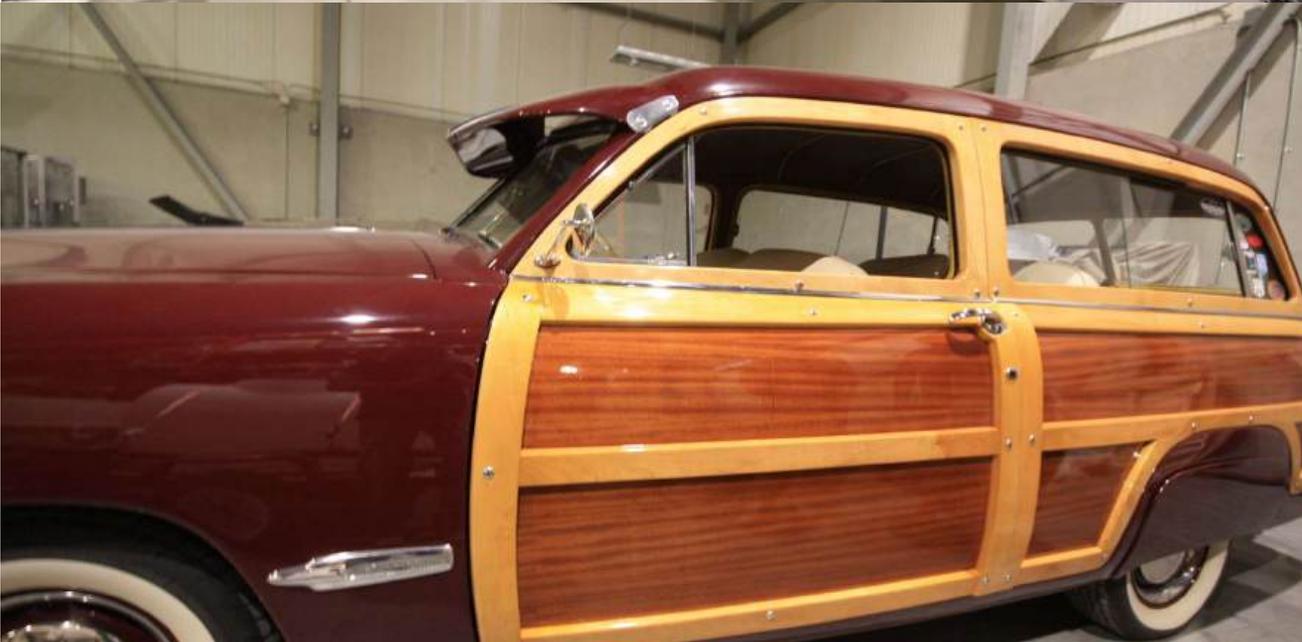
Body

Condition Rating:	Comments :
Hood		2	Restored
Roof		2	Restored
Fender	Left & Right	2	Restored
Door	Left & Right	2	Restored
Trunk		2	Restored
Quarter Panel	Left & Right	2	Restored
Floors		2	Restored

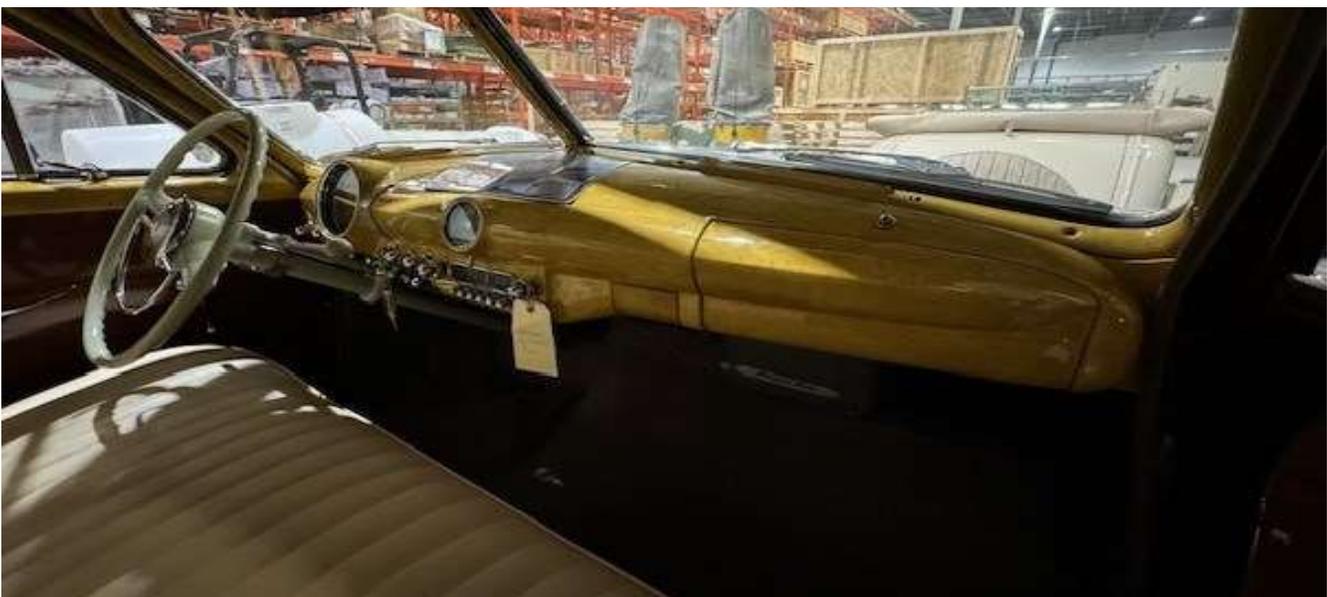
A New Tan color Interior is done in Leather has been reupholstered and shows beautifully when opening the door. The dash is Hand Painted wood grain that looks like Birds Eye Maple The Metal door panels and the rest of the Interior wood panels are done in Philippine Mahogany veneer ribbon grain.

The Original headliner is in Very Good condition with all of the roof ribs done in refinished Ash

The Original Steering wheel has been restored with no cracks or separation. All of the chrome dash bezels and trim are in Very Good condition.

The complete Interior including the cargo area has been treated to New carpet as well.

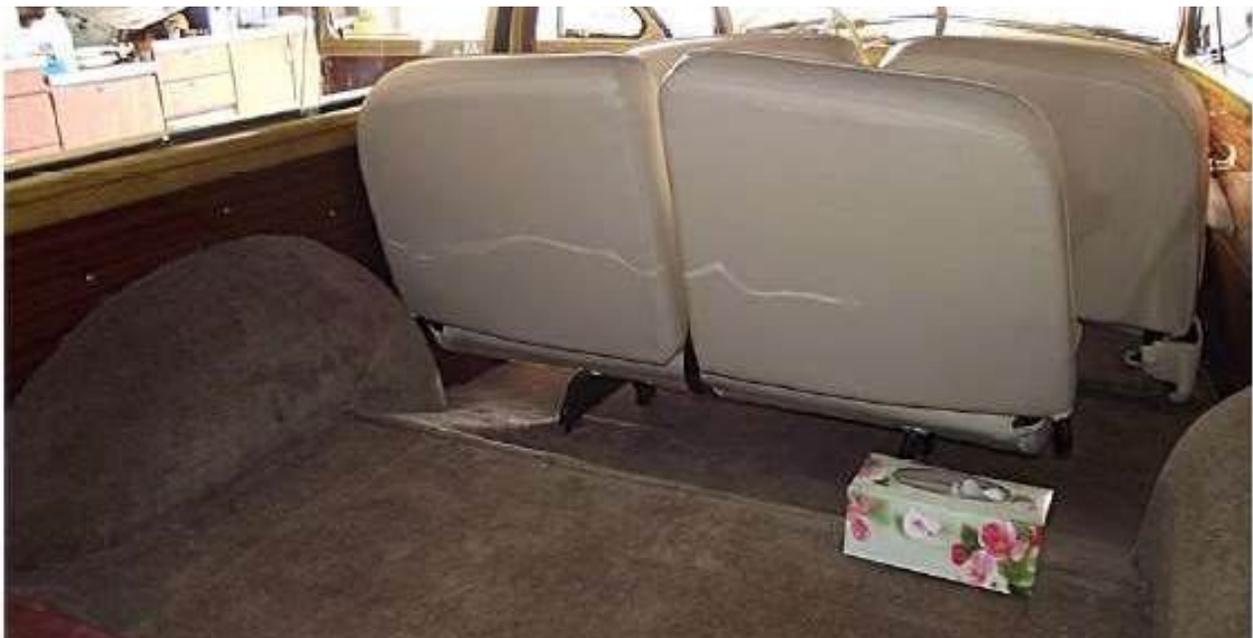
- Original restored steering wheel shows no signs of wear or damage.
- The headliner is not sagging or damaged and is in Very Good condition with the roof ribs done in refurbished Ash.
- The dash is done in a Bird Eye Maple wood grain accents that shows beautifully.
- The Metal door panels and the rest of the Interior wood panels are done in Philippine Mahogany veneer ribbon grain.

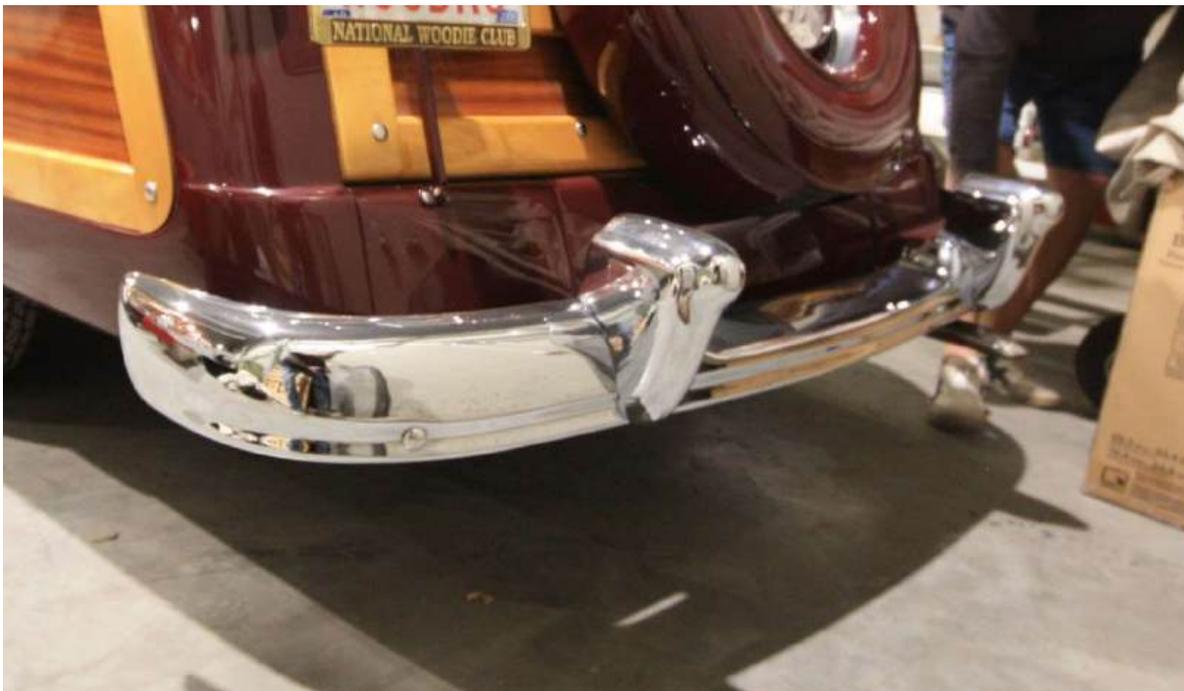
Bumpers

Front and rear bumpers have been re-chromed and have an excellent fit and finish that show well. All trim pieces are present and have a brilliant finish. Front lights are free of cracks. Front grill show no signs of fading or cracking and has a beautiful glow to it.

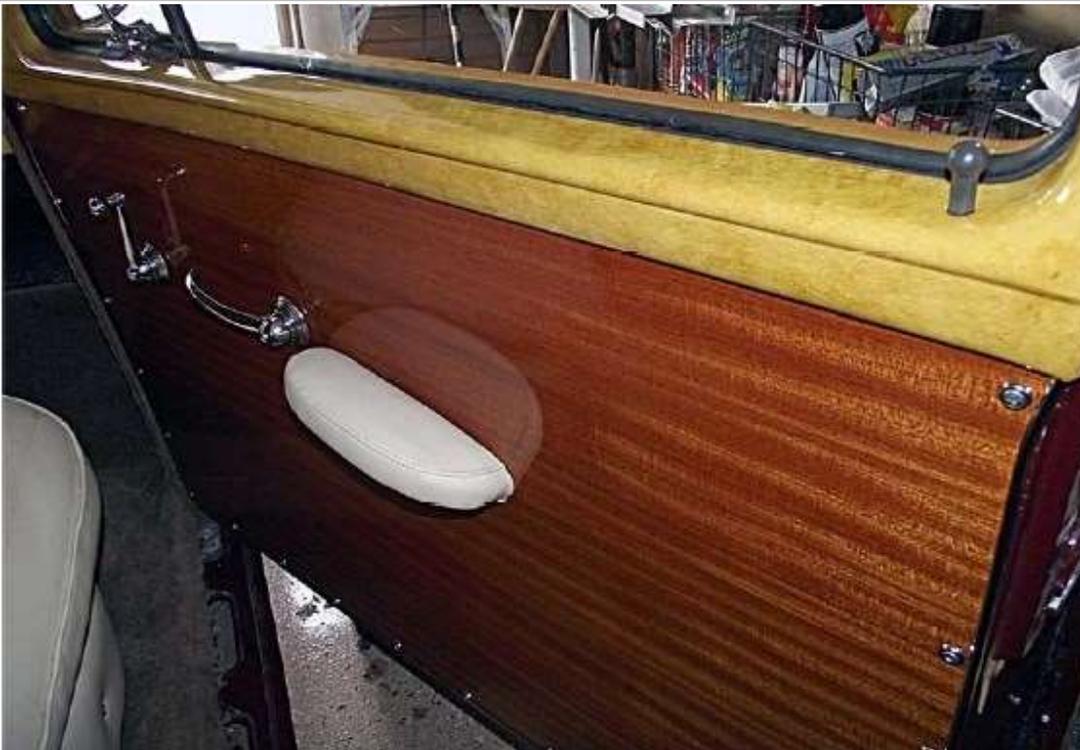
Panels

The Panel fits is good with uniform gaps and no pinch points. Doors open and close easily, with no sagging or binding. The manual windows crank up and down effortlessly. The weather-stripping surround the doors needs to be installed. The glass is in Very Good condition with no signs of drying, tearing or shrinkage.

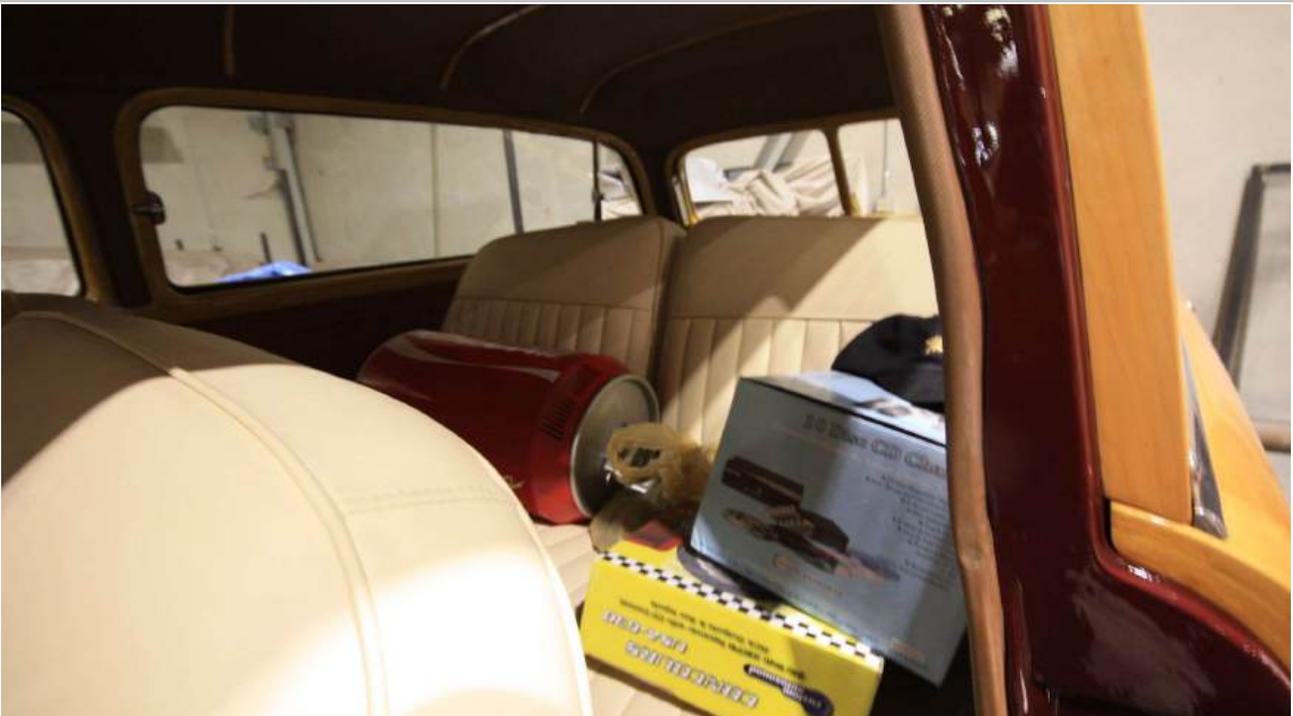
Rear Seating

This vehicle is not equipped with the rear facing “suicide seat”. The cargo appears to have been used except for storing the car cover.
