# POINT LOMA LIGHTHOUSE RECALLED TO LIFE

By Kim Fahlen

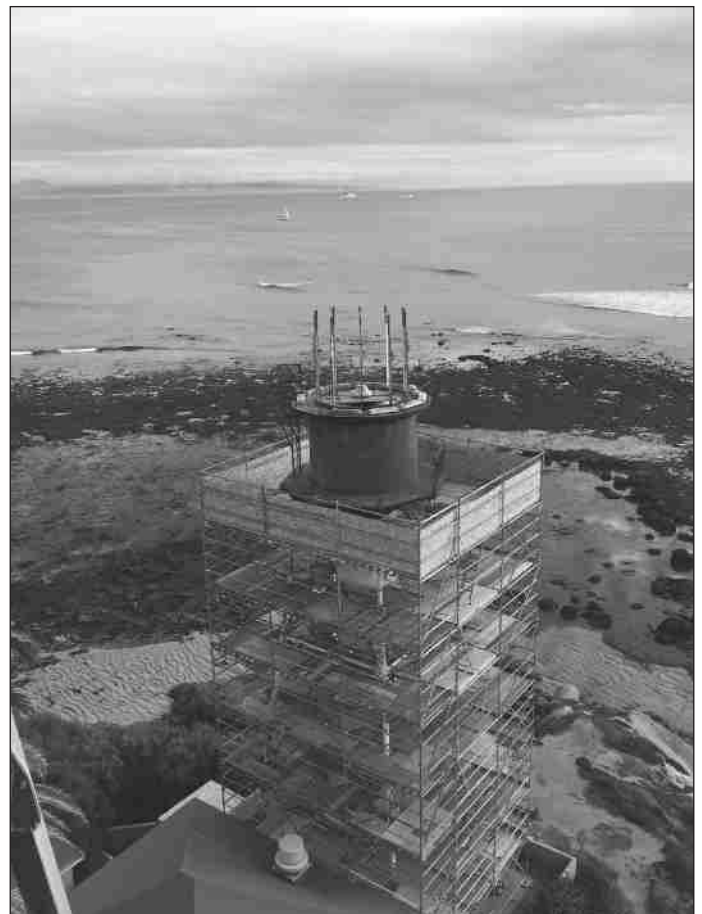
**Right: The lantern comprises two levels. The upper "lens room" is now removed, leaving the barrel of the "watch room." Drone image courtesy of Ryan Strack.**

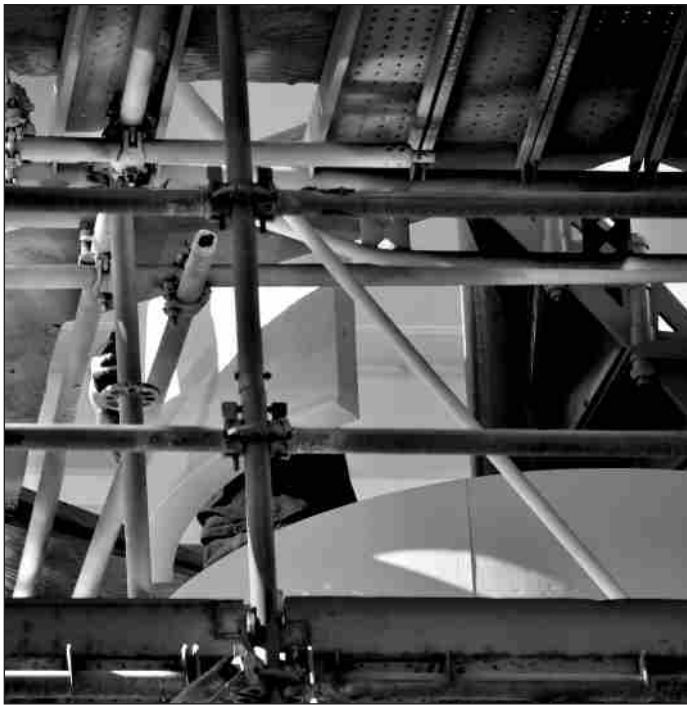
**Above left: Easing into its mate underneath is the first recast cylinder wall plate. Note stairs on right, which soon will be encircled and out of view from outside after five companion wall plates are bolted together. Courtesy of Kim Fahlen**

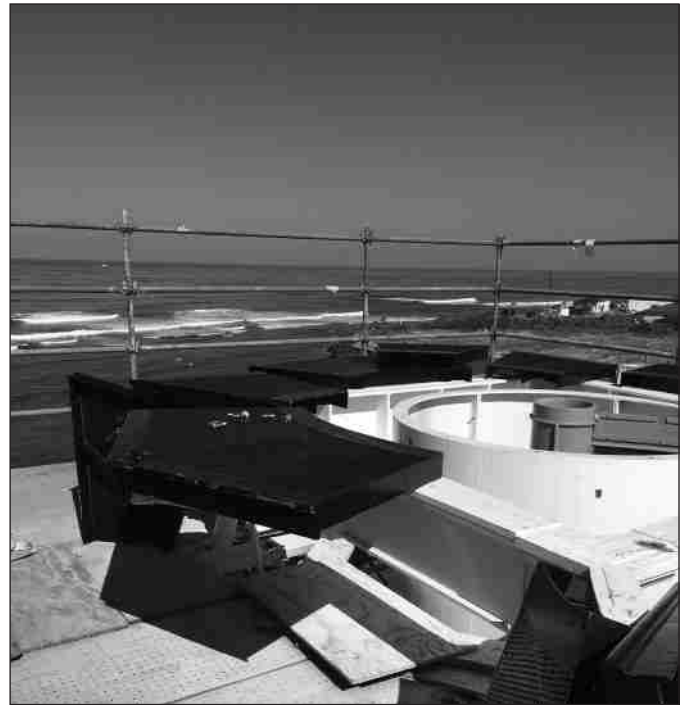
**Above right: Recast stair cylinder wall panels are in place and new architrave (support) beams are accepting the new deck plates. Courtesy of Ryan Strack.**

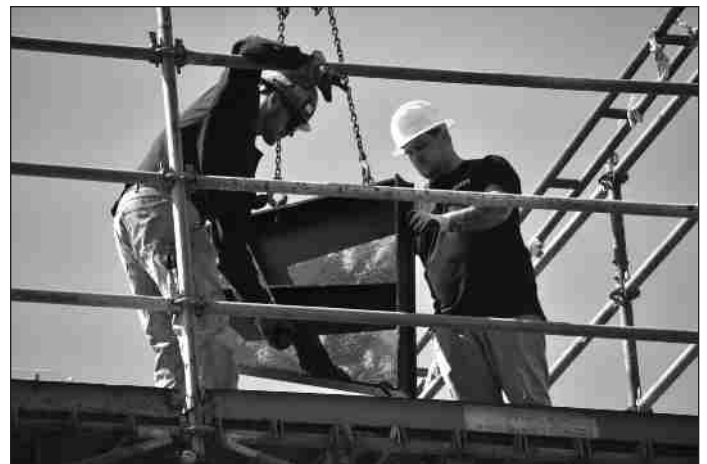
**At least 100 new castings were created for renovating the lighthouse tower. Nick Bliler and Ryan Strack are about to uncouple from the crane another exterior gallery plate. Each weighs roughly 180 pounds and there are 16 of them. Photo by Kim Fahlen.**

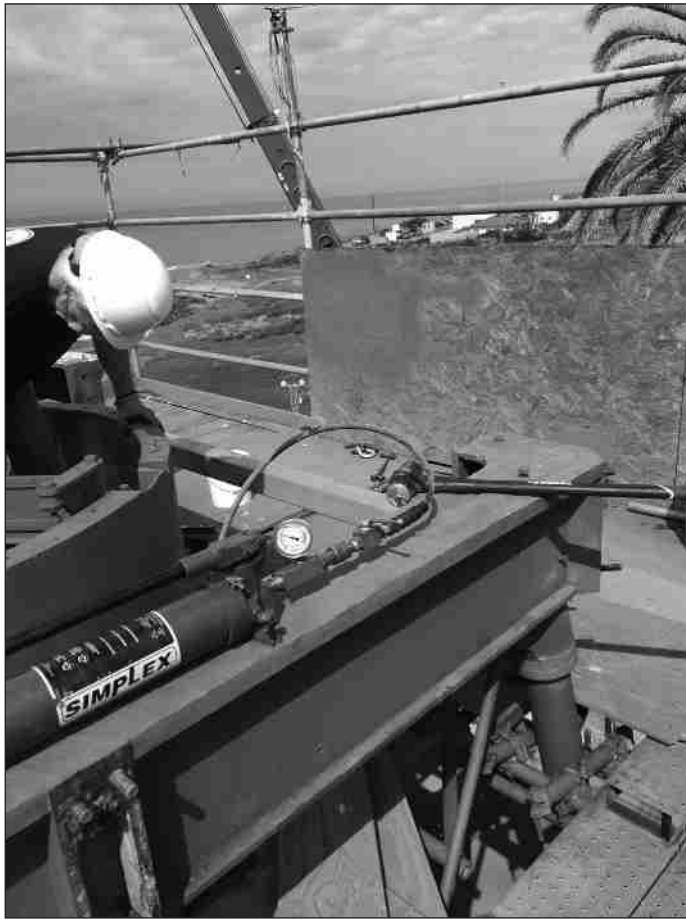
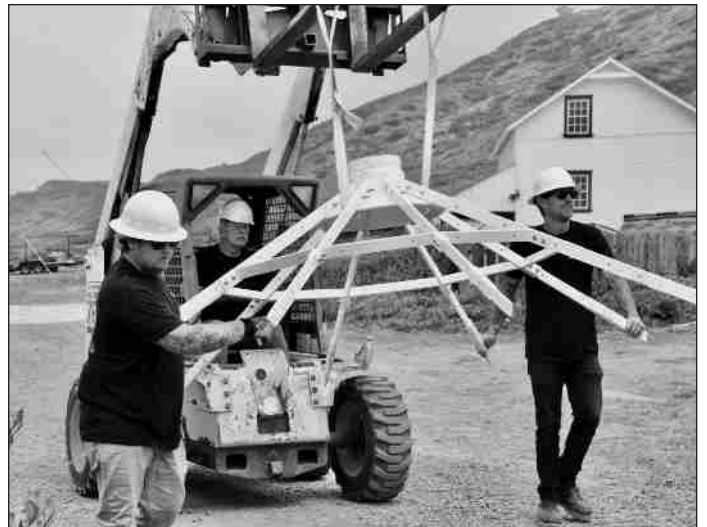
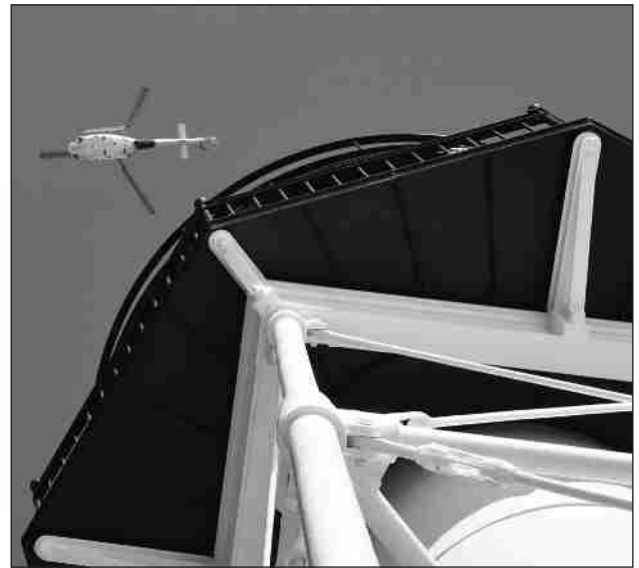
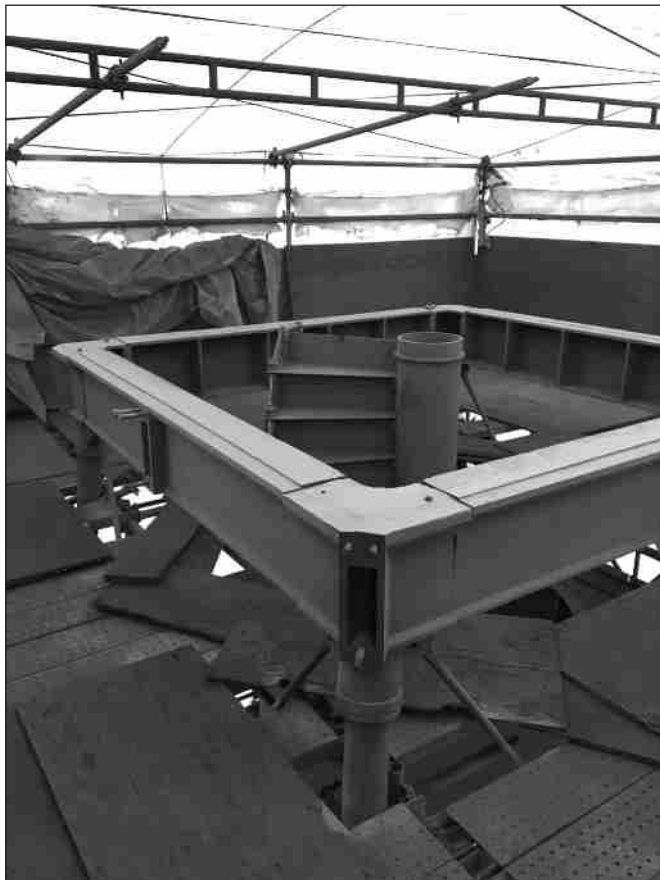
**Above:** Architrave now seen from underside with its striking white against the black. Photo courtesy of Kim Fahlen.

**Top left:** Old support beams are in process of being removed and replaced, one at a time. Ruddy coloration is a temporary protective coating applied to most of the structure following the initial blasting that removed old coatings and rust.

**Left:** For many months the scaffolded structure was enclosed with plastic sheeting, looking like a big marshmallow from across the city. Here are the new beams and corner castings of the architrave, now dressed in primer. Photos courtesy of Ryan Strack.

**Top right:** Ryan and Nick steady the roof frame as Neil drives it to the waiting crane. The top chimney section is original, as can be recognized by pockmarking around it.

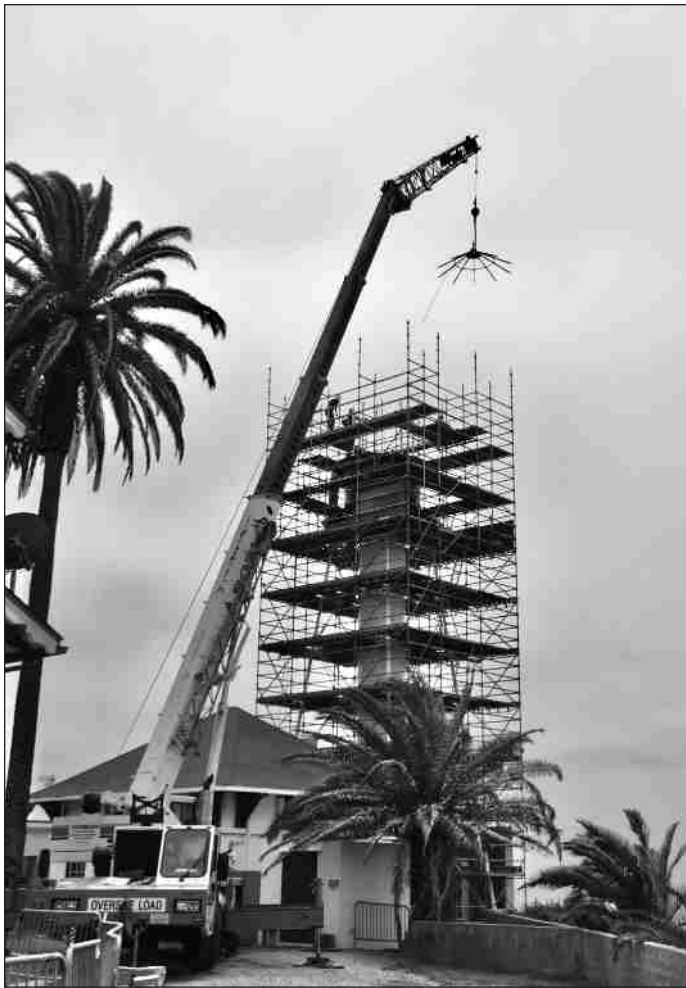
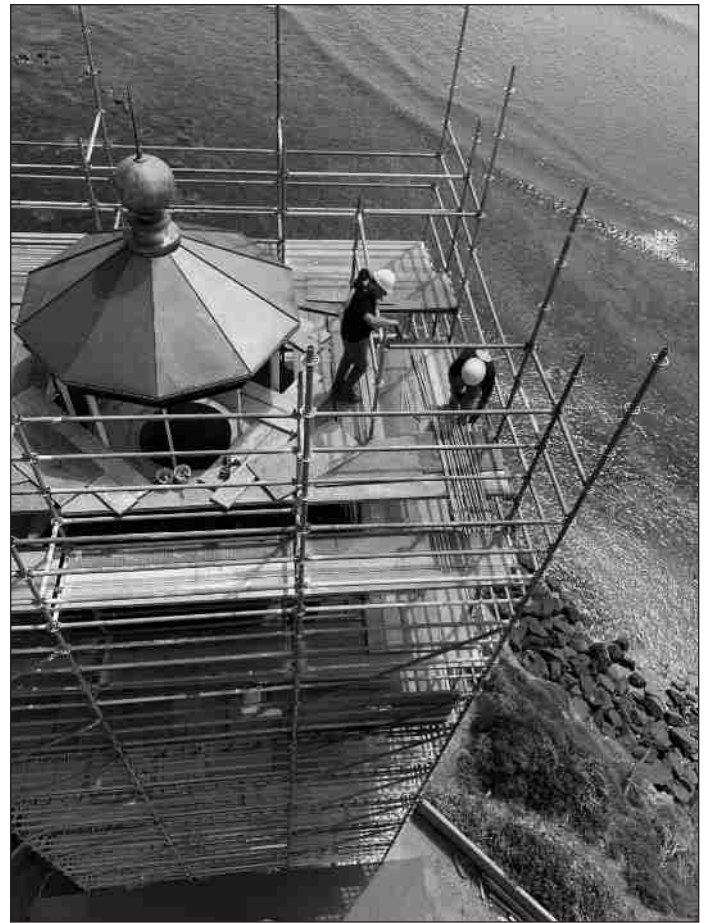
**Facing page, top:** Looking tiny in the air, the roof frame is about to meet its 10 upright rods. Some uprights were fractured but reusable after repair in Neil Gardis' Morena workshop. Last two photos courtesy of Kim Fahlen.

**Facing page, bottom:** Contractor Neil Gardis is prepared to ascend with the fine copper vent ball and its lightning rod, which Nick and he will soon happily install on the rooftop. Courtesy of Karen Scanlon.

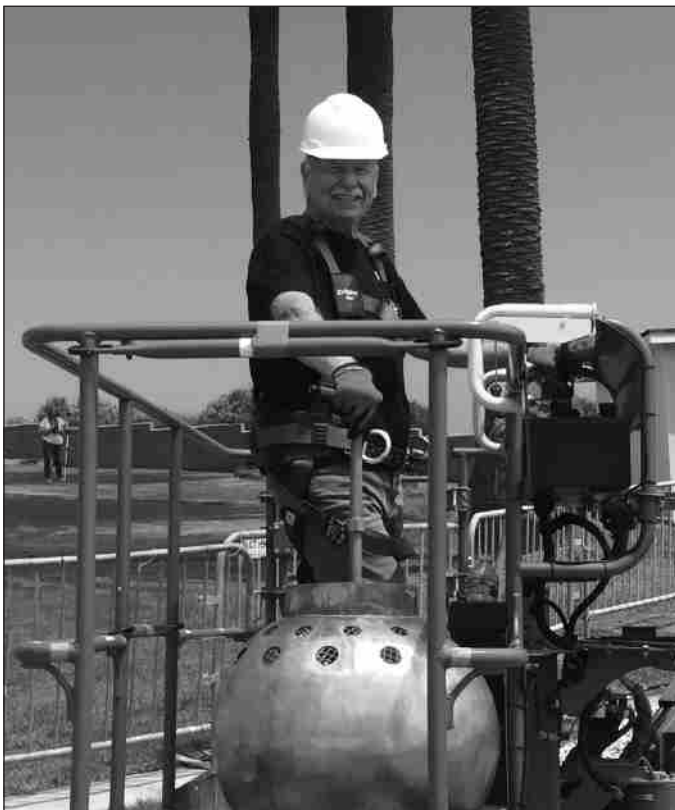
What a day when the lighthouse was finally crowned with its copper roof and ventilator system! No longer needing roof ventilation of long-ago-used oil lamps, the opening was sealed. Tower doors were then given “shutters” to allow air circulation. The shiny copper began overnight to oxidize in the sea air, returning the illusion of a painted black roof. Photo courtesy Kim Fahlen.

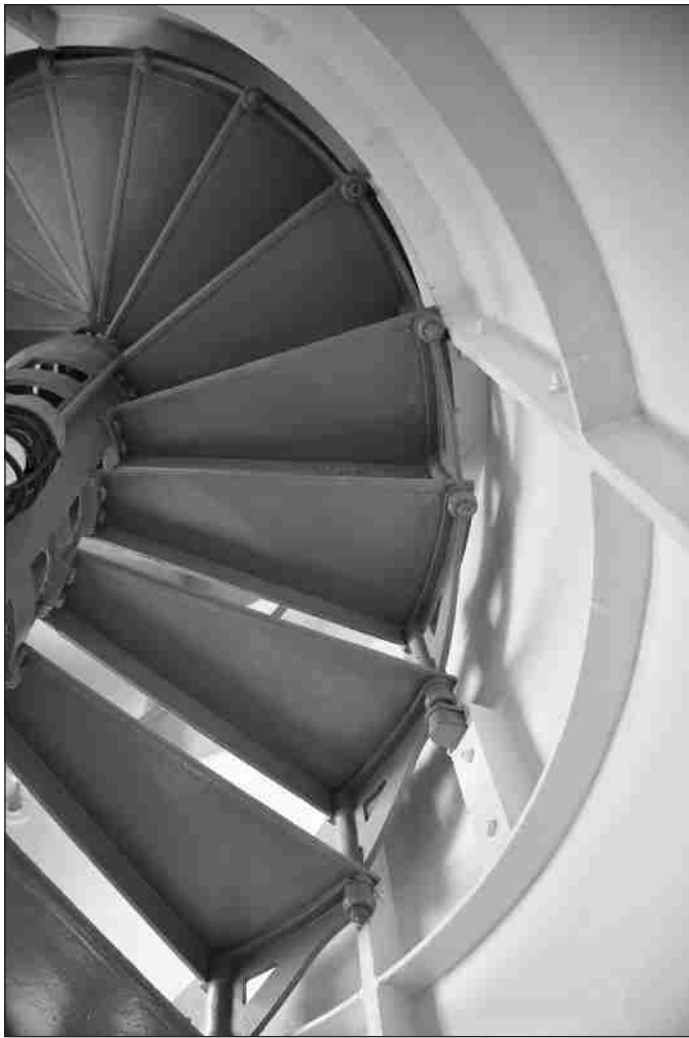
So tidy! Abrasive blasting away of old coatings and rusted surfaces have given way for today's sophisticated coatings. Inside the cylinder, stairs bolt to walls and central support, which before electricity, served as the clockwork-operated weight drop for Fresnel lens rotation. Photo courtesy of Kim Fahlen.
